Fluvial Geomorphological Assessment and Baseline Monitoring

Tributary of Etobicoke Creek

Snell's Hollow Secondary Plan Town of Caledon, Ontario

April 8, 2021
PN19033

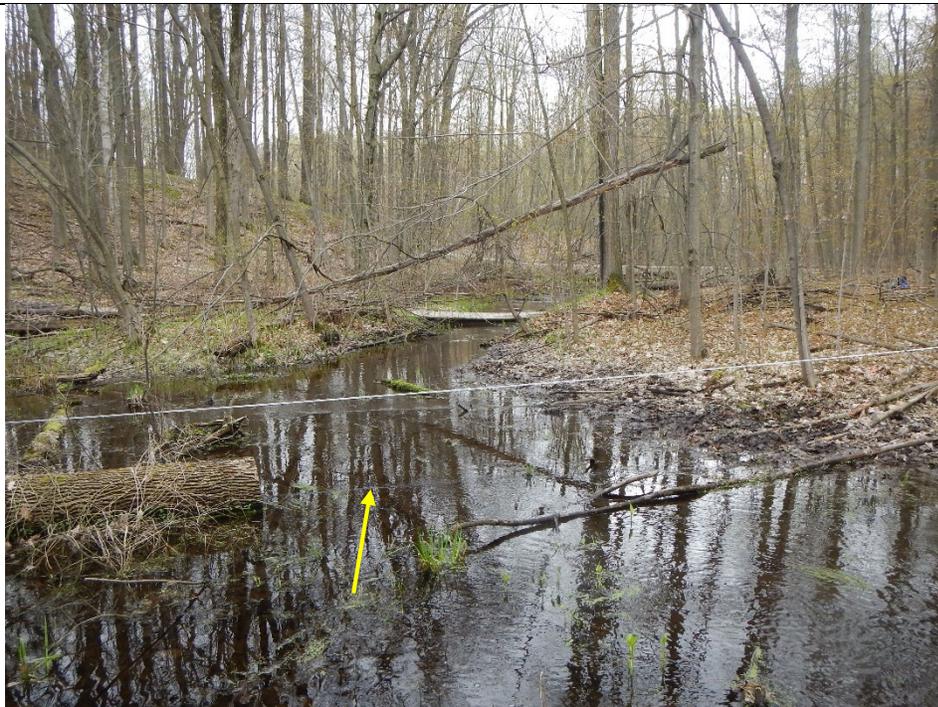
Photo 5
Tributary of Etobicoke Creek
Reach EC-1 Cross section 3-M

View of one of two pedestrian crossings observed in the reach.

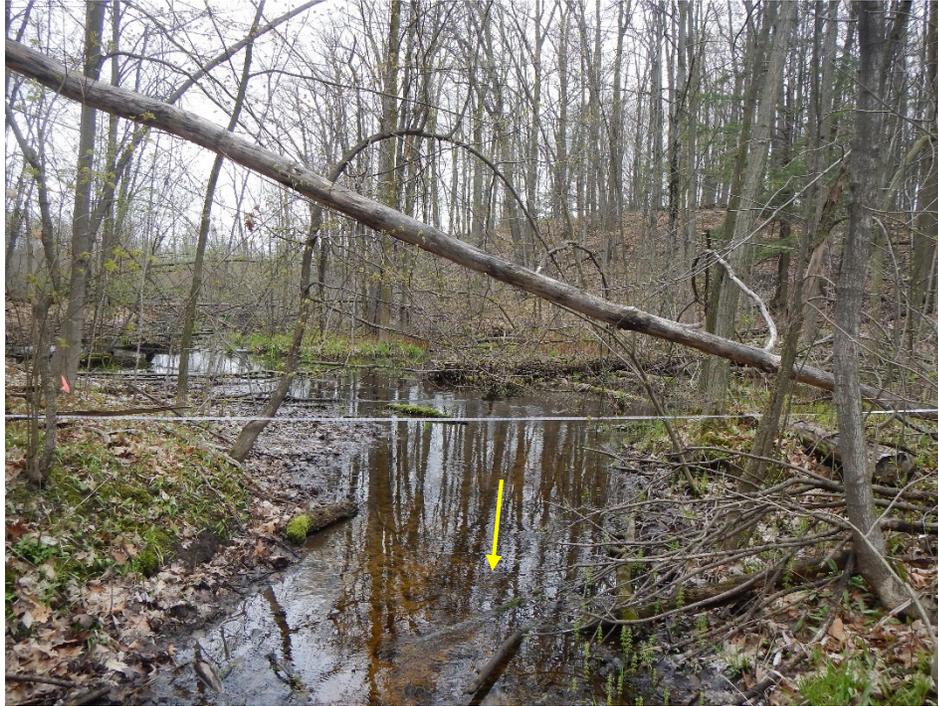
Photo 6
Tributary of Etobicoke Creek
Reach EC-1 Cross section 3-M

Representative view of one of two monumented cross sections installed as part of the detailed geomorphological assessment.

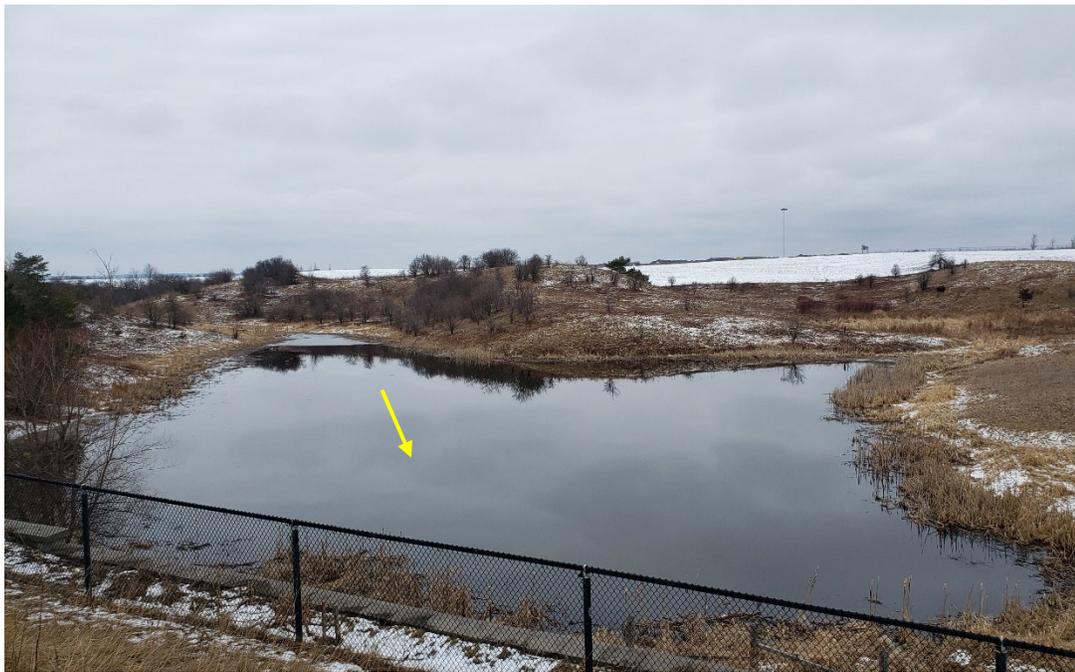
Photo 15
Tributary of Etobicoke Creek
Reach EC-2a

Photo taken from Mayfield Road, facing north towards the pond.

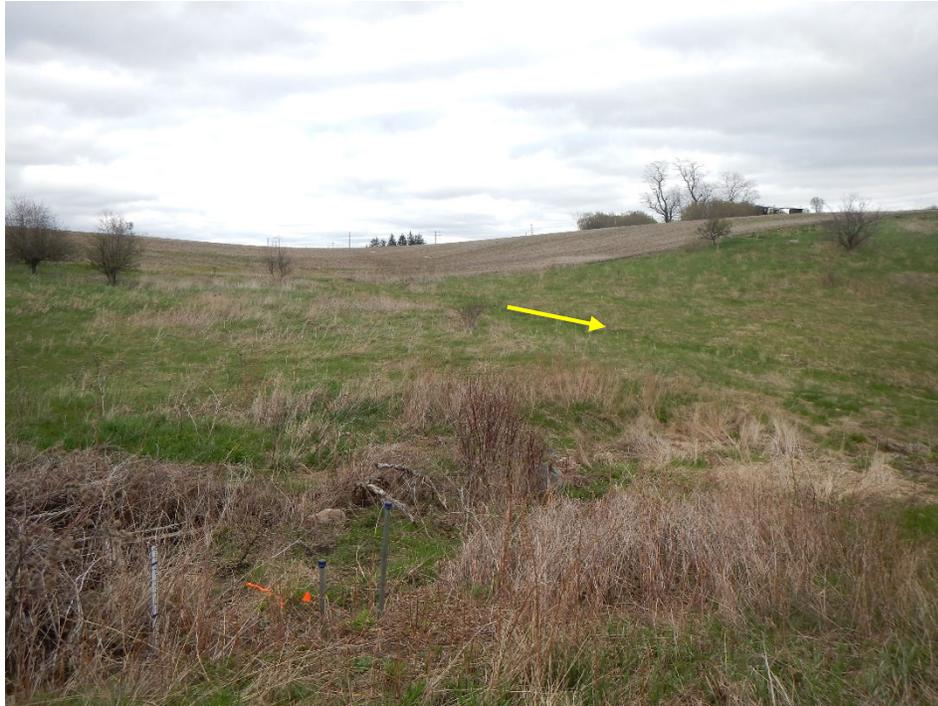
Photo 16
Tributary of Etobicoke Creek
Reach EC-2a

View of conditions mid-reach. Flows drain from adjacent agricultural fields and flow downslope to the pond feature.

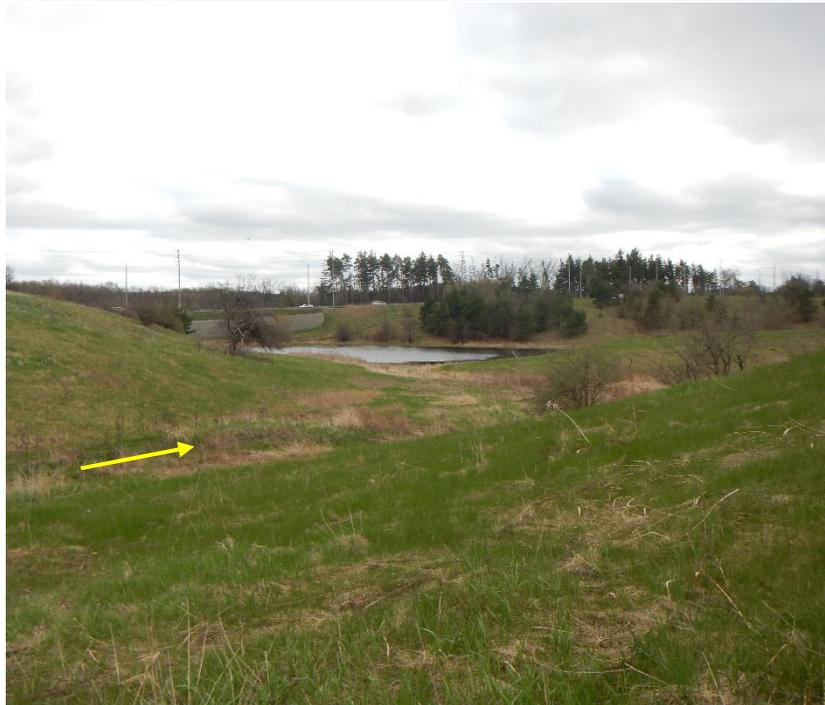
Photo 17
Tributary of Etobicoke Creek
Reach EC-2a

Photo taken from mid-reach towards the pond feature. The channel was poorly defined and lacked riffles and pools

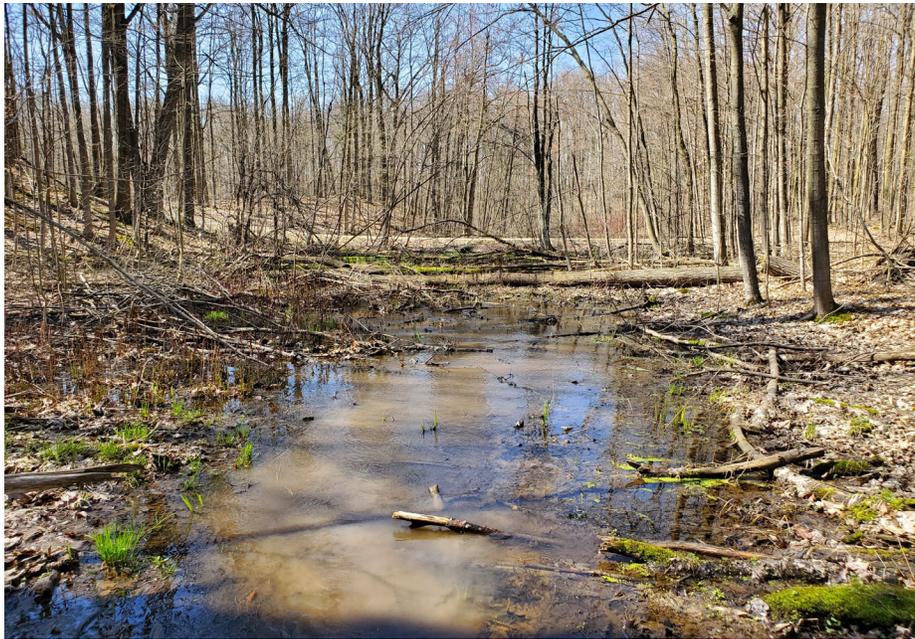
Cross Section 4 - Facing Downstream

Reach EC-1 consisted of a fairly straight and low gradient channel through a confined valley. The continuous and wide riparian buffer zone consisted of mature trees. The average bankfull width and depth were 17.95 m and 0.32 m. Bank materials ranged from clay to sand. Little to no bank erosion was observed. There were no riffles or pools. Bed materials consisted of organic material, clay, silt, and fine sand. Two trail crossings were present across the channel and valley. Woody debris was present within the channel but not due to the channel widening.
