**Appendix D:  
Rapid Field Assessment Sheets**

# Fluvial Geomorphology Field Key

**Rapid Geomorphic Assessment**

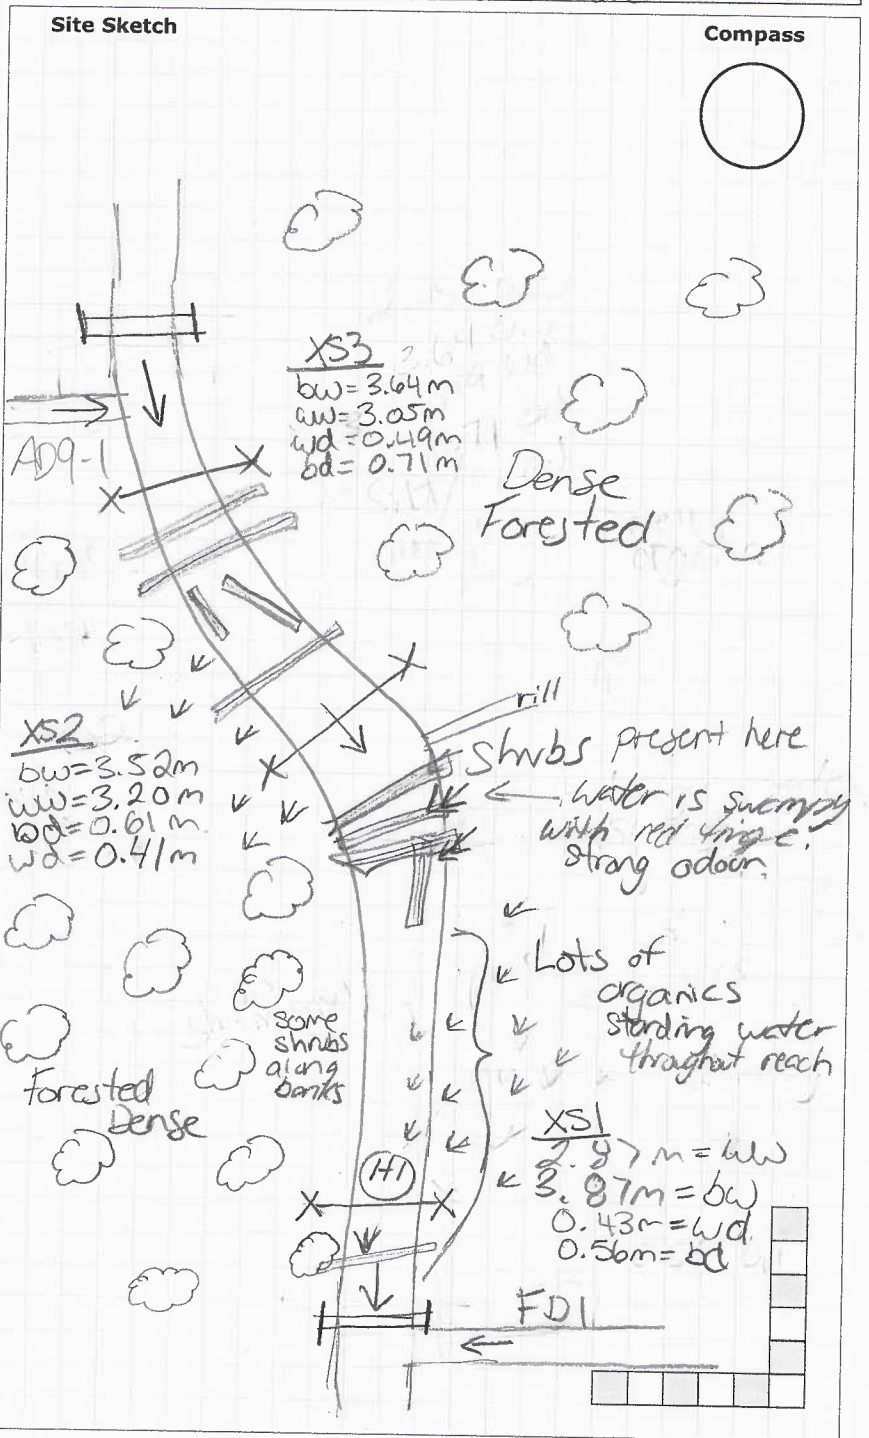
**Notes:** S1/S2 bed & bank substrate

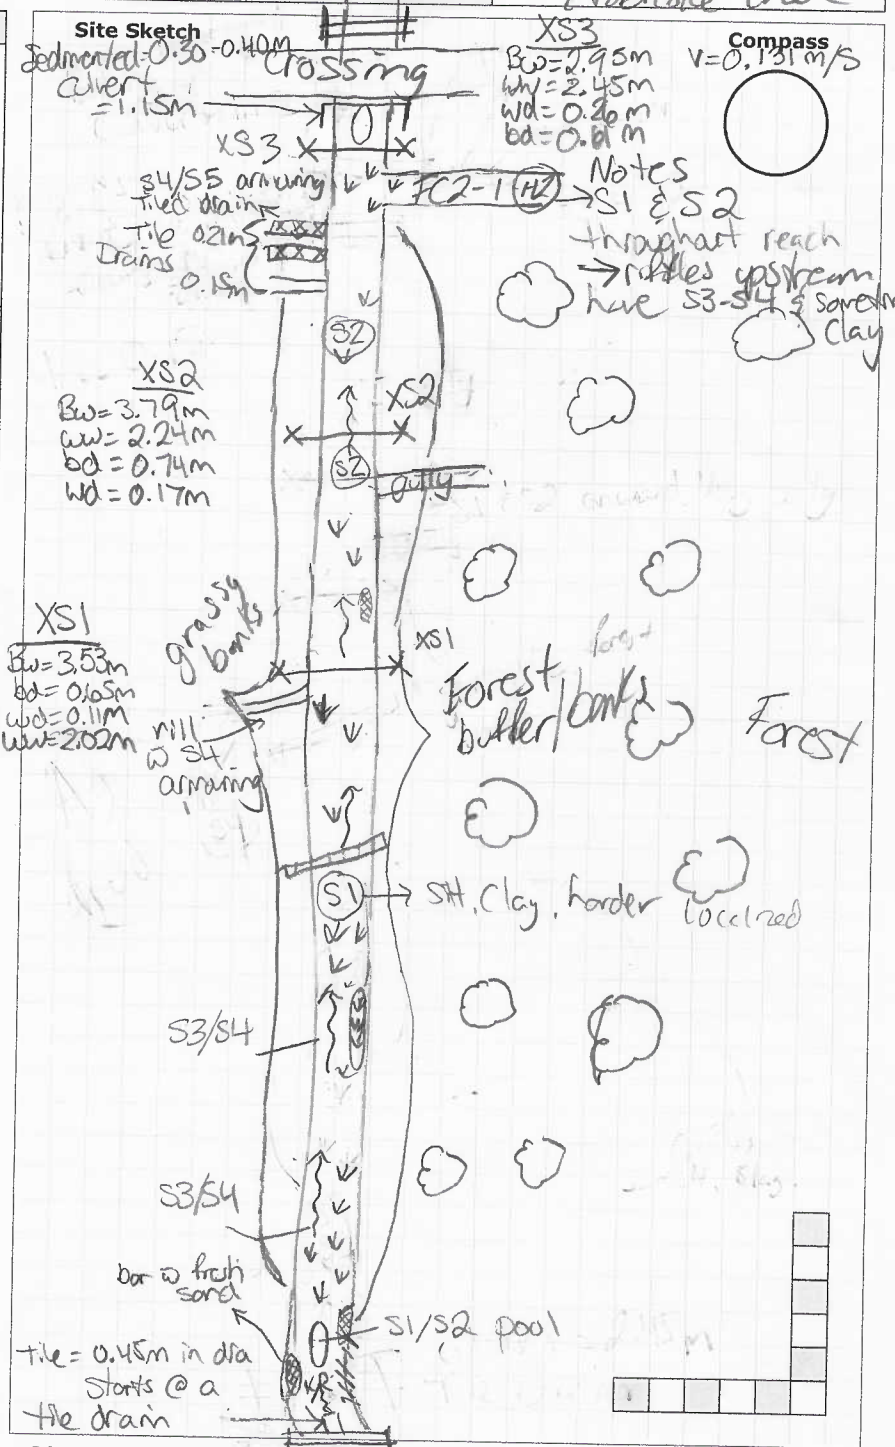
**Notes:** KP right after drain  
Silty throughout reach.

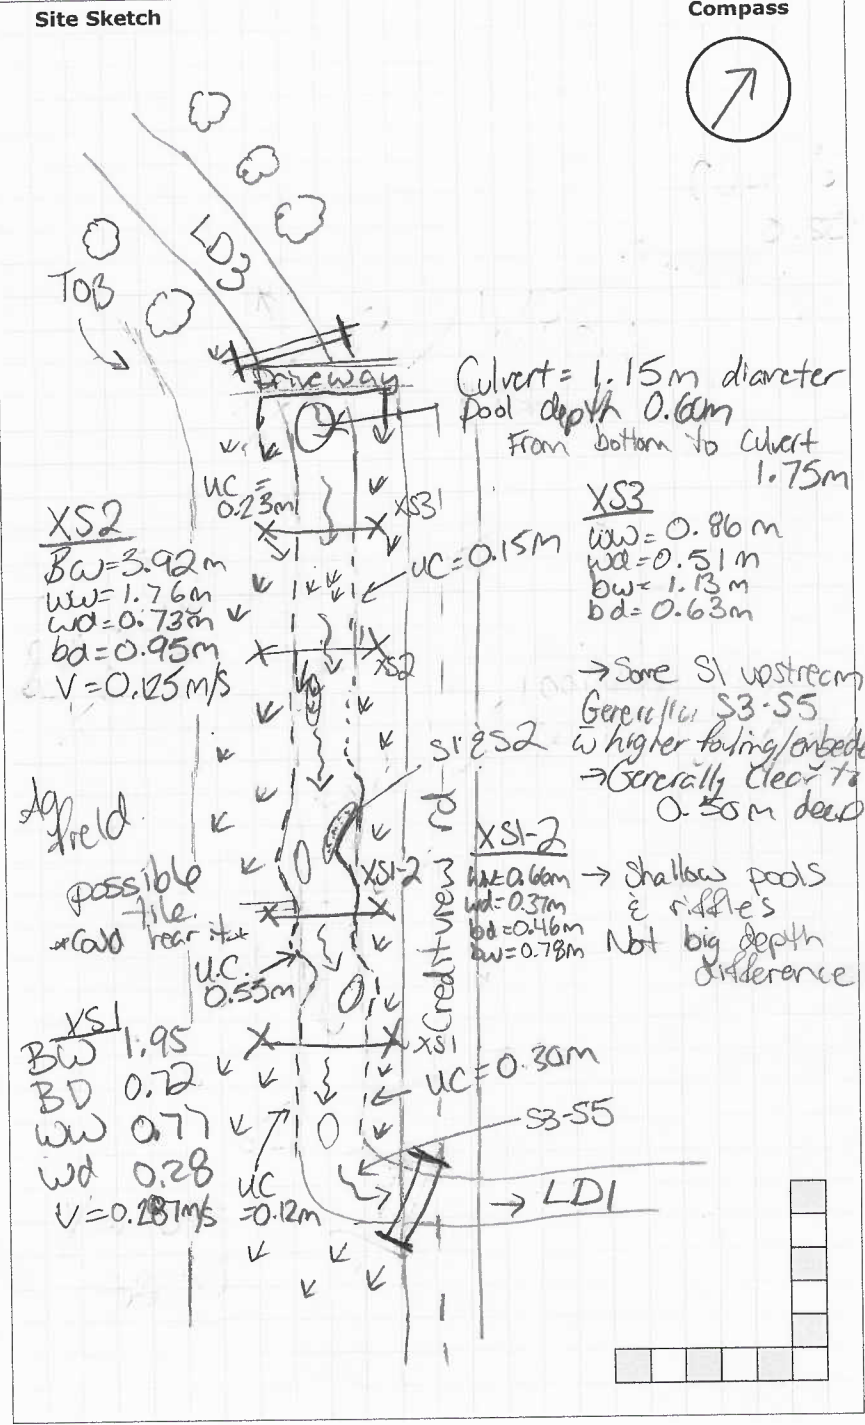
**Notes:** Multi-flow paths mid-reach

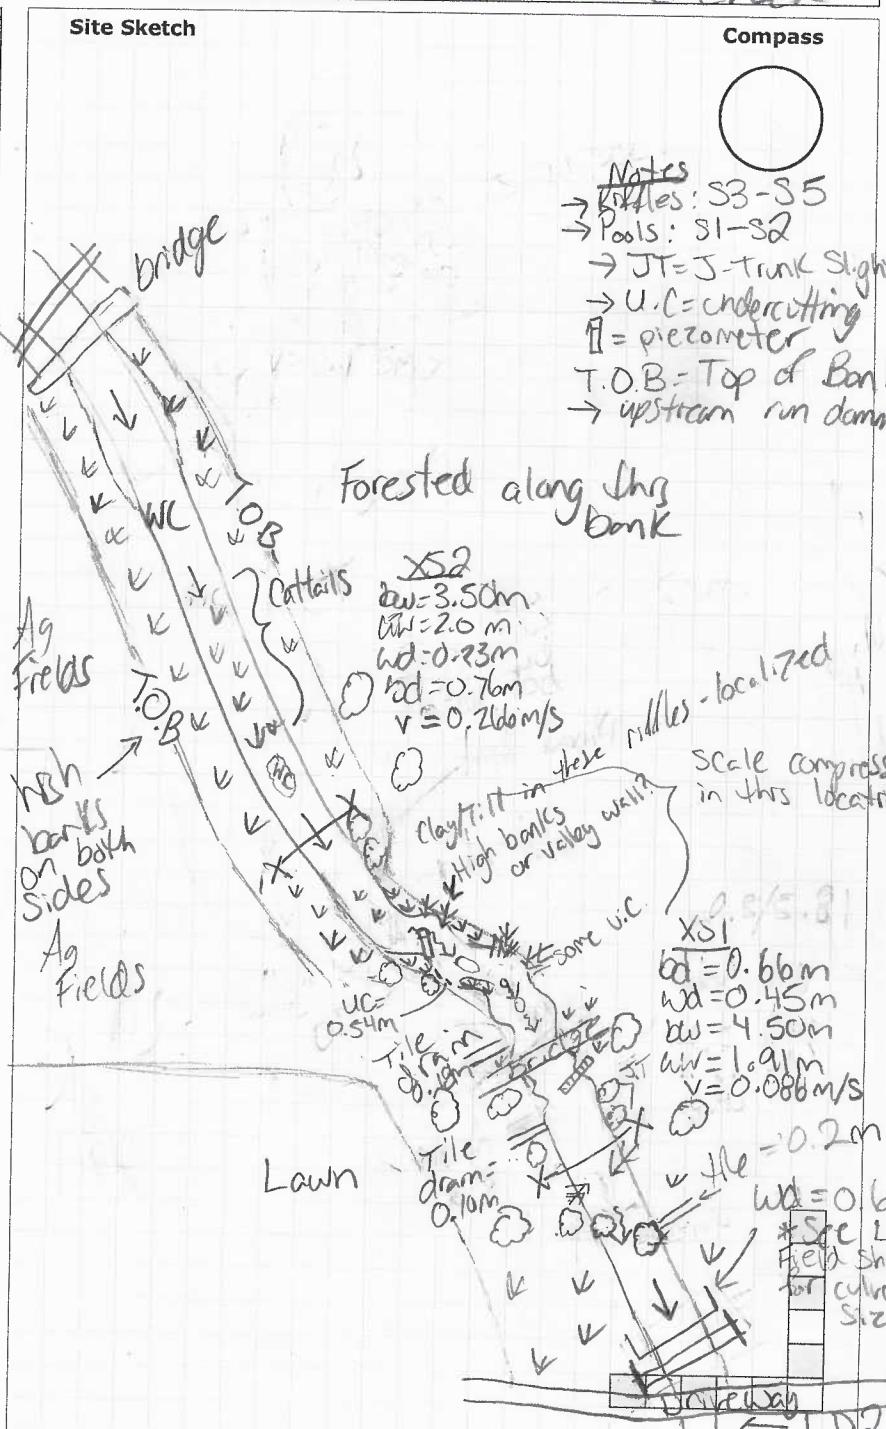
Notes: → Both bridges failing, however there are no loadings so not due to the watercourse.
