Fluvial Geomorphology Assessment and Conceptual Natural Corridor Designs

Alloa Secondary Plan Area – Phase 1 Lands
Caledon, Ontario

Submitted:
March 17, 2026

GEO Morphix Project No. 24018

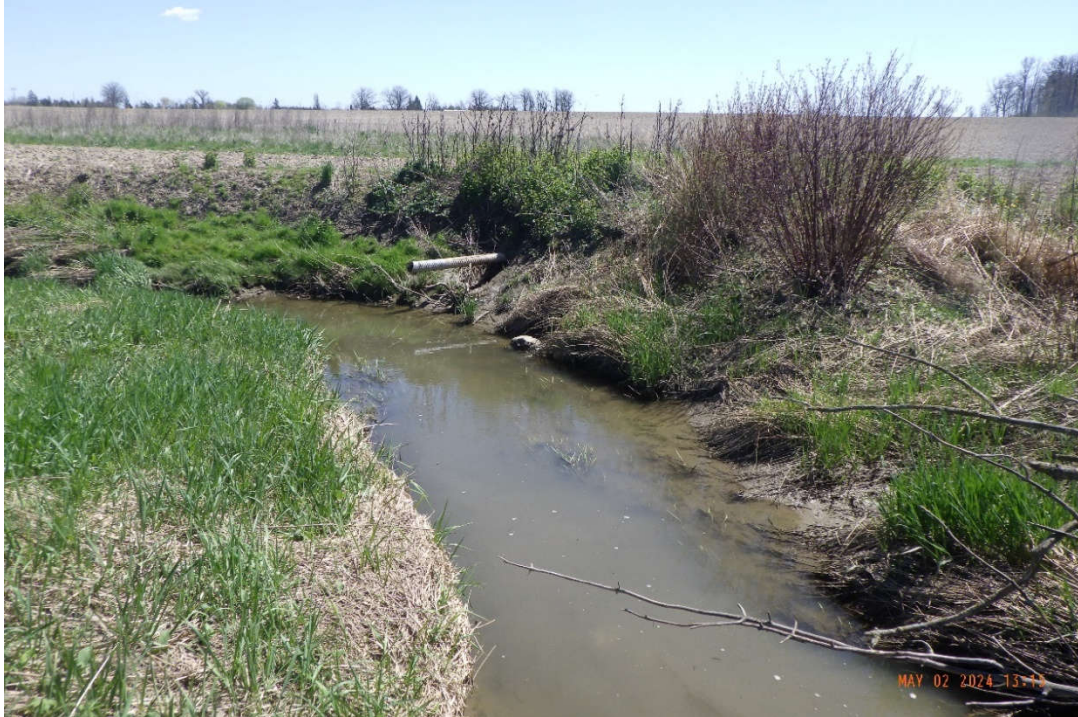
Photo 3
Alloa Drain - Reach AD2, Caledon, Ontario

An exposed tile drain that was previously buried was observed at an outer bank of a meander bend and was in poor condition.

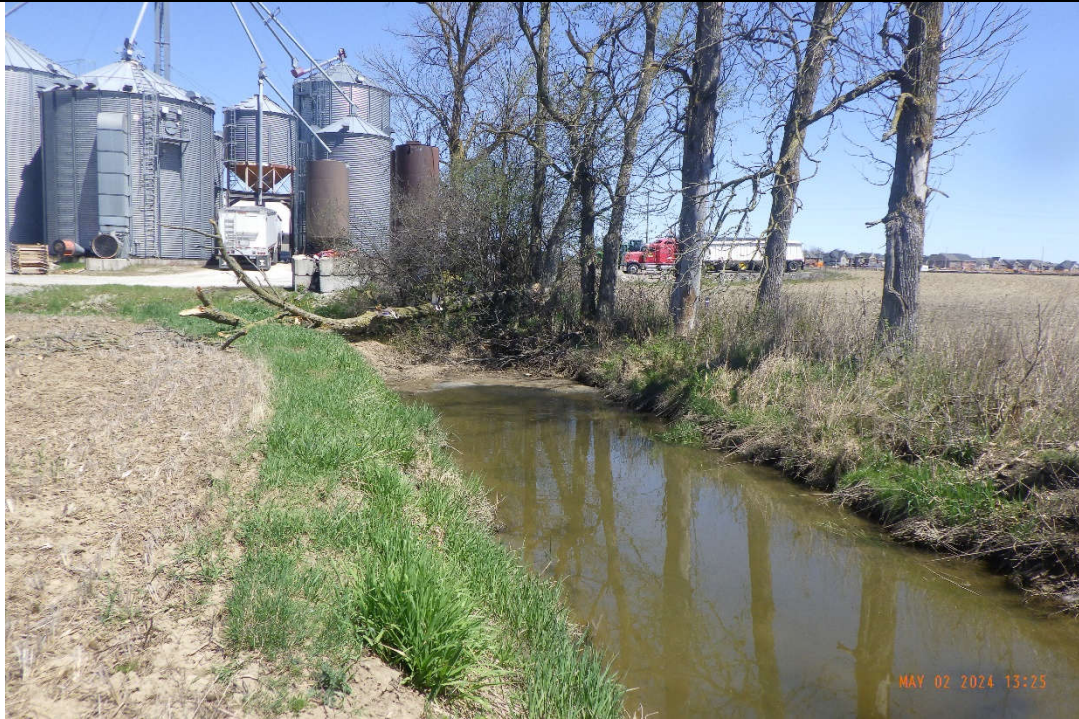
Photo 4
Alloa Drain - Reach AD2, Caledon, Ontario

Minimal erosion was observed within the reach, with localized undercutting in the downstream extent. Undercuts of up to 0.30 metres were measured.

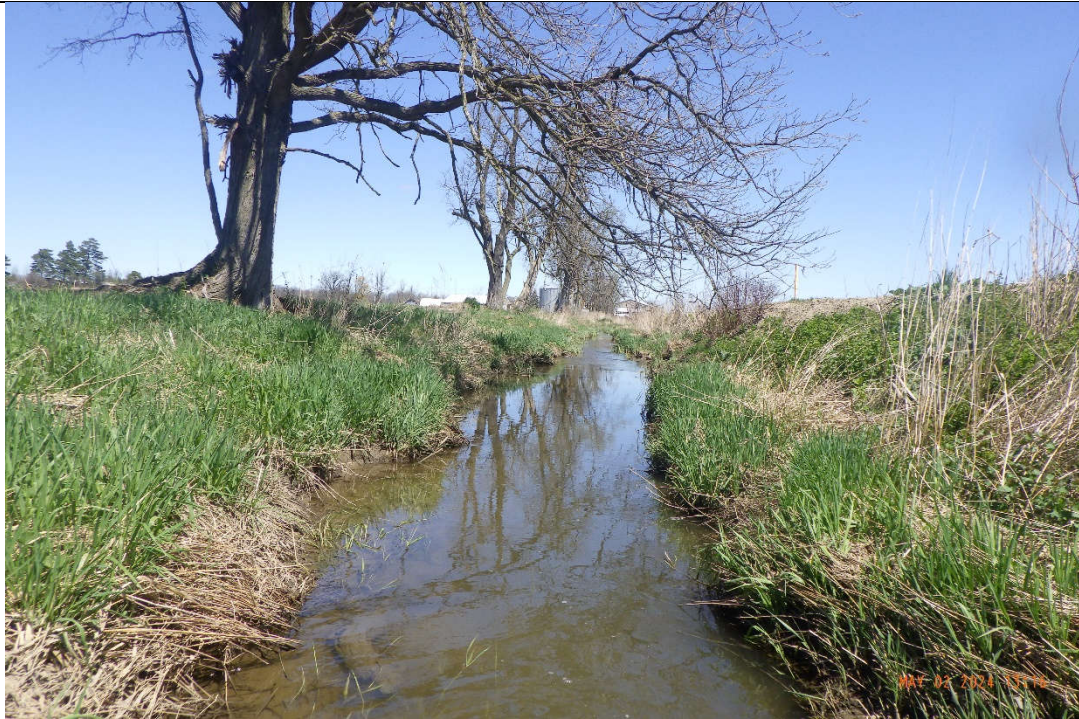
Photo 5
Alloa Drain - Reach AD3, Caledon, Ontario

The channel was straight, flowed between agricultural fields and was moderately entrenched.

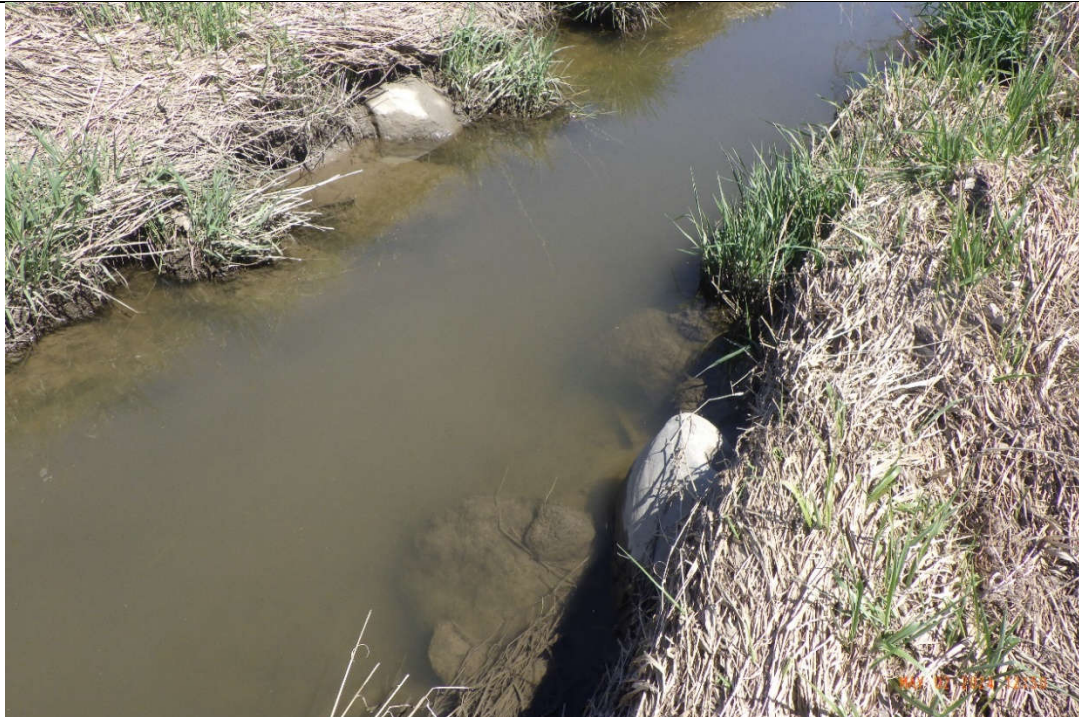
Photo 7
Alloa Drain - Reach AD3, Caledon, Ontario

Poor longitudinal sorting of bed materials was observed throughout the reach, with bed substrate ranging from clay/silt to cobbles. A few boulders were also present.

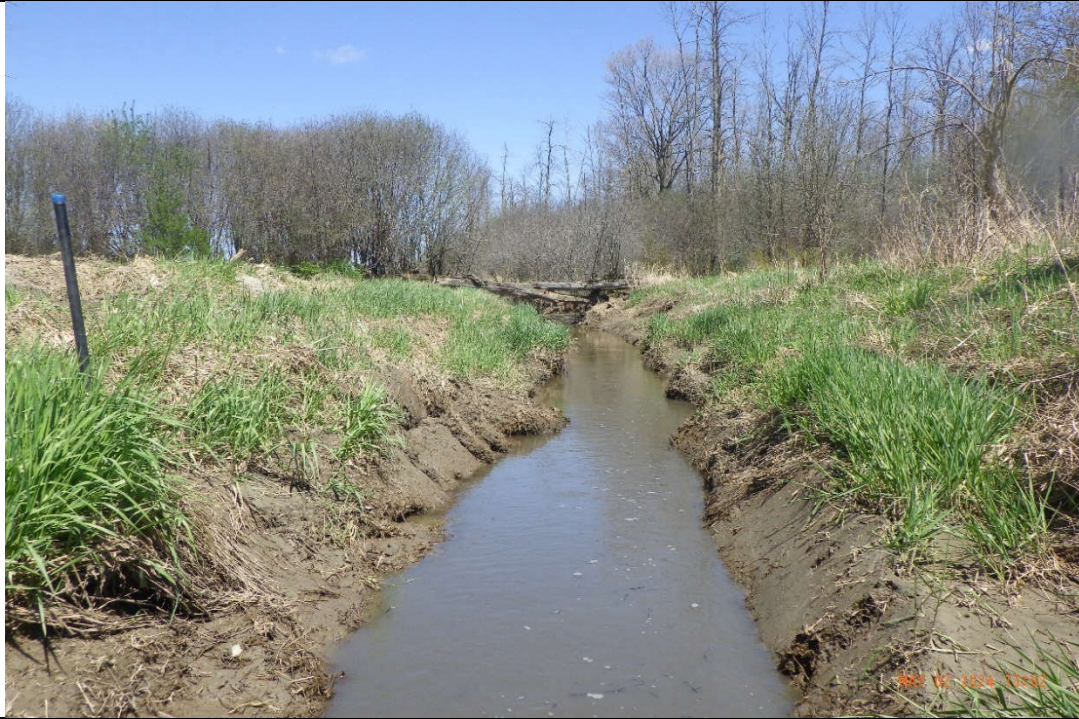
Photo 8
Alloa Drain - Reach AD3, Caledon, Ontario

One localized area in the downstream portion of the reach showed evidence of recent dredging (sloped bare banks).

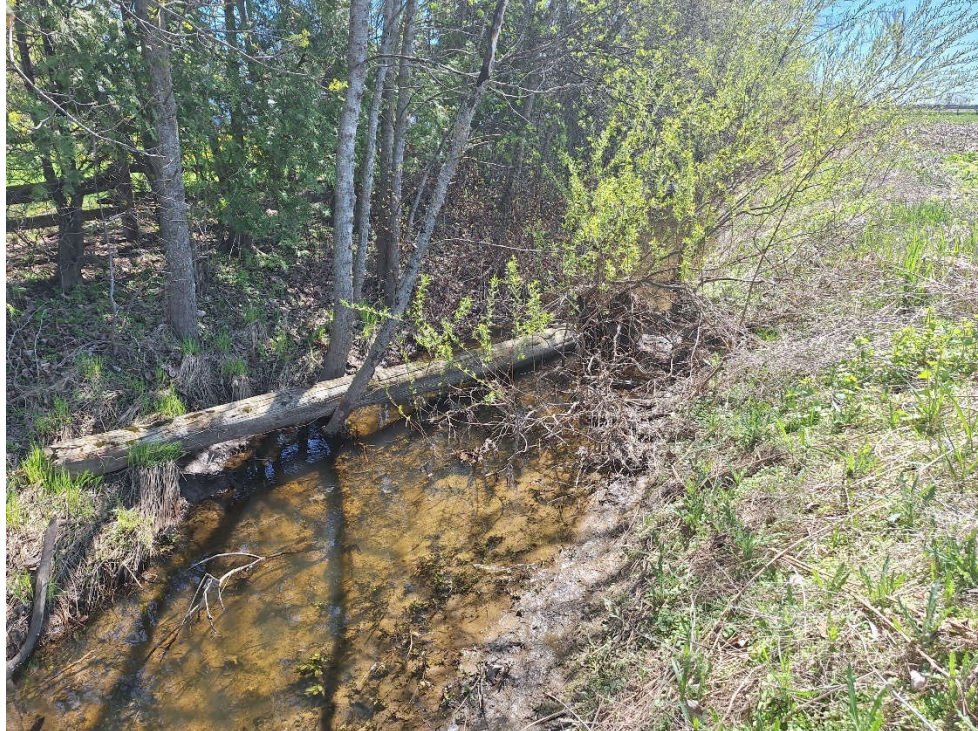
Photo 14
Lyons Drain - Reach LD1, Caledon, Ontario

Leaning and fallen trees were observed along the reach.

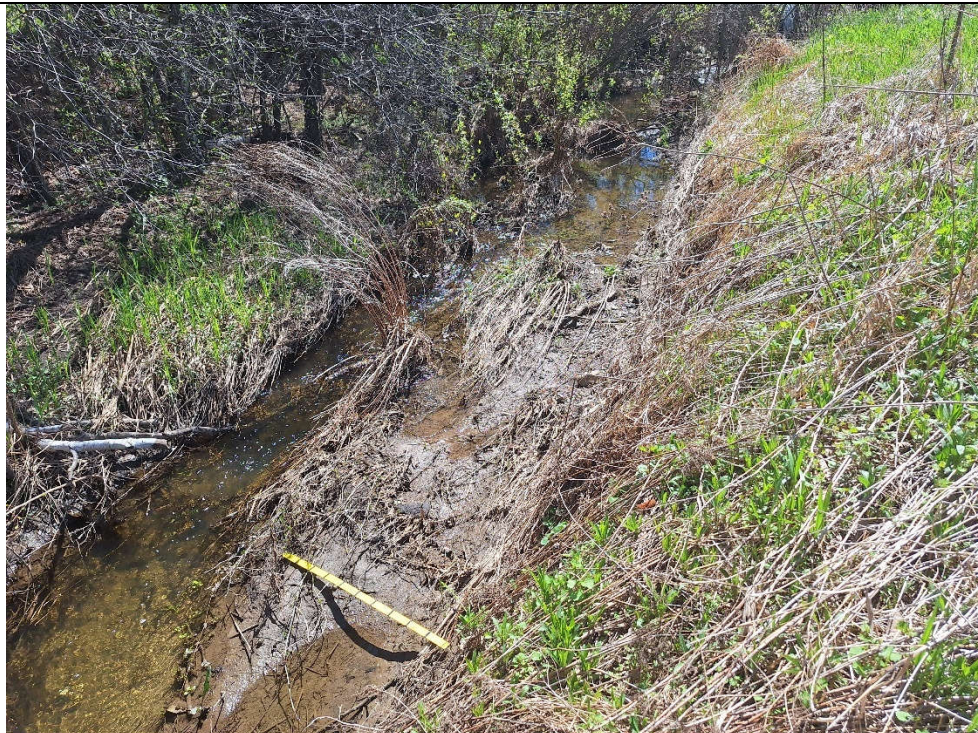
Photo 15
Lyons Drain - Reach LD1, Caledon, Ontario

There were minimal bar forms present throughout the reach but those observed were accreting.

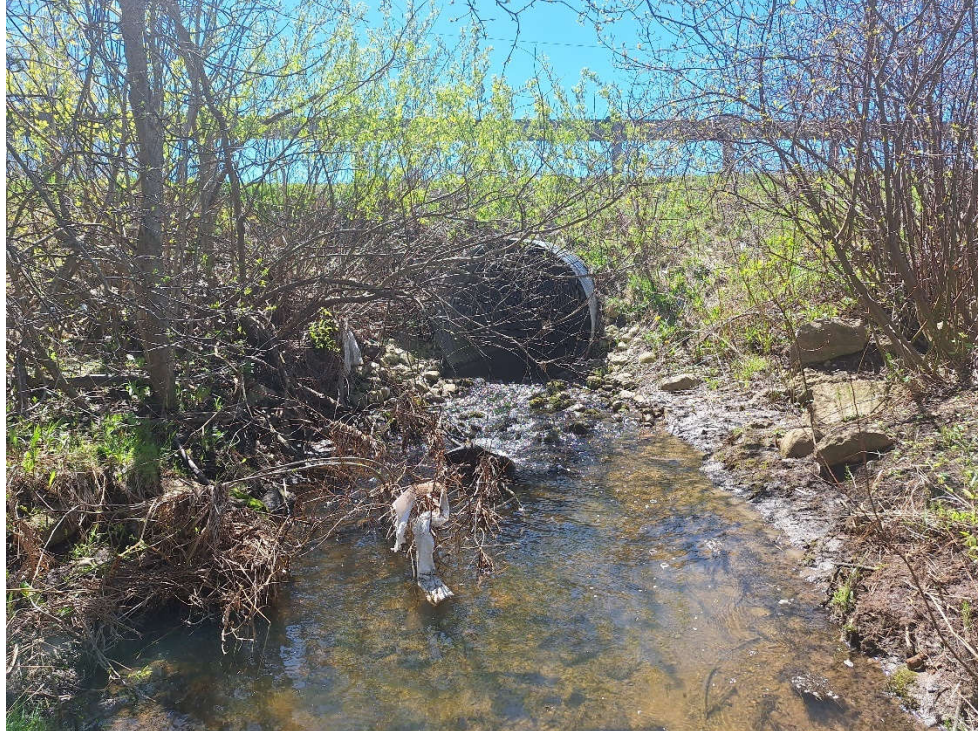
Photo 16
Lyons Drain - Reach LD1, Caledon, Ontario

The reach was run-dominant with a lack of riffle pool morphology. One artificial riffle was identified at the culvert at Creditview Road.
