Fluvial Geomorphology Assessment and Conceptual Natural Corridor Design

**Mount Hope West Secondary Plan Area
Local Subwatershed Study**
Town of Caledon, Ontario

Submitted:
February 25, 2026

GEO Morphix Project No. 25026

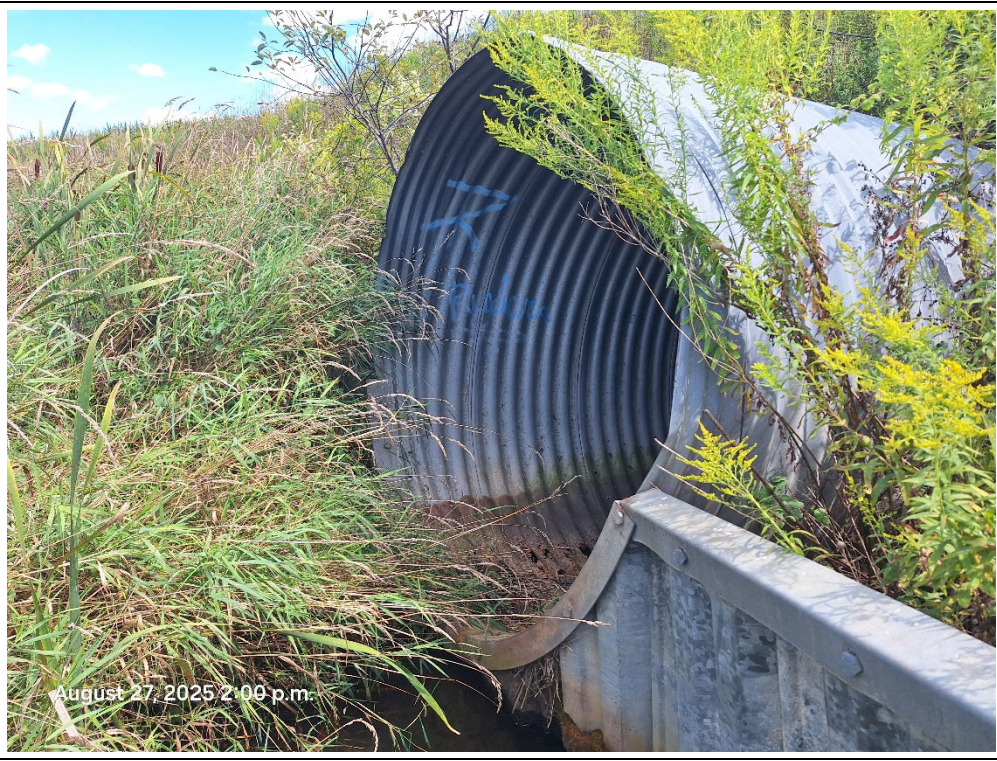
Photo 1
Tributary of Humber River– Reach THRE-1-1
Caledon, Ontario

The culvert crossing Columbia Way was positioned at the confluence of two reaches, was perched above the channel bed, and was in disrepair.

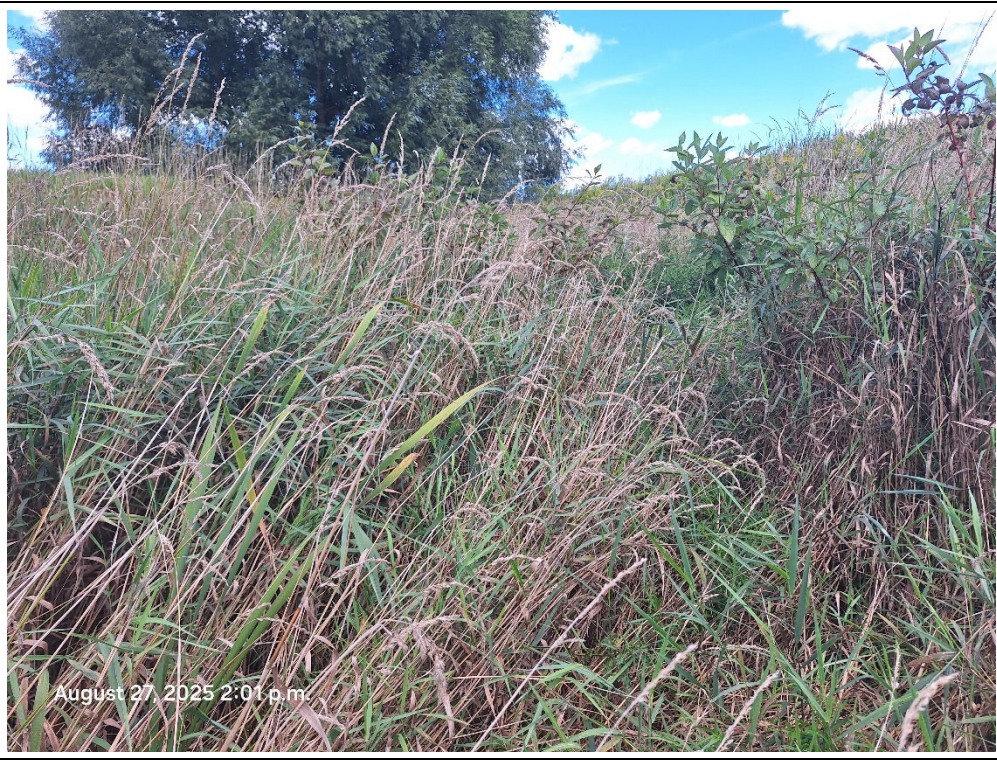
Photo 2
Tributary of Humber River– Reach THRE-1-1
Caledon, Ontario

Photo of Reach **THRE-1-1** facing upstream from the culvert at Columbia Way, where the watercourse was positioned within a shallow valley.

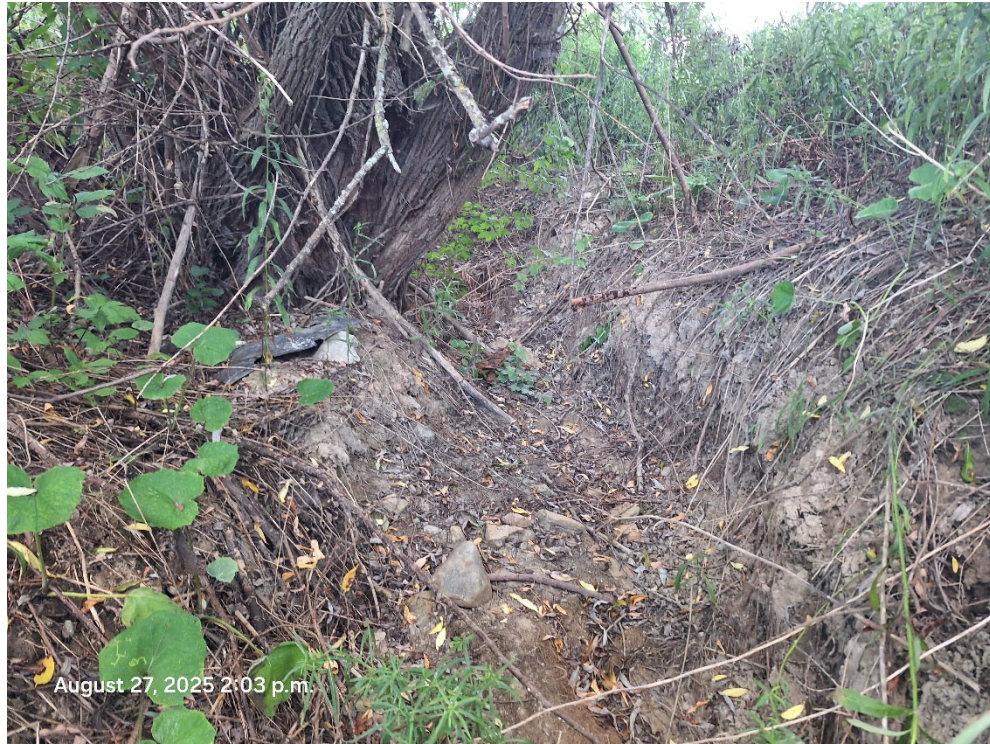
Photo 3
Tributary of Humber River– Reach THRE-1-1
Caledon, Ontario

The downstream extent of the reach was defined adjacent to a tree, with local scour on both banks and exposed roots.

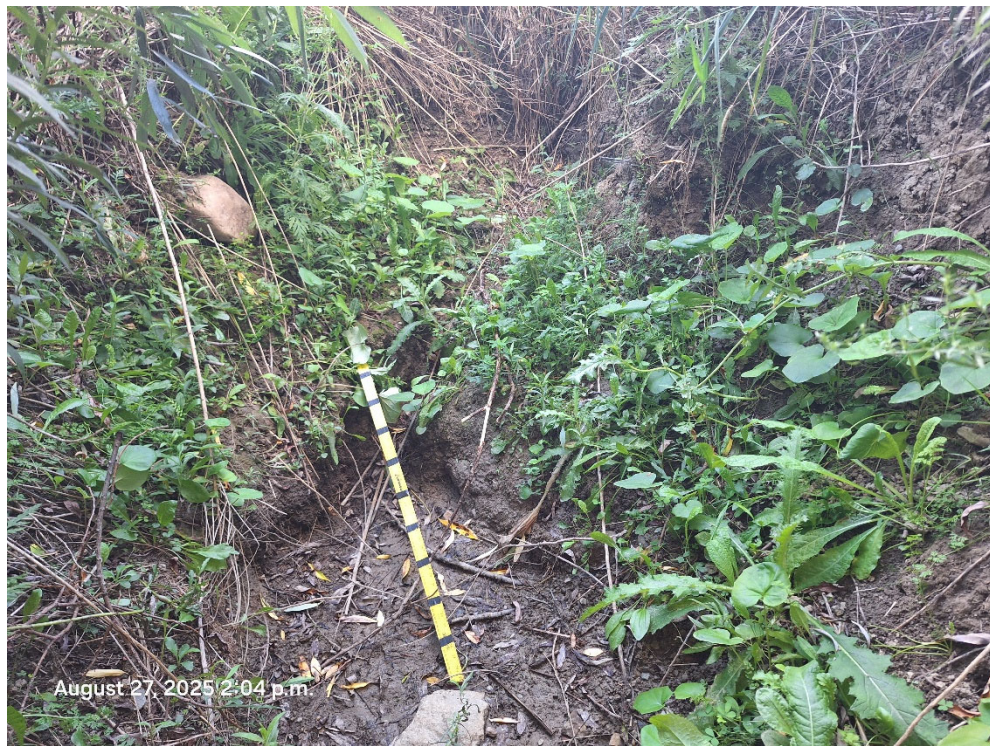
Photo 4
Tributary of Humber River– Reach THRE-1-1
Caledon, Ontario

Photo of Reach **THRE-1-1** facing upstream. Two knickpoints, 0.55 m and 0.63 m in height, were present where the reach transitioned from the agricultural field to the shallow valley.

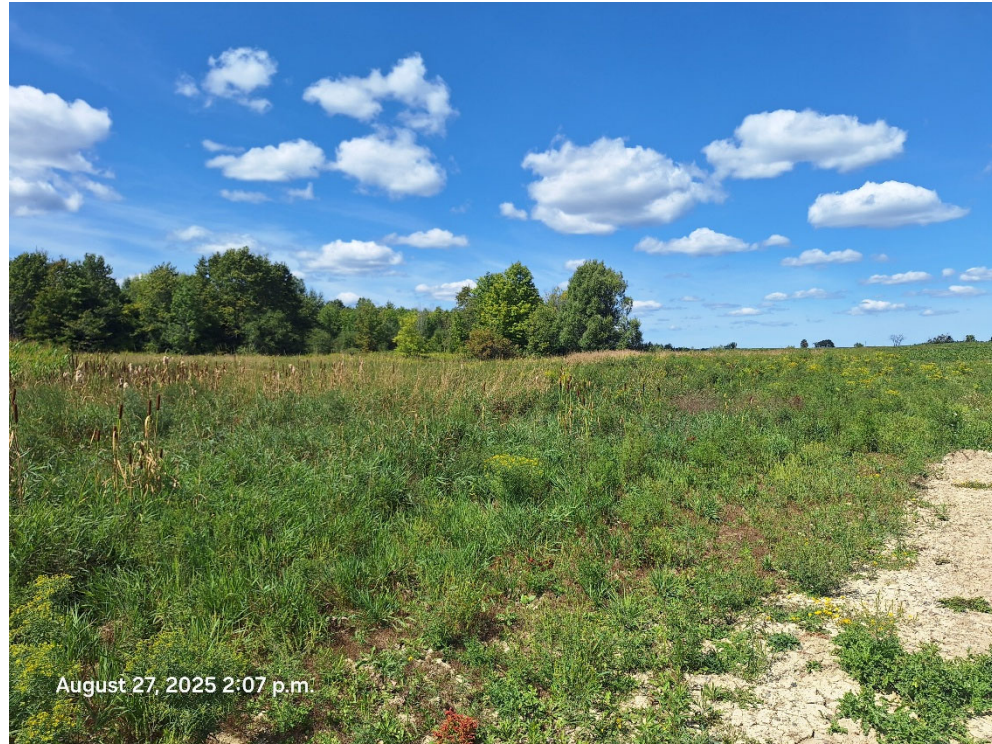
Photo 5
Tributary of Humber River– Reach THRE-1-1-1
Caledon, Ontario

The edge of the tree line to the left represents the reach break between **THRE-1-1** and **THRE-1-2**. Vegetation heavily encroached into the channel.

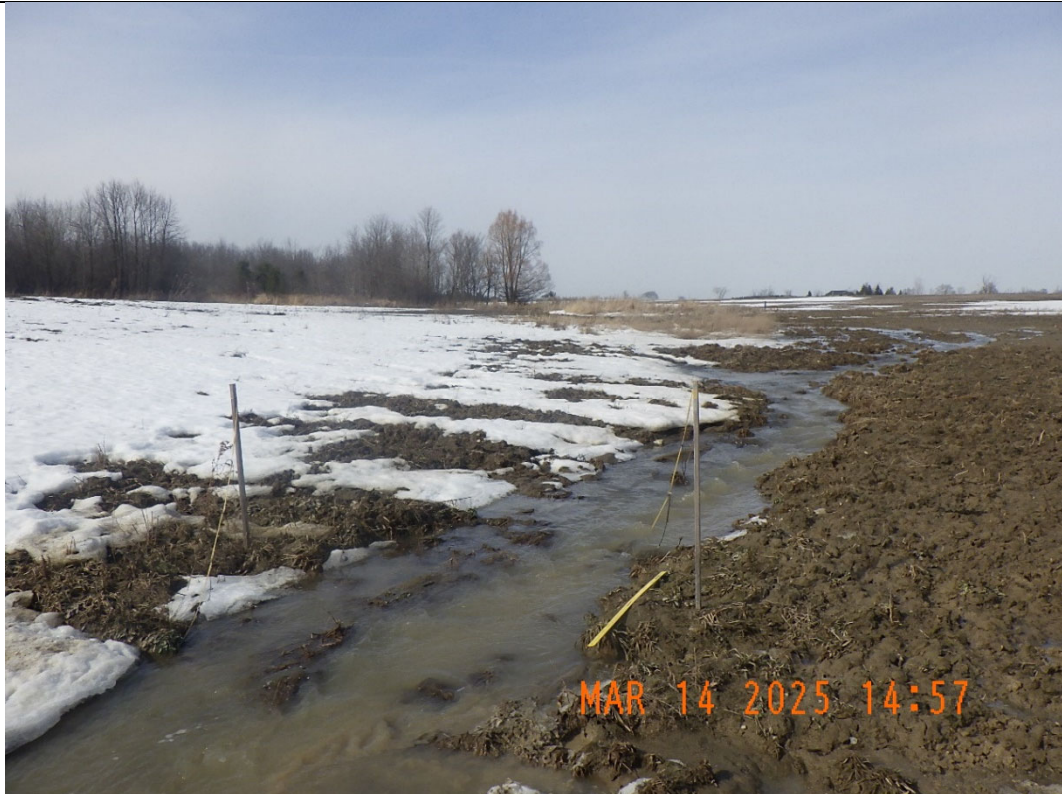
Photo 6
Tributary of Humber River– Reach THRE-1-1-1
Caledon, Ontario

Photo of Reach **THRE-1-1** taken facing upstream. The reach appeared to be ploughed to the edge of channel, which was poorly defined.

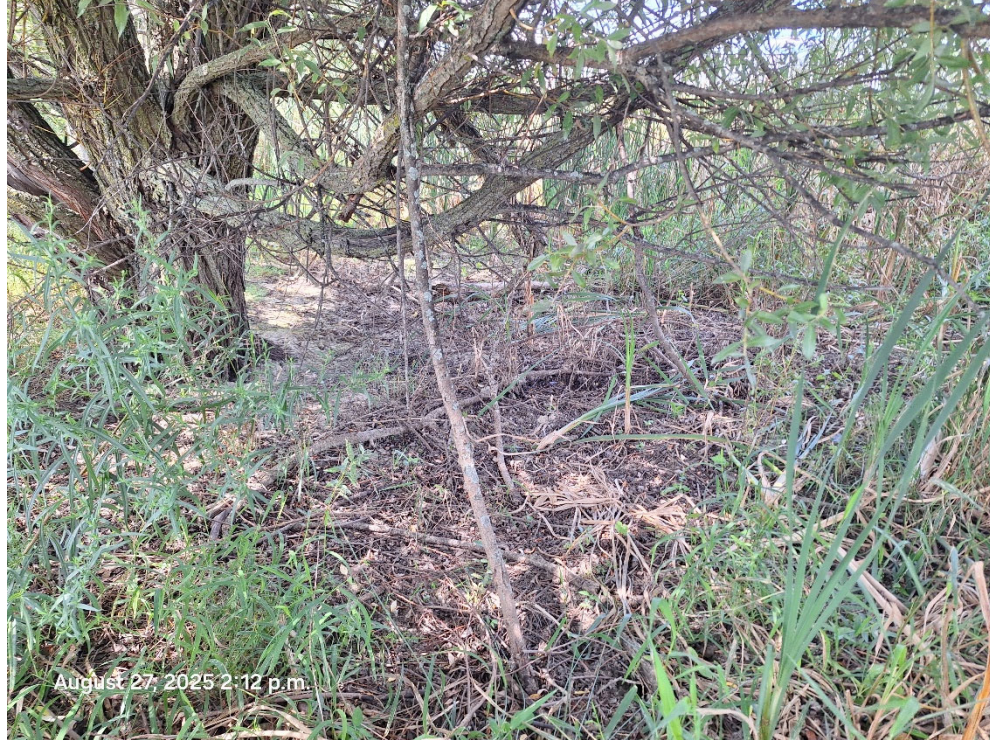
Photo 7
Tributary of Humber River– Reach THRE-1-2
Caledon, Ontario

Photo of Reach **THRE-1-2** taken facing downstream. The channel had little to no definition at the downstream extent of the reach.

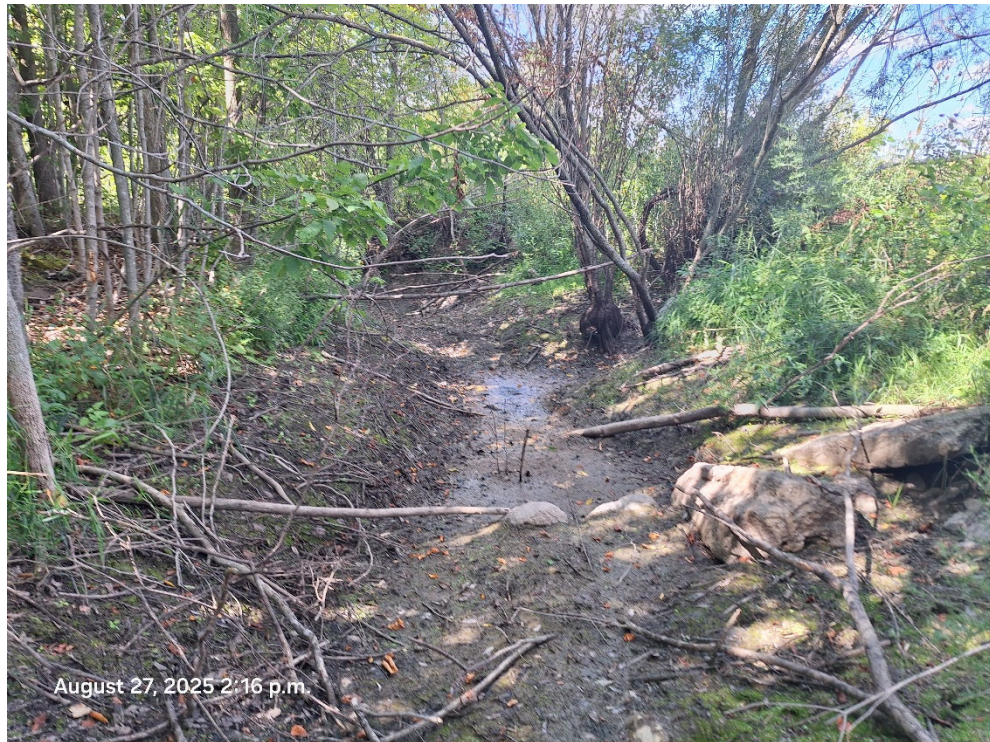
Photo 8
Tributary of Humber River– Reach THRE-1-2
Caledon, Ontario

Most of the substrate within the reach was comprised of clay and silt, with occasional boulders and cobbles. Woody debris was common and basal scour was intermittent.

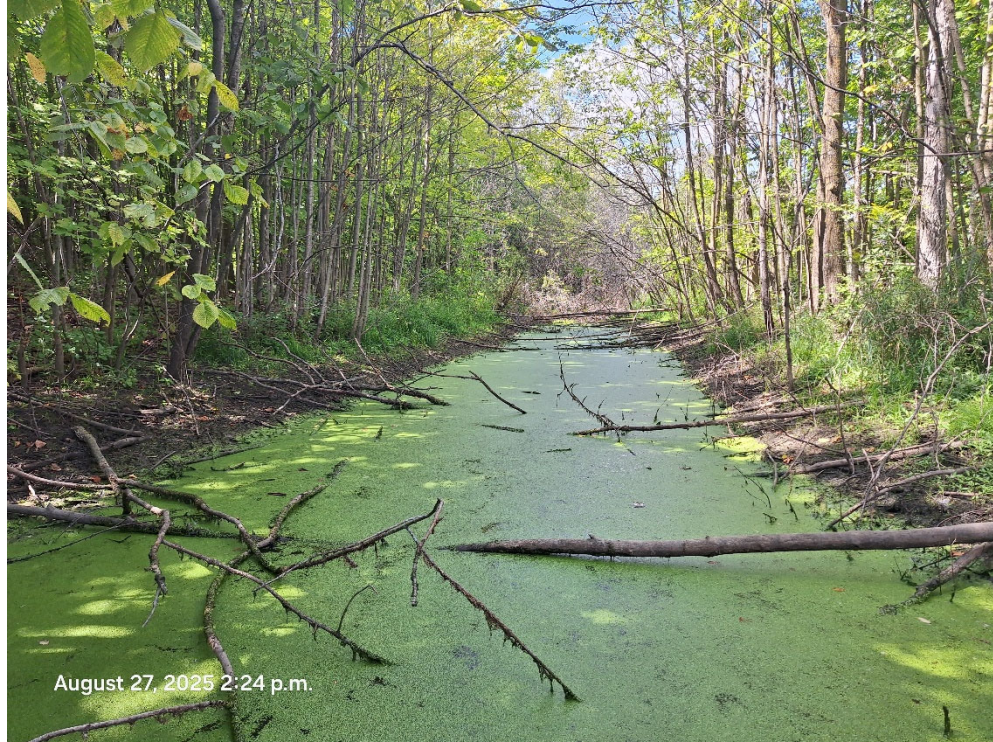
Photo 9
Tributary of Humber River– Reach THRE-1-2
Caledon, Ontario

Towards the upstream extent of the reach, the channel widened and the surface was covered in duckweed. Fallen trees crossed the channel.

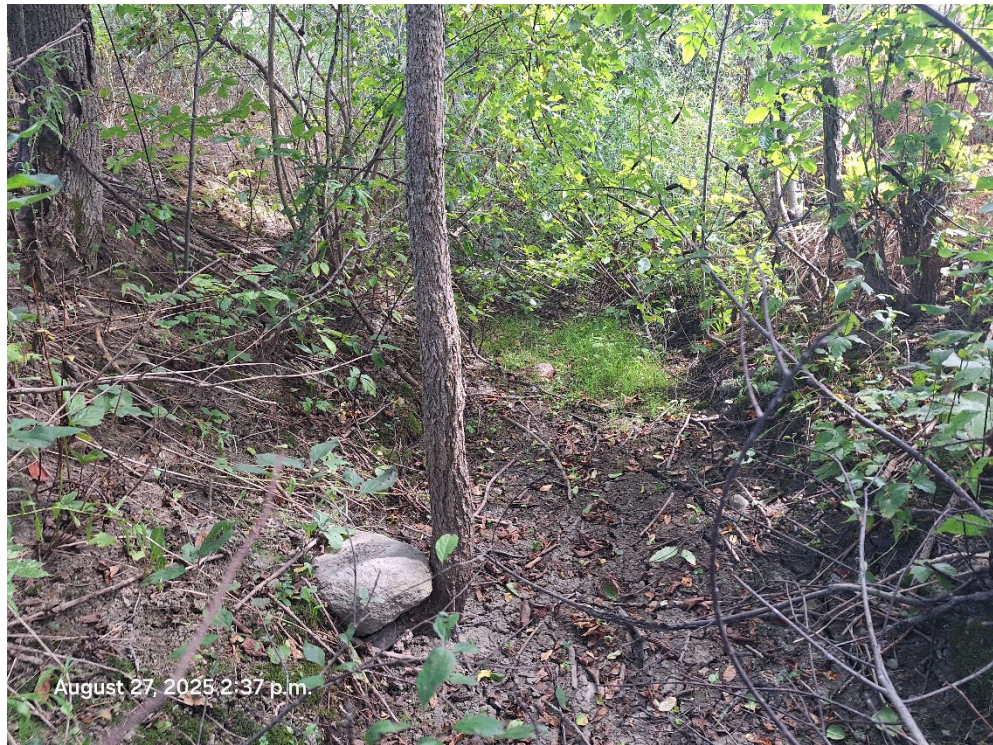
Photo 10
Tributary of Humber River– Reach THRE-1-2
Caledon, Ontario

Photo of Reach **THRE-1-2** taken facing upstream just before the reach break, where the trees were denser and encroached the channel, which narrowed.

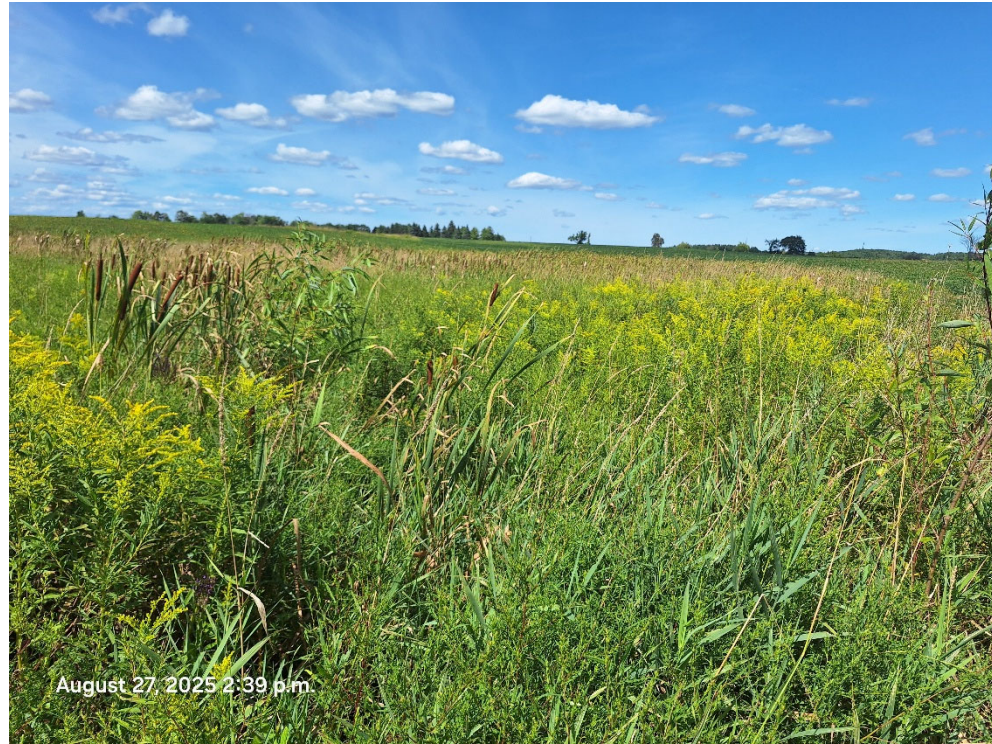
Photo 11
Tributary of Humber River– Reach THRE-1-3
Caledon, Ontario

Photo of Reach **THRE-1-3** taken facing upstream from the downstream reach break. The channel was encroached with little to no definition.

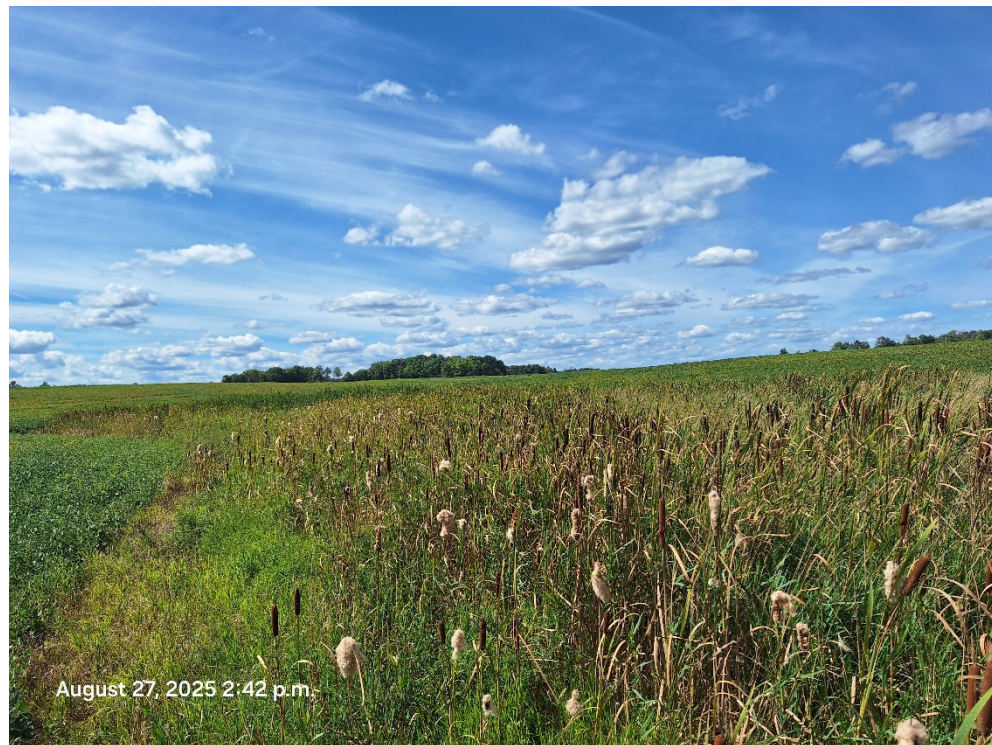
Photo 12
Tributary of Humber River– Reach THRE-1-3
Caledon, Ontario

The area was vegetated with hydrophilic emergent vegetation such as cattails and the channel was undefined.

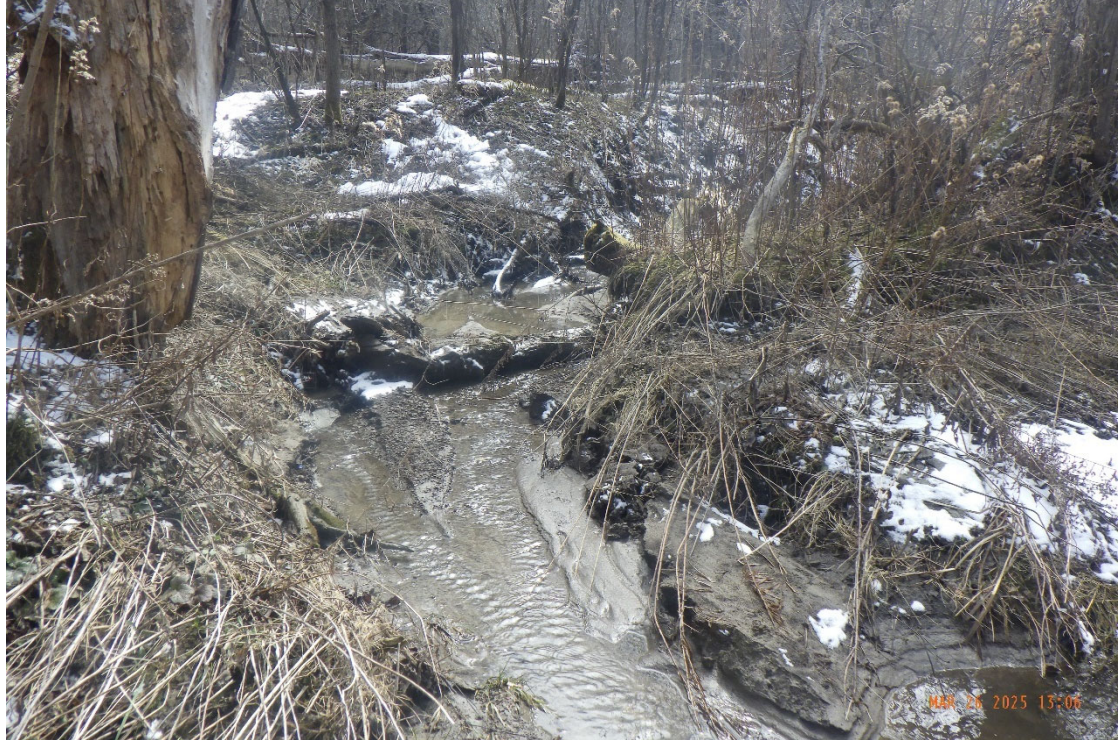
Photo 13
Tributary of Humber River, Reach- THRF-1
Caledon, Ontario

Photograph taken facing upstream at the downstream extent of **Reach THRF-1**. The channel flowed through a continuous, mature forest. Sand and gravel deposits were noted on the channel bed at the downstream extent of the reach.

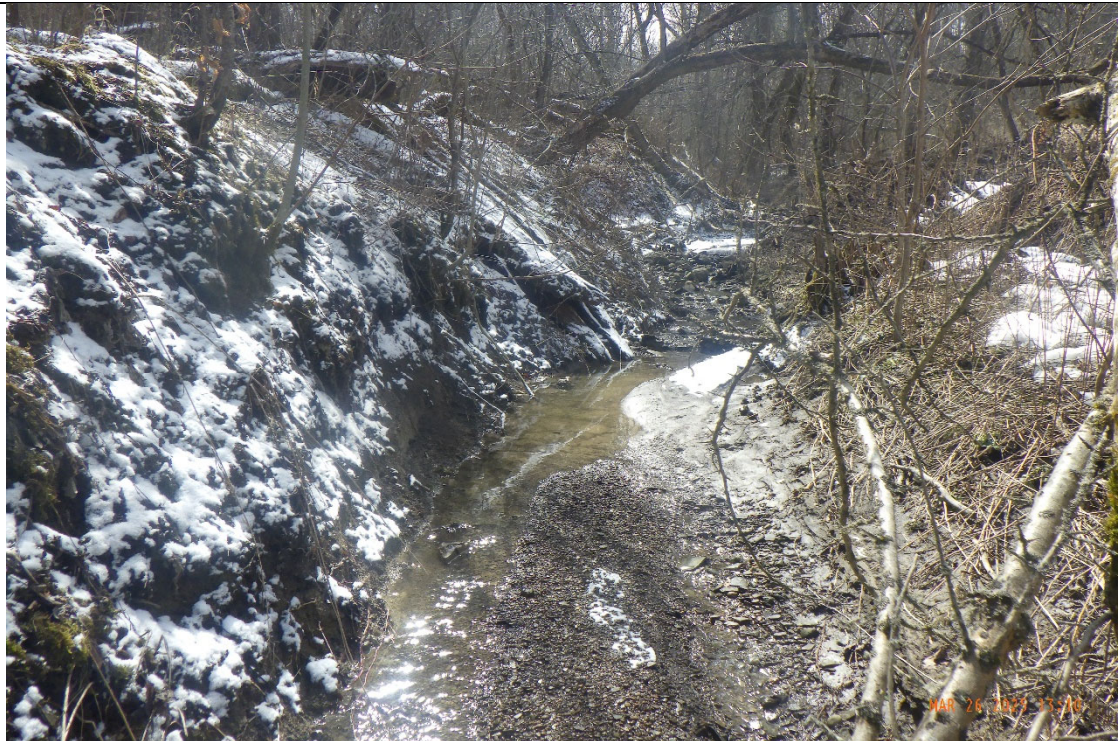
Photo 14
Tributary of Humber River, Reach- THRF-1
B Caledon, Ontario

Banks were generally high and steep, and erosion was common. At this location banks were measured to be 1.8 m.

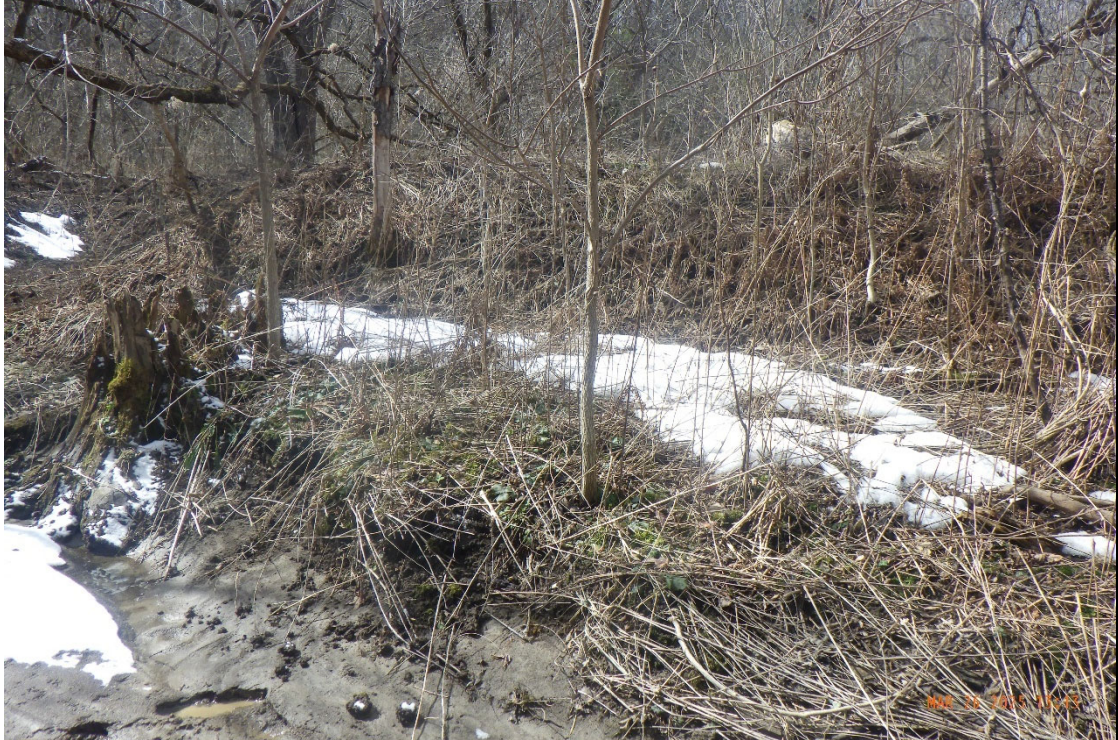
Tributary of Humber River, Reach- THRF-1
Caledon, Ontario

Photograph taken facing the left bank (facing downstream) of a terrace cut through older bar material.

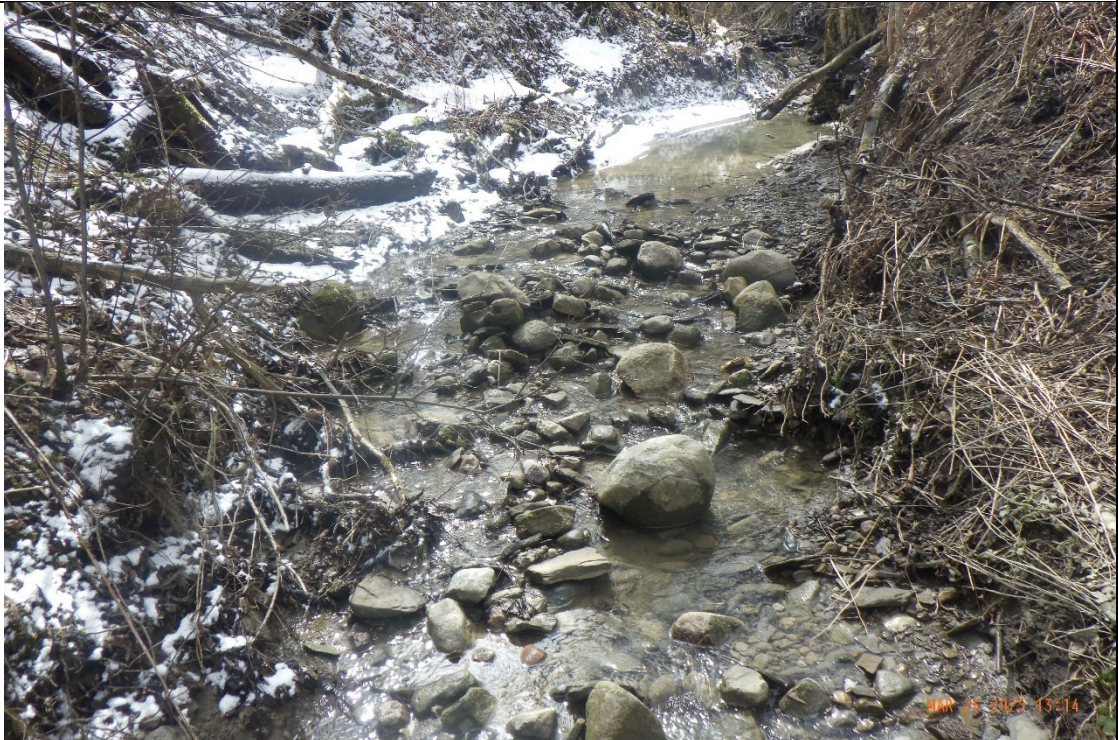
Tributary of Humber River, Reach- THRF-1
Caledon, Ontario

Bed substrate ranged from silt to large boulders. Riffles were composed primarily of cobbles, with a low level of embeddedness. Substrate fowling was not observed.

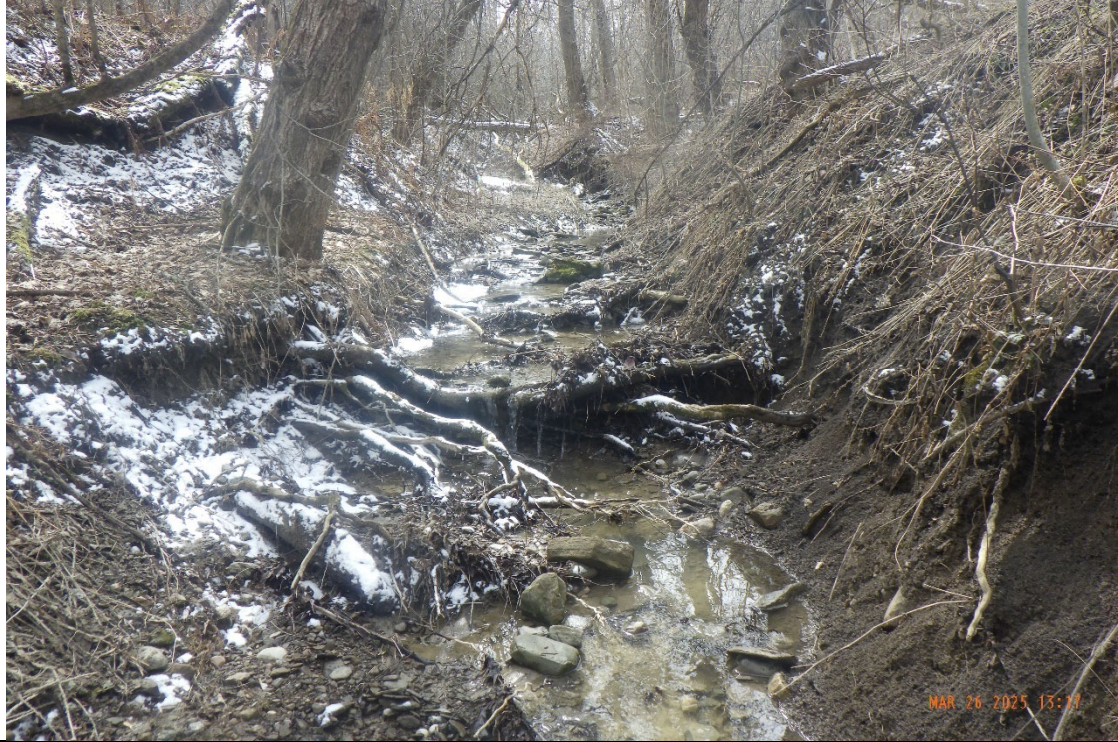
Tributary of Humber River, Reach- THRF-1
Caledon, Ontario

Photograph taken facing upstream of the first rooted knickpoint observed. The height was 0.30 m.

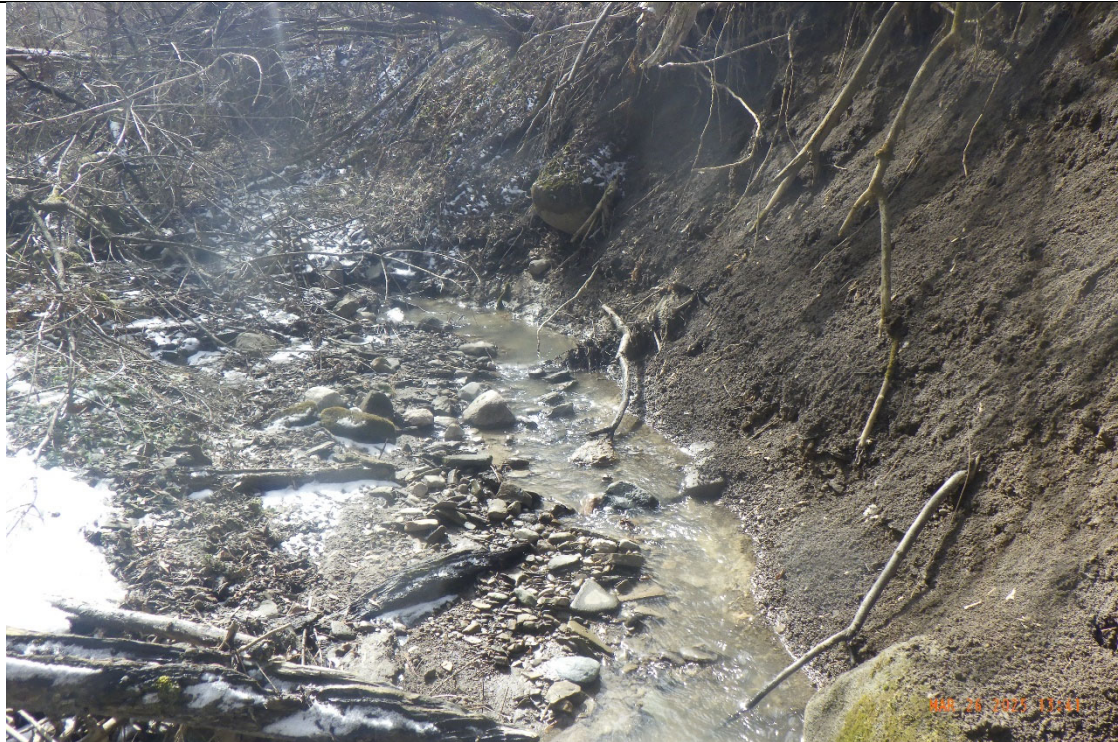
Tributary of Humber River, Reach- THRF-1
Caledon, Ontario

Exposed clay was noted throughout the channel, increasing in frequency upstream. Channel bed morphology was primarily comprised of riffles, with few deep pools. Measured riffle lengths were between 8.40 and 11.20 m.

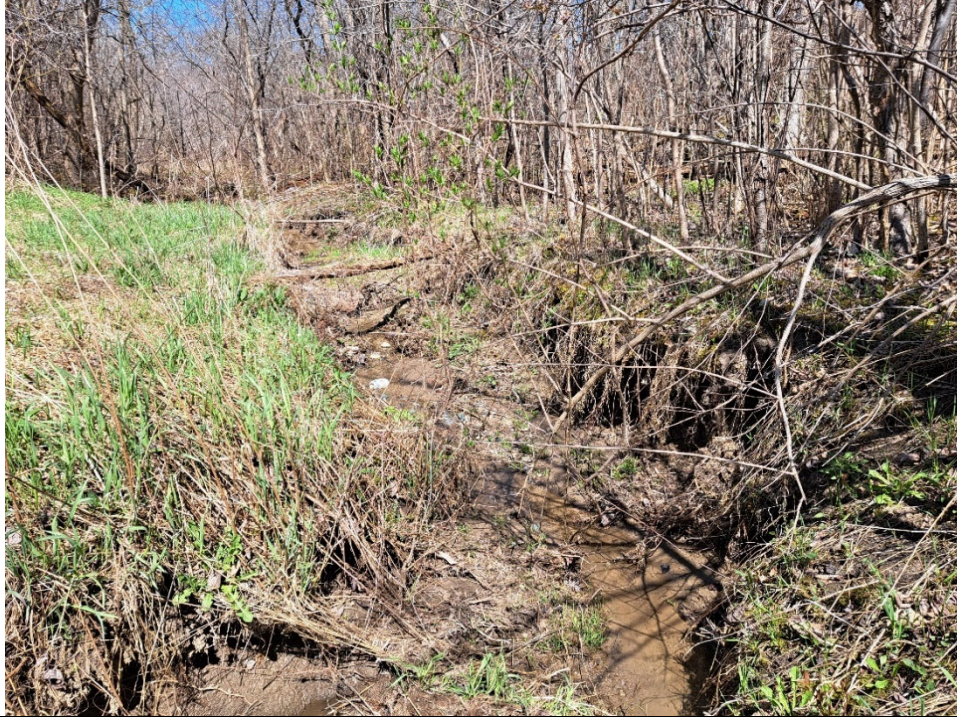
Photo 19
Tributary of Humber River, Reach- THRF-2
Caledon, Ontario

Photograph taken facing downstream. In the upstream portion of the reach erosion and undercutting was commonly observed. Undercuts measured up to 0.48 m.

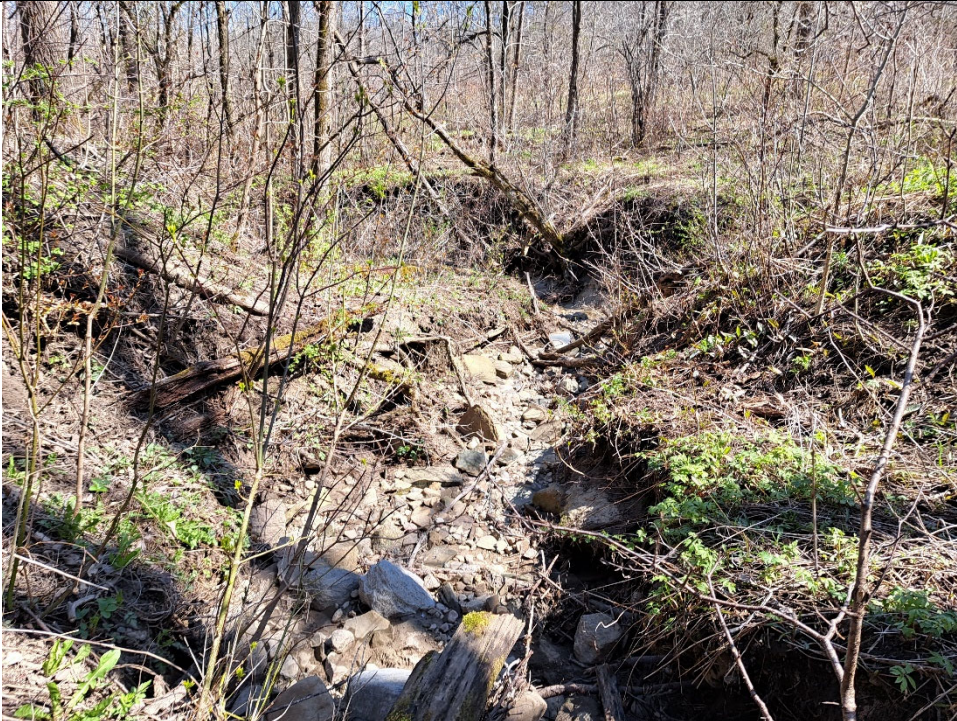
Photo 20
Tributary of Humber River, Reach- THRF-2
Caledon, Ontario

Photograph taken facing downstream. The bed substrate consisted of gravel and cobbles, and the bank substrate consisted of clay, silt, and gravel primarily.
