# Soil Engineers Ltd.

Reference No. 2405-S038

**Re: Slope Stability Assessment  
Proposed Stormwater Management Pond  
12879 The Gore Road  
Town of Caledon**

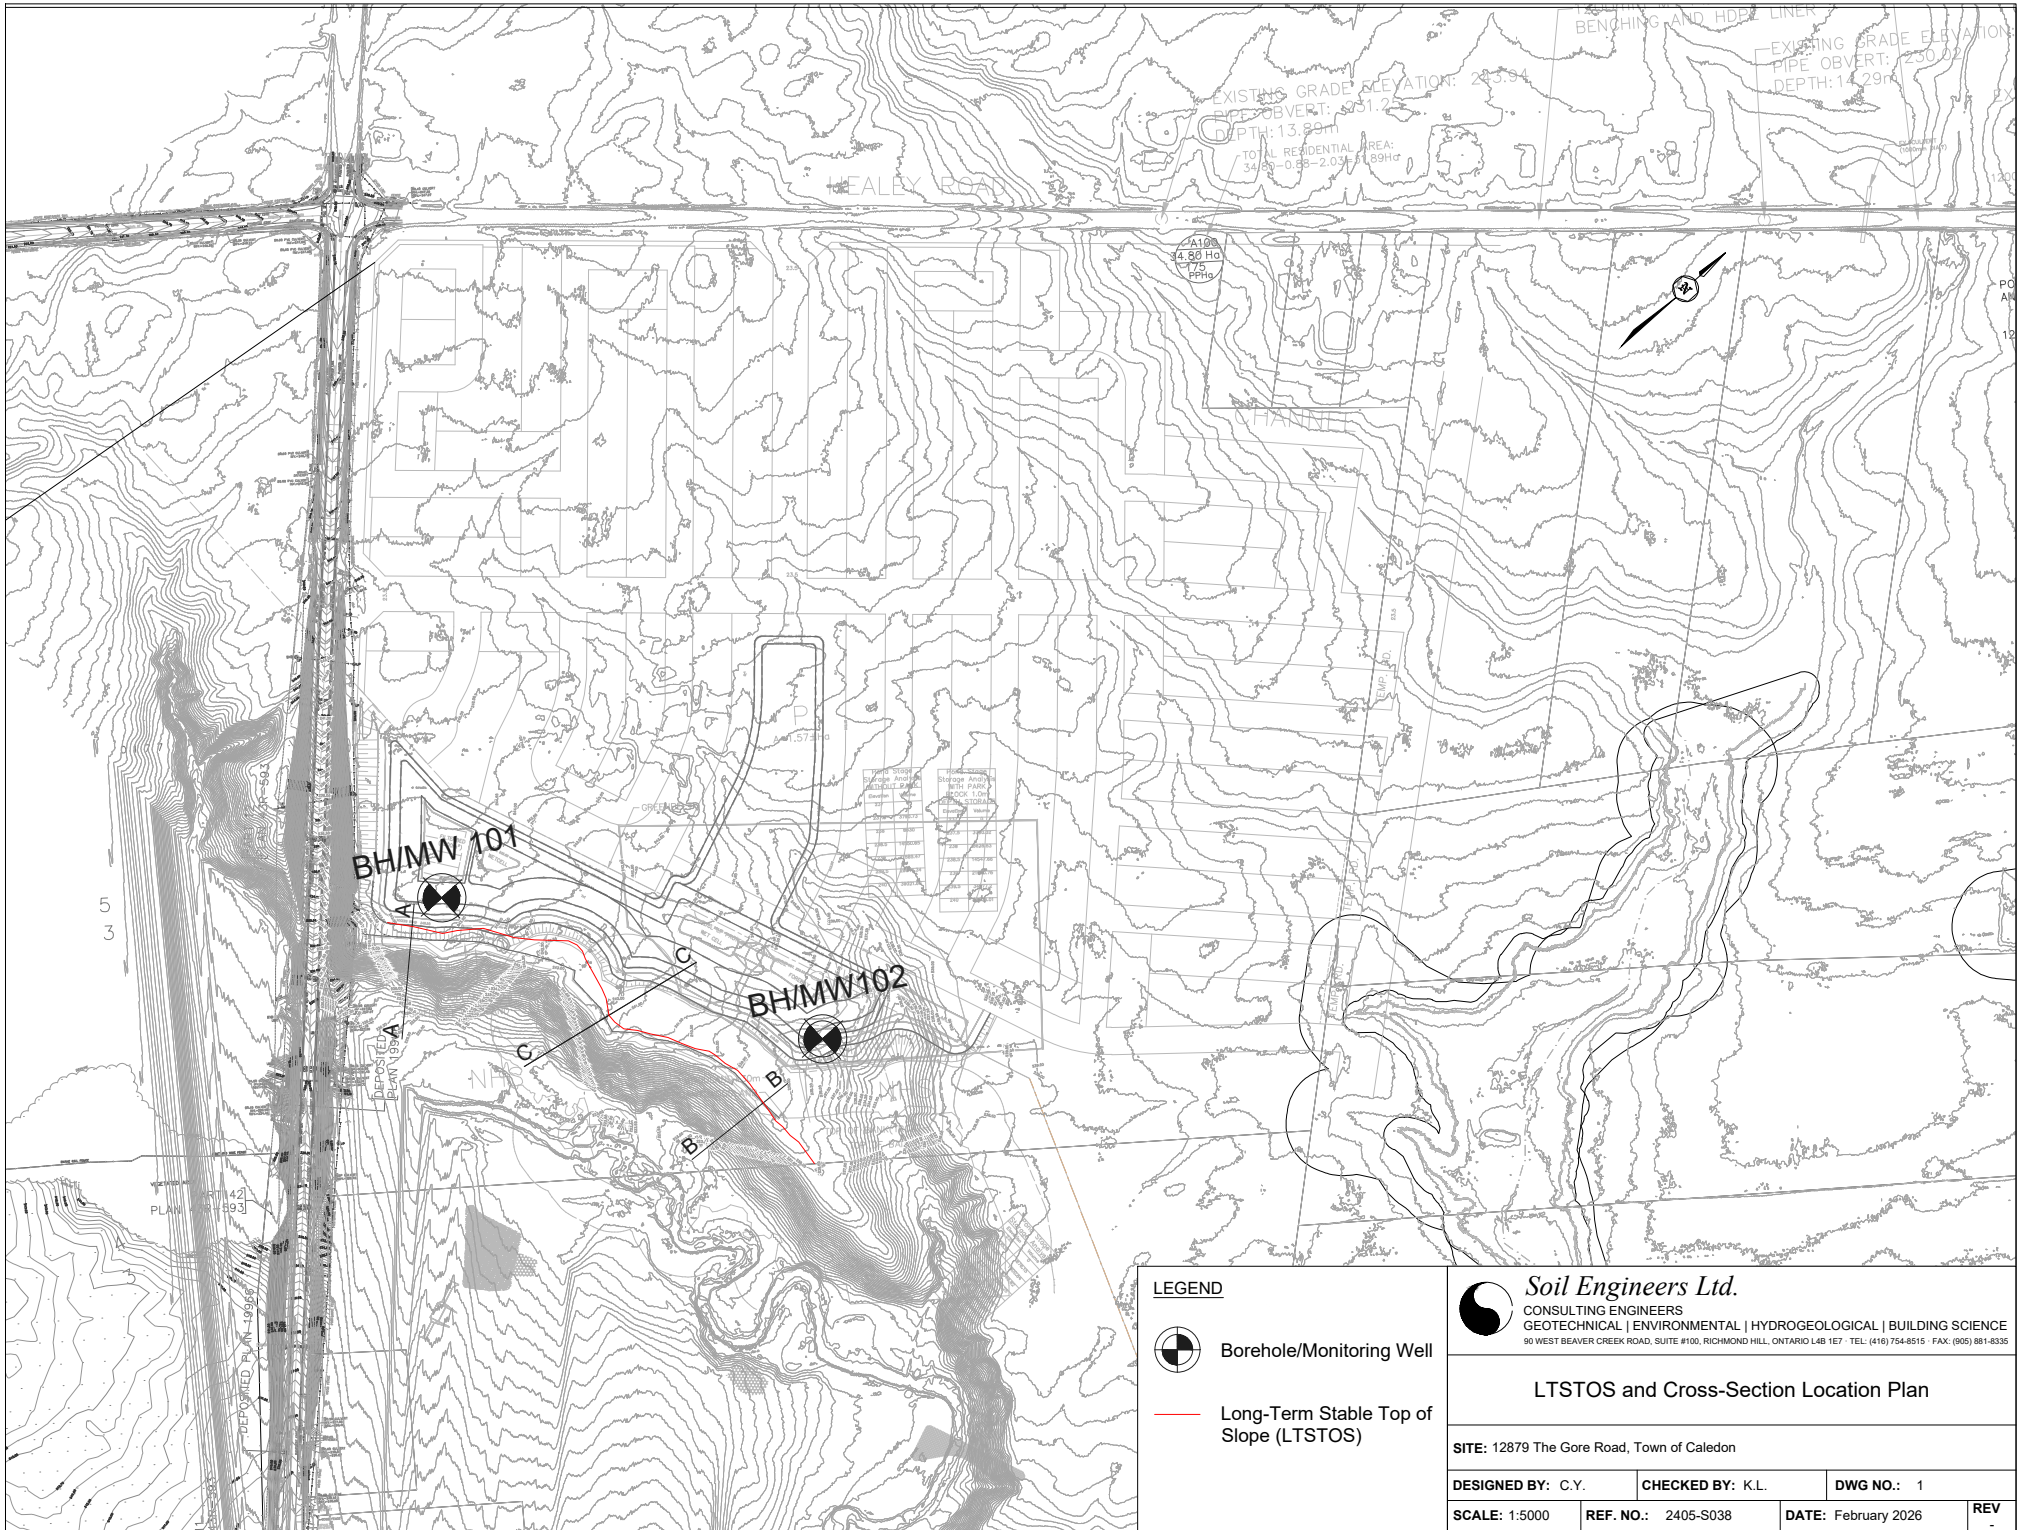
**LTSTOS and Cross-Section Location Plan**

The location of the slope is illustrated on Drawing No. 1. The LiDAR data with elevation contours was provided by the client and was utilized for the slope stability assessment. In

A total of 3 cross-sections (Cross-Sections A-A to C-C) were selected for the slope stability assessment. The surface profiles of the cross-sections are interpreted from the LiDAR elevation contours and the locations of the cross-sections are illustrated on Drawing No. 1.

The resulting LTSTOS, incorporating the specified stable gradient component is established and illustrated on Drawing No. 1.

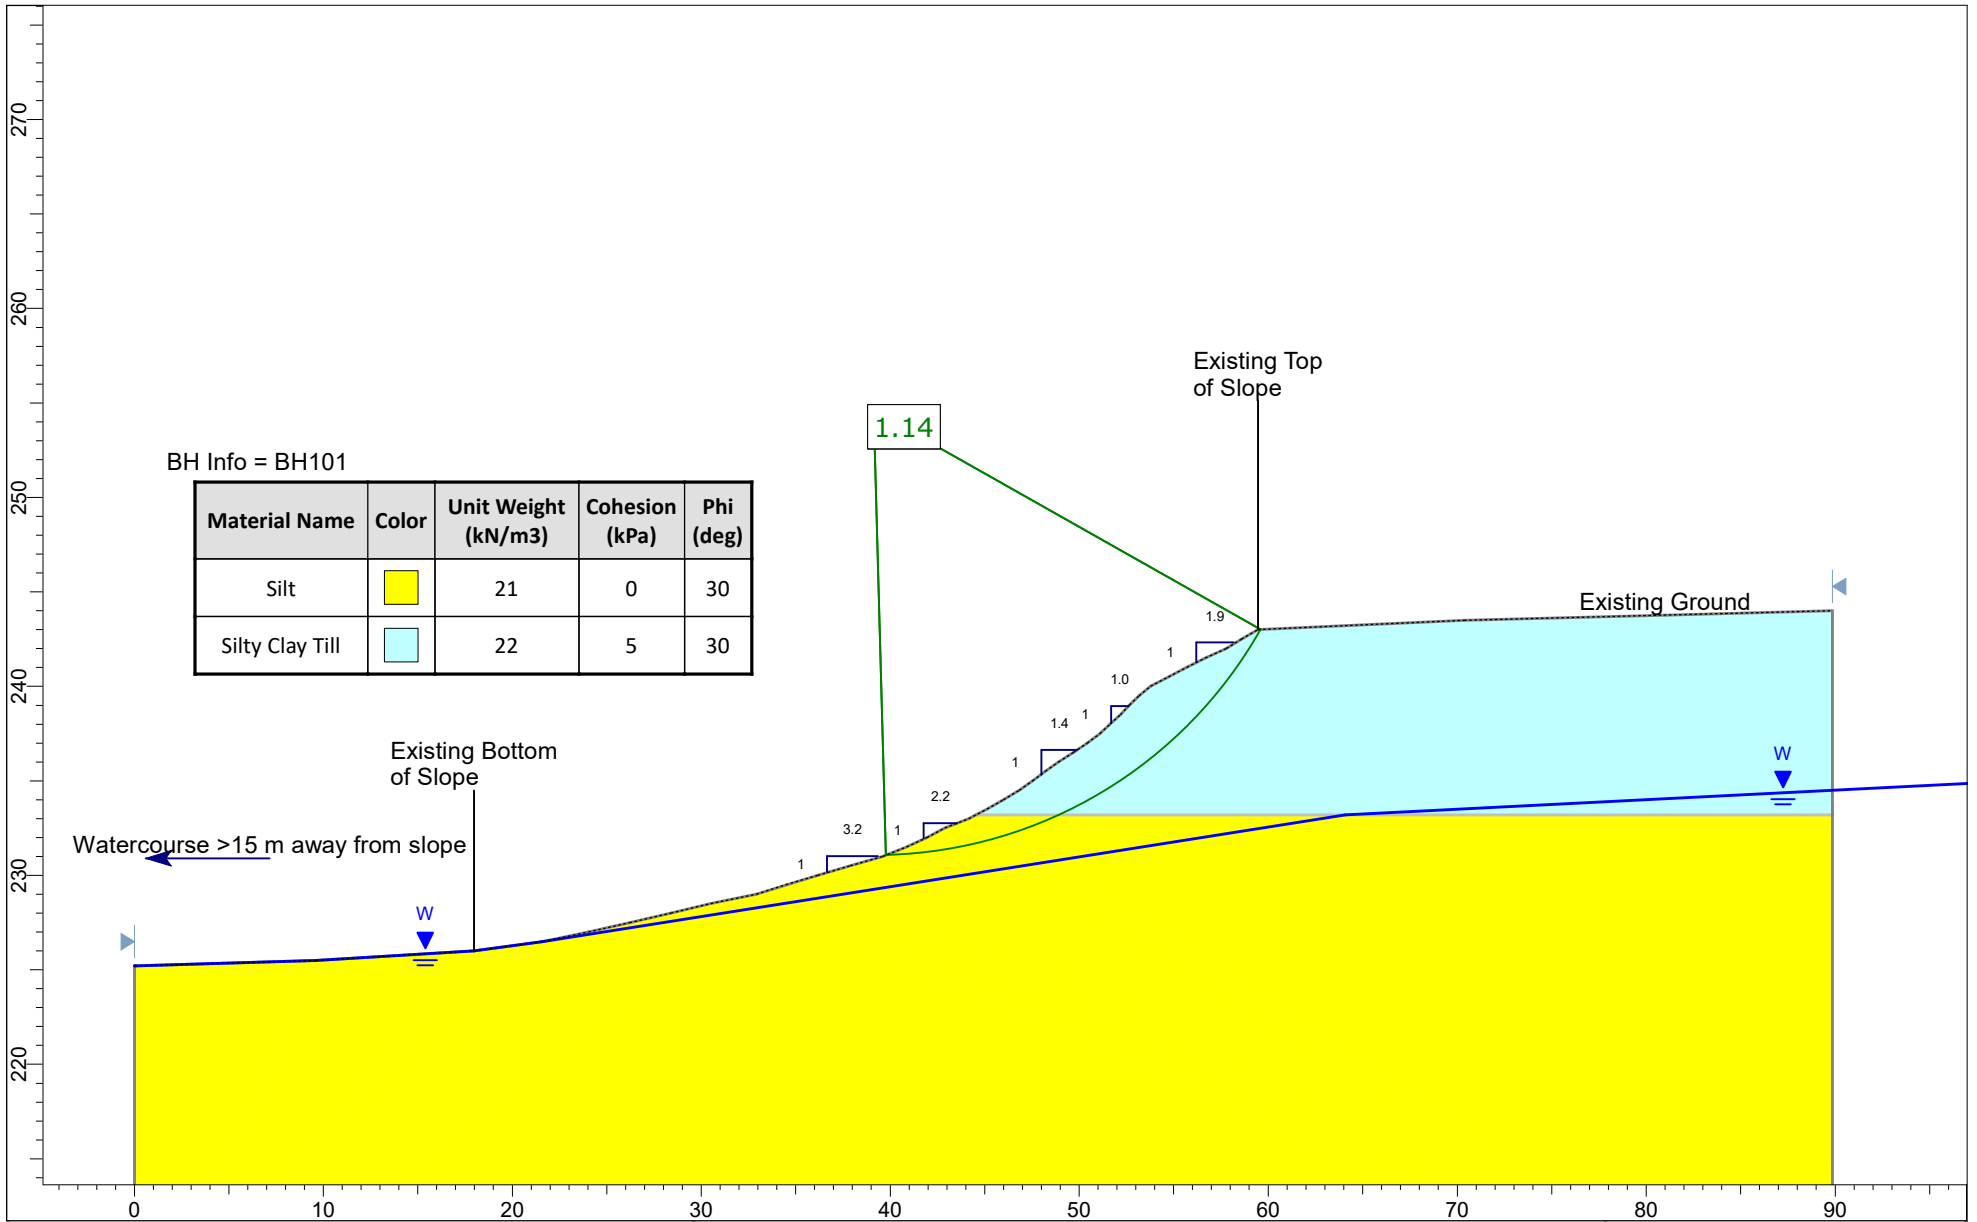
The slope stability analysis results are summarized in the table below. The results indicate that the slope at Cross-Sections has a minimum factor of safety (FOS) 1.08 to 1.34 respectively, which fails to meet the Ontario Ministry of Natural Resources (OMNR) guideline requirements for active land use (minimum FOS 1.5). The results of the existing condition of the slope at the cross-sections are illustrated on Drawing Nos. 2a, 3a and 4a.

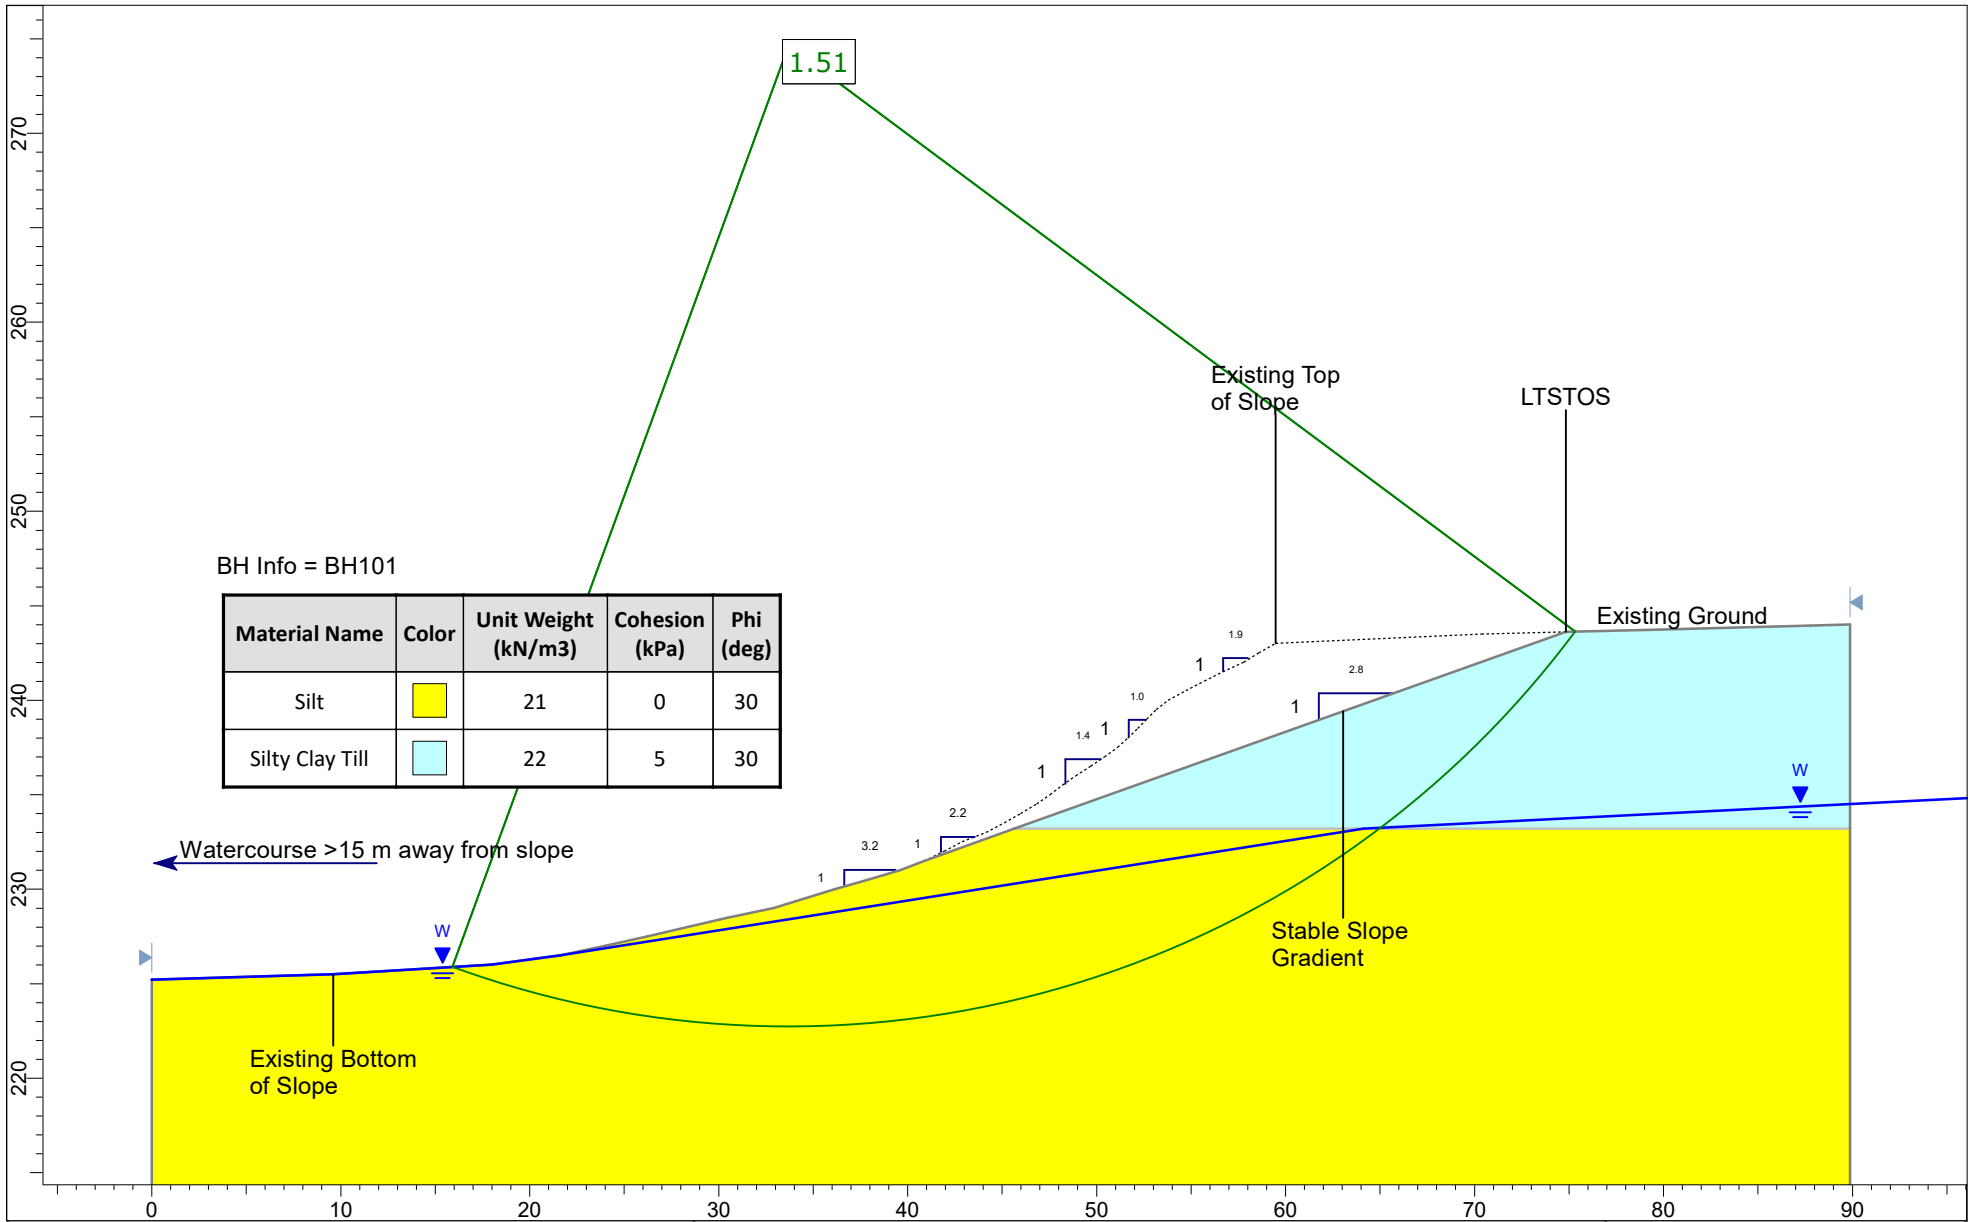
After applying the remodelled slope gradient, the cross-sections were reanalyzed and yielded minimum FOSs of 1.51 to 1.53 meeting the OMNR requirements. The results of the stable condition of the slope at the cross-sections are illustrated on Drawing Nos. 2b, 3b and 4b.

As such, in order to determine the LTSTOS, the slope sections were remodelled using stable slope gradient varying between 2.5H to 3.0H:1V. It should be noted that given the bottom of slope is more than 15 m away from the creek bank, thus, a Toe Erosion Allowance is not required.
