**Tree Inventory and Assessment Report (Updated)**  
**Laurelpark Subdivision**  
**Part Lot 19, Concession 6, Town of Caledon (Albion)**  
Town of Caledon, Region of Peel

Prepared by:  
Azimuth Environmental  
Consulting, Inc.

April 2020

AEC 08-019

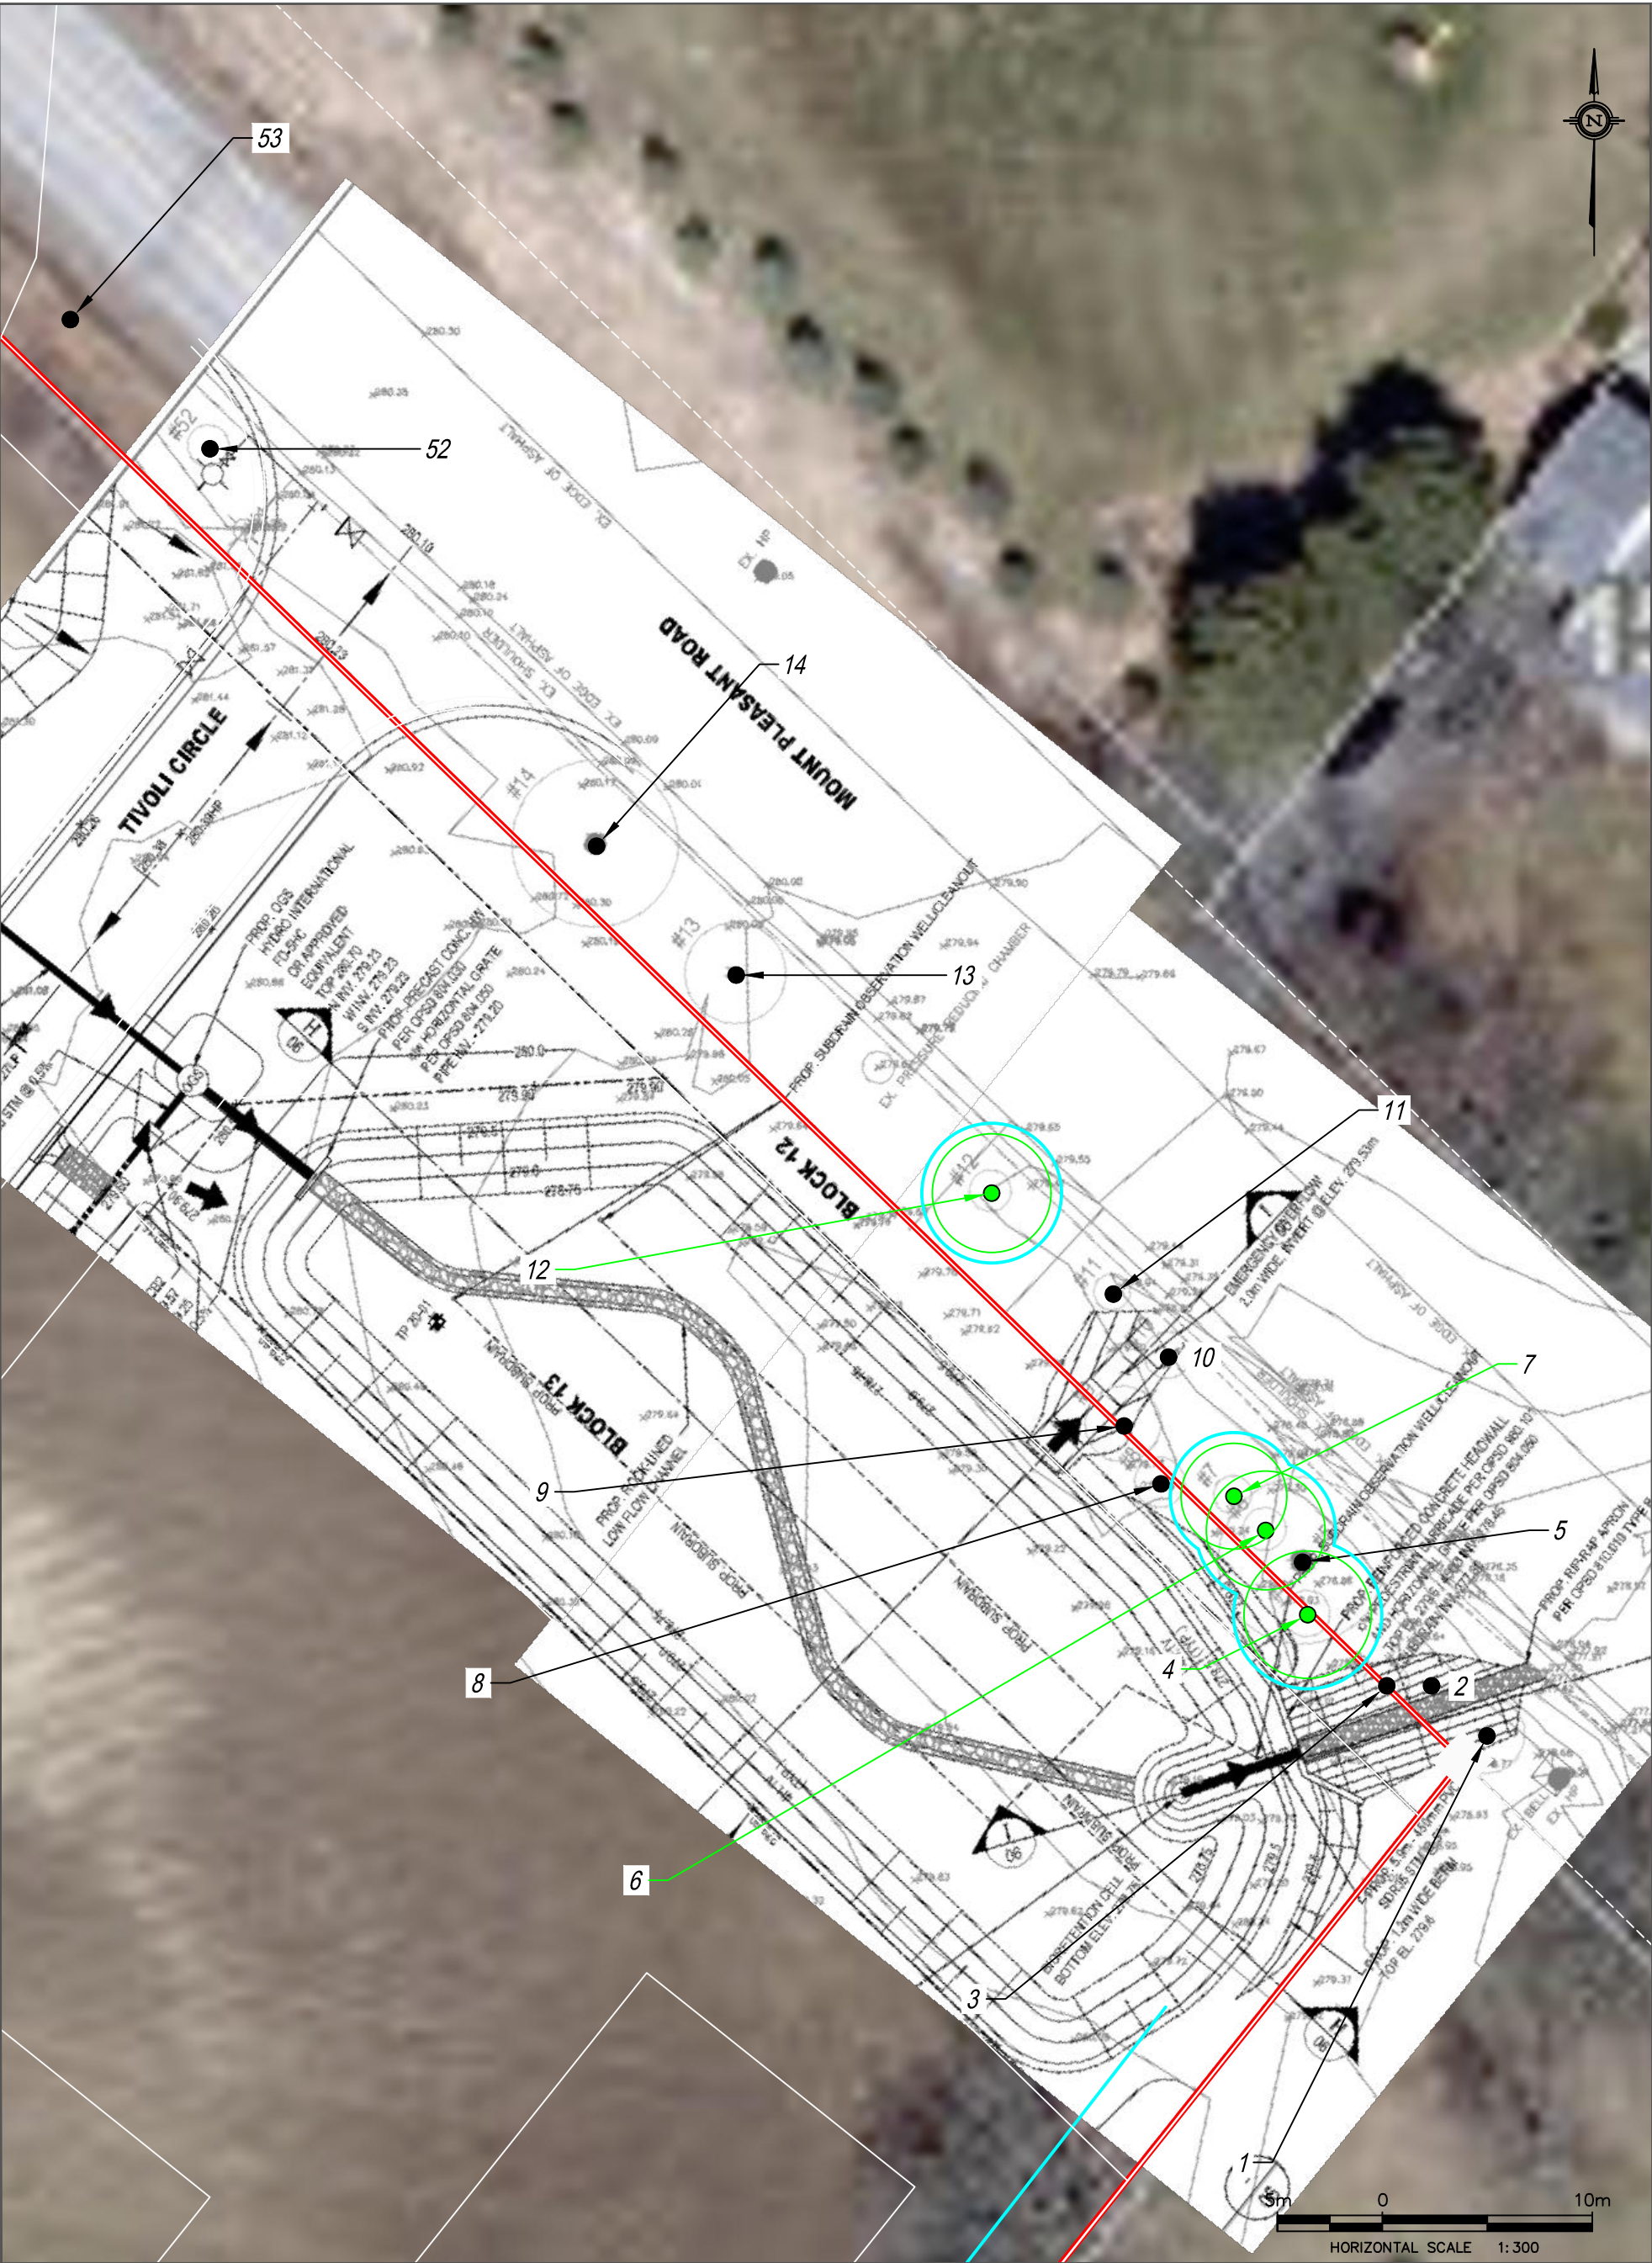
Date Issued:	March 2020	Figure No. <b>4</b>
Created By:	JLM	
Project No.	08-019	
Reference:	First Base Solutions

Bioretention Pond Trees

A minimum protection zone (MPZ) has been calculated for each tree to be protected/preserved during construction, which estimates the extent of tree root zone based on the diameter at breast height. The formula accepted by the International Society of Arboriculture (1 inch dbh = 1 foot MPZ) was used to determine the recommended root protection zone for each tree. For example, the dbh for Tree #47 was measured as 20cm, which converts to 7.9 inches. Thus, the MPZ for Tree #47 is a radius of 7.9 feet (2.4 metres) surrounding the base of the trunk. MPZ radius measurements for all trees to be retained are listed in Appendix B and shown in Figures 3 and 4.
