Tree Inventory and Assessment Report (Updated)
Laurelpark Subdivision
Part Lot 19, Concession 6, Town of Caledon (Albion)
Town of Caledon, Region of Peel

Prepared for:
Laurelpark Inc.

Prepared by:
Azimuth Environmental
Consulting, Inc.

November 2020

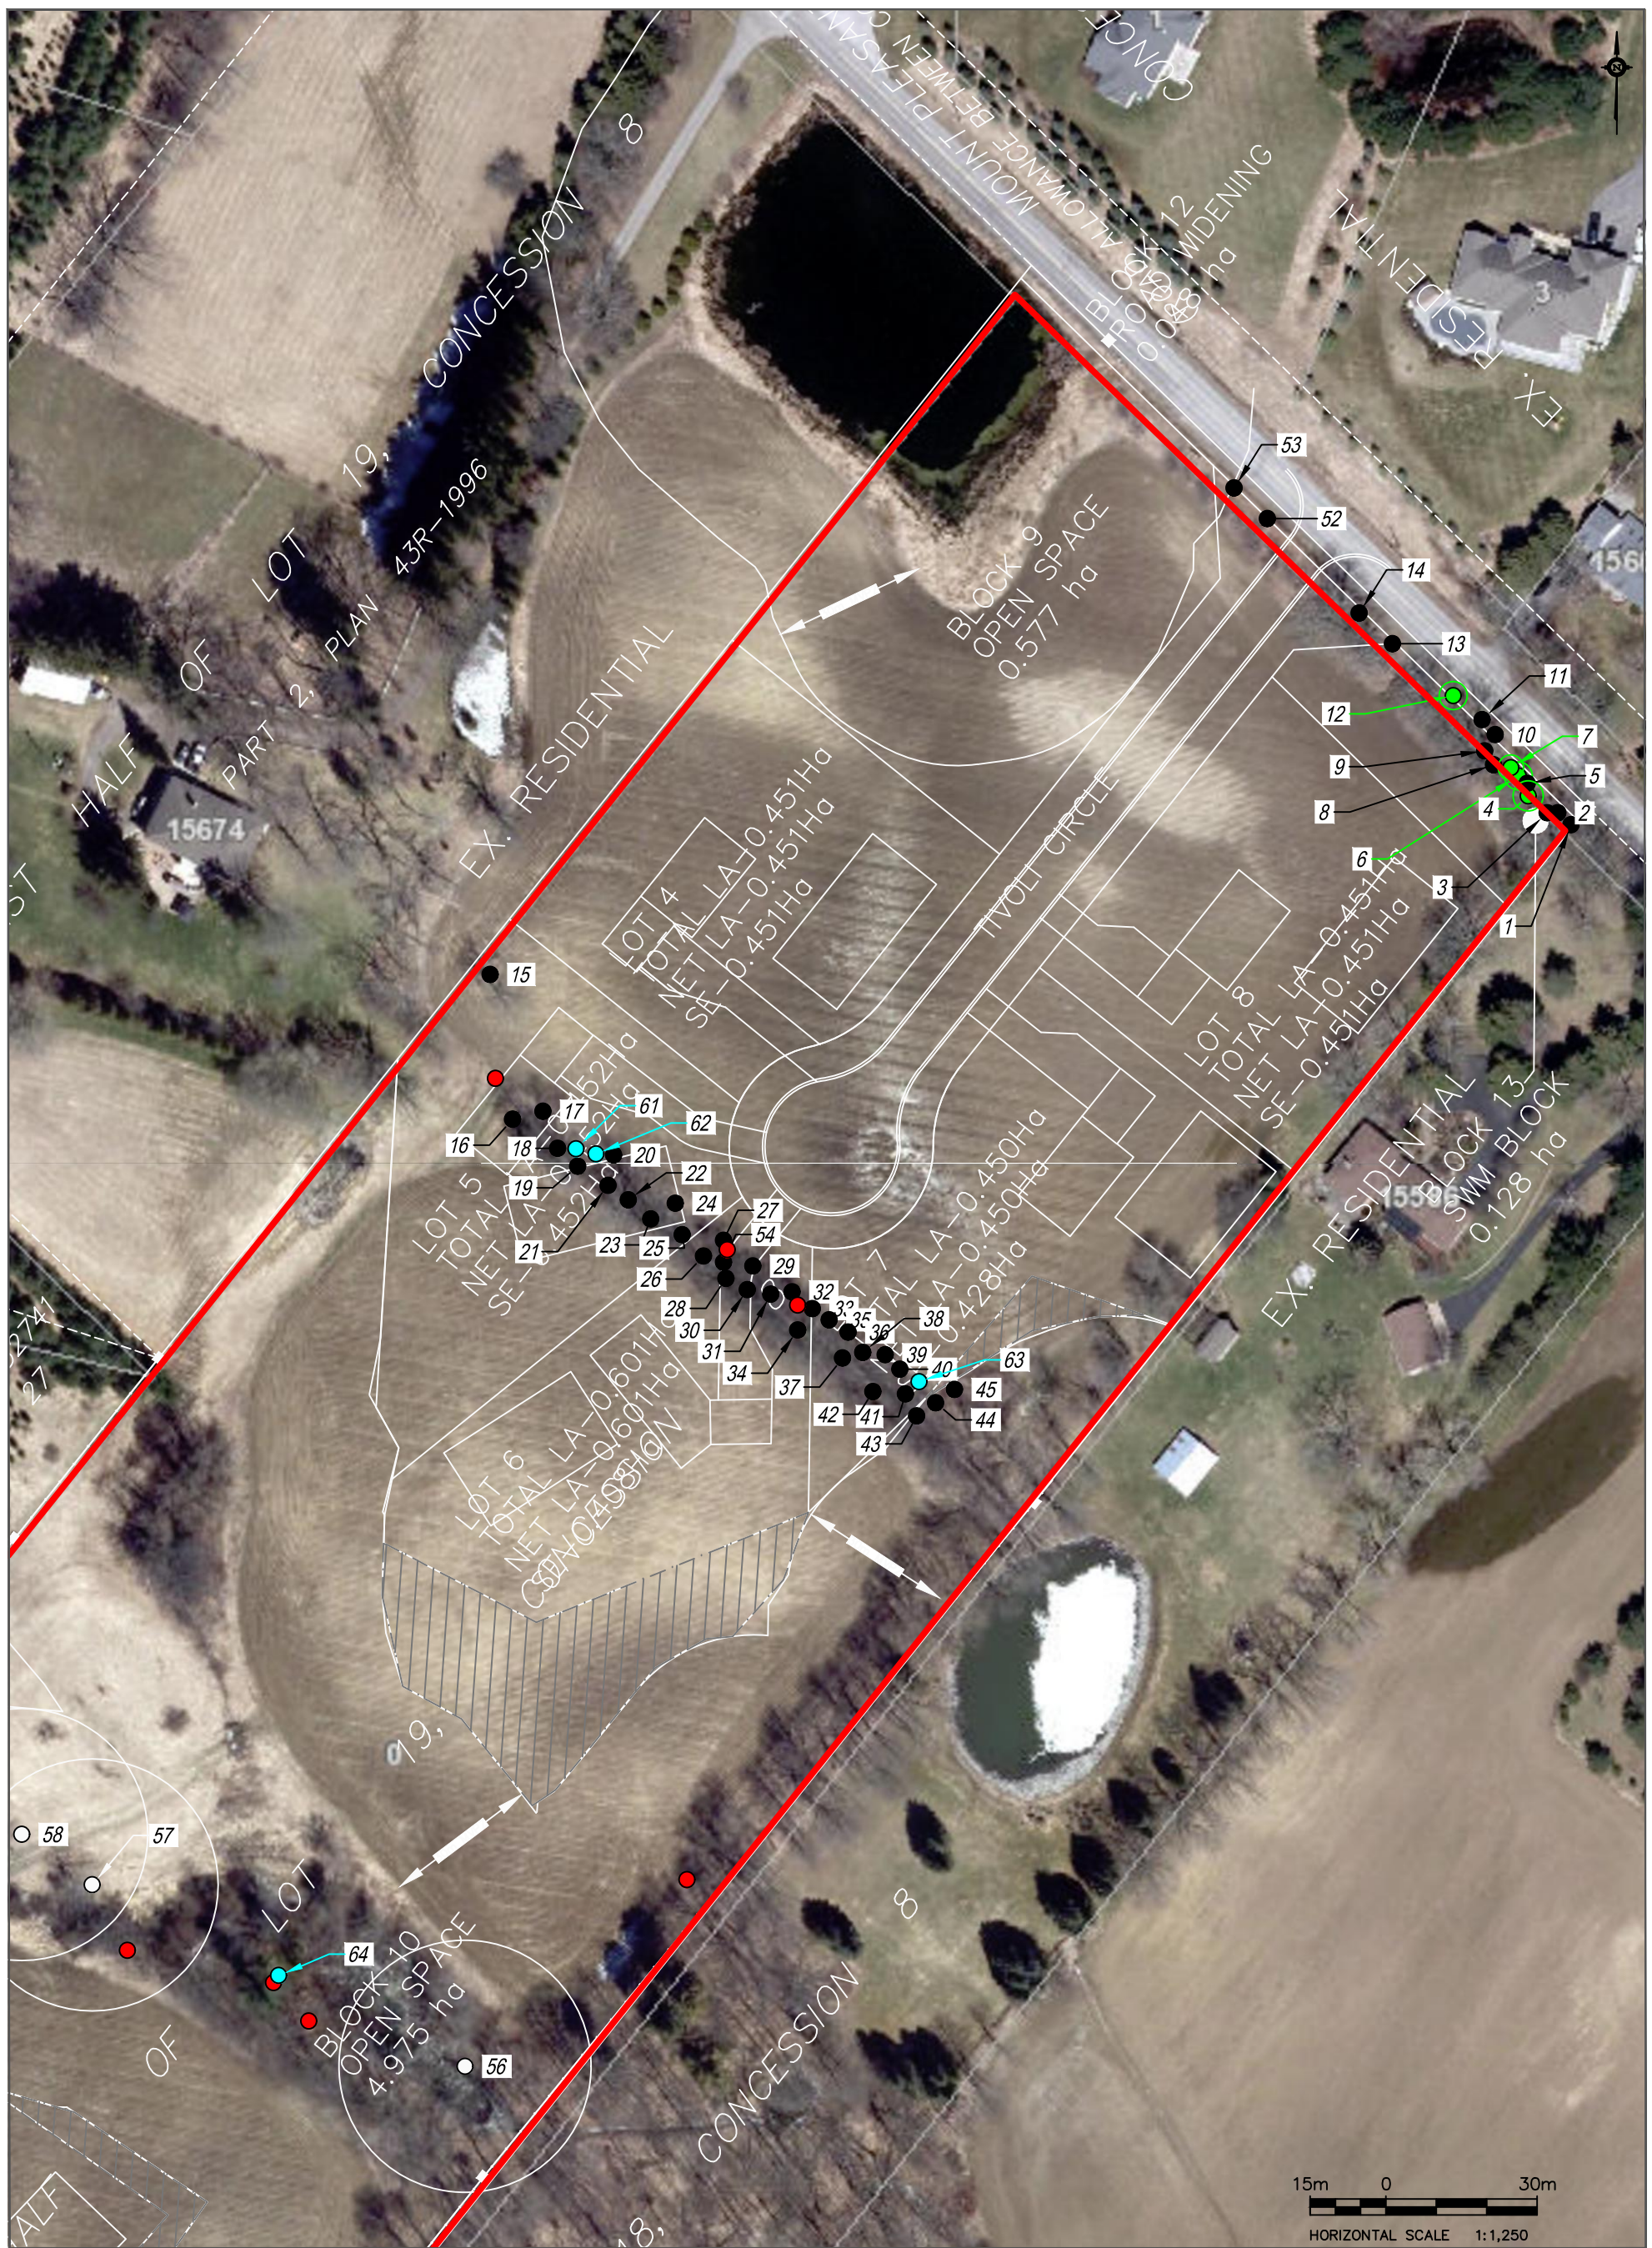
Northern Tree Locations

Trees #1, #2 and #15 (see Figure 2) have been identified as hazard trees within 10 metres of residential lands and should be removed from the property prior to any construction activities. Theoretically, all 25 inventoried trees in a state of decline should be considered a safety hazard, although the trees listed above in proximity to residential lands should be considered as top priority for removal.

The neighbouring residential property to the southeast has several mature trees growing in the front yard, with portions their root zones likely extending into the subject site. It is recommended that tree protection fencing be installed 3 metres offset from the southeastern property boundary (see Figure 2) adjacent to these trees to ensure minimal

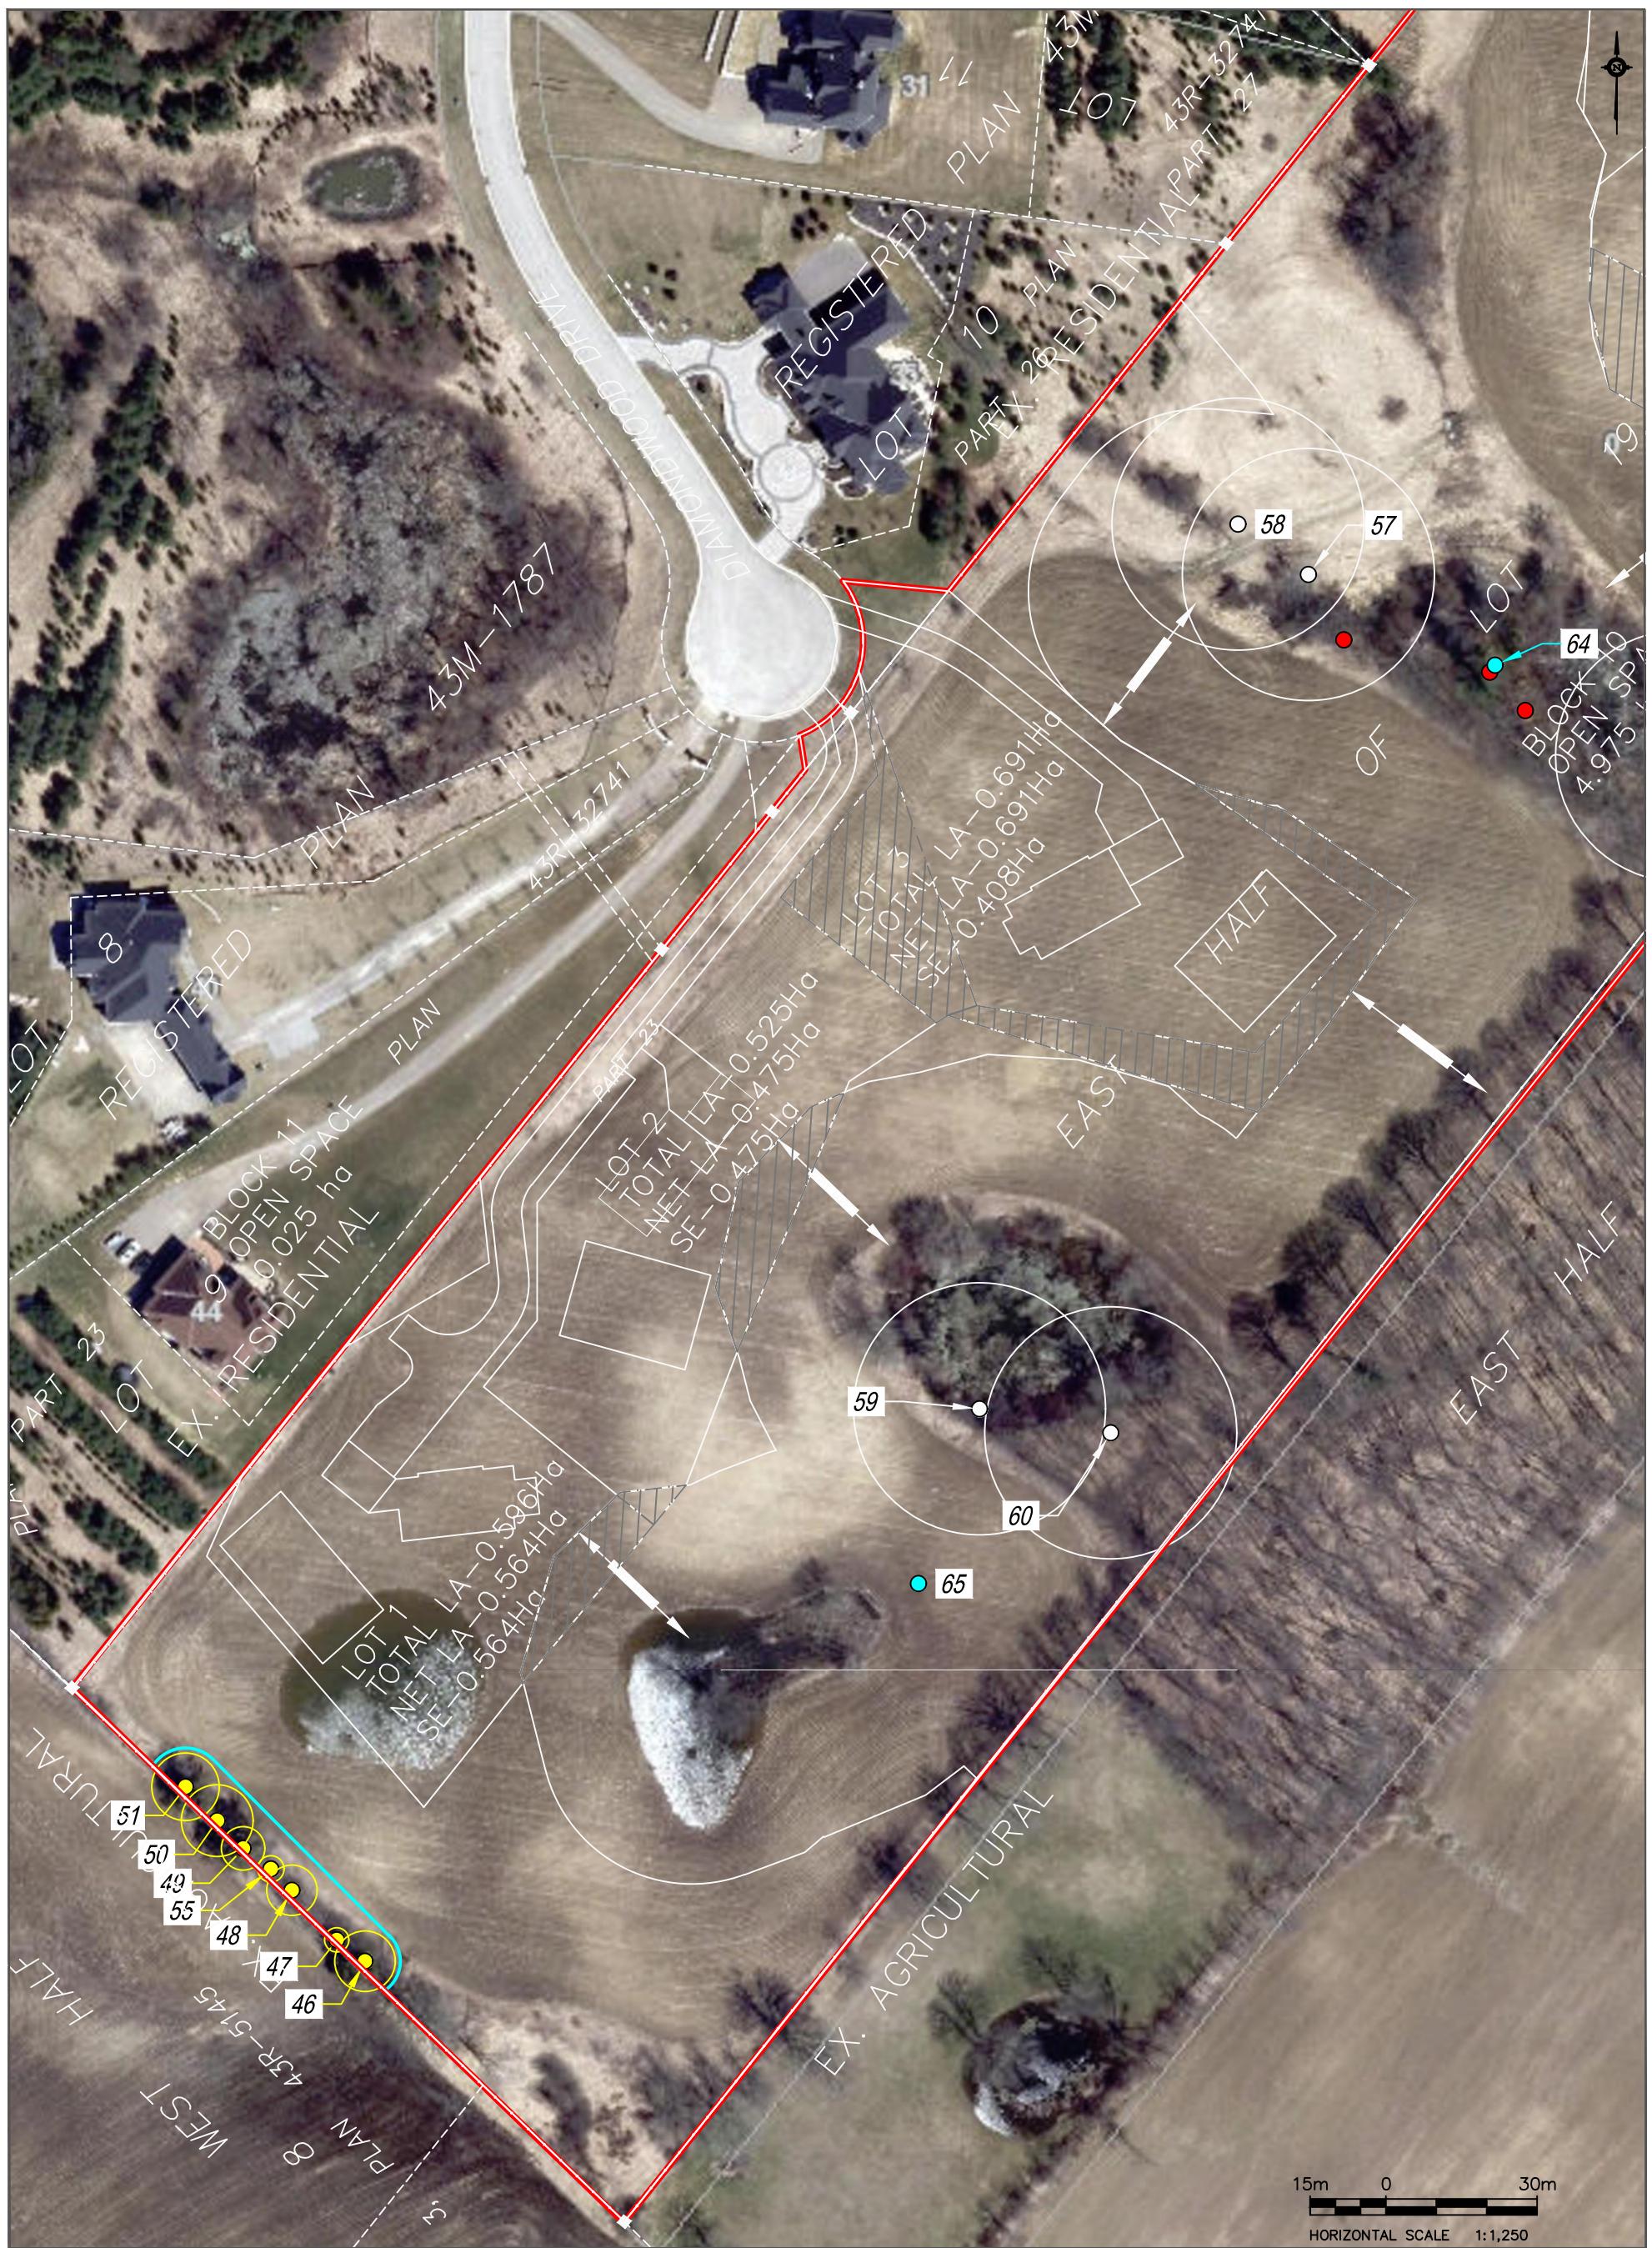
Southern Tree Locations

Figures 2 & 3 show locations of all Butternut trees (existing and removed). All Butternut trees to be retained on-site are located within the designated wetland/woodland buffer areas and will not be subject to development/construction impacts. No development is proposed within 25 metres of the Butternut trees to be retained. Please refer to Figure 6 of Azimuth's Environmental Impact Study and Management Plan which shows the proposed area for Butternut compensation planting.

A minimum protection zone (MPZ) has been calculated for each tree to be protected/preserved during construction, which estimates the extent of tree root zone based on the diameter at breast height. The formula accepted by the International Society of Arboriculture (1 inch dbh = 1 foot MPZ) was used to determine the recommended root protection zone for each tree. For example, the dbh for Tree #47 was measured as 20cm, which converts to 7.9 inches. Thus, the MPZ for Tree #47 is a radius of 7.9 feet (2.4 metres) surrounding the base of the trunk. MPZ radius measurements for all trees to be retained are listed in Appendix B and shown in Figures 3 and 4.
