Arborist Report

Pre-Construction Report

Site Address:
Coleraine Rd.

February 17, 2016

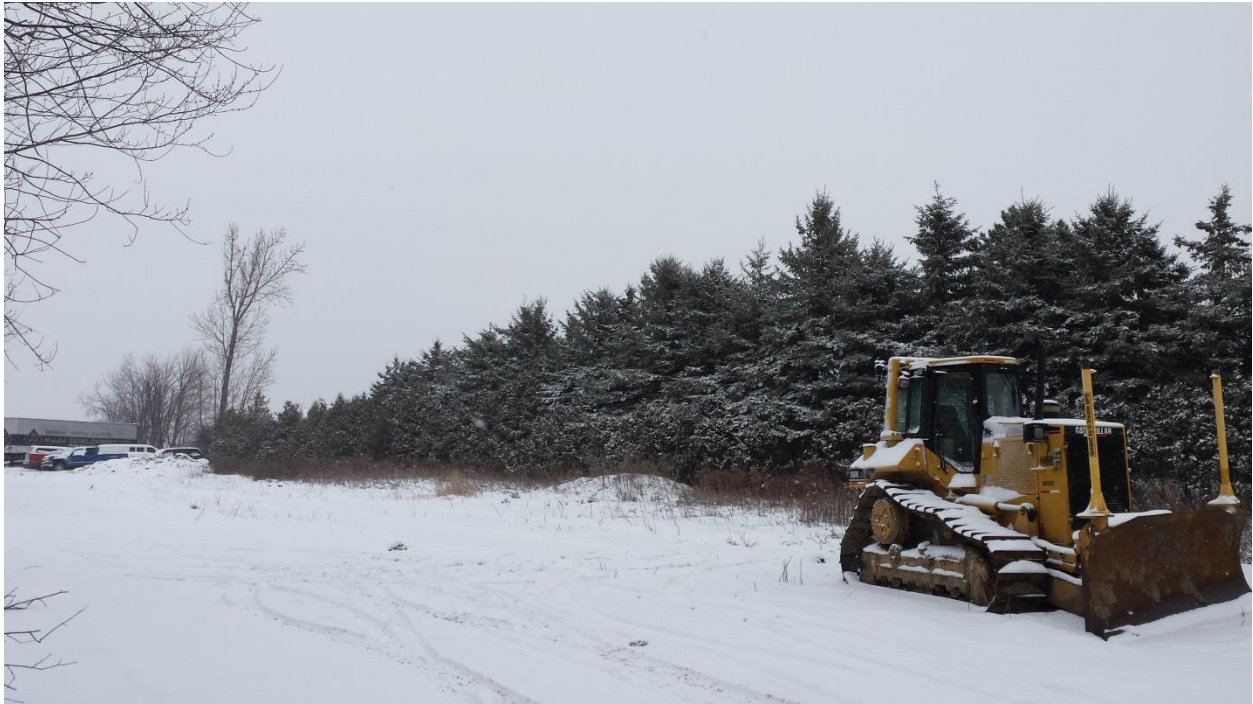
Figure 3: Hedges.

42	apple, common	<i>Malus pumila</i>	15	2. Neighbors	1.8	Fair	Fair	Fair		Estimated DBH
43	apple, common	<i>Malus pumila</i>	15	2. Neighbors	1.8	Fair	Fair	Fair		Estimated DBH
44	spruce, spp.	<i>Picea spp.</i>	15	2. Neighbors	1.8	Good	Good	Good		Hedge of spruce and cedar; Approximately 27 spruce trees all approximately 20 cm DBH
45	poplar, balsam	<i>Populus spp.</i>	35	2. Neighbors	2.4	Fair	Fair	Fair		Hedge of poplar and maple; All of the trees were multistem; There are approximately 10 trees; Estimated DBH
