6. FARMSTEADS OF FORMER CHINGUACOUSY TOWNSHIP

6.1 HISTORICAL CONTEXT

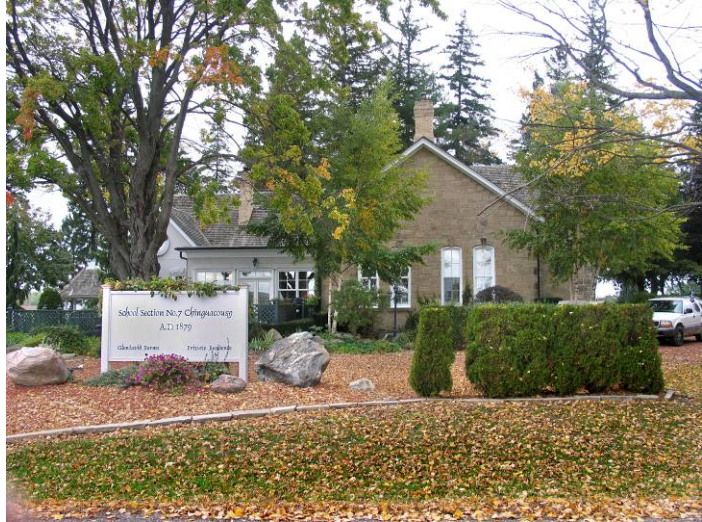
A schoolhouse has been located at the northwest corner of the crossroads at Creditview Road and Old School Road since at least the mid 19th century. It was constructed on a corner of the lot owned by David Henderson (E ½ Lot 23, Con. 4) who also owned Lot 22, south of what is now Old School Road, on which he built his house. Schoolhouse S.S. #7 was reconstructed in stone in 1879. On the west half of Lot 23, Con. 3, William Hutchison had a home by mid century and before 1877 had donated land for a church (no longer extant) on the corner of the lot across the road from the schoolhouse. With schoolhouse and church, the crossroads became the community focus of this rural area, though it never grew into a hamlet. Land ownership was stable with the above families, along with those of Thomas Taylor, William Wilkinson, John Cameron and William Lyons, on the land throughout the latter half of the 19th century.

The Old School House

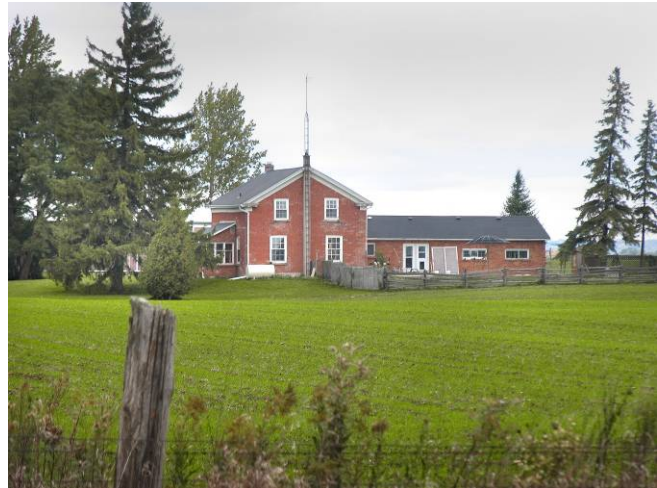
Possibly the oldest surviving farmhouse in the Candidate area, the three-bay, 1 ½ storey brick building has side gables, medium pitched roof, end chimneys, returned cornice, and dentillated eave typical of the vernacular classicism of the first half of the 19th century. An unfortunate addition has been placed on the front obscuring the original entrance, which may have included a transom. This building was built likely c.1850 by William Hutchison.

CF-3 13089 Creditview Road (W ½ Lot 23, Con. 3)

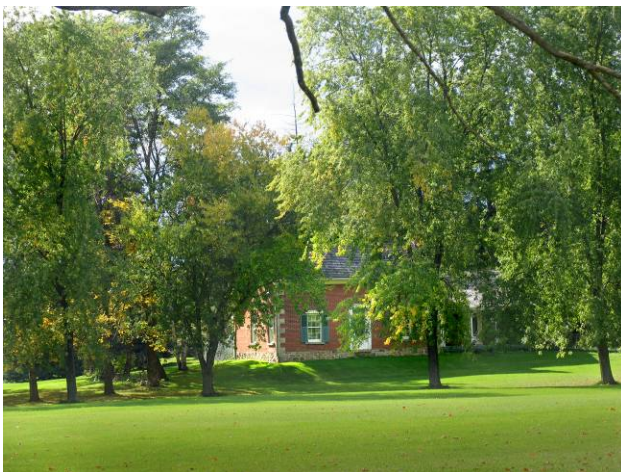
13278 Creditview Road

This is the most intact farmhouse and yard within the Candidate area (though severances have occurred to the north section of the property). The fine three bay, 1 ½ storey brick house has cut stone quoins, six light over six light double hung windows within voussoired openings and a pilastered main entrance with transom and original 6 panel door. While it has a typical medium pitch side gable roof at the front, at the rear the roof extends into a ‘saltbox’ form from which a board and batten carriage house extends. The structure was built c.1863 as the home for Thomas and Jane

Taylor, originally from Scotland. An addition with verandah was built to the north and served as the home for Jane and her daughter Christina when son Peter inherited the property in 1872. The many mature deciduous trees greatly enhance the grounds.

CF-1 *13278 Creditview Road, 'Taylor-Echlin House' (now Pt. E ½ Lot 24, Con. 4)

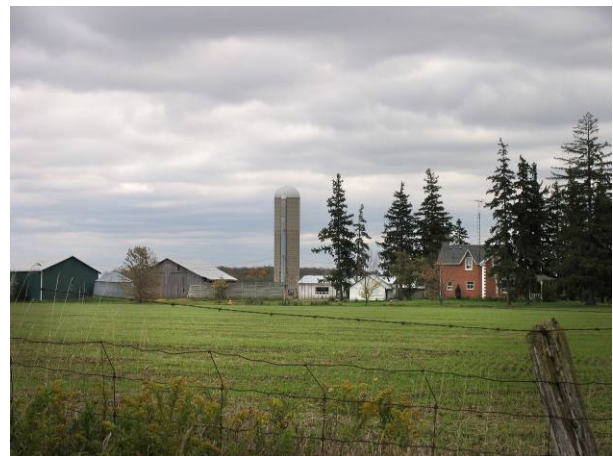
Constructed c.1875, this brick structure has the contrasting brick detailing (here painted), scrollwork verge, bellcast verandah with scrolled ‘gingerbread’, and projecting bay window typical of the later 19th century. A two storey addition with centre gable extends to the east. Unfortunately the window sash has been changed. A working farm, the full range of outbuildings, encompassing a number of generations, is extant. The long lane to the house and the rear yard is lined with conifers.

CF-6 12911 Creditview Road (W ½ Lot 22, Con.3)

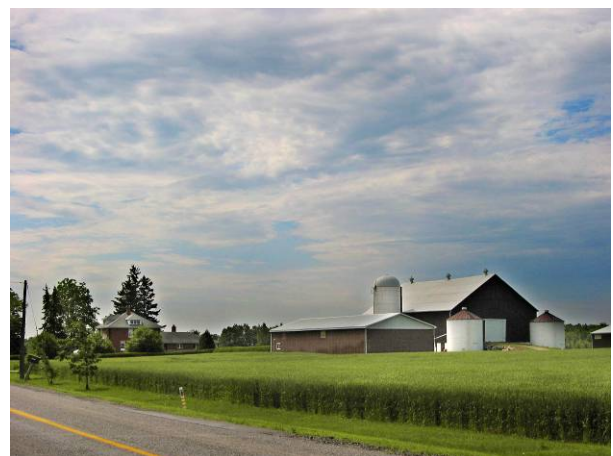
This brick ‘four-square’ from the early 20th century either has replaced, or incorporates, the original home of David Henderson already in place in 1859. This property is a working farm with a full complement of barns and sheds spanning the generations, and, except for a small severed section at the northwest corner, retains its full original lot.

Barn Complex at 12872 Creditview Road

CF-7 12872 Creditview Road (E ½ Lot 22, Con. 4)
