**Phase One
Environmental Site Assessment**

10819 Highway 9
Caledon, Ontario

Safetech Environmental Limited

April 18, 2019

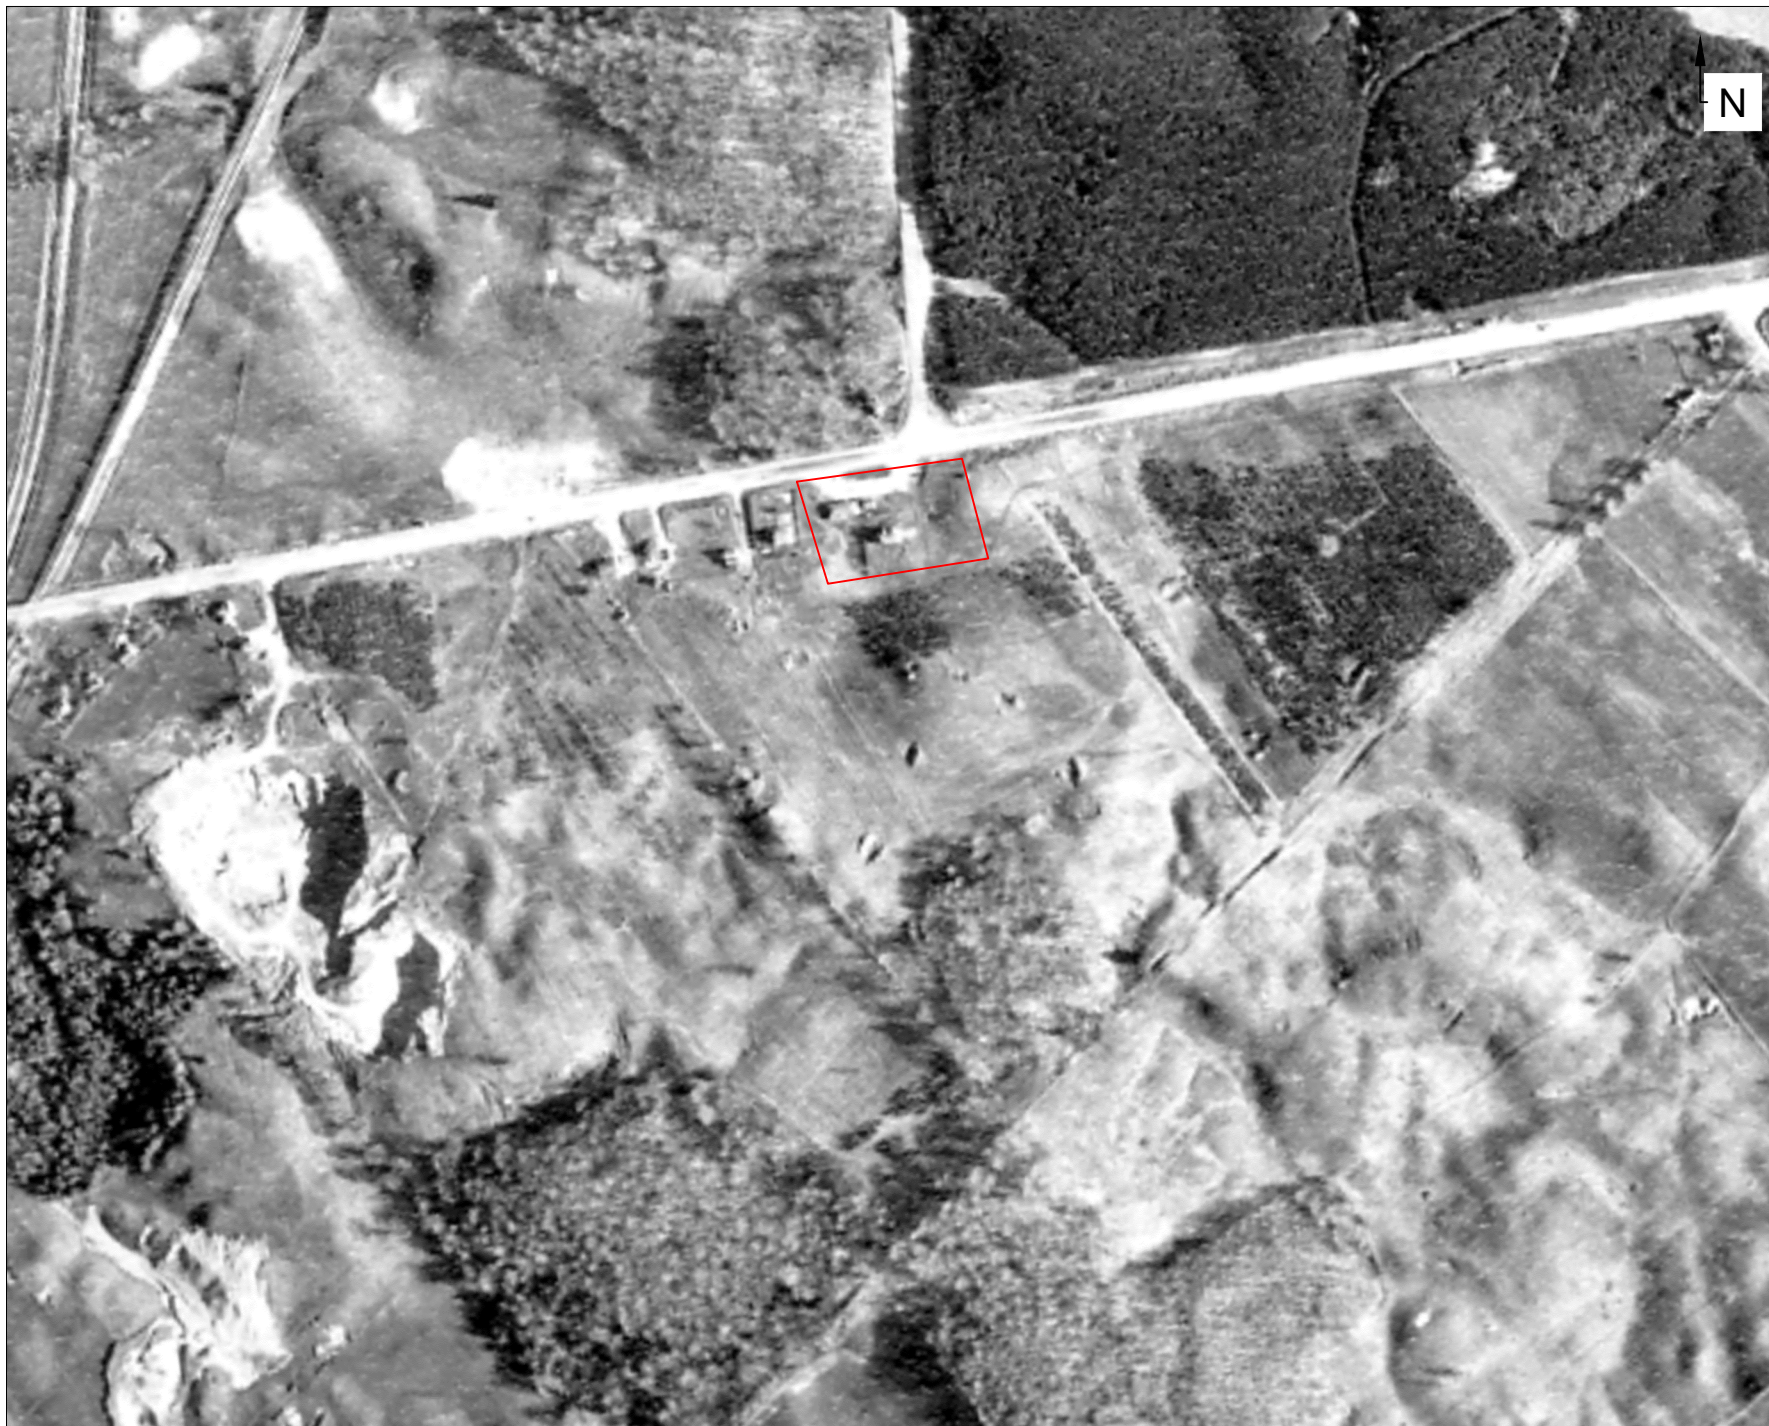
Title:
Figure 6 - Historical
Aerial Photograph
1960

- 1960: There appeared to be development all along the south side of Highway 9 west of Tottenham Road at this time. One property on the northwest corner of the intersection also appeared to be present. The Site Buildings appeared to be in the same condition as the previous aerial photograph. The excavations at the quarry approximately 100m to the southwest of the Site appeared to have commenced at this time as there was visible pooled water in the area.

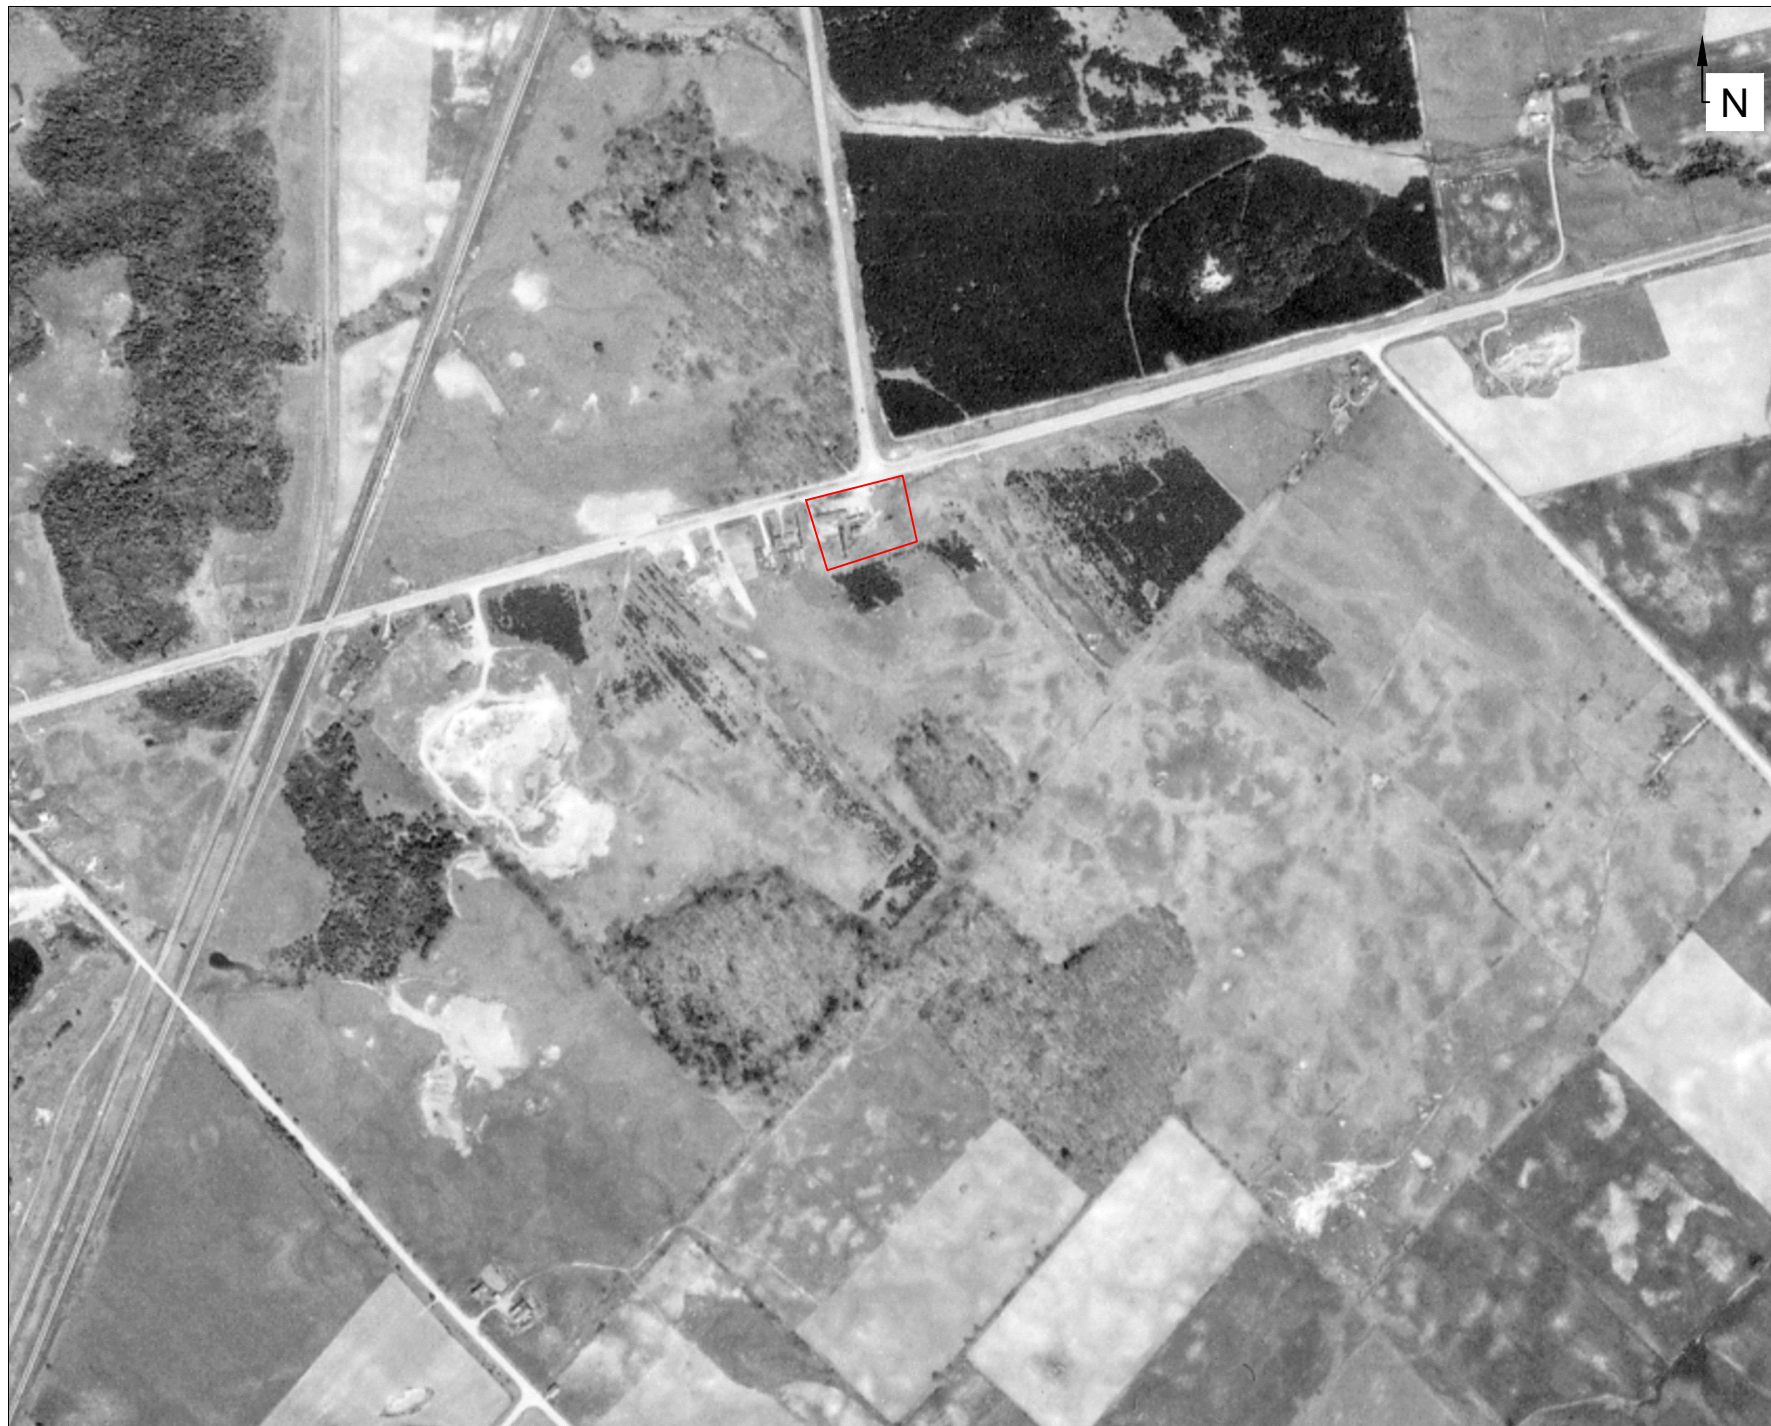
Title:
Figure 7 - Historical
Aerial Photograph
1964

- 1964: The Site and surrounding area appeared to be consistent with the previous aerial photograph.
- 1974: Additional buildings appeared on the southwest of the Site on the property adjacent to the west.

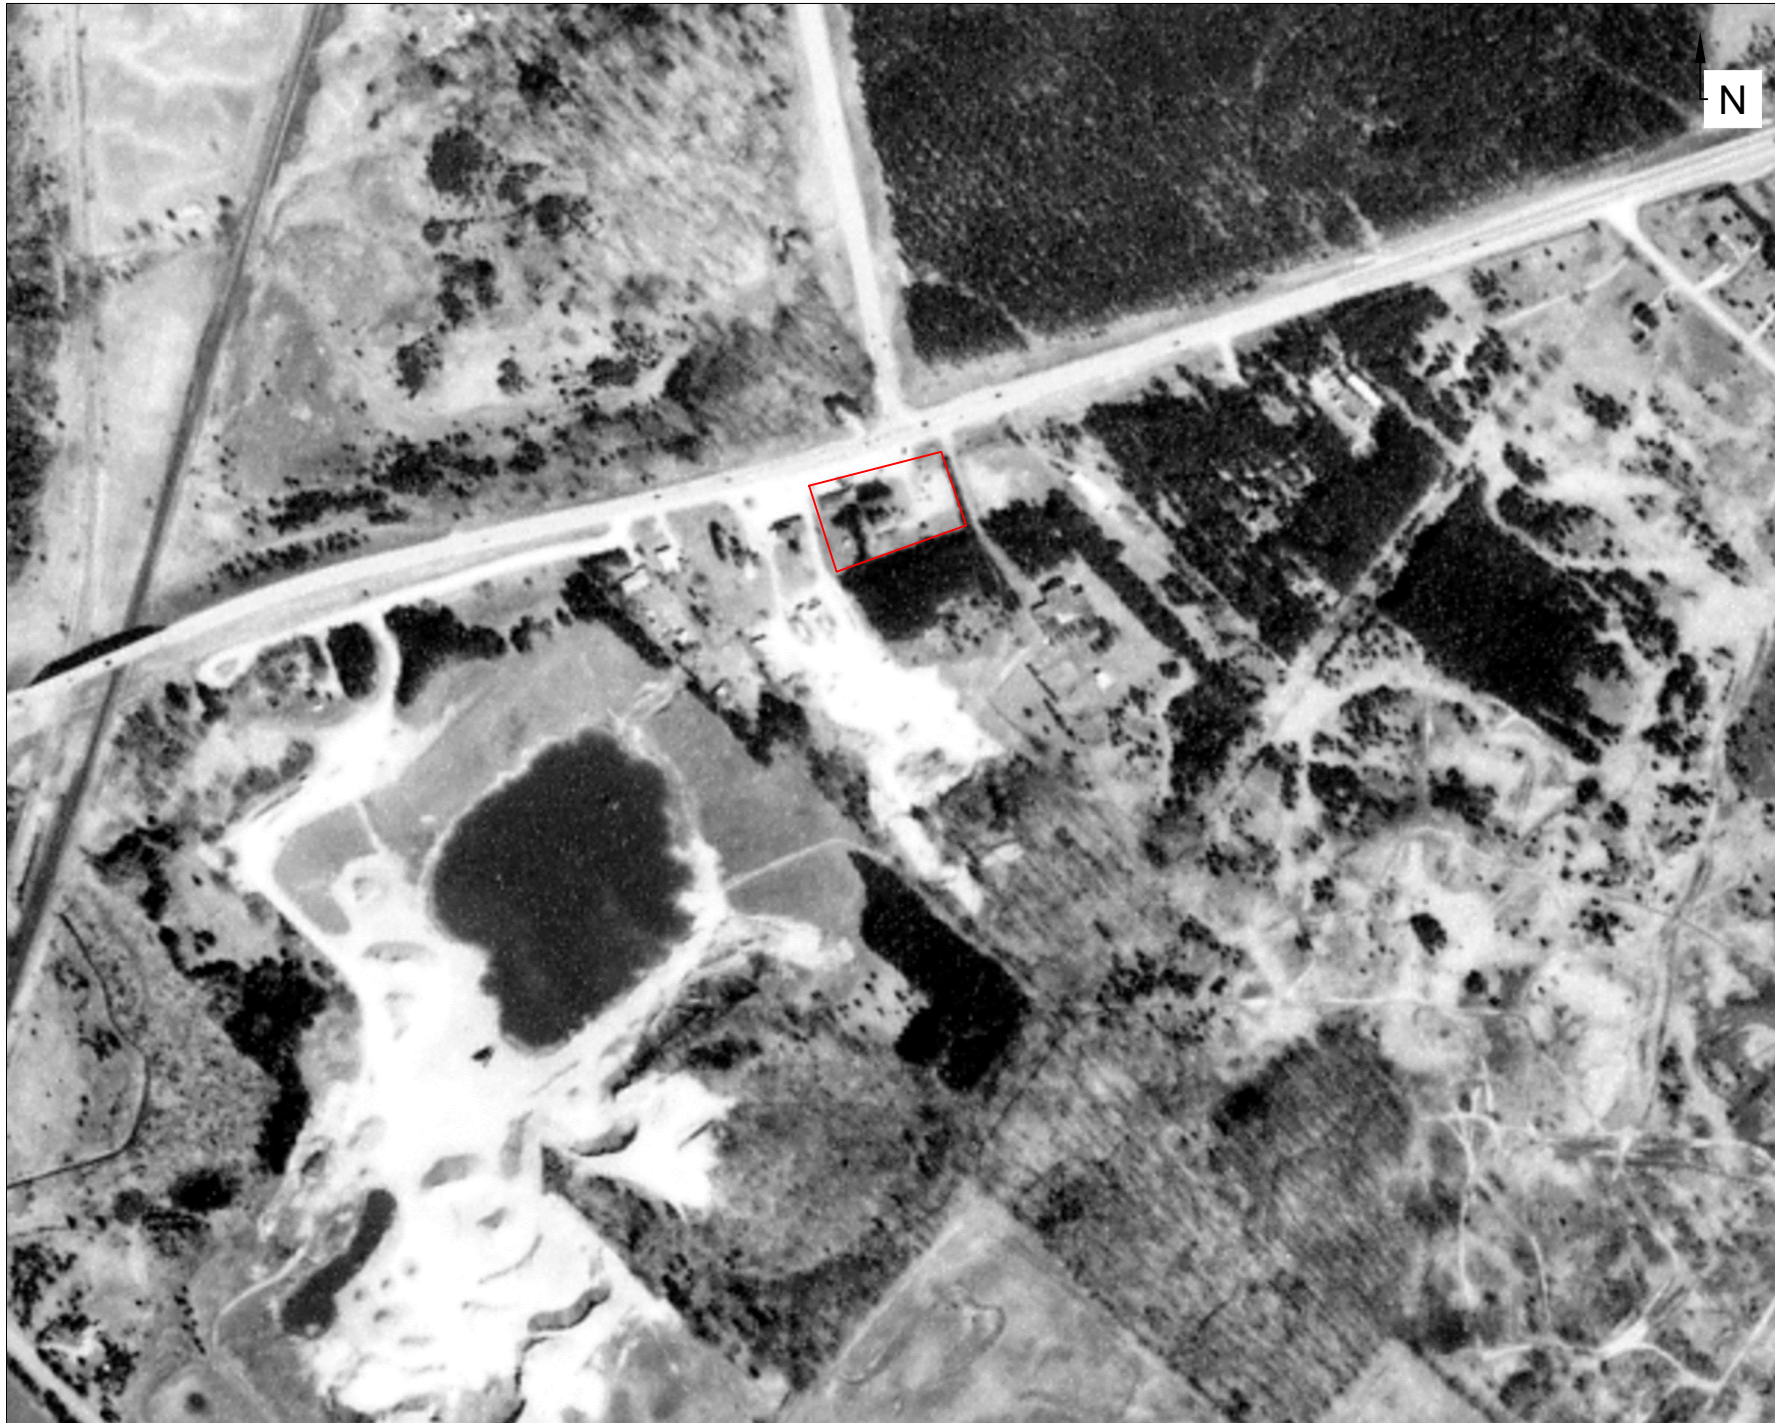
Title:
Figure 11 - Historical
Aerial Photograph
1995

- 1995: The large parking lot observed from the previous aerial photograph appeared to have approximately five vehicles parked on it at this time. There appeared to be further development east and southeast of the Site at this time.

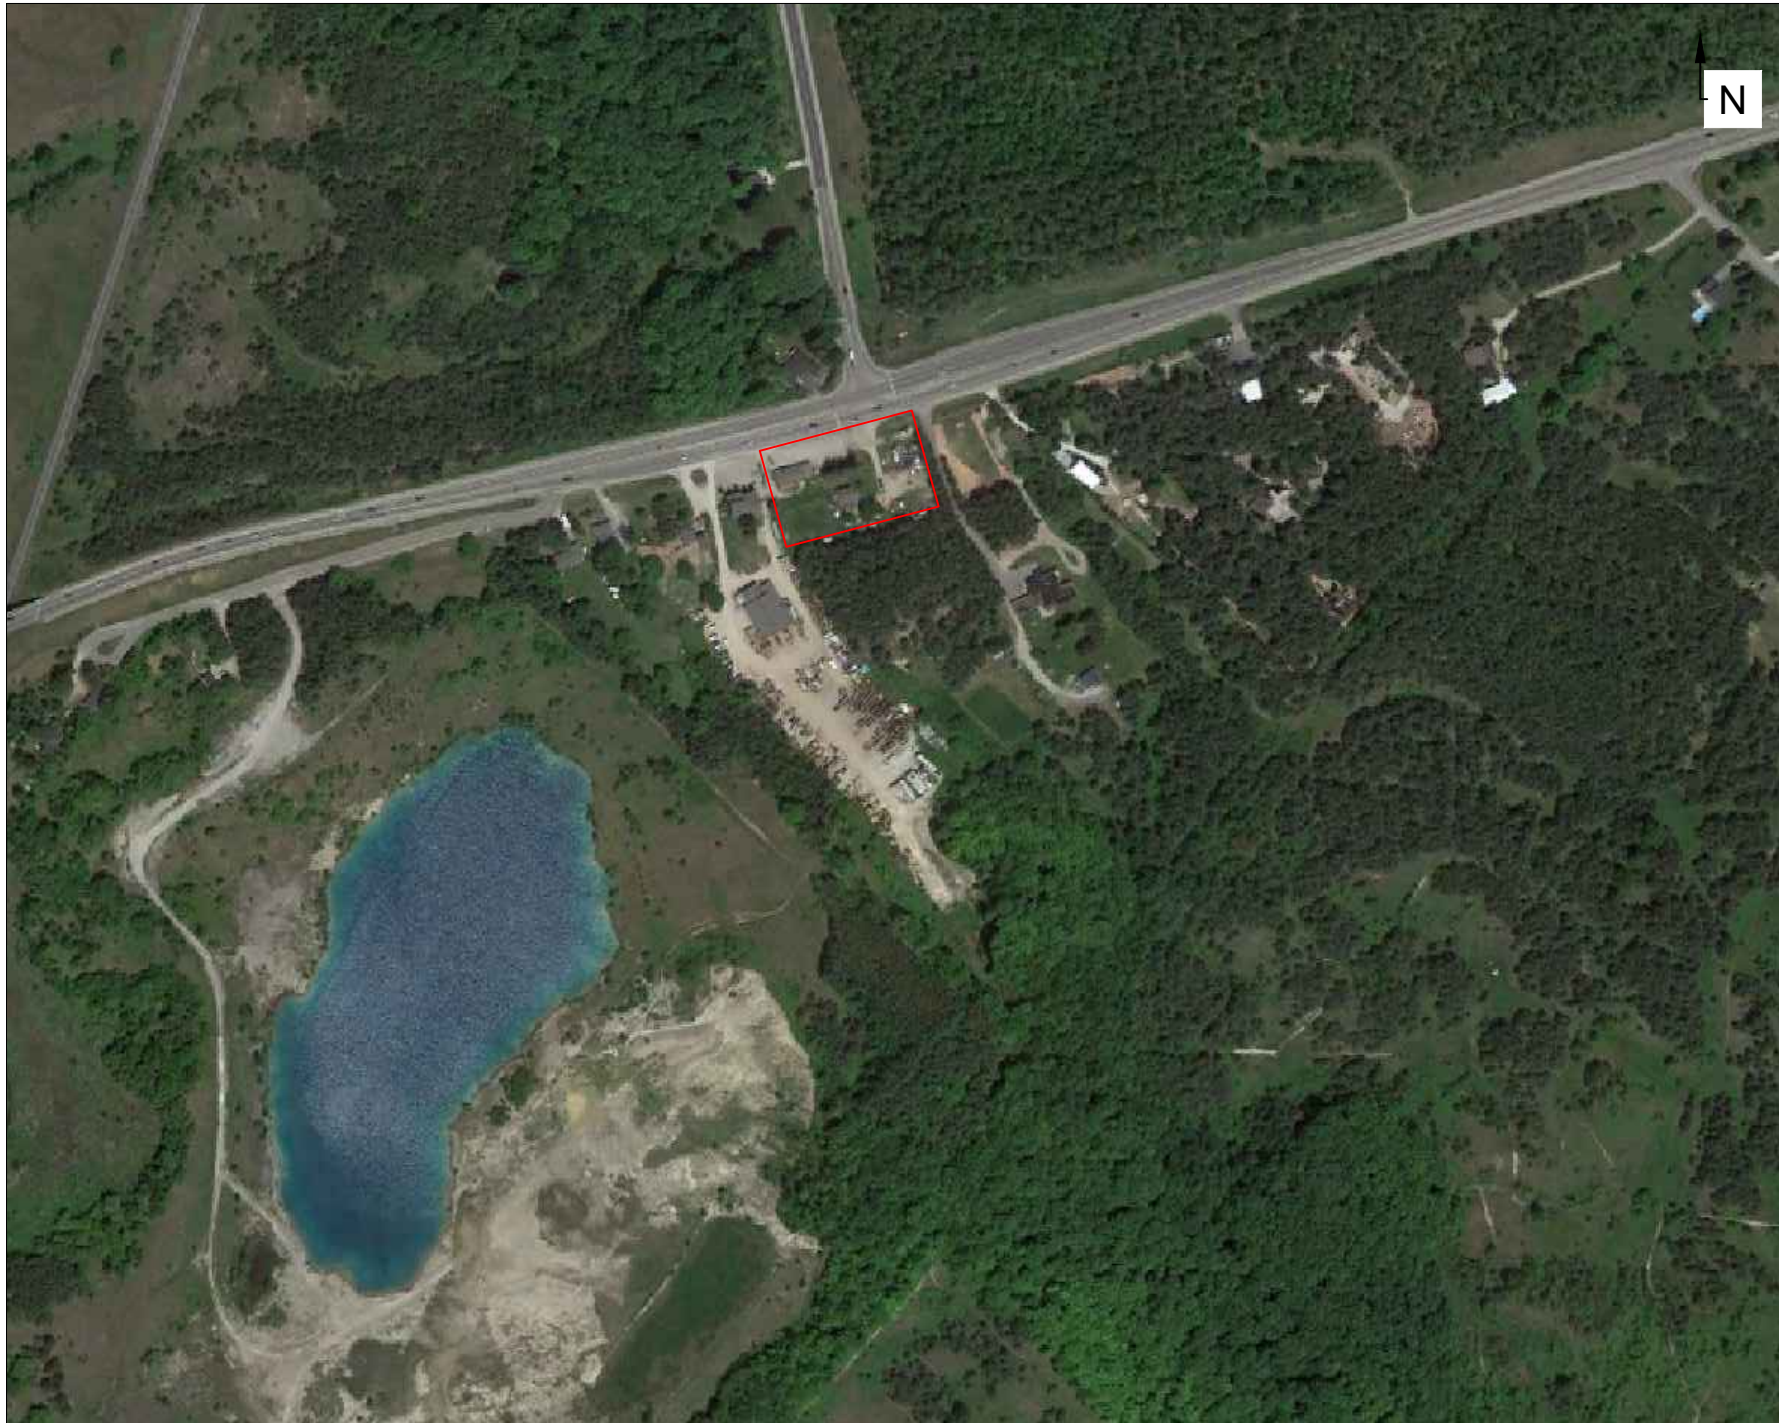
Title:
Figure 13 - Historical
Aerial Photograph
2015

- 2015: The parking lot identified on the east area of the Site appeared to be less of a parking lot and more of an area for vehicle/boat storage from this aerial photograph. There appeared to be 14 vehicles and 1 boat on in the grass/dirt area at this time. The rest of the surrounding area appeared to be consisted with the previous aerial photograph and current day conditions.

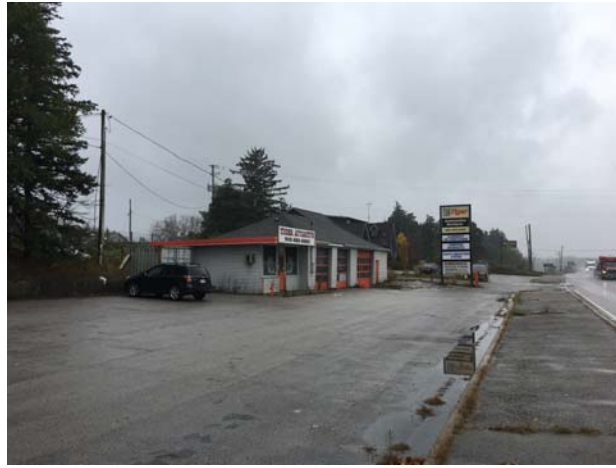
Site Building 1 was a ground level one storey building with a three door garage automobile servicing area, a reception office and a bathroom. The exterior walls of the building appeared to be wood panels. The interior walls appeared to be made up of cinder bricks in the service garage and drywall in the reception area and bathroom. The floors appeared to be made up of solid cement with no visible cracks in the service garage and square tiles in the reception and bathroom. The building appeared to be illuminated by mostly hanging fluorescent and incandescent light fixtures.

Photograph 1: View of Site Building 1.

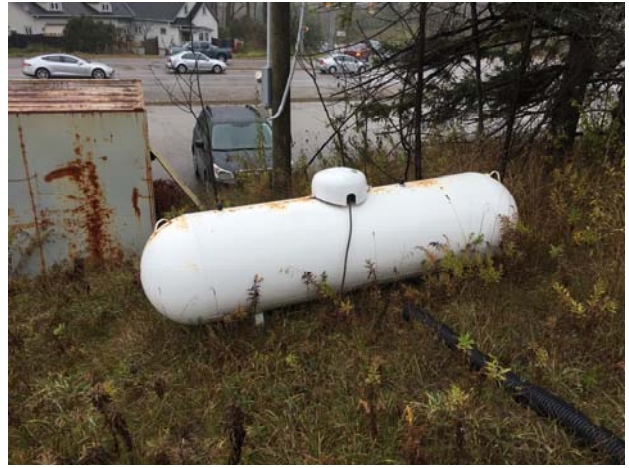
Heating in Site Building 1 was reportedly provided by the propane tank observed outside south of the building. There was one hot water storage tank observed in the ceiling between the service garage and reception area. There was a window air conditioning unit protruding from the east wall of Site Building 1 for the reception area which appeared to be very old, weathered and possibly containing refrigerant R-22. No other cooling systems were observed for Site Building 1. It is recommended that the window air conditioning unit be disposed of as hazardous waste at an appropriate waste disposal facility.

Photograph 2: View of propane tank supplying gas to Site Building 1.

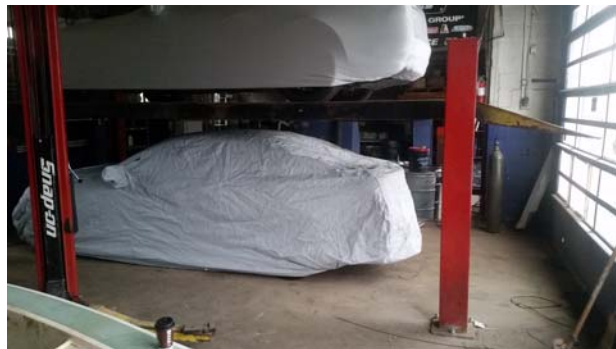
Photograph 3: View hydraulic lift and vehicle storage inside Site Building 1

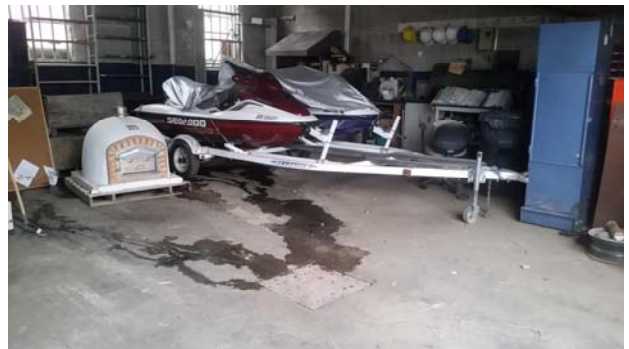
There were two drains observed on the inside and outside of the furthest west garage door of Site Building 1 and there was a sump located in the basement of Site Building 2. Drains were also located in the sinks/toilets of each Site Building. Contents entering the drains were reportedly transported into a septic bed which was reportedly located underneath the ground just south of Site Building 1.

Photograph 4: View of drain and seadoo storage inside Site Building 1.

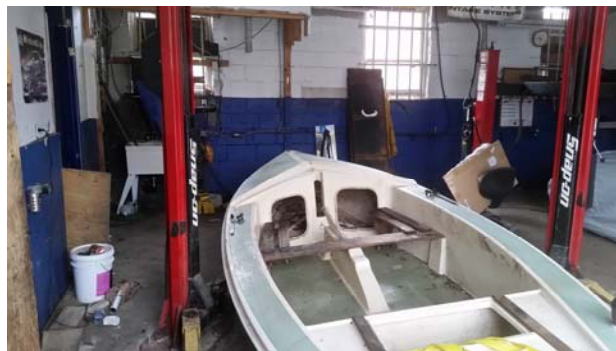
Photograph 5: View of boat frame and hydraulic lift inside Site Building 1.

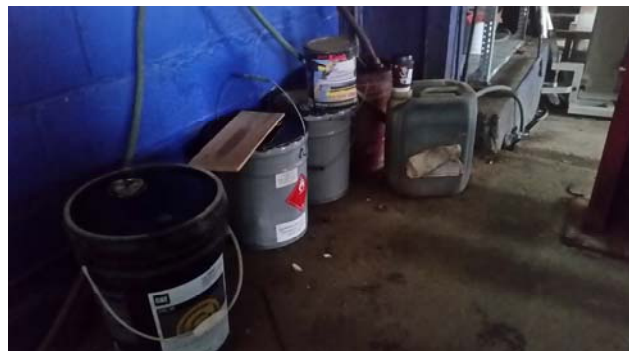
- i) There was reportedly no processing or manufacturing operations conducted at the Site.
- ii) Hazardous materials observed within Site Building 1 included but was not limited to hydraulic oil, engine oil, muriatic acid, leather finisher, heptane/IPA and mineral spirits.

Photograph 6: View of used pales of various mechanical fluids in Site Building 1.

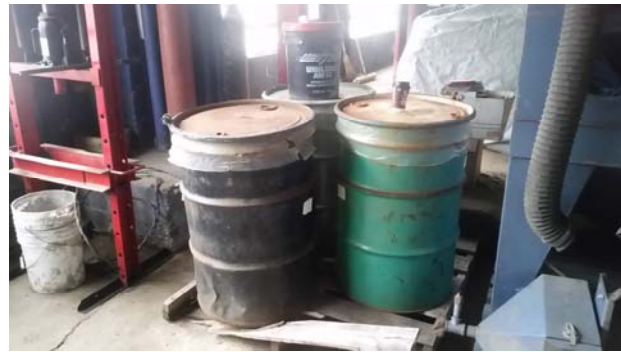
- v) There did not appear to be any raw material storage on the Site at the time of the Site assessment.
- vi) There were four unlabelled drums observed within Site Building 1. Three of them appeared to contain fluids (based on their weight) and were positioned on a skid in the centre of the garage area. The fourth appeared to be empty (based on its weight) and was positioned on a shelf/desk along the southern wall of the garage.

Photograph 7: View of barrels in Site Building 1 used for storage of unknown fluids.

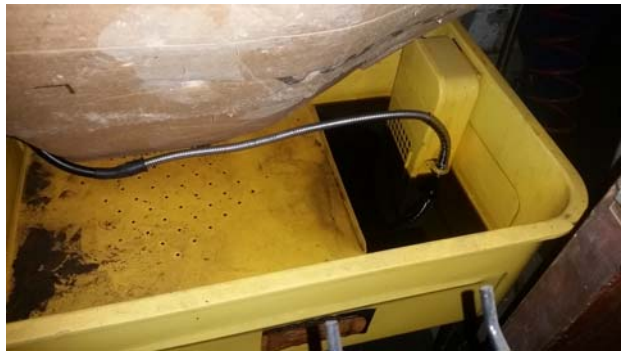
Photograph 8: View of parts cleaning tray in Site Building 1 with leftover fluid contents.

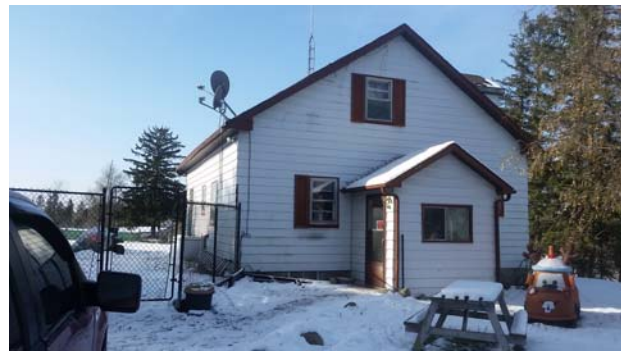
Heating in Site Building 2 was reportedly from natural gas supplied to a 'Goodman' furnace system. There was no observed air conditioning unit observed for the building therefore was assumed to be cooled through window ventilation.

Photograph 9: View of Site Building 2.

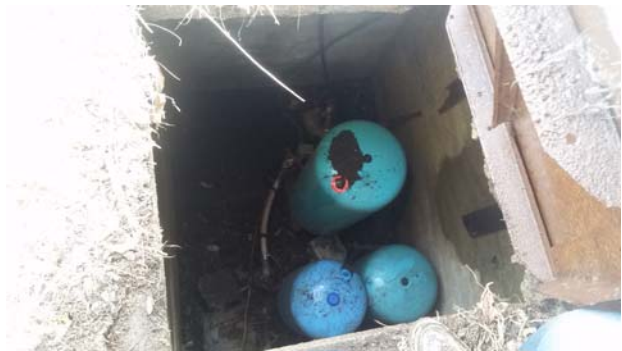
Only one domestic water supply well was reported to be present on the Site by Mr. Jay Hemming. There was what was reported to be a domestic well with three associated tanks within the ground observed to the north of Site Building 2 within the treeline. There was also what appeared to be a groundwater well outside of the northeast corner of Site Building 1.

Photograph 10: View of domestic groundwater well from Site.
