PHASE ONE ENVIRONMENTAL SITE ASSESSMENT

2650 MAYFIELD ROAD, CALEDON, ONTARIO

WSP File No.: 161-01959-00

26 FEBRUARY 2016

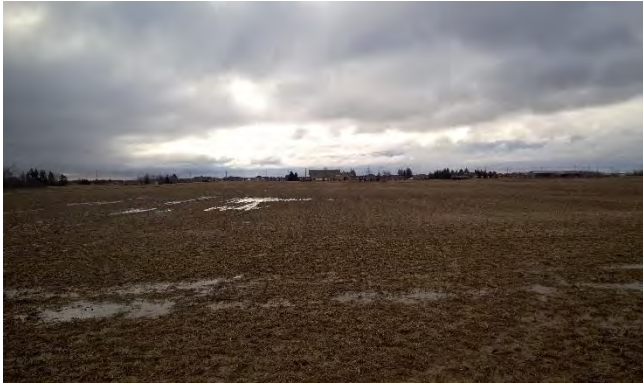
1. View of the Phase One Property, facing south.

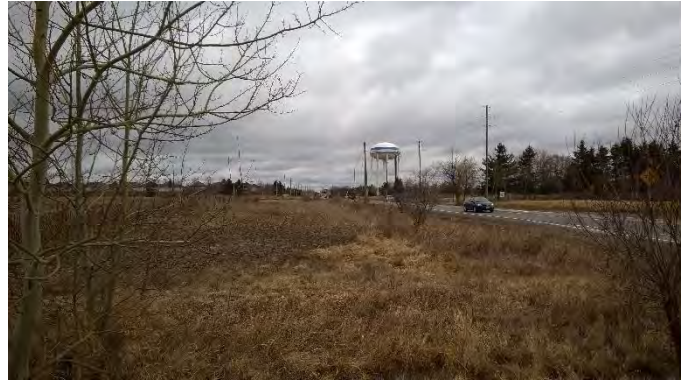
2. View of the Phase One Property, facing east.

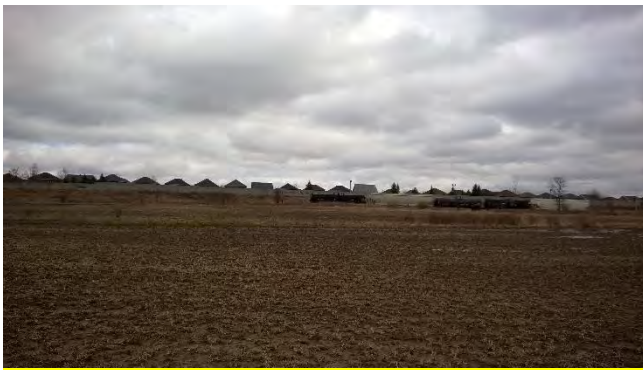
3. View of the Phase One Property and the Orangeville Brampton Rail, facing east.

46. Rail Yards, Tracks and Spurs	Phase One Property – The Orangeville Caledon Railway runs along the eastern portion of the Phase One Property and is considered to be contributing to APEC 3 .

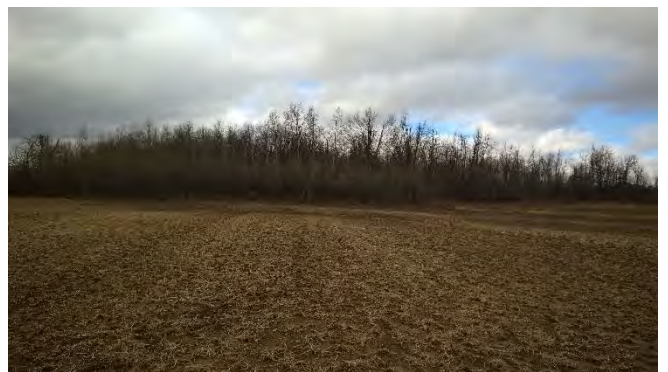
6. View of the Provincially Significant Wetland on the northeast portion of the Site, facing north.
