APPENDIX 6 CONTAMINATION OVERVIEW STUDY

CONTAMINATION OVERVIEW STUDY COLUMBIA WAY ENVIRONMENTAL ASSESSMENT STUDY BETWEEN HIGHWAY 50 AND CALEDON-KING TOWNLINE TOWN OF CALEDON, ONTARIO

Date: August 28, 2020

File: 27855-20

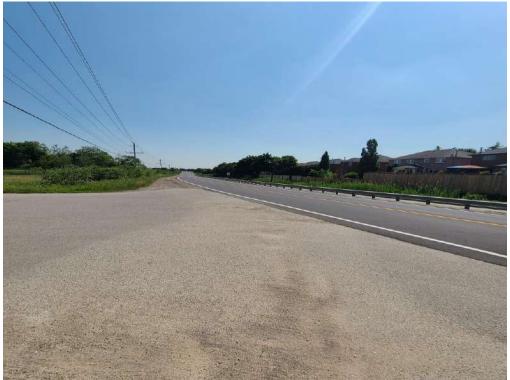
The Site consisted of an asphalt paved two-lane roadway (Columbia Way) that was judged to be in good condition as the road appeared to be recently paved, as shown on Photo 1. Generally, the ditches along either side of the road were vegetated with overgrown tall grass, weeds and

Photo 1: View of Columbia Way to the east/northeast, 600m east of Highway 50.

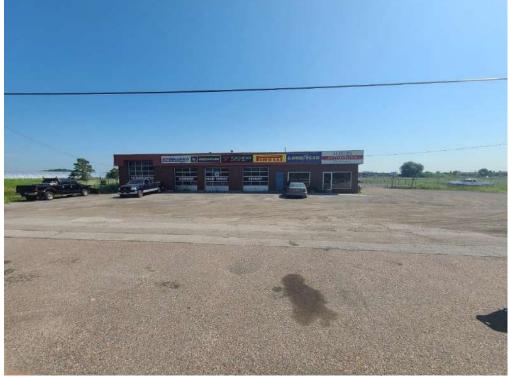
- o 14289 Highway 50: Auto Garage (former YG's Gas Bar) A single building was observed on the property (appeared to be temporarily closed); multiple vehicles; fence surrounding back of property; tool/machinery shed, hoists (observed in 2011 from Google Map street-view imagery) and multiple solid waste bins were observed on the property. There was no evidence of underground storage tanks on the property.
- 14124 Highway 50: Motor Home Travel Canada A single office-type building was observed on the property, including two large storage-type and maintenance structures, multiple motor home trailers and multiple solid waste bins.

Photo 2: View to the East showing an automotive garage (former YG's gas bar), approximately 250m north of the Site on the east side of Hwy 50.

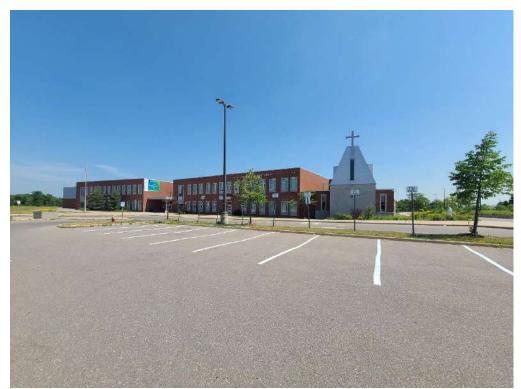
9130 Columbia Way: St. Michael's Catholic Secondary School – a single building (temporarily closed), pad-mounted transformer box, multiple pole-mounted transformers, two garages and storage facilities observed on the property.

Photo 3: View to the North showing St. Michael's Catholic Secondary School located along Columbia Way.

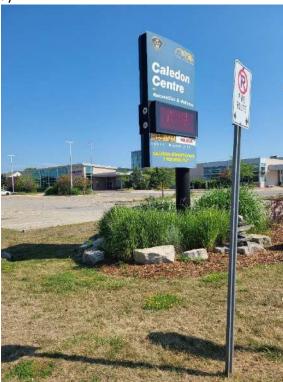
Photo 4: View to the northeast showing Caledon's Community Centre located approximately 150m south of the intersection of Highway 50 and Columbia Way.

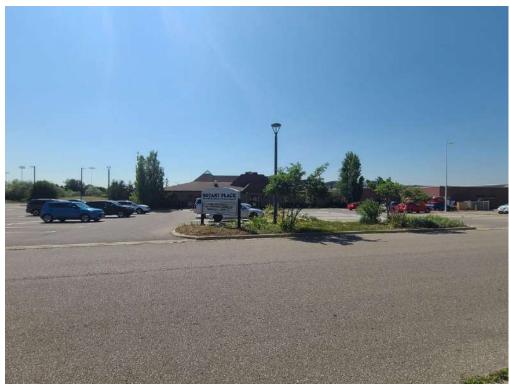
Photo 5: View to the south showing Caledon's Senior's Centre located approximately 150m south of the Site.

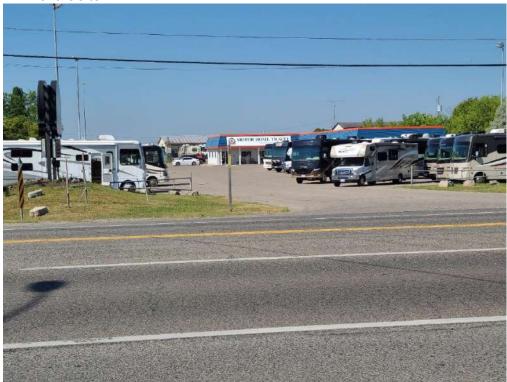
Photo 6: View to the west showing Motor Home Travel Canada, the commercial property proximal to the Site located approximately 120m south of the intersection of Hwy 50 and Columbia Way.

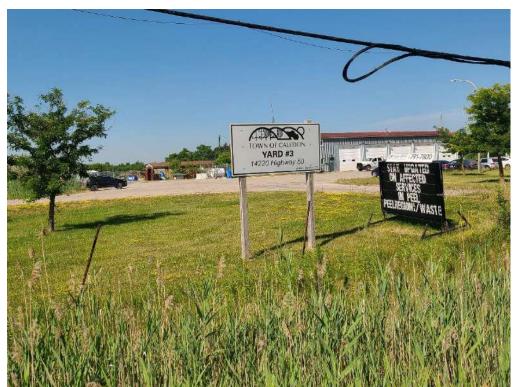
o 14220 Highway 50: Bolton's Public Work's Yard #3 – Three buildings were observed on the property that included a garage with 5 bay doors, a storage building near the back portion of the property and a Quonset Hut near the road.

Photo 7: View to the west showing the Town of Caledon's Public Works Yard #3 located westly adjacent to the Site

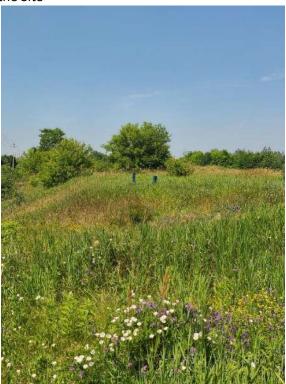
Four monitoring wells were observed within the Study Area during the field visit. Two stick up monitoring wells existed approximately 50 m to the west of the intersection of Columbia Way and Westchester Boulevard within tall grass (Photo 8). A well record was not available on the MECP's Water Well Records database for the monitoring well.

Photo 8: View to the west showing two stick-up monitoring wells north of Columbia Way, located approximately 50m west of the intersection of Columbia Way and Westchester Boulevard.

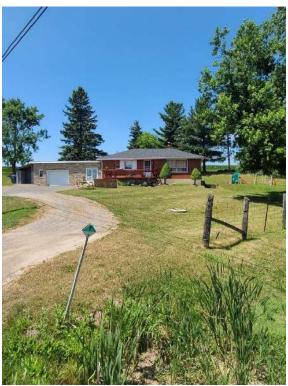
Photo 9: View to the north showing a location of a dug well within the Study Area, located on the property at 9706 Columbia Way.

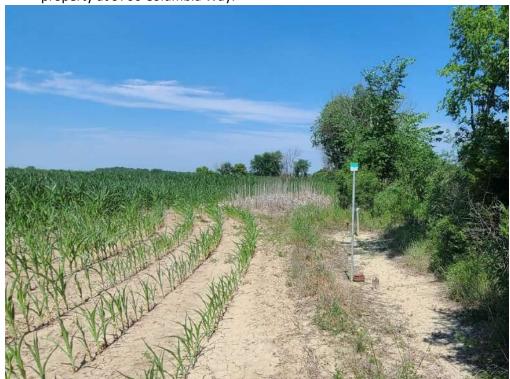
An additional well was observed approximately 50 m to the north of the Site alongside Mount Hope Road. The well was located adjacent to an agricultural field. A vent was also observed 2 m to the north of the water well (Photo 10). A review of the MECP's Water Well Records database identified a single well (Well ID 4906158) which was installed in 1984 to a depth of 93 m bgs for domestic use.

An additional well was observed approximately 50 m to the north of the Site adjacent to Mount Hope Road. The well was located near an agricultural field with a vent observed 2 m to the north of the water well (Photo 10), as noted in Section 6.5.3 of this report.

Photo 10: View to the North showing a water well and vent on an agricultural property north of Columbia Way and west of Mt. Hope Road.

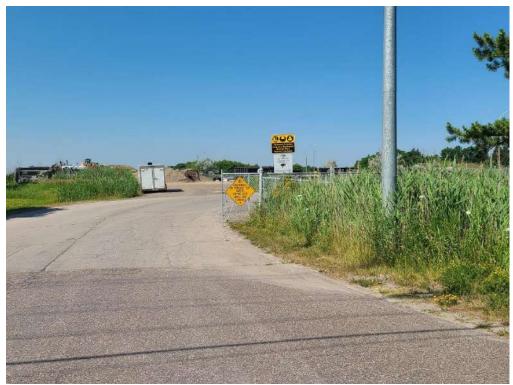
The subsurface conditions of the Site could not be assessed during the Site Reconnaissance, however, there is a potential for fill materials to exist beneath asphalt pavement structures surrounding the Site (i.e. parking lots and roadways). In addition, stockpiles of fill and construction equipment were observed at 14220 Highway 50 (Photo 11).

Photo 11: View to the west showing the fill, construction material and equipment located at 14220 Highway 50.

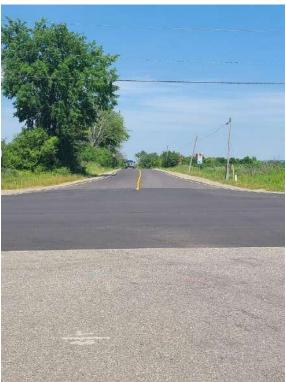
Residential roads intersected Columbia Way at three locations from the south residential subdivisions, and a regional road (Mount Hope Road) intersected Columbia Way in the central portion of the Site alignment (Photo 12). No parking spaces were observed on Site, however, parking spaces associated with the institutional, commercial, community and industrial properties were observed adjacent to the Site. At the time of the Site Reconnaissance, the parking lots on the community and institutional properties were generally empty due to temporary closures during the coronavirus pandemic. The commercial property at 14124 Highway 50 was primarily occupied by company owned vehicles (i.e. RV motor homes), and multiple vehicles were stored near the south property line at 14289 Highway 50 (Photo 15).

Photo 12: View to the north at the intersection of Mt. Hope Road and Columbia Way.

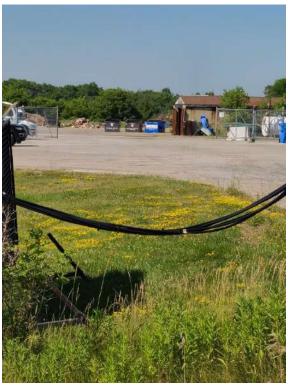
Solid waste bins were observed at the time of the Site Reconnaissance on the commercial, institutional and community properties within the Study Area, including on the Public Work's Yard #3 at 14220 Highway 50 (Photo 13); however, no chemicals, hazardous substances, or non-domestic wastes were observed on the properties from the publicly accessible areas during the Site Reconnaissance.

Photo 13: View to the west showing waste bins/containers on the property located at 14220 Highway 50.

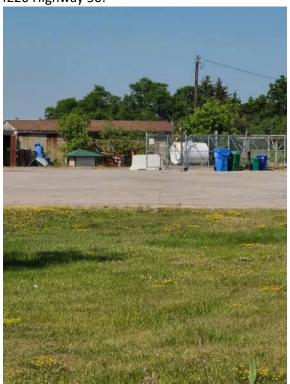
An aboveground storage tank was observed during the Site Reconnaissance at Bolton Public Works Yard #3 (14220 Highway 50), a property adjacent to the Site (Photo 14). The contents and age of the storage tank are unknown, however the volume is estimated at approximately 900 L. No evidence of existing underground storage tanks was observed on Site during the Site Reconnaissance.

Photo 14: View to the northwest showing the above ground storage tank located on the property located at 14220 Highway 50

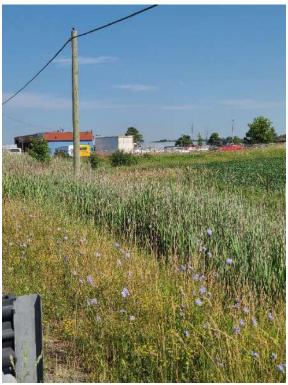
Photo 15: View to the northeast at stored vehicles at the garage located at 14289 Highway 50.

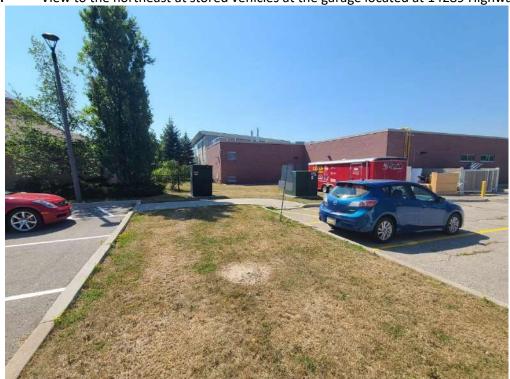
Multiple green pad-mounted transformer boxes were observed along Columbia Way and within the adjacent residential subdivision and community properties (Photo 16). Random pole-mounted transformers were also observed within the Study Area (Photo 17).

However, the vegetation around the pad- and pole-mounted transformers appeared healthy; and, generally no staining was observed on exposed portions of the concrete pads, on the ground surface near the transformer pads, or on the transformers and poles beneath the transformers.

Photo 16: View to the southwest showing two of the pad-mounted green transformer boxes located on the Caledon Recreation Centre at 14111 Highway 50.

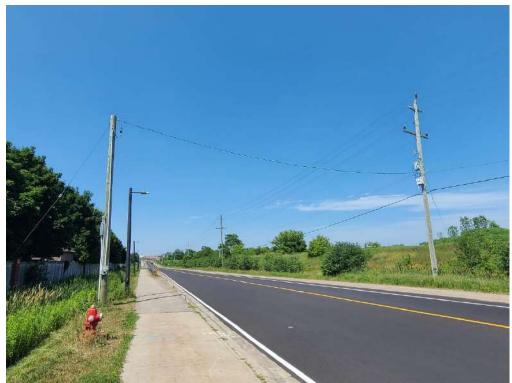
Photo 17: View to the southwest showing one of the pole-mounted located along Columbia Way.
