**HYDROGEOLOGICAL ASSESSMENT  
SCHEDULE C  
CLASS ENVIRONMENTAL ASSESSMENT  
FOR WIDENING OF MCLAUGHLIN ROAD  
AND CONSTRUCTION OF EAST-WEST SPINE ROAD  
(MAYFIELD WEST PHASE 2)  
CALEDON, ONTARIO**

**The Corporation of the Town of Caledon**  
Town Hall, 6311 Old Church Road  
Caledon, Ontario, L7C 1J6  
Canada

**Amec Foster Wheeler Environment & Infrastructure,  
a Division of Amec Foster Wheeler Americas Limited**  
160 Traders' Boulevard East, Suite 110  
Mississauga, Ontario, L4Z 3K7  
Canada

October 16, 2017

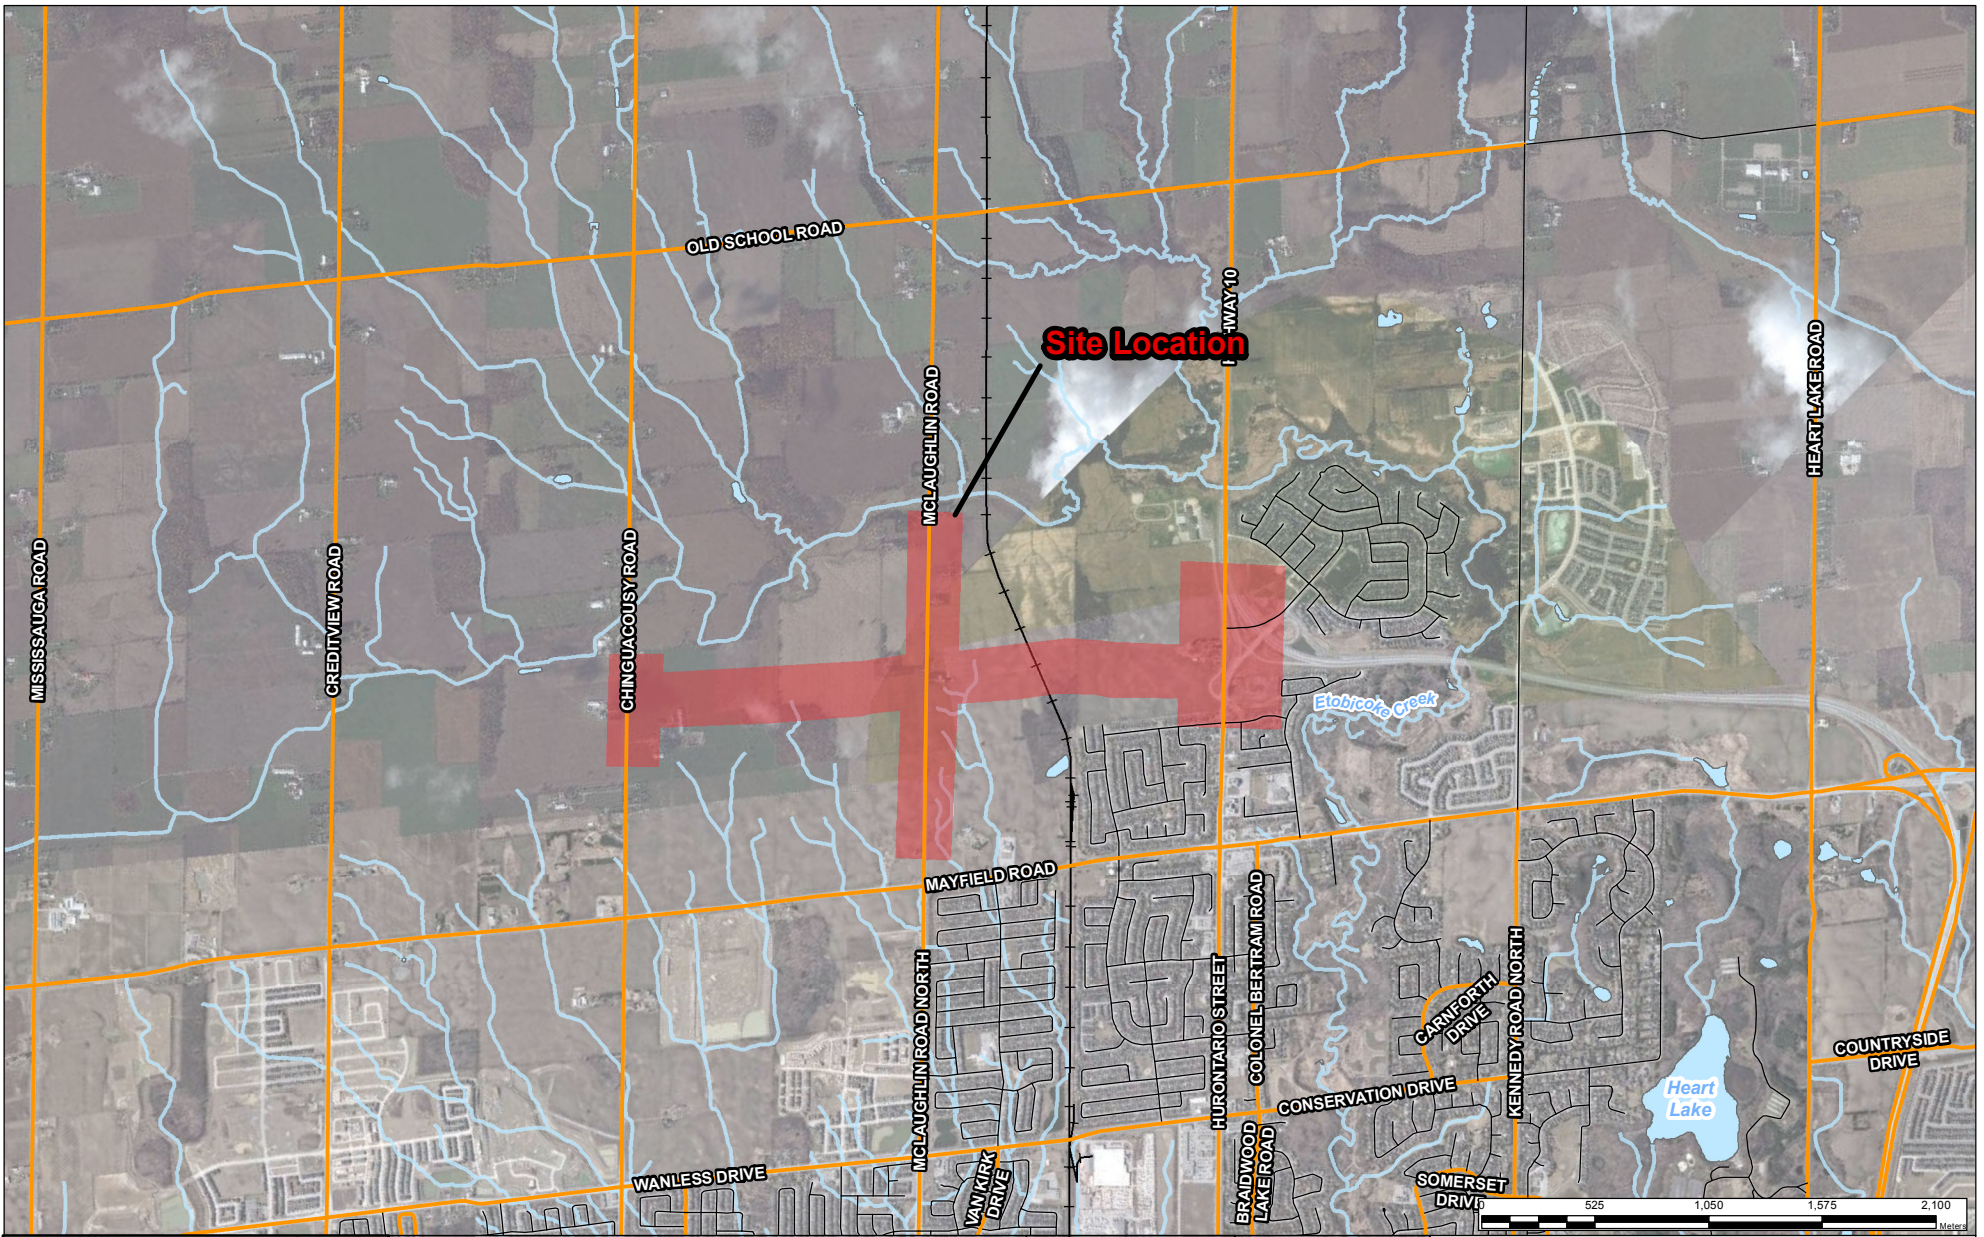
<b>HYDROGEOLOGICAL INVESTIGATION</b>	
McLaughlin Road, Brampton Ontario	
Site Location Plan	
PROJECT N°: TPB166090	FIGURE: <b>1</b>
DATE: October 2017	
<b>Amec Foster Wheeler Environment &amp; Infrastructure</b> 505 Woodward Ave., Hamilton, Ontario, L8H 6N6 tel: 905-312-0700    www.amecfw.com

The Site is situated within the Etobicoke Creek watershed within the south part of the City of Caledon in Peel Region (Figure 1). The Site is located between Mayfield Road (south) and Old School Road (north) and between Hurontario Street (northeast) and Chinguacousy Road (southwest).

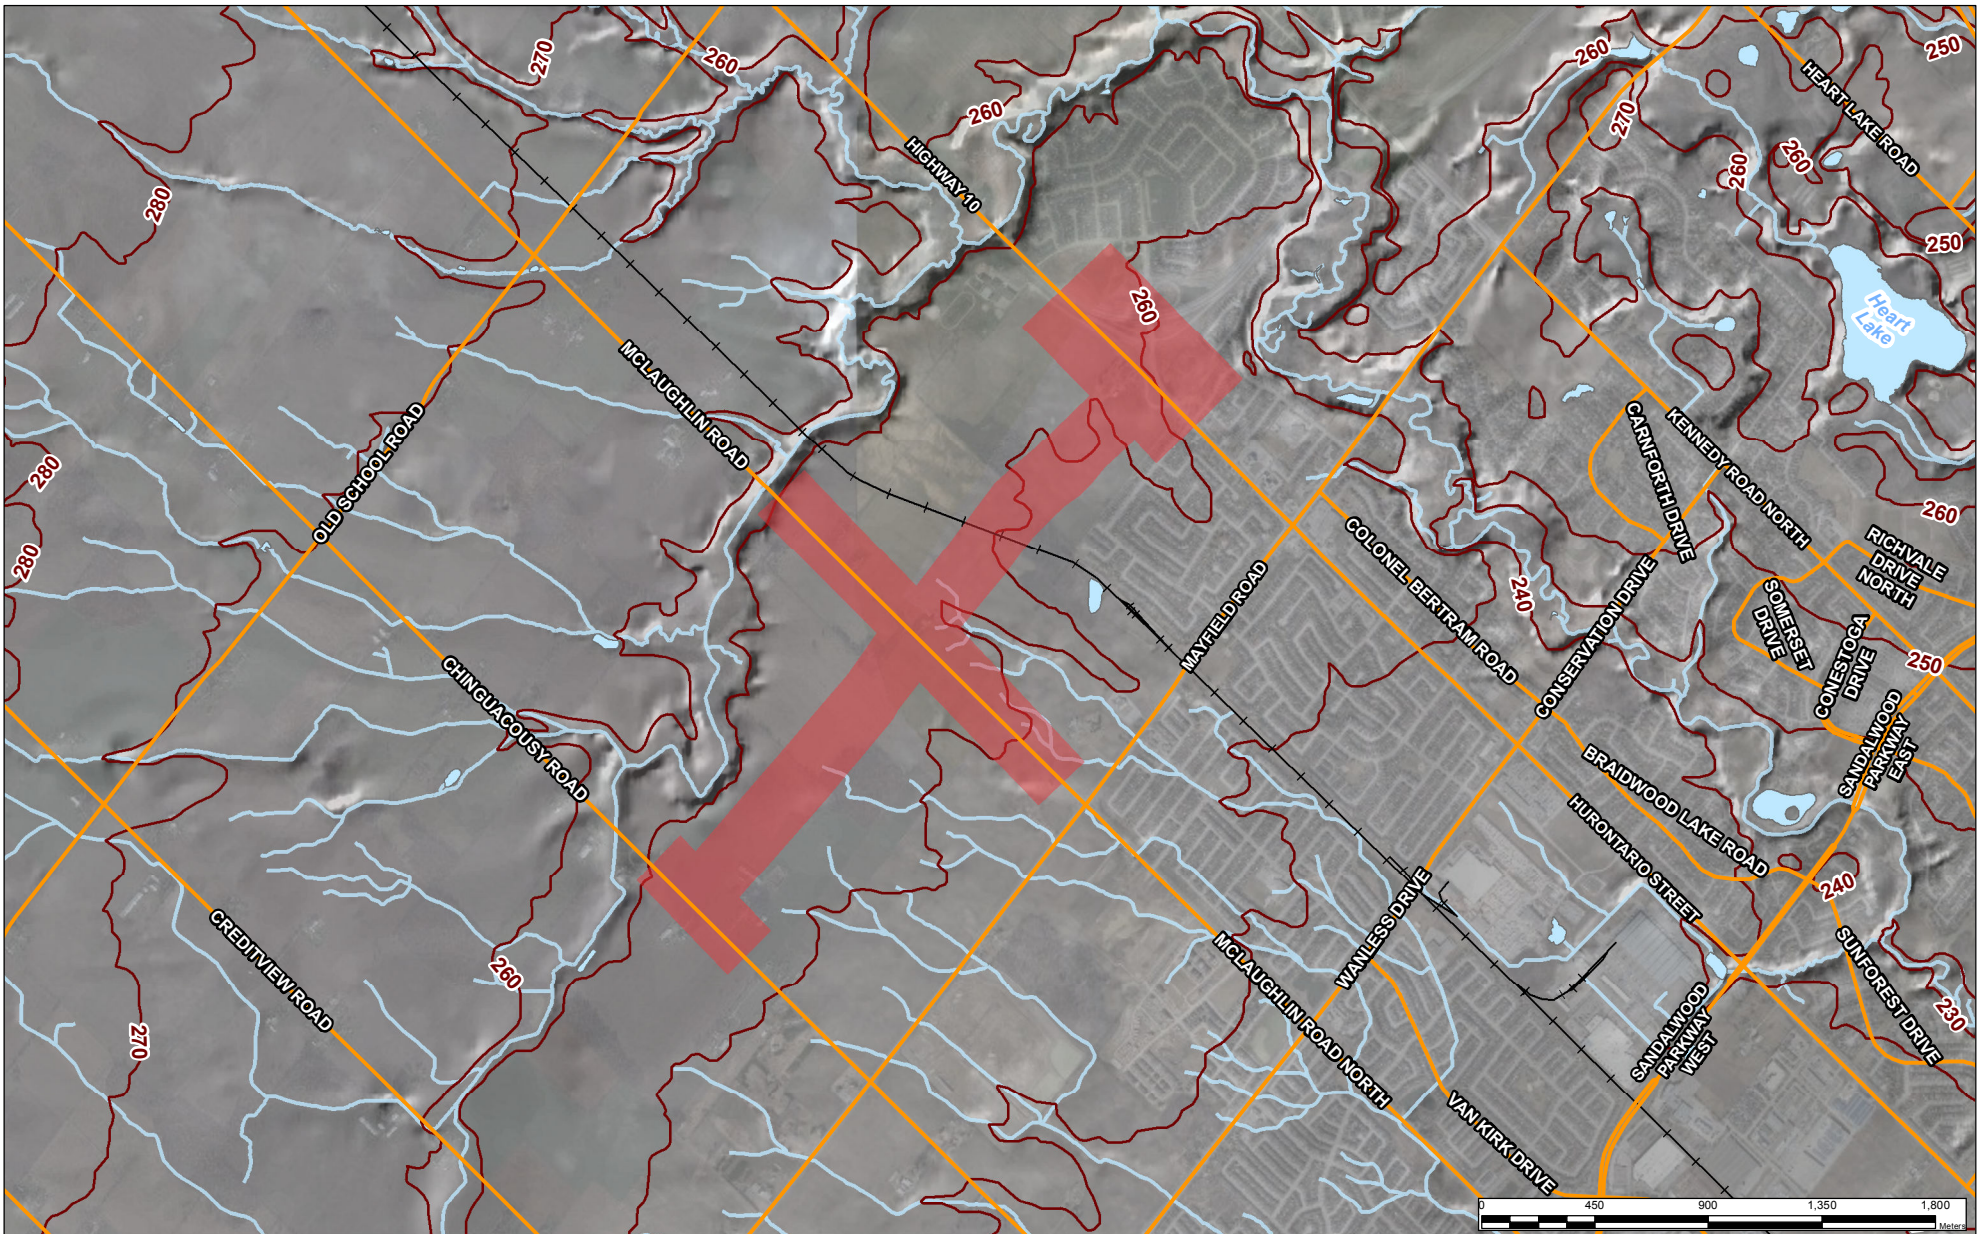
Topography and Surface Water Features

The proposed location of the road expansion appears to cross a local topographic high, generally located at approximate elevations of between 255 masl (at the east end of the site) and 265 masl (generally between 260 and 265 masl across the majority of the site).

Along the alignment, the topography ranges between elevations of approximately 264 masl and 255 masl based on the surveyed ground surface elevations of the WSP geotechnical boreholes drilled across the Site.

## **6.2 Surface Water Features**

The proposed construction will be situated within close proximity to Etobicoke Creek, but while the upper reaches of the main branch of Etobicoke Creek and tributaries of Credit River are present around the planned construction and these tributaries from both watersheds begin nearby and flow away from the Site, the planned construction area does not contain any creek crossings through the exact route of the Spine Road construction.

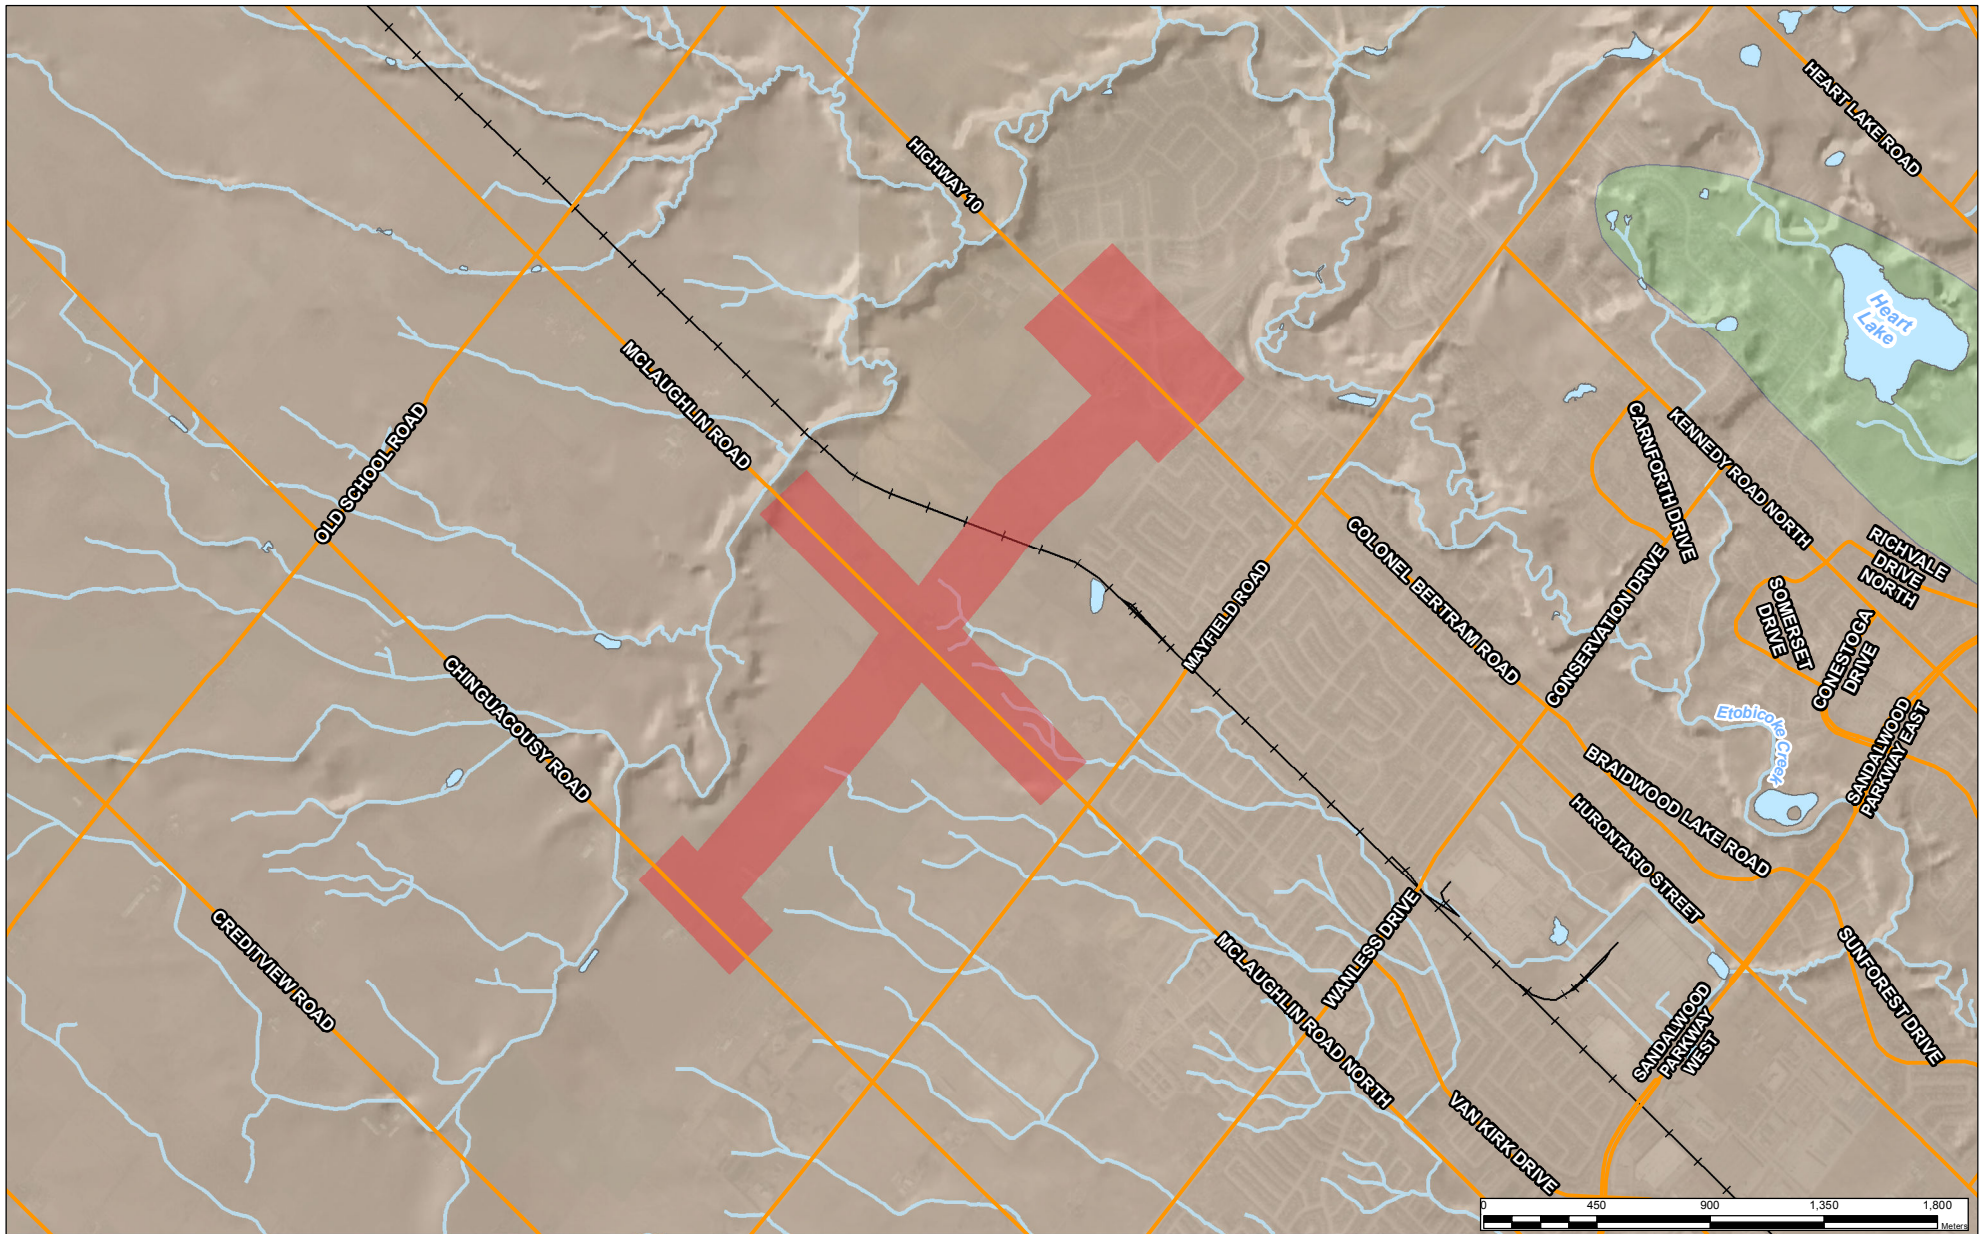
Physiography

The local physiography consisted of drumlinized till plains. These are associated with the South Slope physiographic region. This physiographic region consists of till soils, with the slope smoothed and faintly drumlinized. The South Slope is cut at intervals by the valleys created by tributaries of several of the river systems of the Greater Toronto Area.

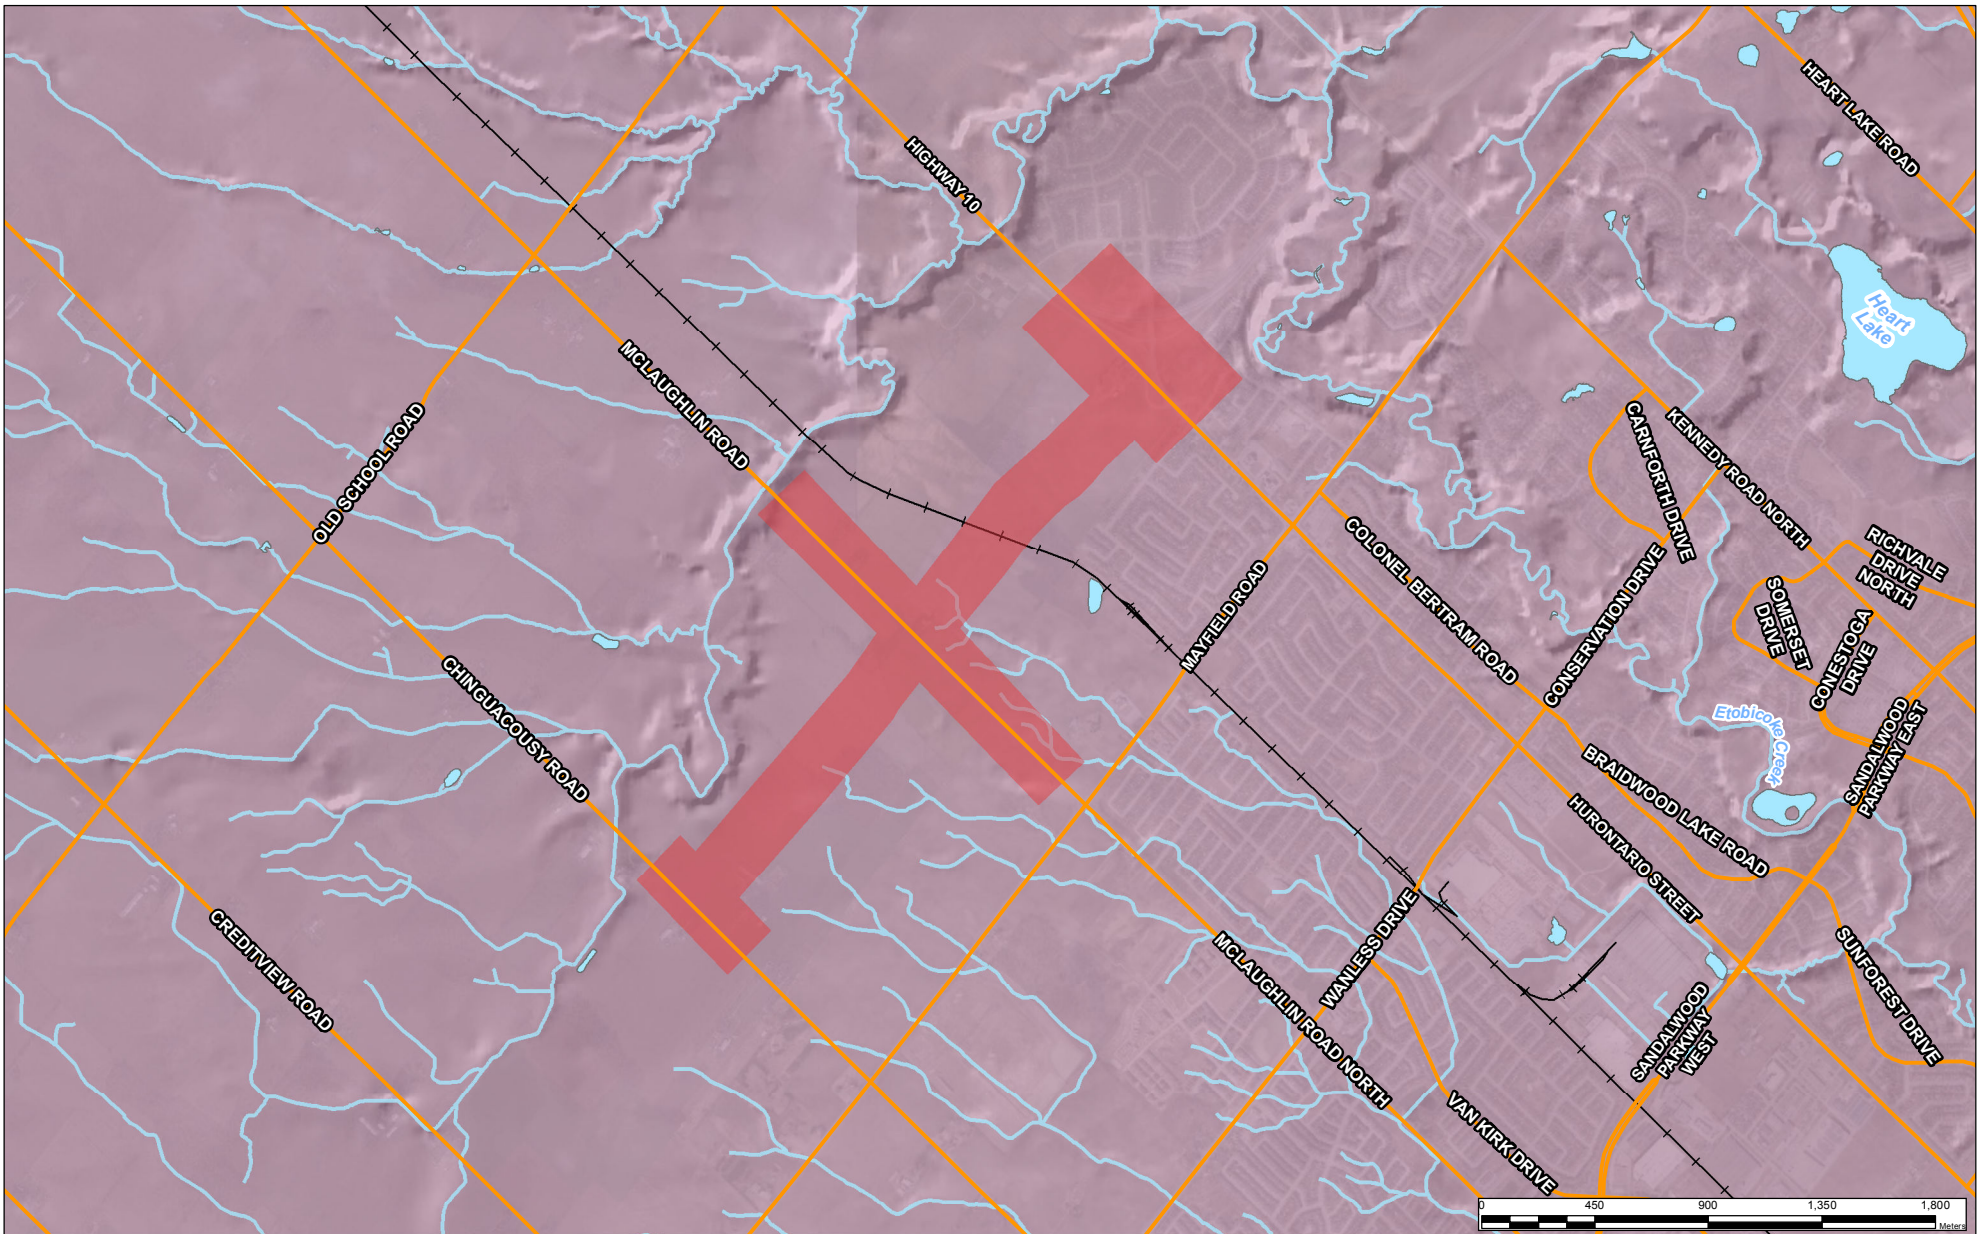
Quaternary Geology

The surficial geology across the site consists of predominantly till materials with a silt to silty clay matrix, high in matrix carbonate content and clast poor. This likely corresponds to the interpreted Halton Till or equivalent.

- predominantly silt to silty clay matrix, high in matrix carbonate content and clast poor

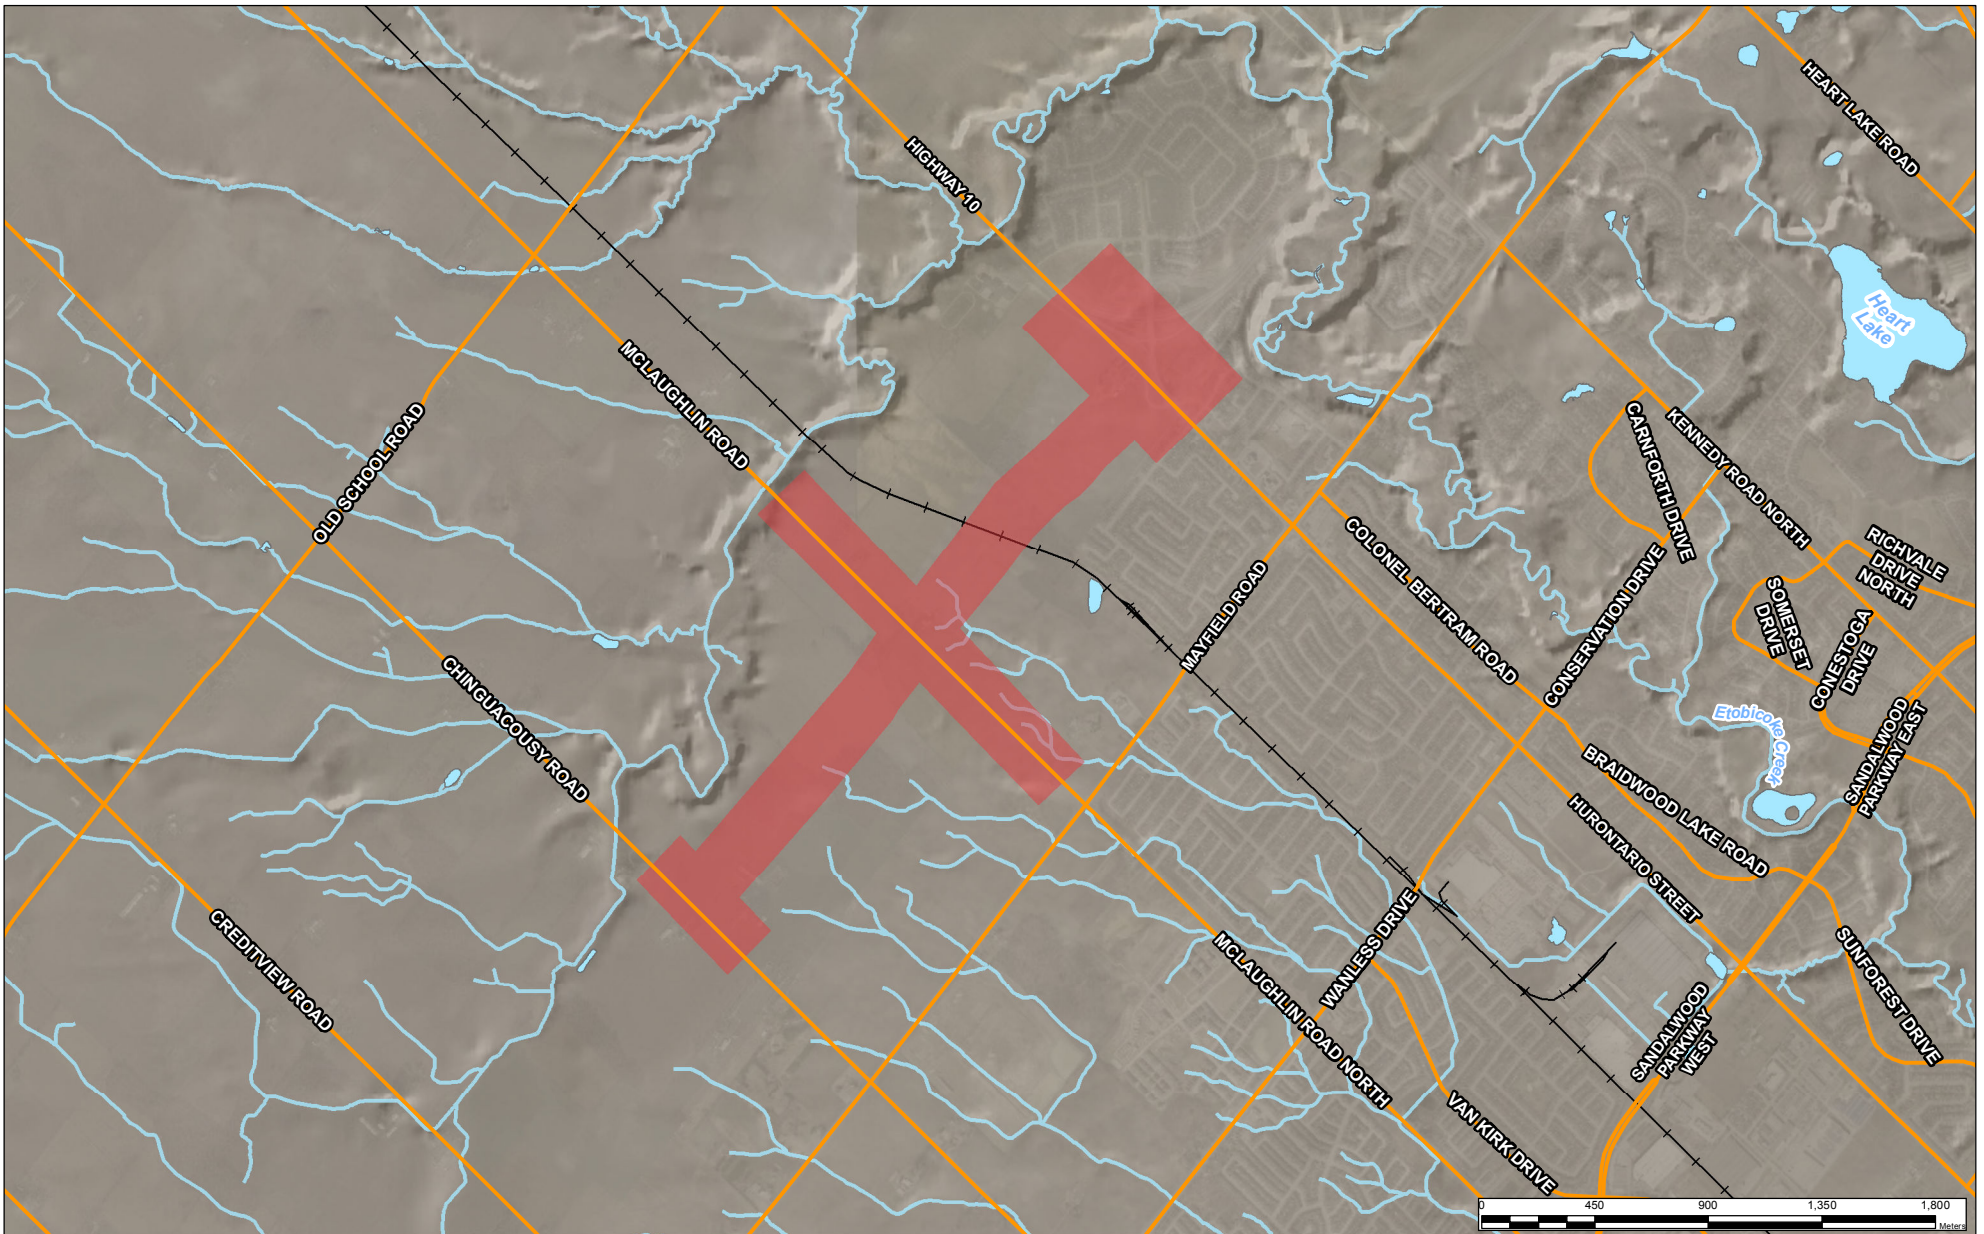
**Bedrock Geology**

The bedrock across the area consists of Queenston Formation shale. Bedrock is not considered a hydrogeological factor in this investigation due to the relatively shallow nature of the works to be completed. This may change depending on whether the train tracks are planned to remain as a level crossing, as they currently are at the road crossings both north and south of the proposed roadway. If either the tracks or the roadway are expected to be raised or tunneled across then the bedrock may factor into tunneling or bridge footing installation activities. Based on the findings of the WSP geotechnical report, some locations may encounter bedrock during excavations for the installation of subsurface infrastructure.

- Queenston Formation
