Phase One Environmental Site Assessment

12205 Creditview Road
Caledon, Ontario

DS Project No : 25-076-101
Date: May 22, 2025

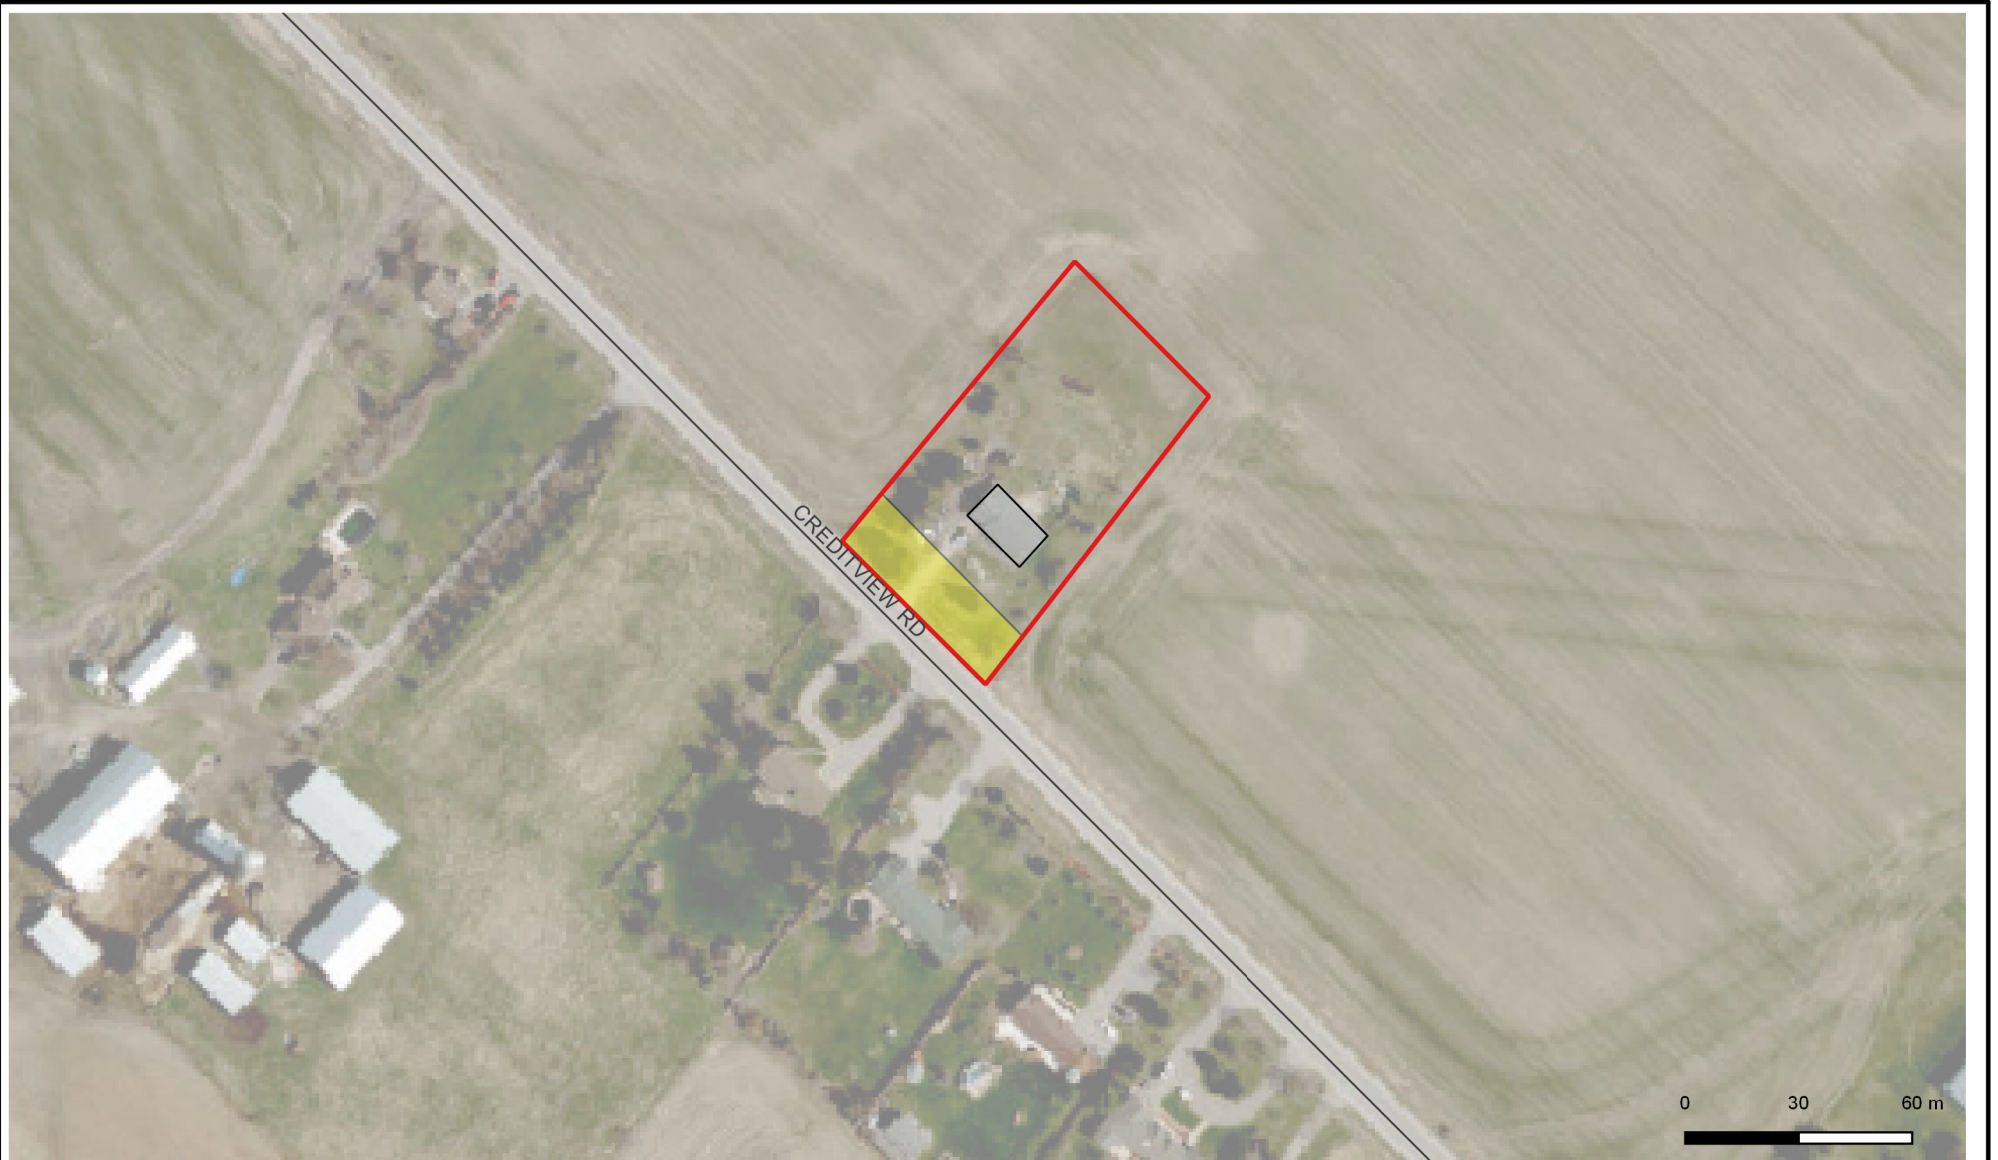
- Property Boundary
- APEC-1
(salt APEC along the western frontage of the property)

One (1) APEC was identified with respect to seasonal application of de-icing salts along Creditview Road. However, investigation of APEC-1 is not required per Section 49.1 (1) of O.Reg. 153/04, “*If an applicable site condition standard is exceeded at a property solely because of one of the following reasons, the applicable site condition standard is deemed not to be exceeded for the purpose of Part XV.1 of the Act*”: “...that a substance has been applied to surfaces for the safety of vehicular or pedestrian traffic under conditions of snow or ice or both”. Any potential impacts associated with EC and/or SAR in soil, and sodium and/or chloride in groundwater are deemed not to exceed the MECP Site Conditions Standards for the area identified as APEC-1.

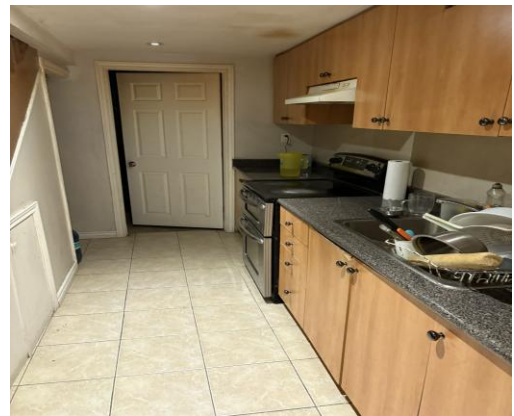
Picture 4: View of basement of the Phase One Property

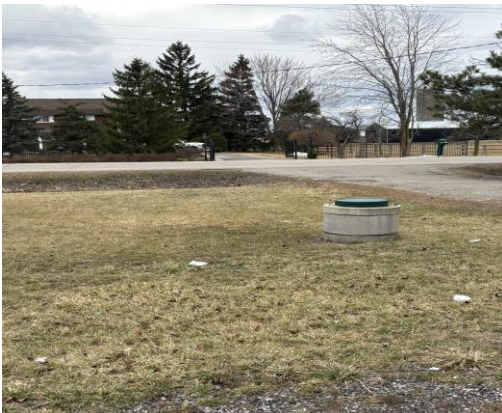
Picture 5: View of the dug well east of the Phase One property, facing west

No further investigation is required at this time. DS recommends the completion of a designated substances survey prior to any demolition or major building renovations. The dug well which is no longer in use should be decommissioned in accordance with the requirements of O.Reg. 903.

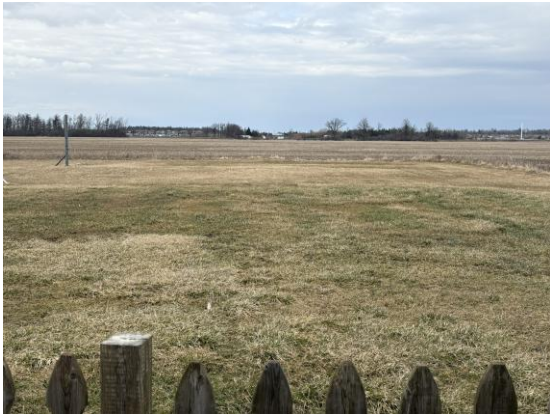
v.	Details of any unidentified substances	None were observed.
vi.	Details, including locations of stains or corrosion on floors other than from water, where located near a drain, pit, sump, crack or other potential discharge location	None were observed.
vii.	Details, including locations, of current and former wells, including all wells described or defined in or under the <i>Ontario Water Resources Act</i> and the <i>Oil, Gas and Salt Resources Act</i>	An unused dug well was observed on the front lawn of the Site. A drilled well was installed as replacement of the dug well.
viii.	Details of sewage works, including their location	Septic system was observed behind of the house, near the fence.

Picture 7: View of backyard and reported location of septic leaching field, facing northeast
