Geomorphic Assessment 12363 Dixie Road, Town of Caledon, region of Peel Humber River Watershed

2476998 Ontario Inc.

Beacon Environmental Limited

2023-05-31

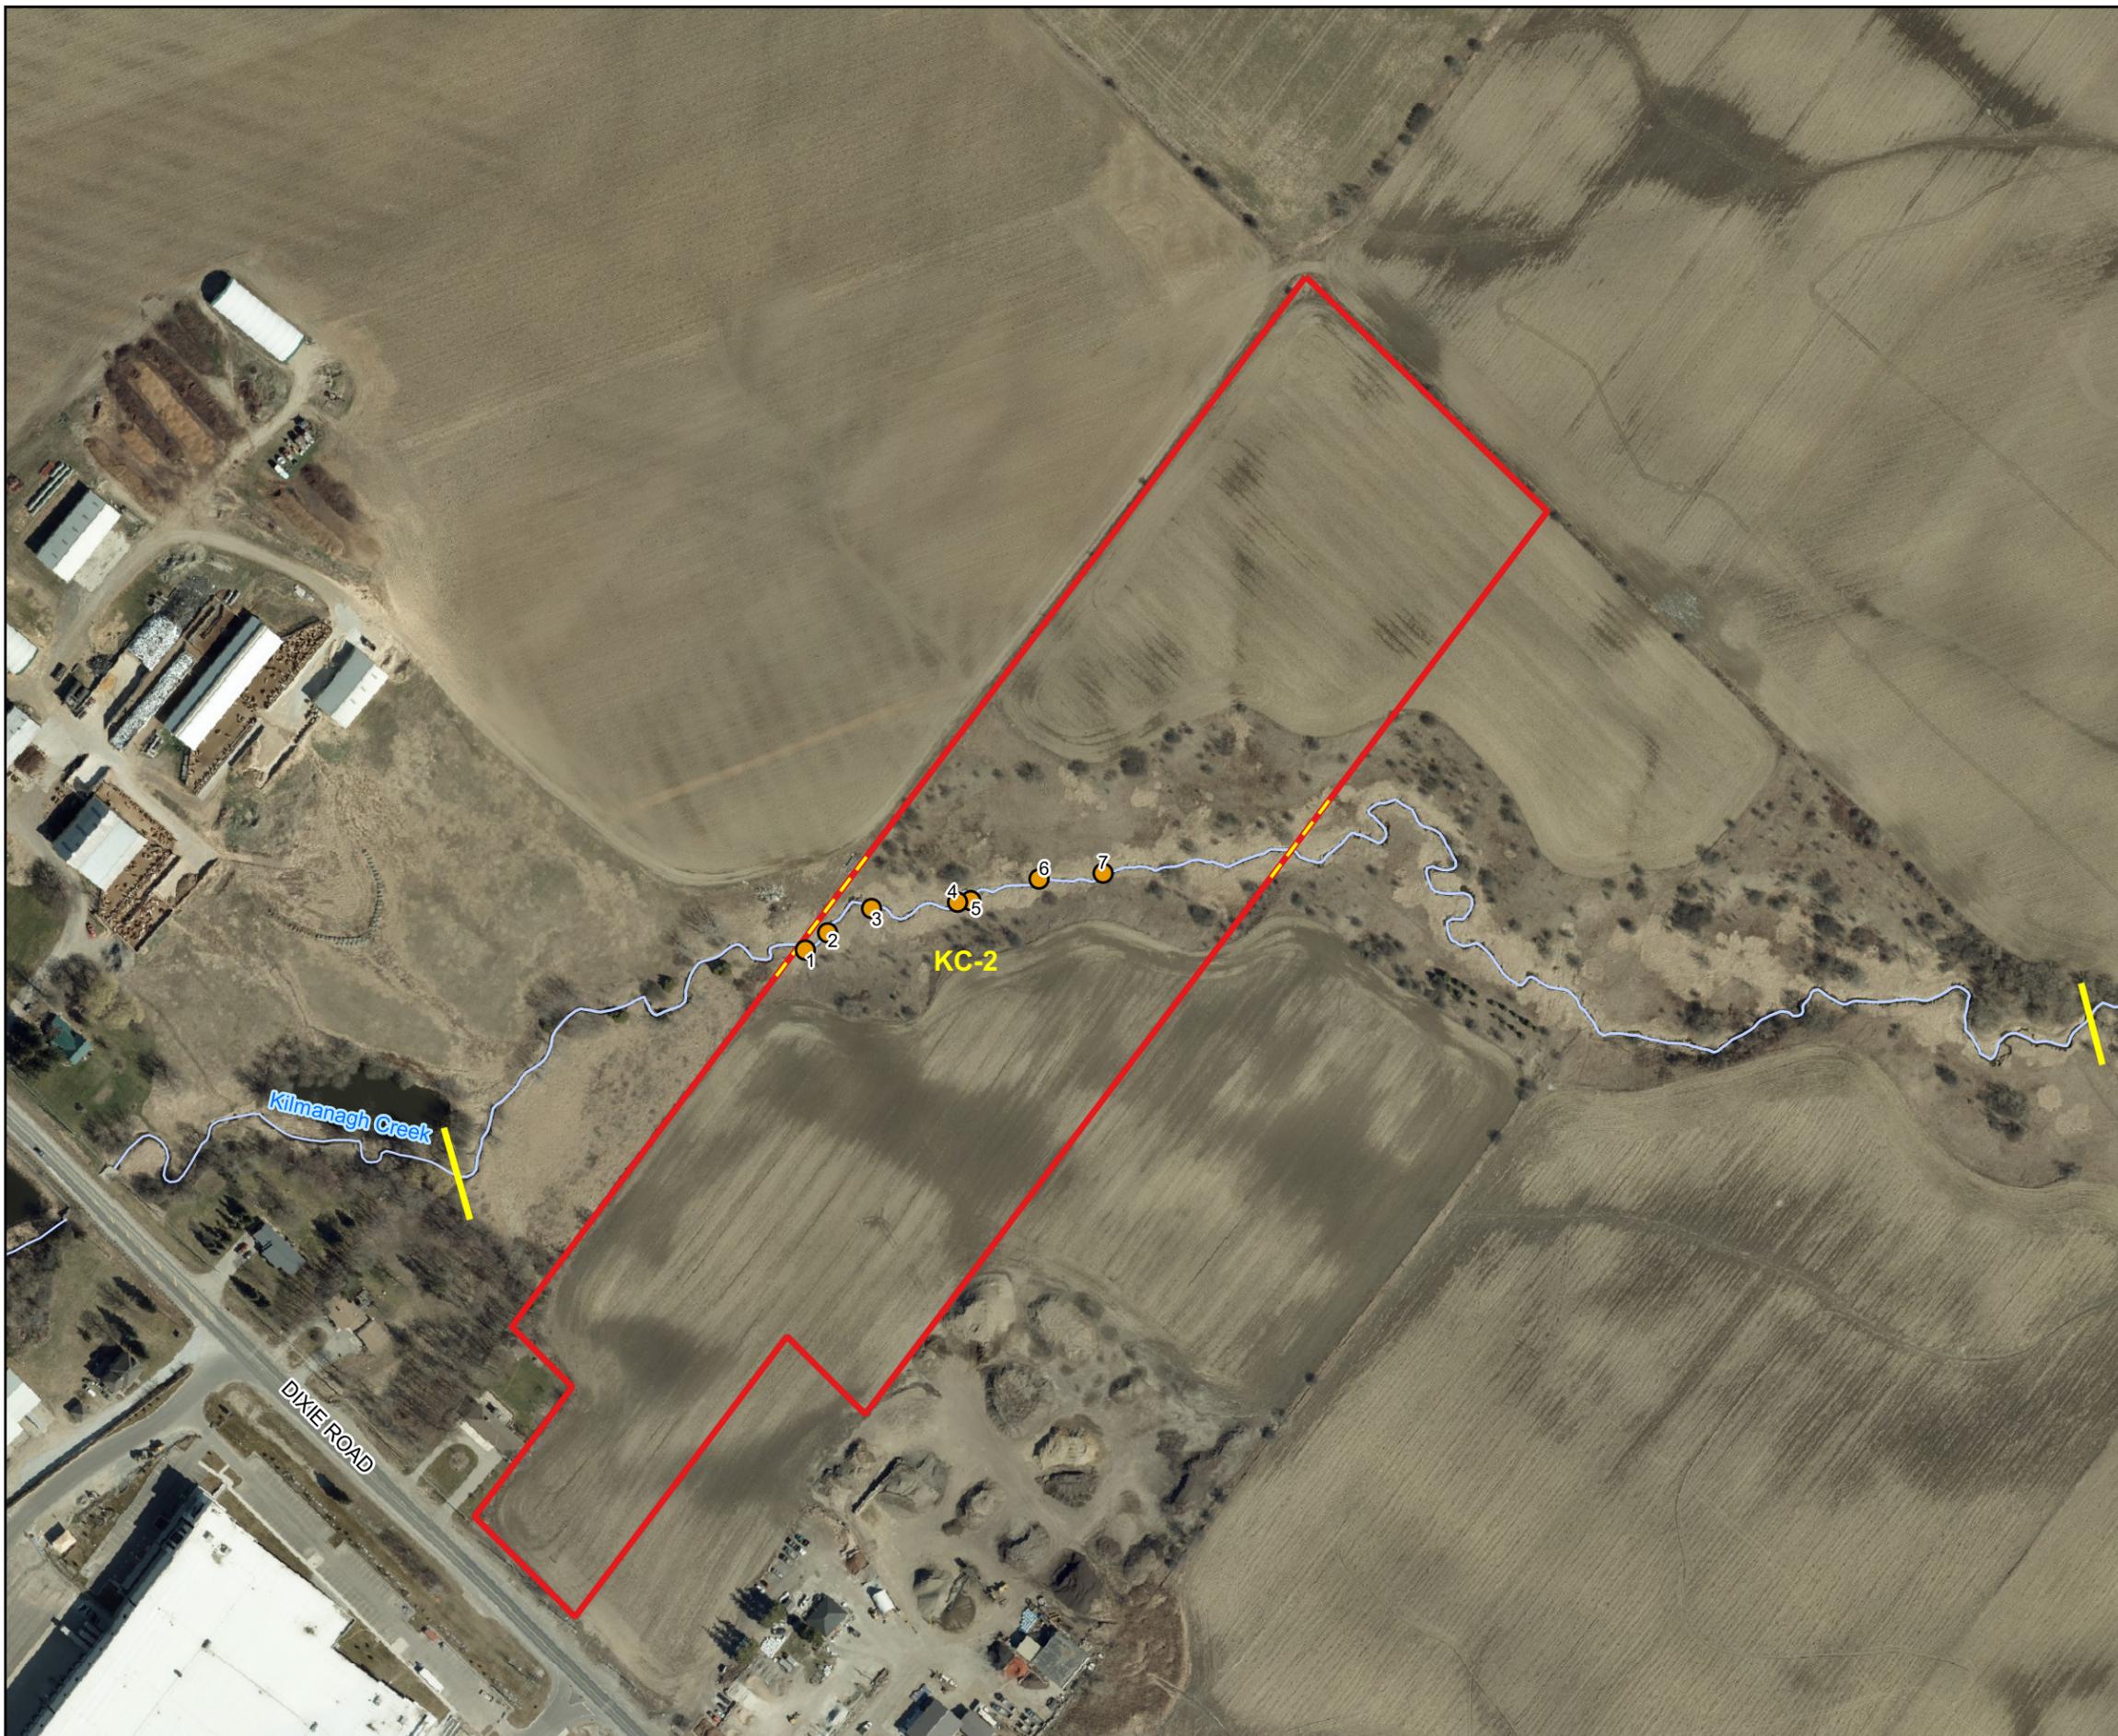
For the purposes of this study, the section of Kilmanagh Creek relevant to the subject property was delineated as a single reach (Reach KC-2, see **Figure 2**). The determination of reach extents was based on a desktop assessment of transitions in riparian vegetation, degree of valley confinement, meander geometry (channel planform) and road crossings based on available aerial imagery and topographic mapping. Due to property access limitations, the reach extents could not be field-verified.

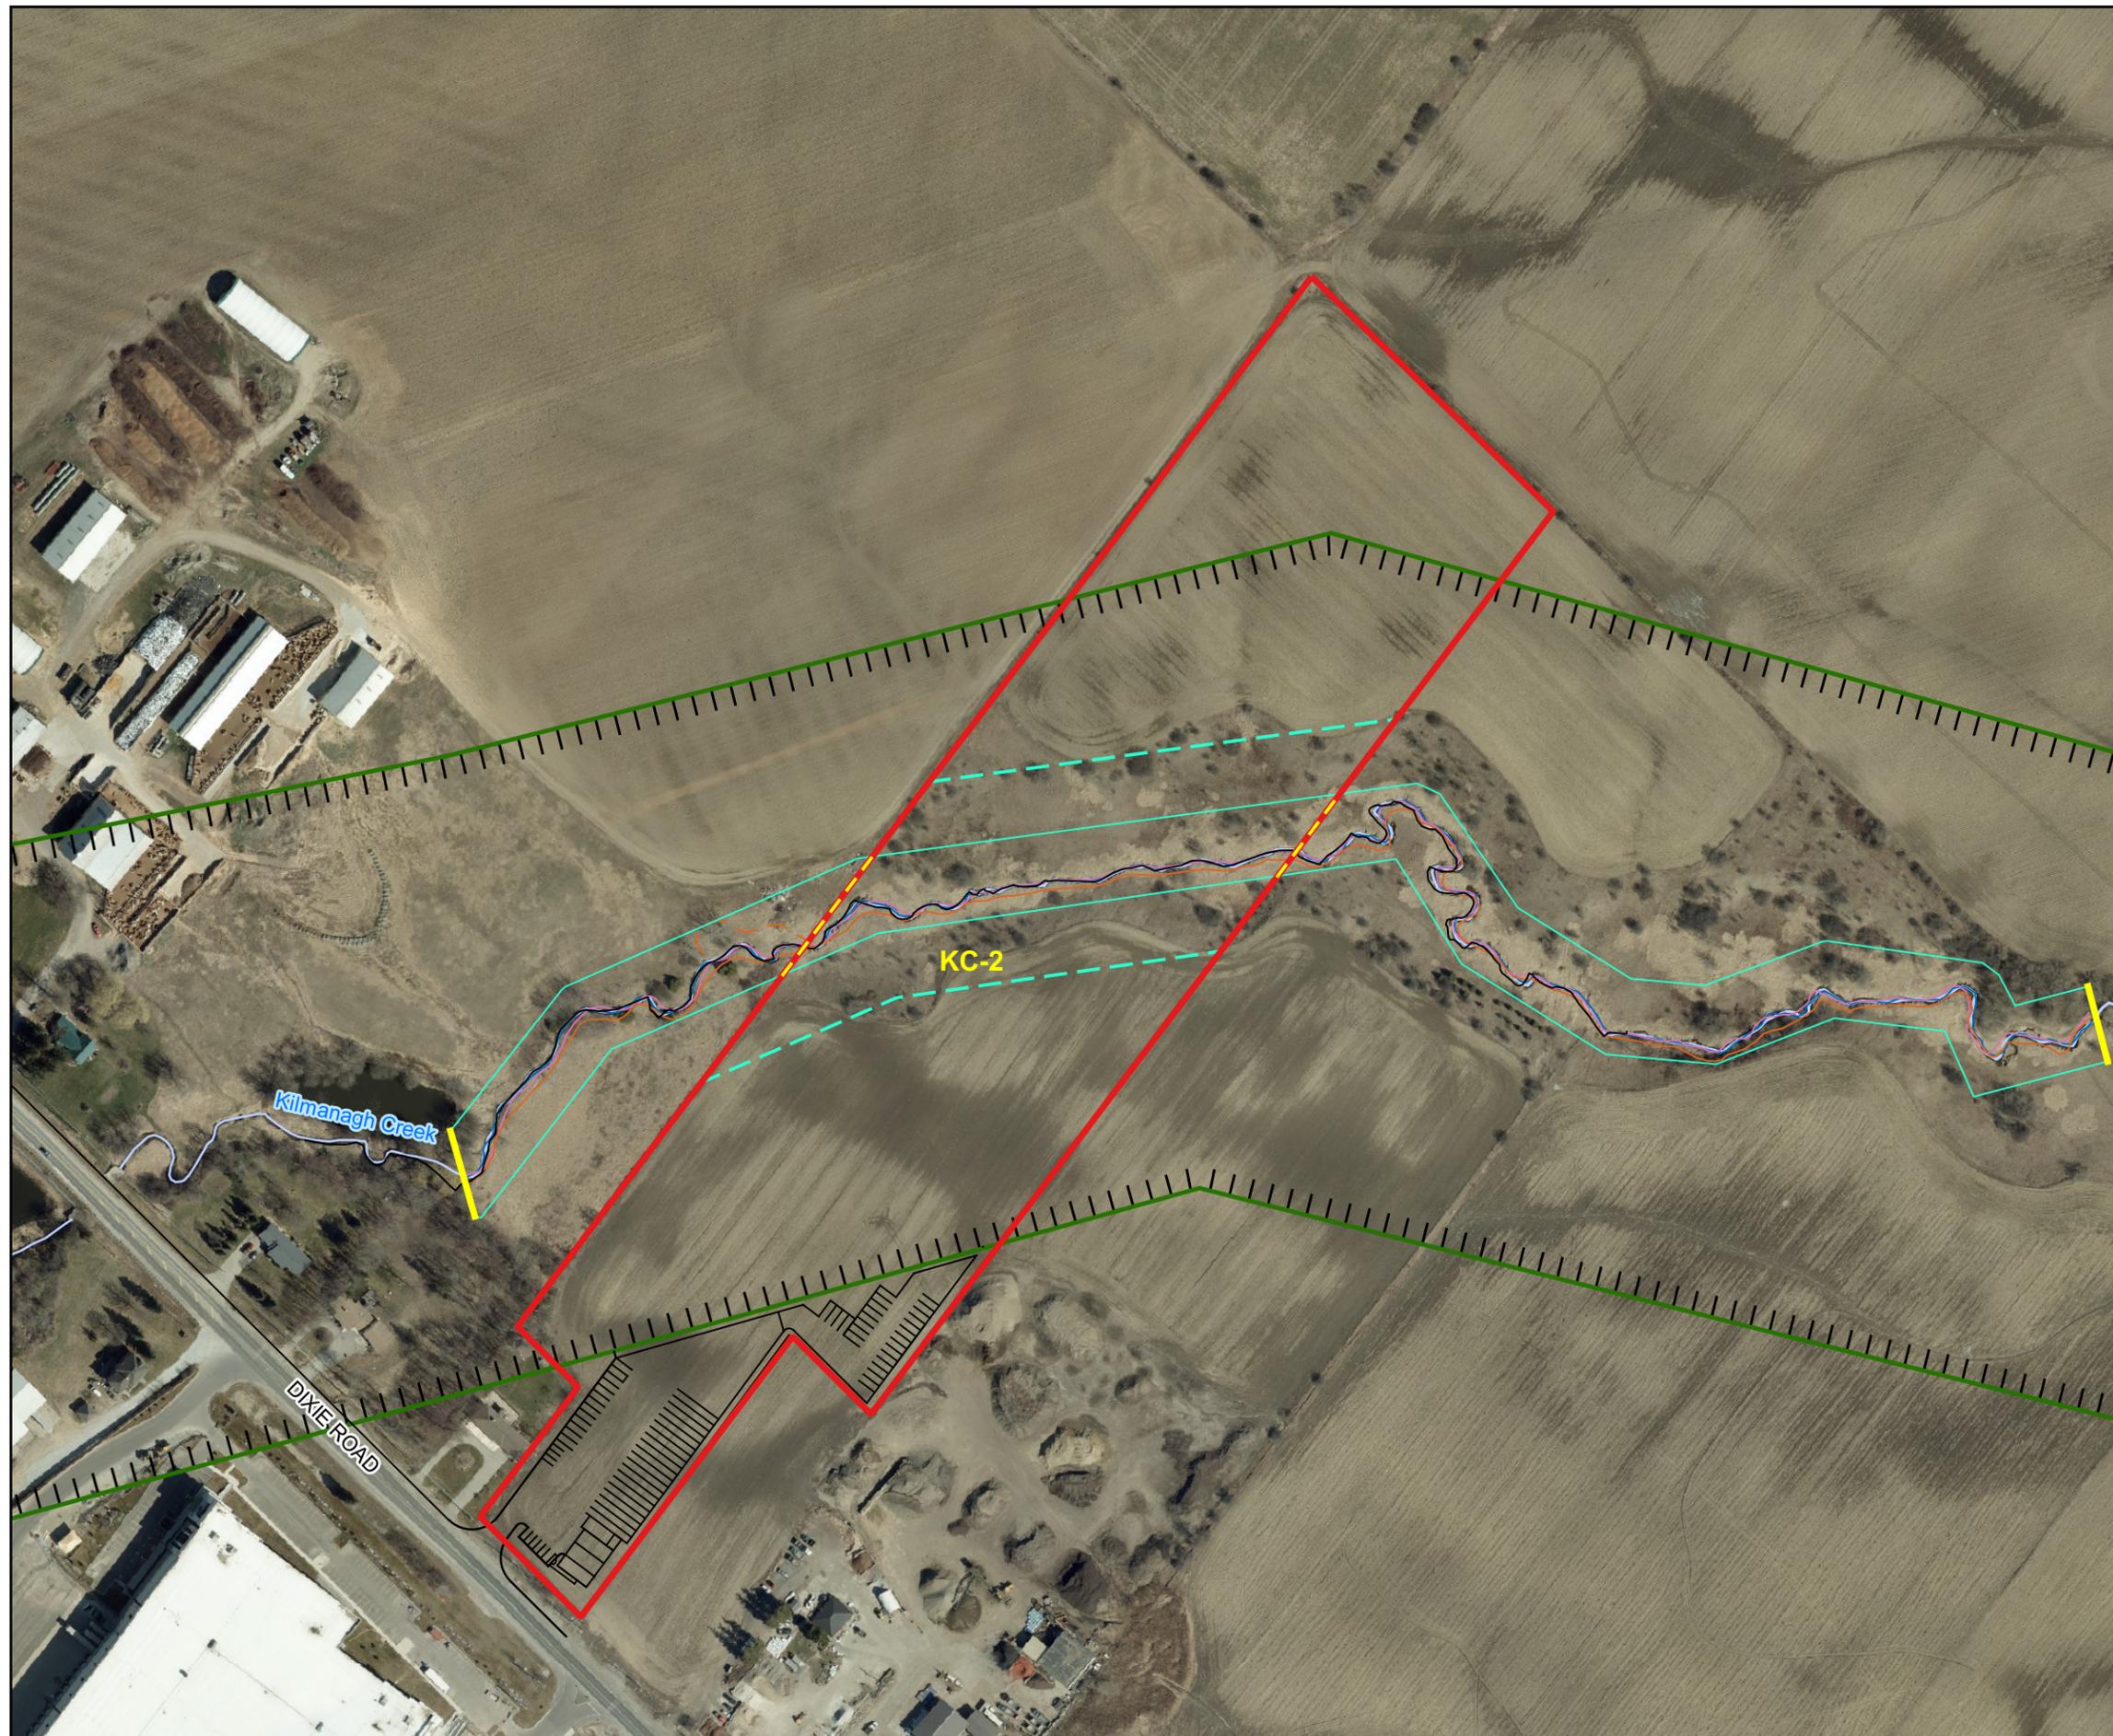
well as evidence of lateral occupation of the floodplain at the reach scale. **Figure 3** illustrates the recommended 35 m meander belt for Reach KC-2.

Figure 3 identifies all lands within 30 m of the meander belt as they pertain to the subject property.

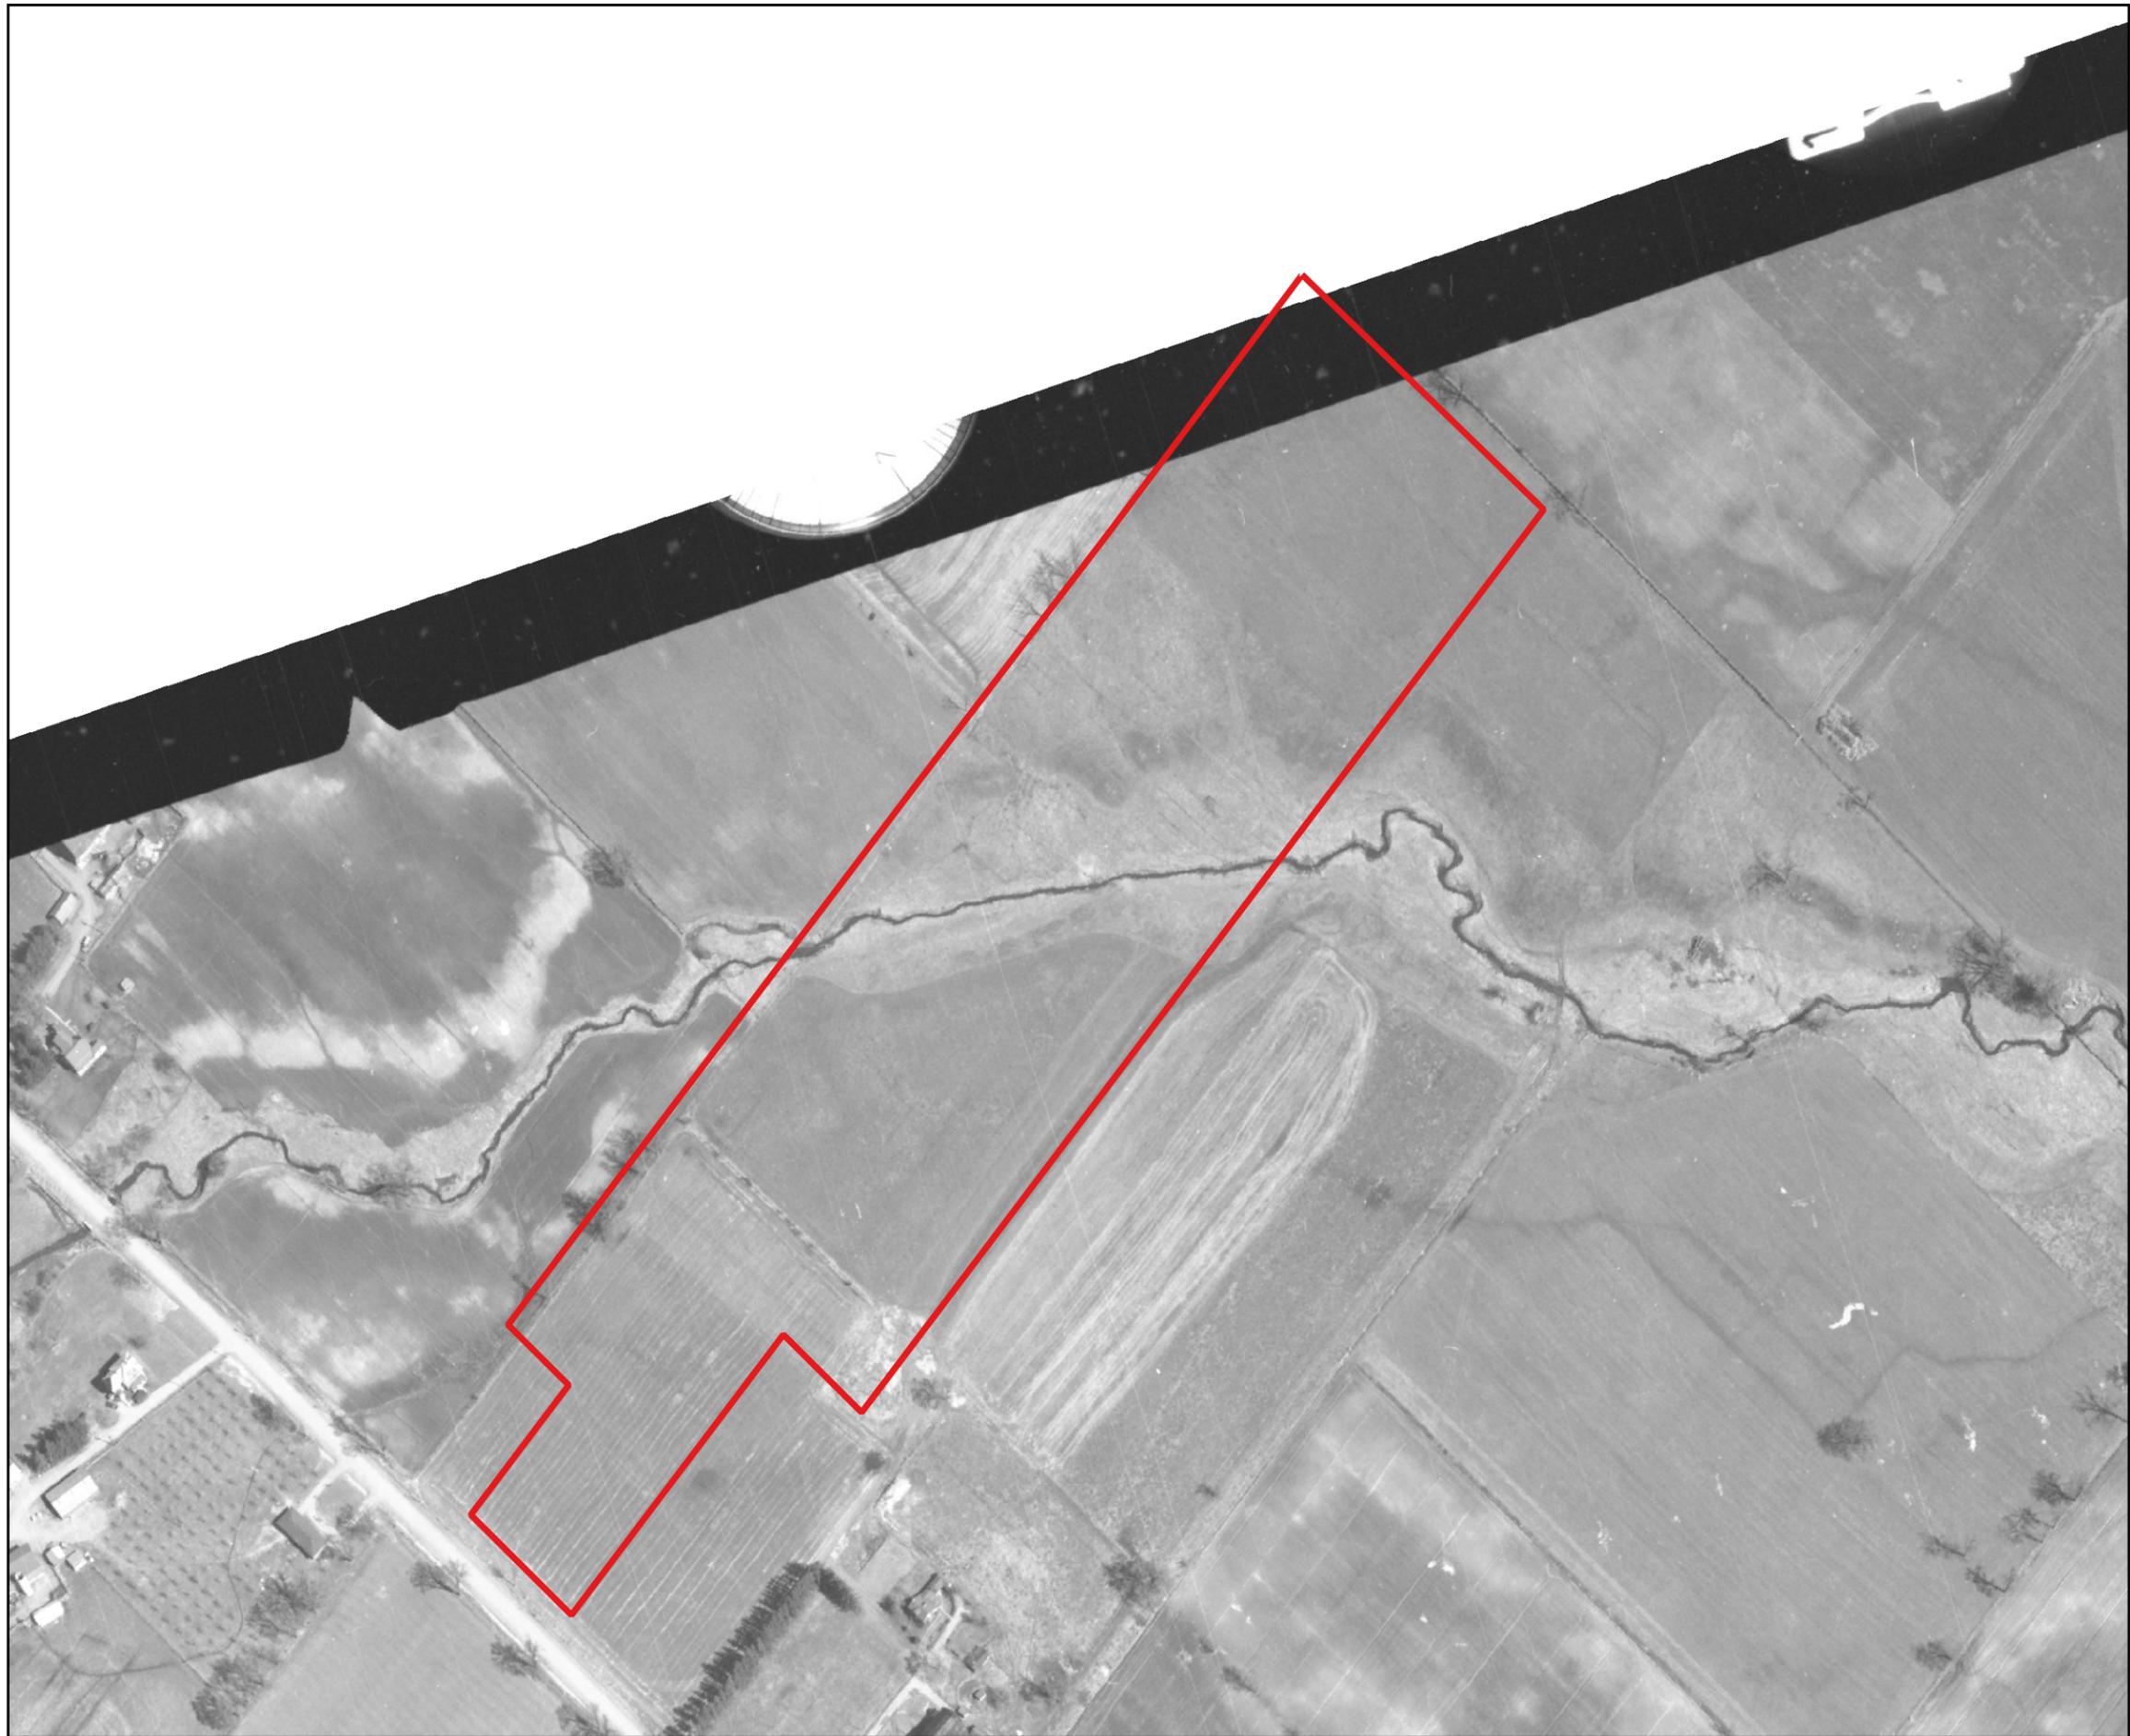
Time Period	Scale, Source	Observations
1964	1:12,000 Northway/Photomap/Remote Sensing Ltd.	Forested areas converted to agricultural fields, with the exception of some woodlots and hedgerows. A few farmhouses and structures are observed along major roadways in the vicinity of the subject property. Riparian vegetation is largely absent. Tablelands within the subject property were actively farmed.
		Within the subject property, the watercourse appears to have been straightened (channelized). Upstream and downstream of the property limits, the channel maintains a more natural, sinuous planform. Upstream (west) of Dixie Rd, an online pond within the floodplain was observed. Evidence of active adjustments in channel form were observed in the form of bank erosion (valley wall contact), slumping and chute formation. An historical floodplain feature can be observed along the eastern valley slope, upstream of the subject property.

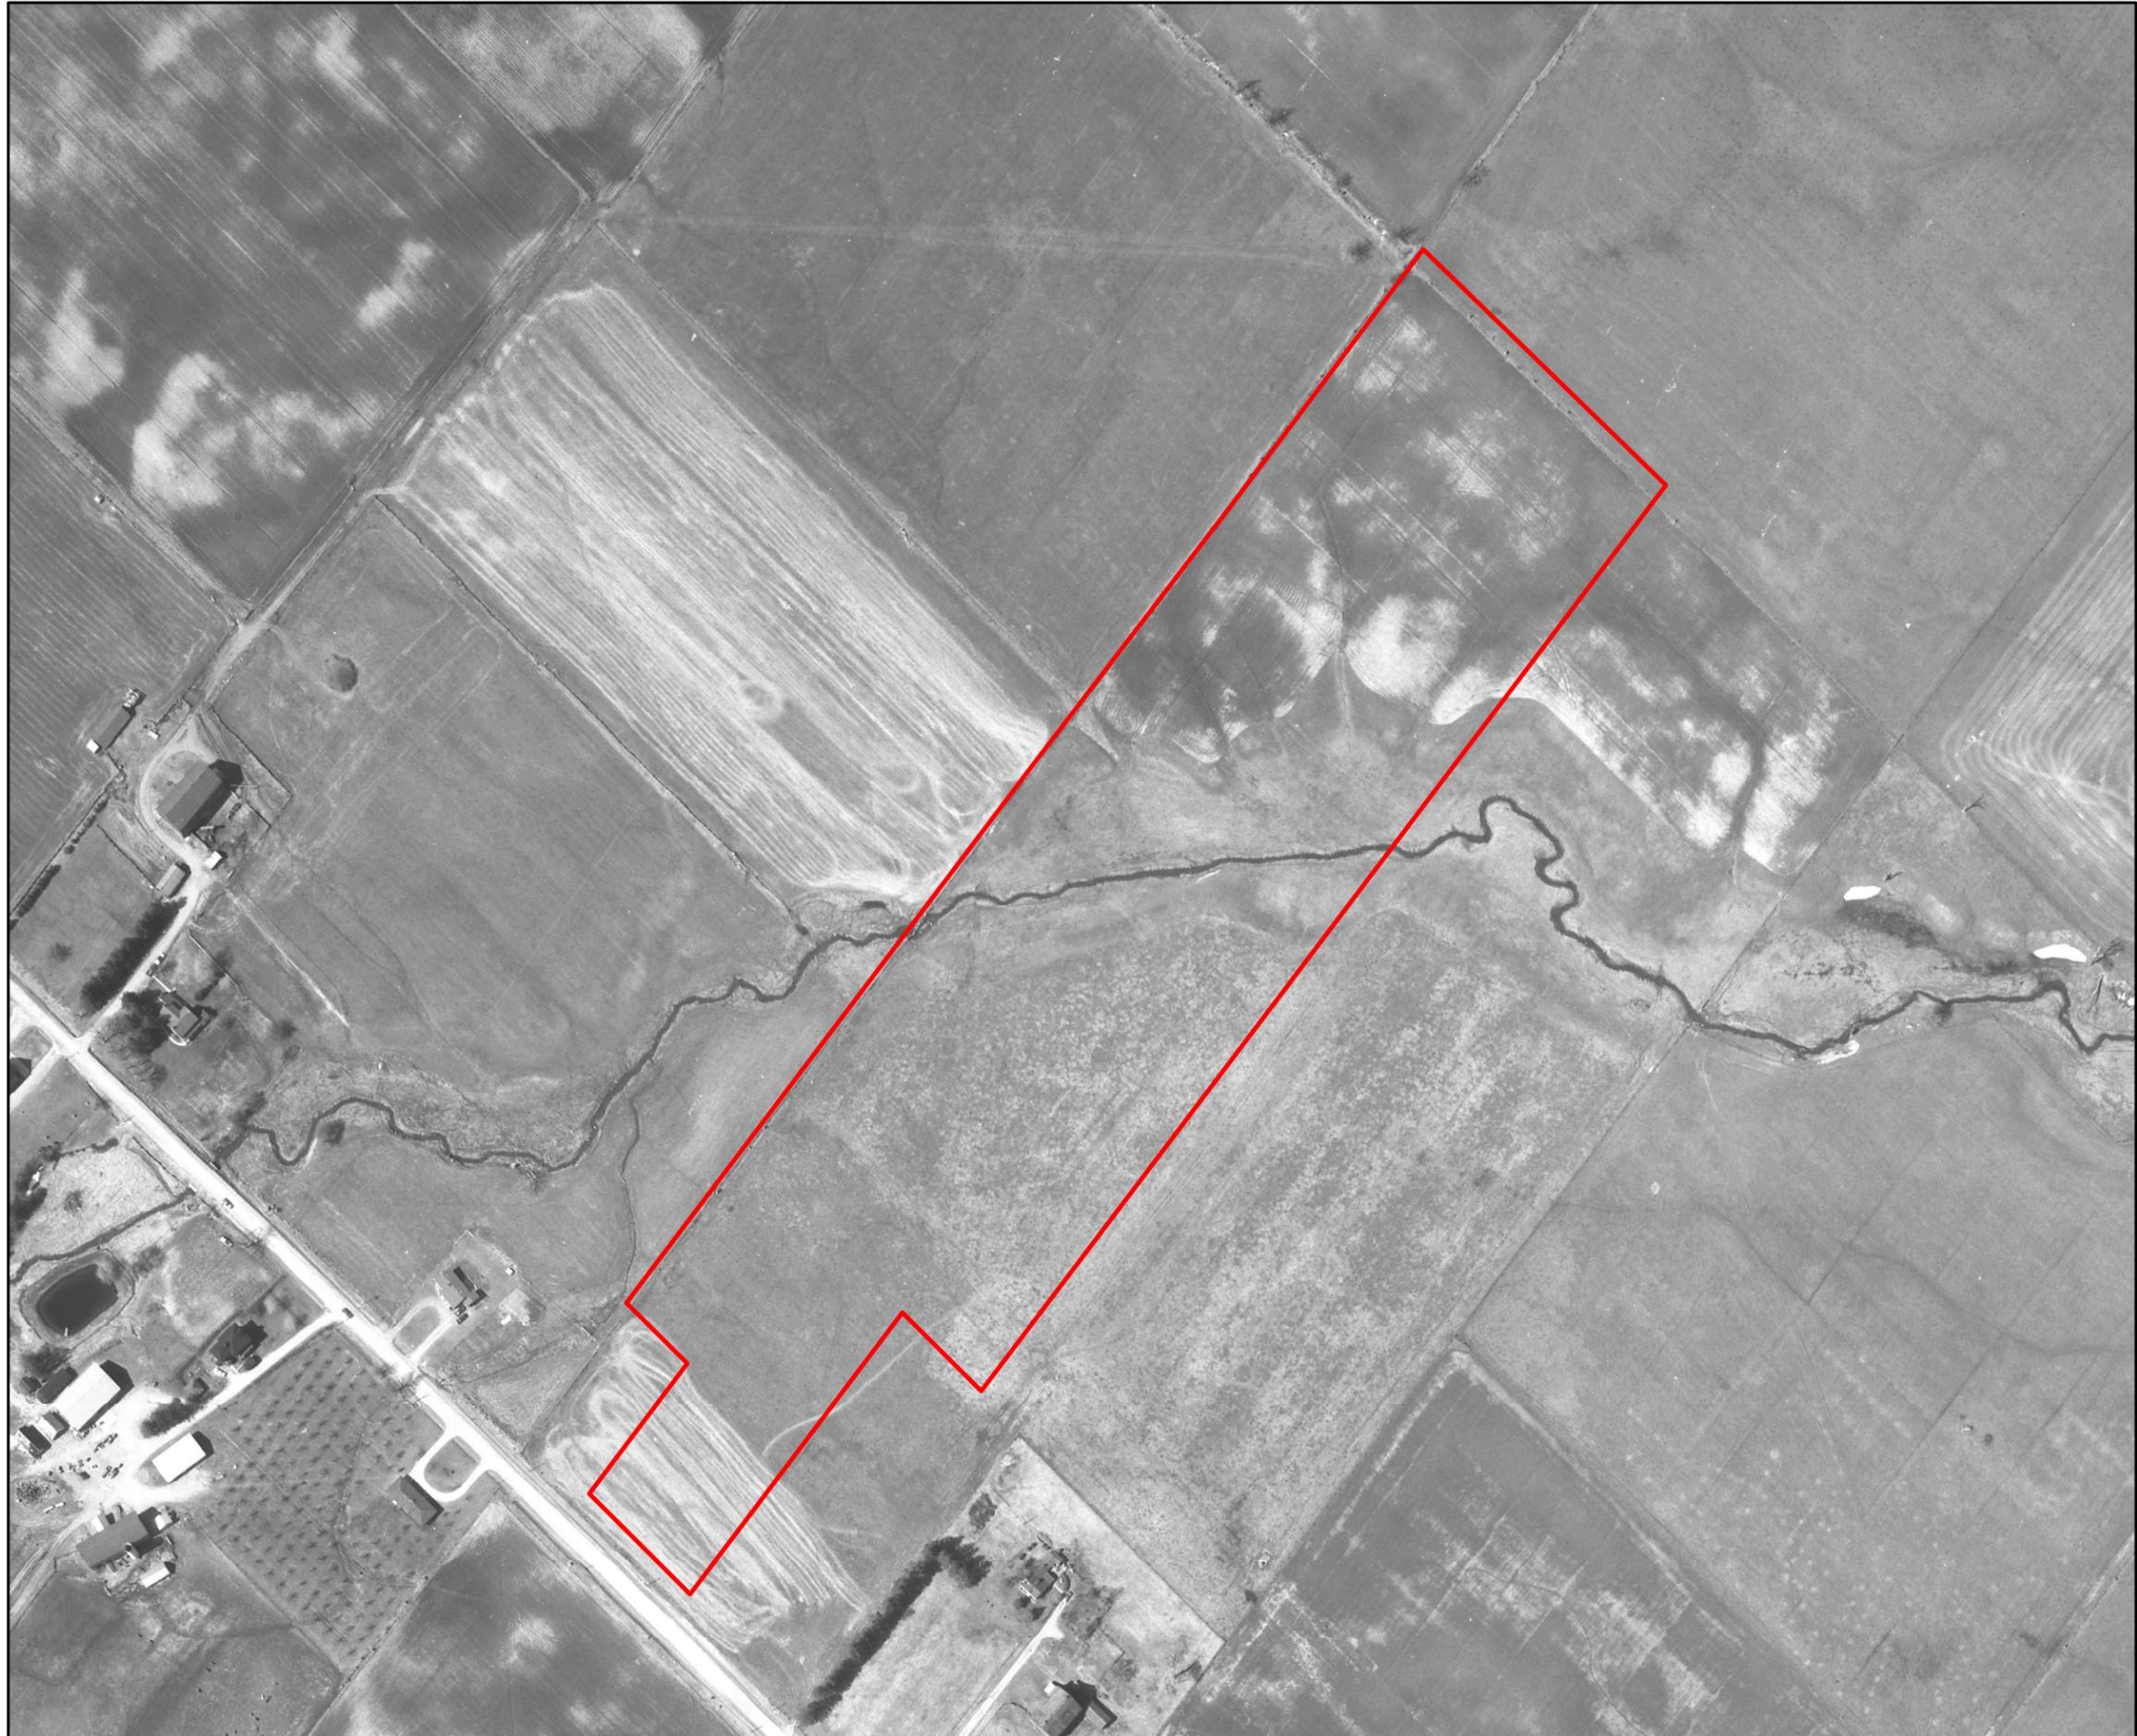
1972	1:12,000 Northway/Photomap/Remote Sensing Ltd.	No notable change in surrounding land use can be observed, except for the construction of a single residence immediately north of the subject property along Dixie Road. The online pond upstream (west of Dixie Road) appears to have been enlarged. No notable change in channel morphology or planform can be observed.
1988	1:8,000 Northway/Photomap/Remote Sensing Ltd.	No notable change in surrounding land use except for the construction of a few residences immediately north of the subject property along Dixie Road. A large pond was constructed east of the channel, upstream of the subject property (east of Dixie Road). An informal crossing of the creek had been constructed adjacent to the pond. Active bank erosion (slumping and at valley wall contact points) remained evident. No notable change in channel morphology or planform could be observed.

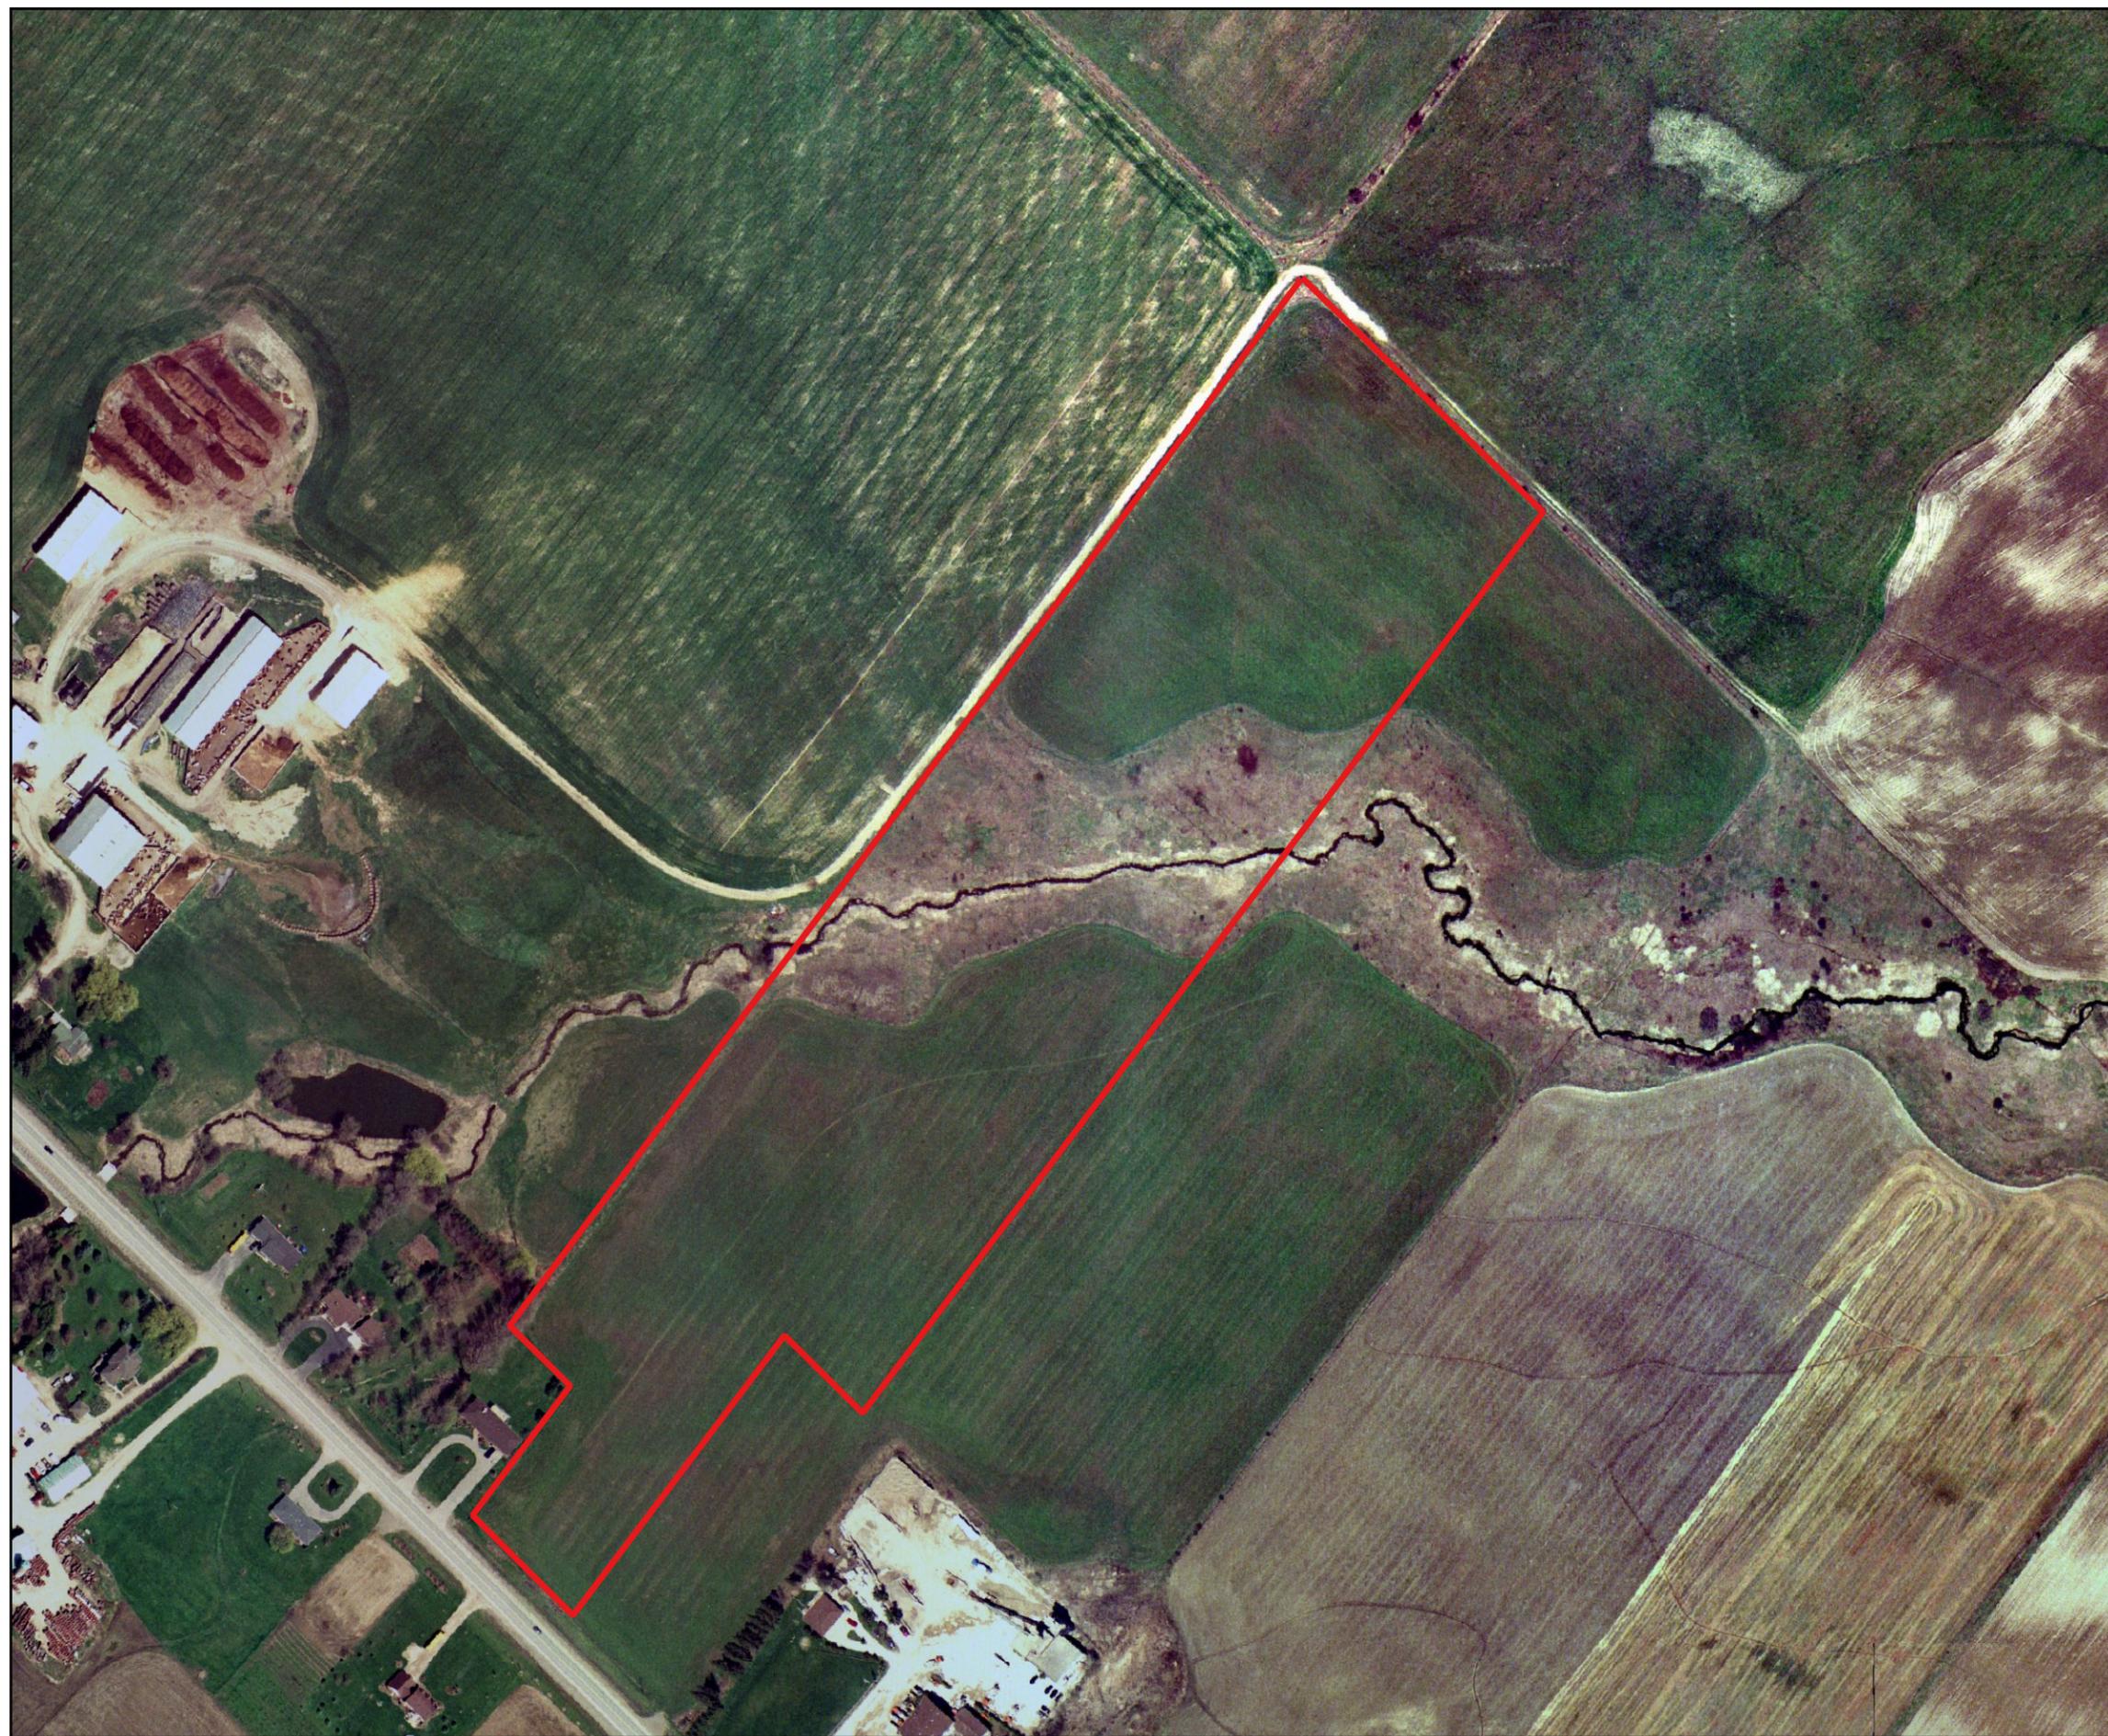
2002	1:3,000 First Base Solutions	Farming activities north of the subject property had expanded and a laneway had been constructed along a portion of the northern property boundary (west of the watercourse). Dixie Road had been widened, including extension of Kilmanagh Creek crossing structure. Land use within the subject property remained agricultural. No notable change in channel morphology or planform could be observed. The informal creek crossing downstream of the subject property could no longer be observed.
2021	1:3,000 First Base Solutions	No notable change in surrounding land use except for the expansion of the landscape supply operation immediately south of the subject property. Increased tree and shrub cover within the valley can be observed.

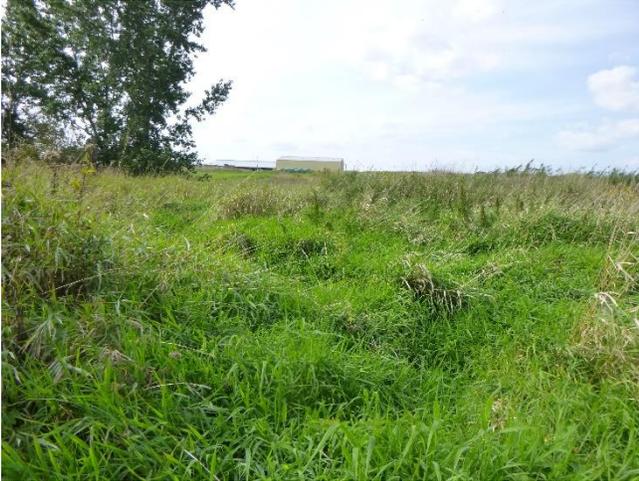
**Photograph 1. Location 1.
Reach KC-1.**

Upstream view of the riparian conditions at the property limit. Note presence of dense riparian grasses and herbaceous species.

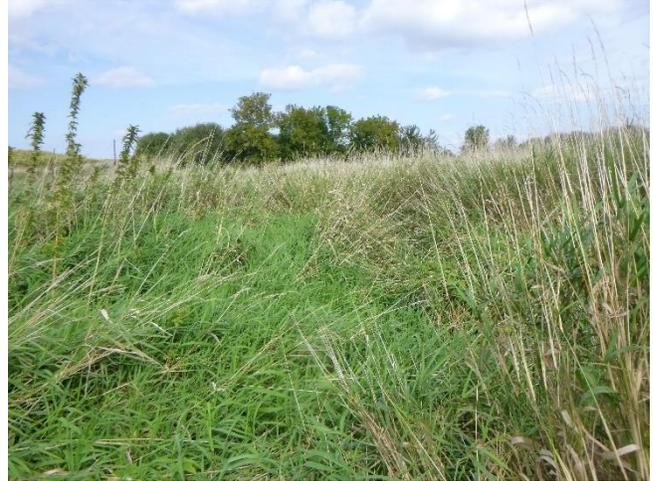
**Photograph 2. Location 1.
Reach KC-1.**

Downstream view of riparian conditions at property extent. Note the presence of dense riparian vegetation (grasses and herbaceous species).

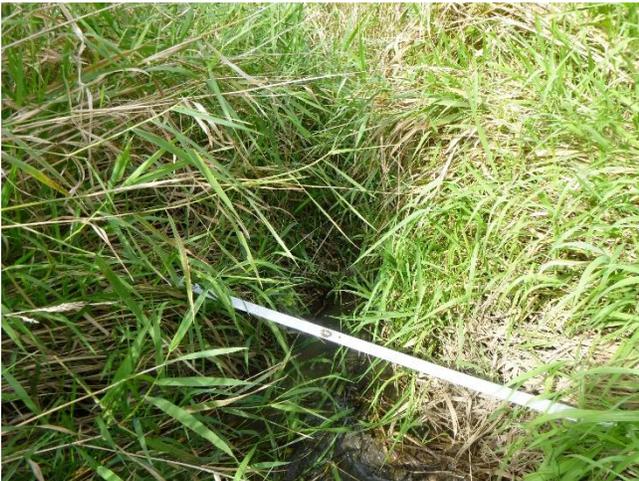
**Photograph 3. Location 2.
Reach KC-1.**

Upstream view of chute formation (right bank).

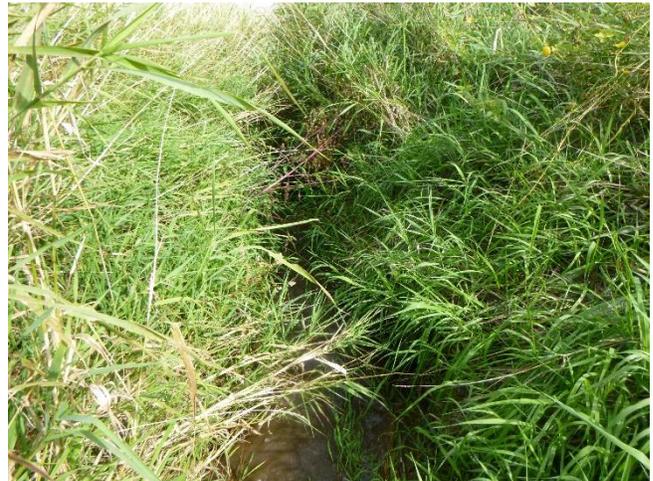
**Photograph 4. Location 3.
Reach KC-1.**

Downstream view of general conditions. Note overhanging riparian grasses.

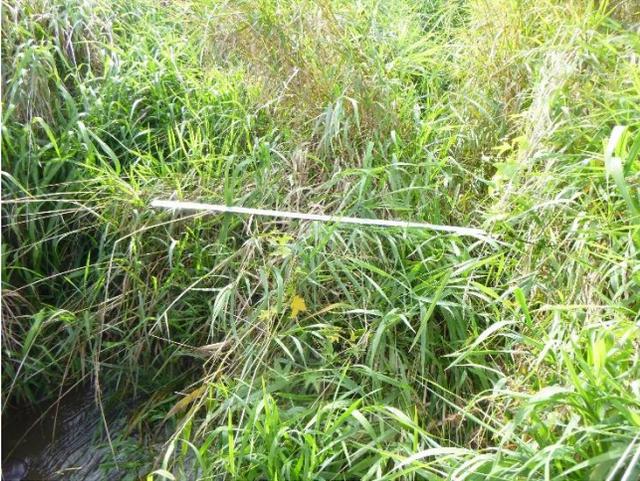
**Photograph 5. Location 4.
Reach KC-1.**
Upstream view island formation and multiple flow paths.

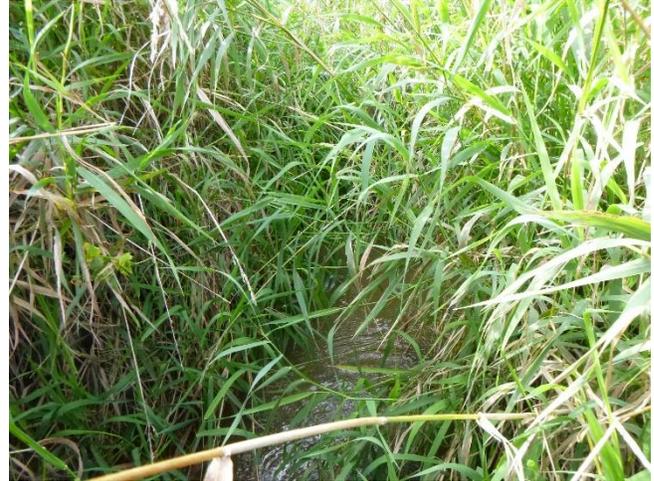
**Photograph 6. Location 5.
Reach KC-1.**
Upstream view of general channel conditions.

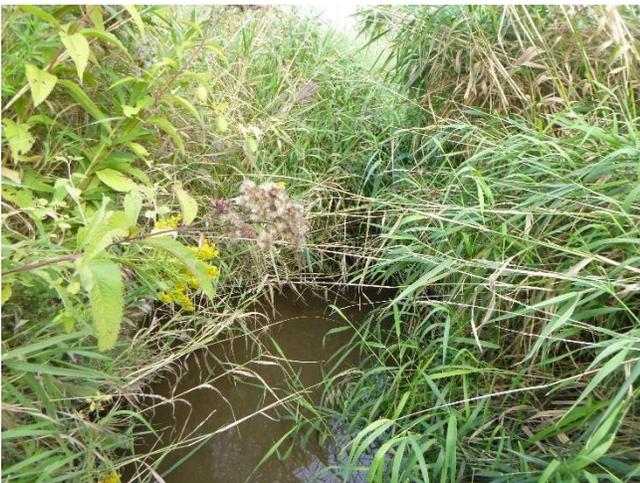
**Photograph 7. Location 6.
Reach KC-1.**
Downstream view of channel conditions.

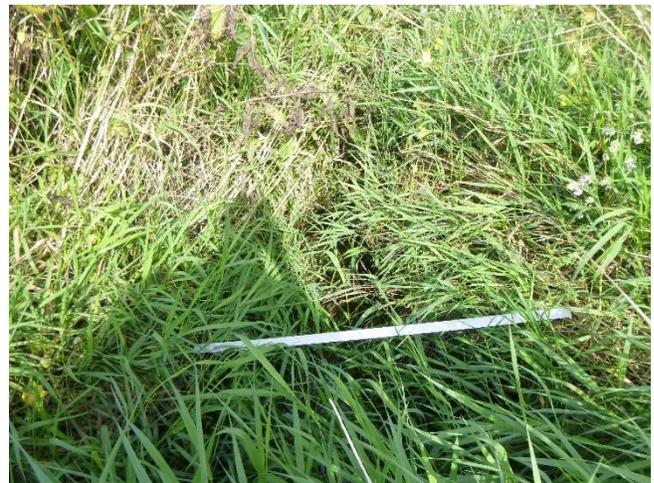
**Photograph 8. Location 7.
Reach KC-1.**
Downstream view of channel conditions. Note dense overhanging riparian grasses.
