Arborist Report and Tree Preservation Plan
Stellar Homes Phase 2
Part of Lot 18, Concession 8
Town of Caledon

AEC 23-056

Re: **January 2025 Update Arborist Report and Tree Preservation Plan
Stellar Estate Homes Phase 2
Part of Lot 18, Concession 8, Town of Caledon, Regional Municipality of
Peel**

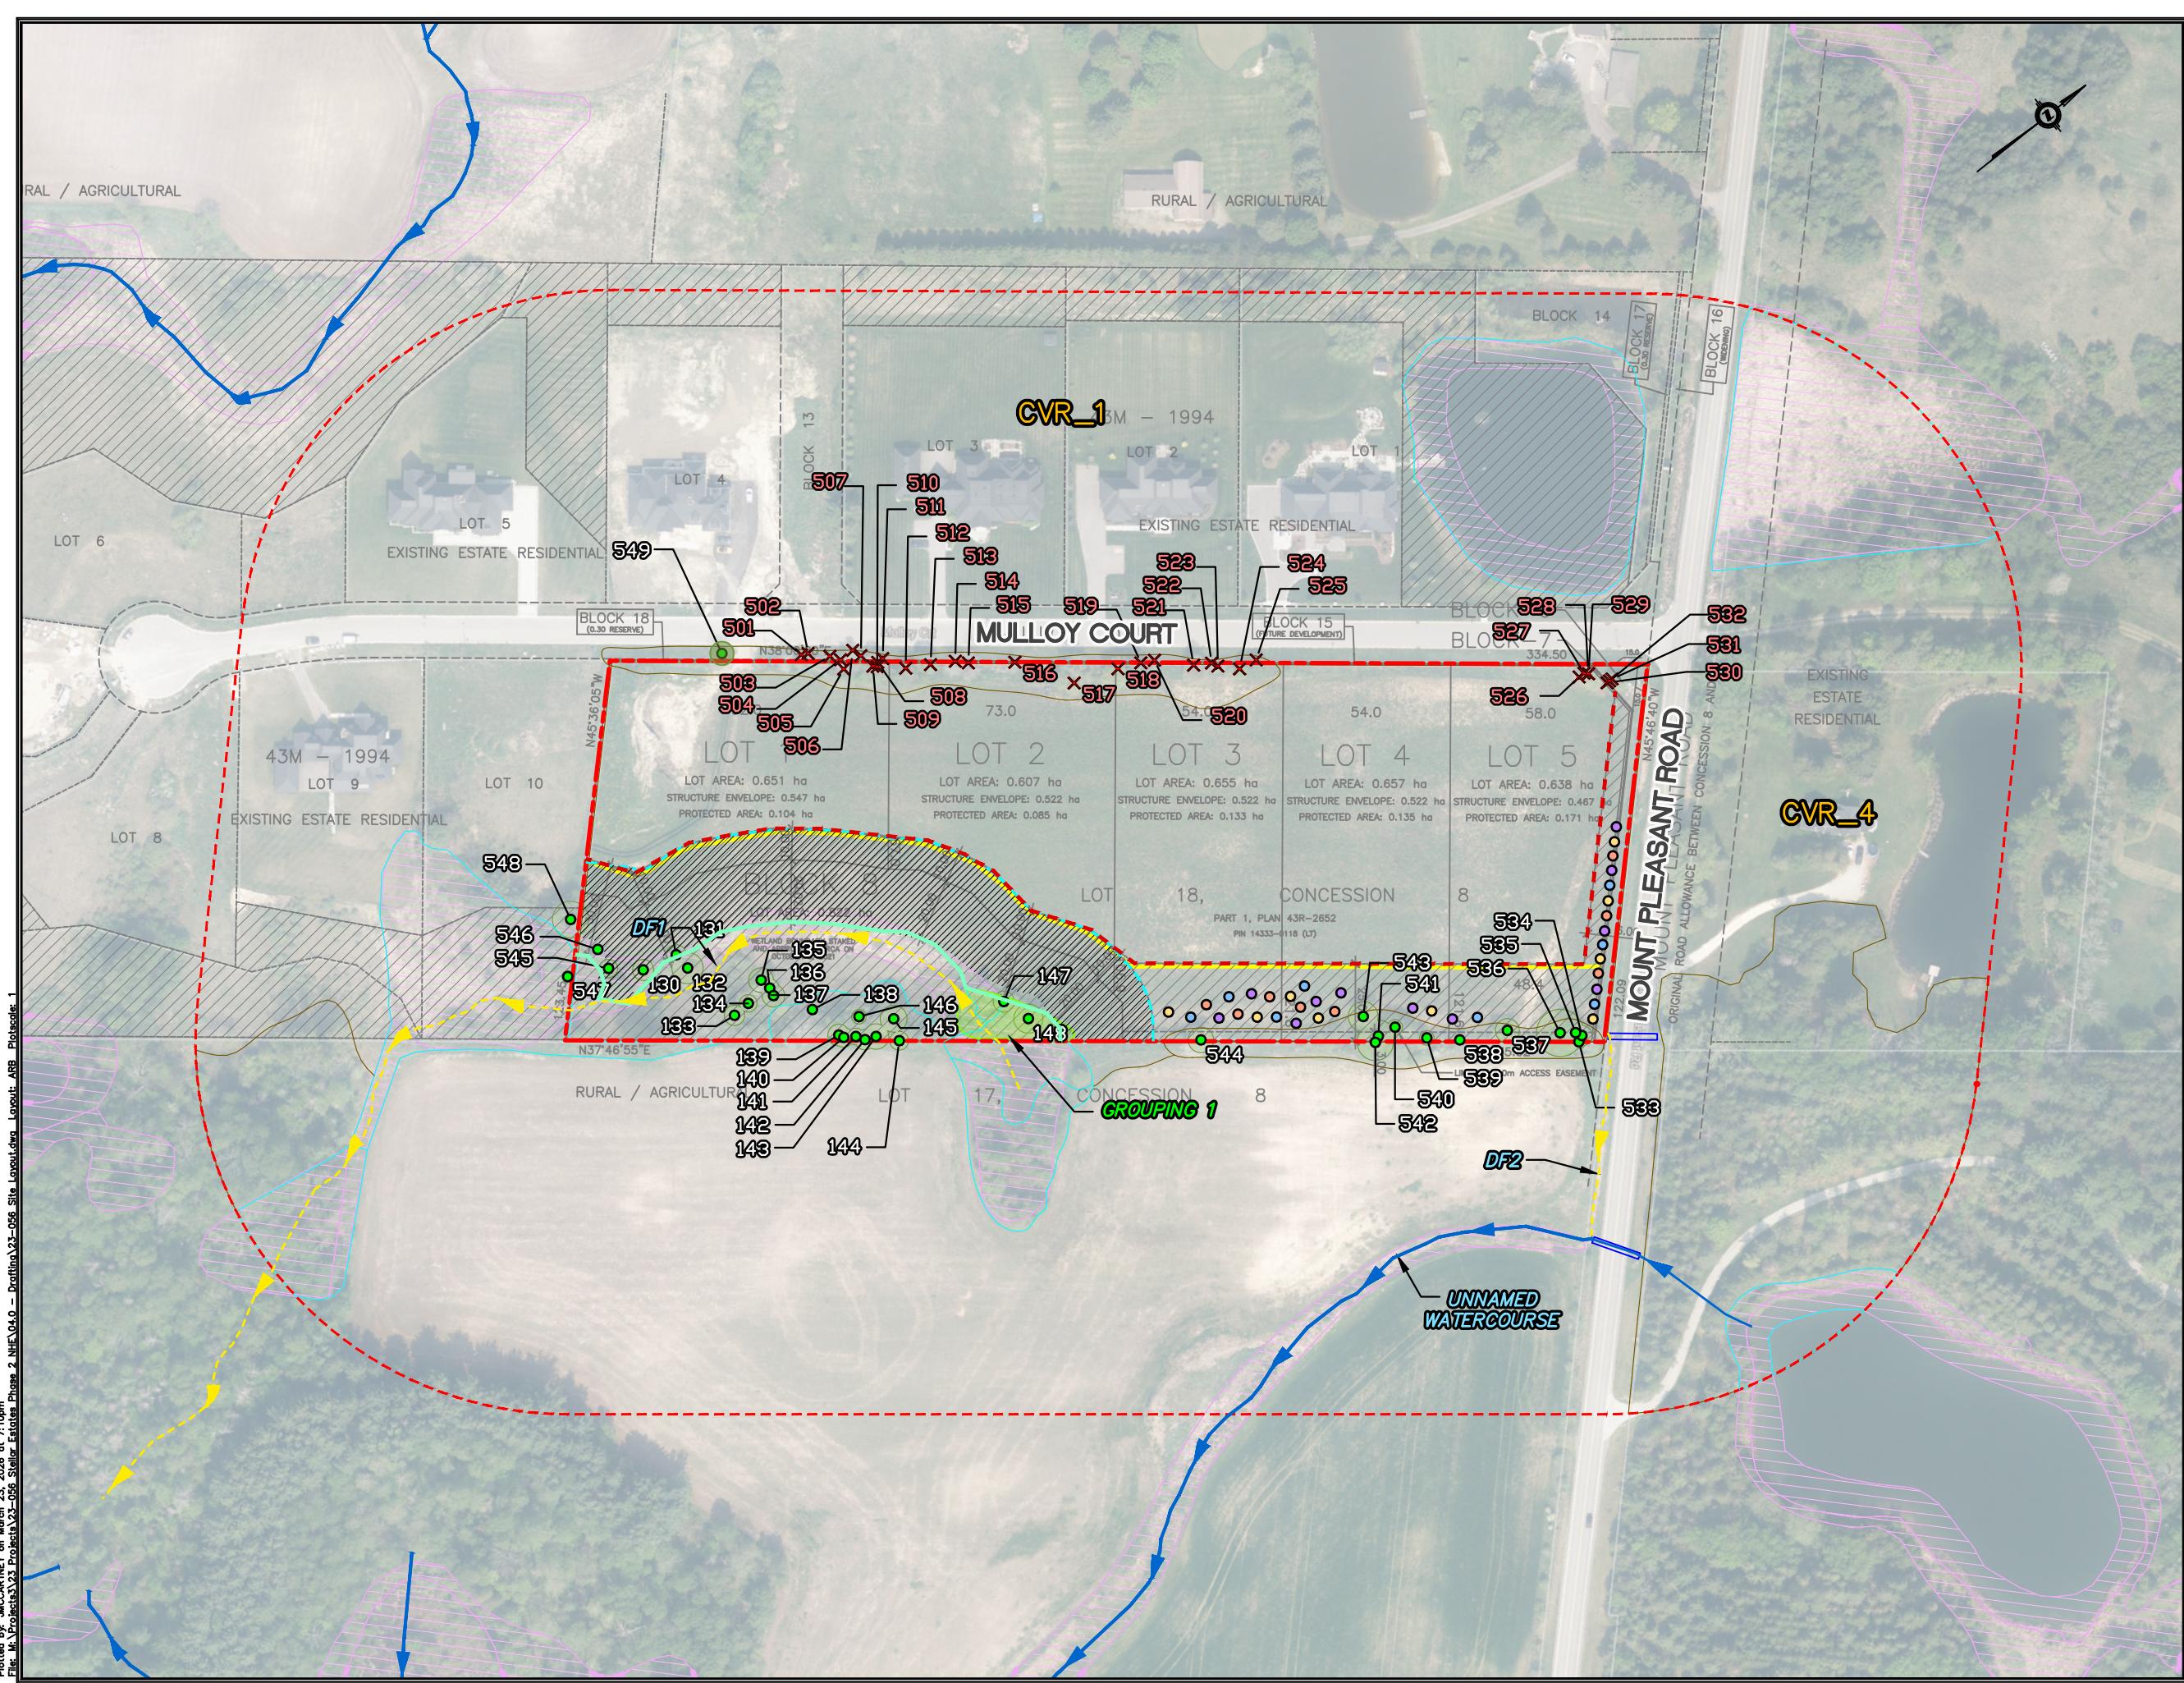
TREE PRESERVATION PLAN

The proponent wishes to convert the subject property into a 5-lot estate residential development, similar to Phase 1 which consisted of 10 lots to the north and west. Please see Figure 2 (Tree Preservation Plan) for the proposed site plan.

In total, 78 trees were included in the inventory and assessed for this report, which included a grouping of 10 willow trees (see Figure 2). Of the 78 trees assessed, 45 trees are located within the on-site wetland or designated 30 metre (m) vegetation protection zone (VPZ) along the southern property boundary.

The TPZ is a defined protection area around an individual tree or groupings of trees which is set out to maintain the existing condition of the root zone, canopy and trunk. This zone is implemented if site disturbance is planned within the area, or if there is a reasonable likelihood of inadvertent encroachment of any form into the area during site disturbance. A TPZ has been calculated for each tree to be protected/preserved during construction, which estimates the extent of tree root zone based on the diameter at breast height. The formula accepted by the International Society of Arboriculture (1 foot TPZ per 1 inch DBH, equivalent to 0.12m of TPZ per 1cm DBH) was used to determine the recommended root protection zone for each tree. For example, the DBH for Tree #132 was measured as 43cm. Thus, the TPZ for Tree #132 is a radius of 5.2 metres surrounding the base of the trunk. For groupings, the dripline was used as a suitable limit to the TPZ. TPZ radius measurements for all trees to be retained are listed in Appendix A, with the resulting TPZ areas around retained trees shown in Figure 2.

Tree protection fencing (hoarding) should be installed along the northern edge of the MVPZ and Open Space Block (see Figure 2) to ensure construction machinery does not enter this preservation zone. As per the Town of Caledon Tree Preservation Standard No. 606, siltation control fencing may be used as a tree preservation fencing substitute if required by engineering at the discretion of the Town. Therefore, if erosion and sediment control (ESC) fencing is already proposed for the MVPZ and Open Space Block, then duplication in fencing alignments should not be necessary. Any tree protection fencing must comply with the standard shown in the Town of Caledon Standard Drawing 606 and the Tree Preservation Standard Notes – Part 1 and 2 (Standard Drawings 710 and 711; Appendix B).

Figure 2 shows where the proposed tree compensation plantings could occur. High value native species such as Sugar Maple (*Acer saccharum*), Silver Maple (*Acer saccharinum*)

As the Town of Caledon has requested that privacy plantings be located along the western side of Mount Pleasant Road for Lot 5, a portion of the 36 trees are proposed within this area. The remainder of compensation trees are proposed along the southern property boundary within the Open Space Block.

A total of 46 trees are recommended for preservation, while a total of 32 trees are recommended for removal due to the proposed development. To compensate for the loss of 32 trees, it is recommended that the developer provide compensation at the ratios prescribed by the Town (2020) for a total of 36 compensation trees at the general locations shown in Figure 2.

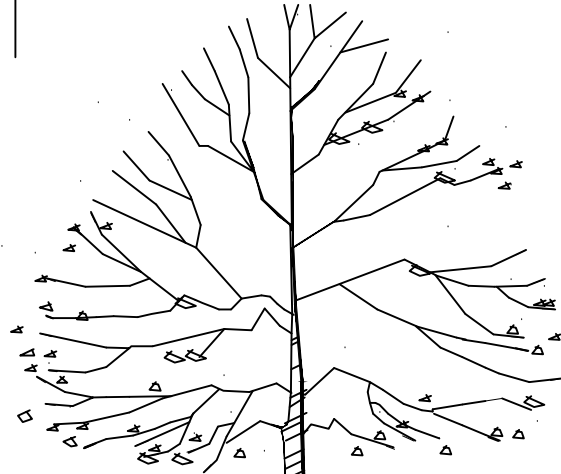
TOWN OF CALEDON					APR'D: C.C.	DATE: JUNE 08
TREE PRESERVATION	3	STANDARD 707 NOW 606		JAN 18	DRAWN: abal	SCALE: NTS
	2	STANDARD No. 1135 NOW 707, NOTES EDIT		JUNE 08		
	1	NOTE NO. 9 ADDED		MARCH 08	STANDARD No. 606	
	NO.	REVISION		APR'D	DATE

TREE PROTECTION FENCING TO BE ERECTED AS INDICATED ON THE LANDSCAPE PLAN AND SHALL REMAIN INTACT UNTIL DIRECTED BY TOWN STAFF.

STANDARD 1200mm HIGH SNOW FENCE SECURED TO T-BAR STAKES AT MIN. 2400mm O.C.

FINISHED GRADE

UNDISTURBED SOIL

1. Prior to construction, the trees to be preserved shall be protected with a Tree Protection Barrier. The barrier shall consist of 1.2m (4ft) high orange plastic snow fence wired to T-bars (see Town of Caledon Tree Preservation Fencing, STD 606).

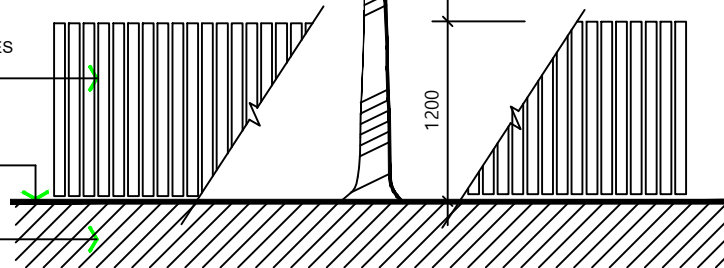
SPECIFICATIONS FOR THE PROTECTION AND PRESERVATION OF EXISTING VEGETATION:

1. PRIOR TO ISSUANCE OF THE GRADING AND SERVICING OR BUILDING PERMIT, ALL EXISTING TREES THAT ARE TO BE PRESERVED SHALL BE FULLY PROTECTED WITH HOARDING (IE SNOW FENCING) OUTSIDE THEIR 'DRIPLINES', OR AS DIRECTED THROUGH ADDITIONAL GOVERNING DOCUMENTS, TO THE SATISFACTION OF THE TOWN.
