Phase One Environmental Site Assessment

14259 Humber Station Road
Bolton, Ontario

DS Project No : Job 21-386-100
Date: 2022-09-09

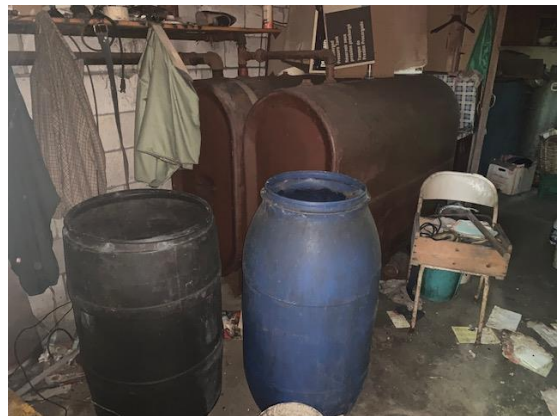
Picture 4: View of the empty ASTs in the basement of the residential house

ii.	Details of existing and former heating systems, including type and fuel source	None Observed. Reportedly a former residential building on the northwest portion of the site has two (2) ASTs.
iii.	Details of cooling systems, including type and fuel source, if any	None observed.
iv.	Details of any drains, pits and sumps, including their current use, if any, and former use	None observed.

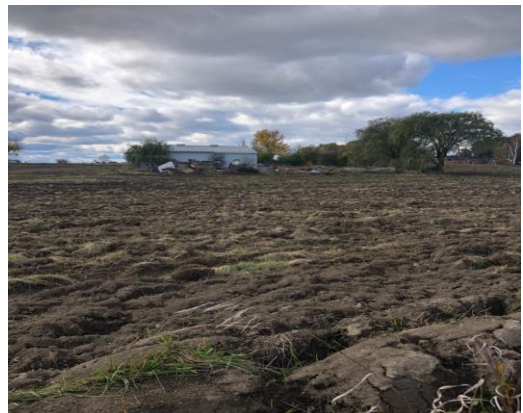
Picture 6: View of the barn in the centre of the Property facing north

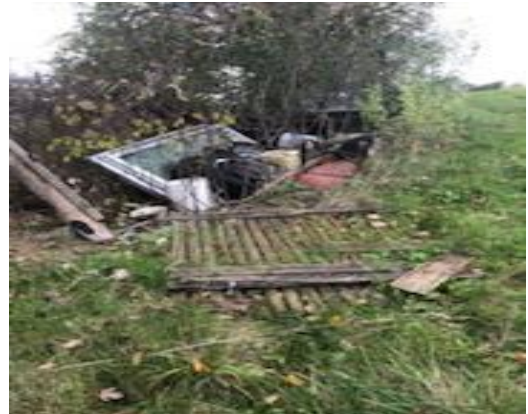
Picture 8: View of debris located behind the residential house.

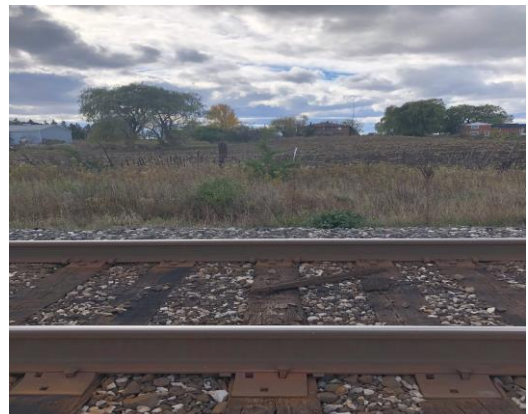
Picture 10: View of the east side of the property and adjacent railway tracks facing east.

PCA ID No.	PCA Description (Per. Table 2, Schedule D of O.Reg. 153/04)	Description	Contributing to APEC (Y/N)
PCA-3	#46: Rail Yards, Tracks and Spurs	Railway tracks are adjacent to the east of the Phase One Property.	Yes – APEC 5
PCA-4	#28: Gasoline and associated products storage in fixed tanks	Approximately 59 meters southwest of the Phase One property, a fuel oil tank is present at property 14196 Humber Station Road.	No- property is downgradient relative to the inferred direction of groundwater flow
PCA-5	#30: Importation of Fill Material of Unknown Quality	Observed during the site reconnaissance, the Phase One Property residential dwelling had been demolished and the basement backfilled with fill material	Yes- APEC 3
PCA - 6	#30: Importation of Fill Material of Unknown Quality	Observed during the site reconnaissance, the Phase One Property barn had been demolished and replaced with fill material.	Yes- APEC 4

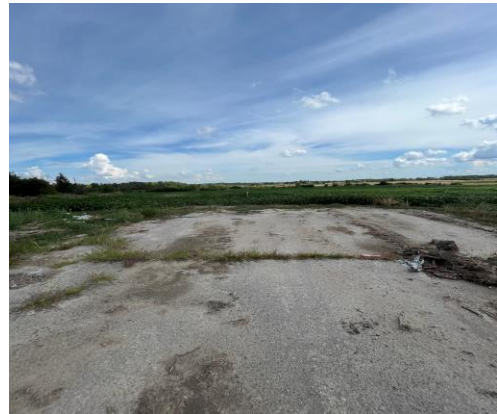
Picture 14: View of previous housing structure location.

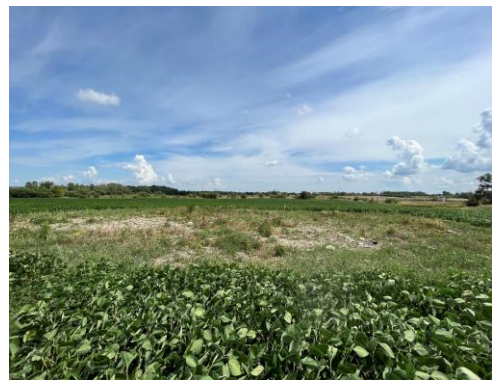
Picture 18: View of previous barn structure

7	#30: Importation of Fill Material of Unknown Quality	Observed during the site reconnaissance, the Phase One Property barn had been demolished and backfilled with fill material.	PCA is on-Site

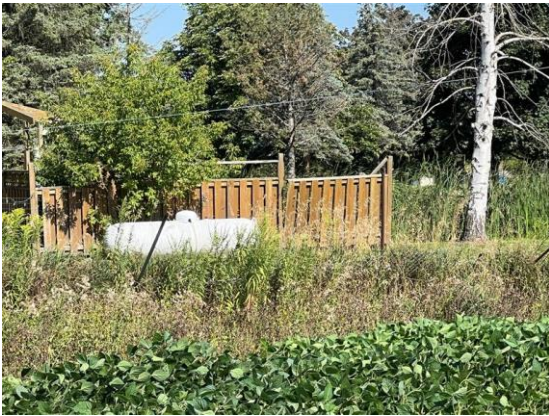
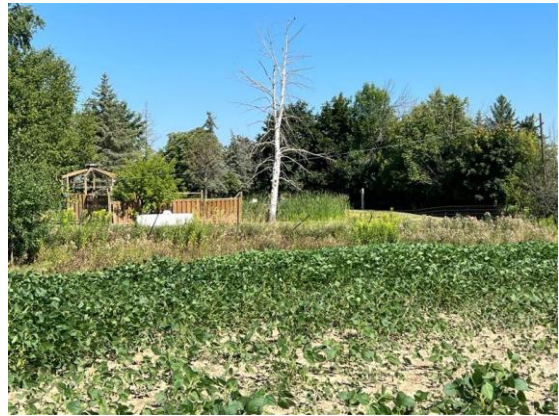
Picture 19 and 20 : View of the Propane Tank on the neighbouring property facing west
