HYDROGEOLOGICAL ASSESSMENT

10249 HUNSDEN SIDEROAD

ESTATE RESIDENTIAL DEVELOPMENT

CFCA FILE NO. 0952-6305

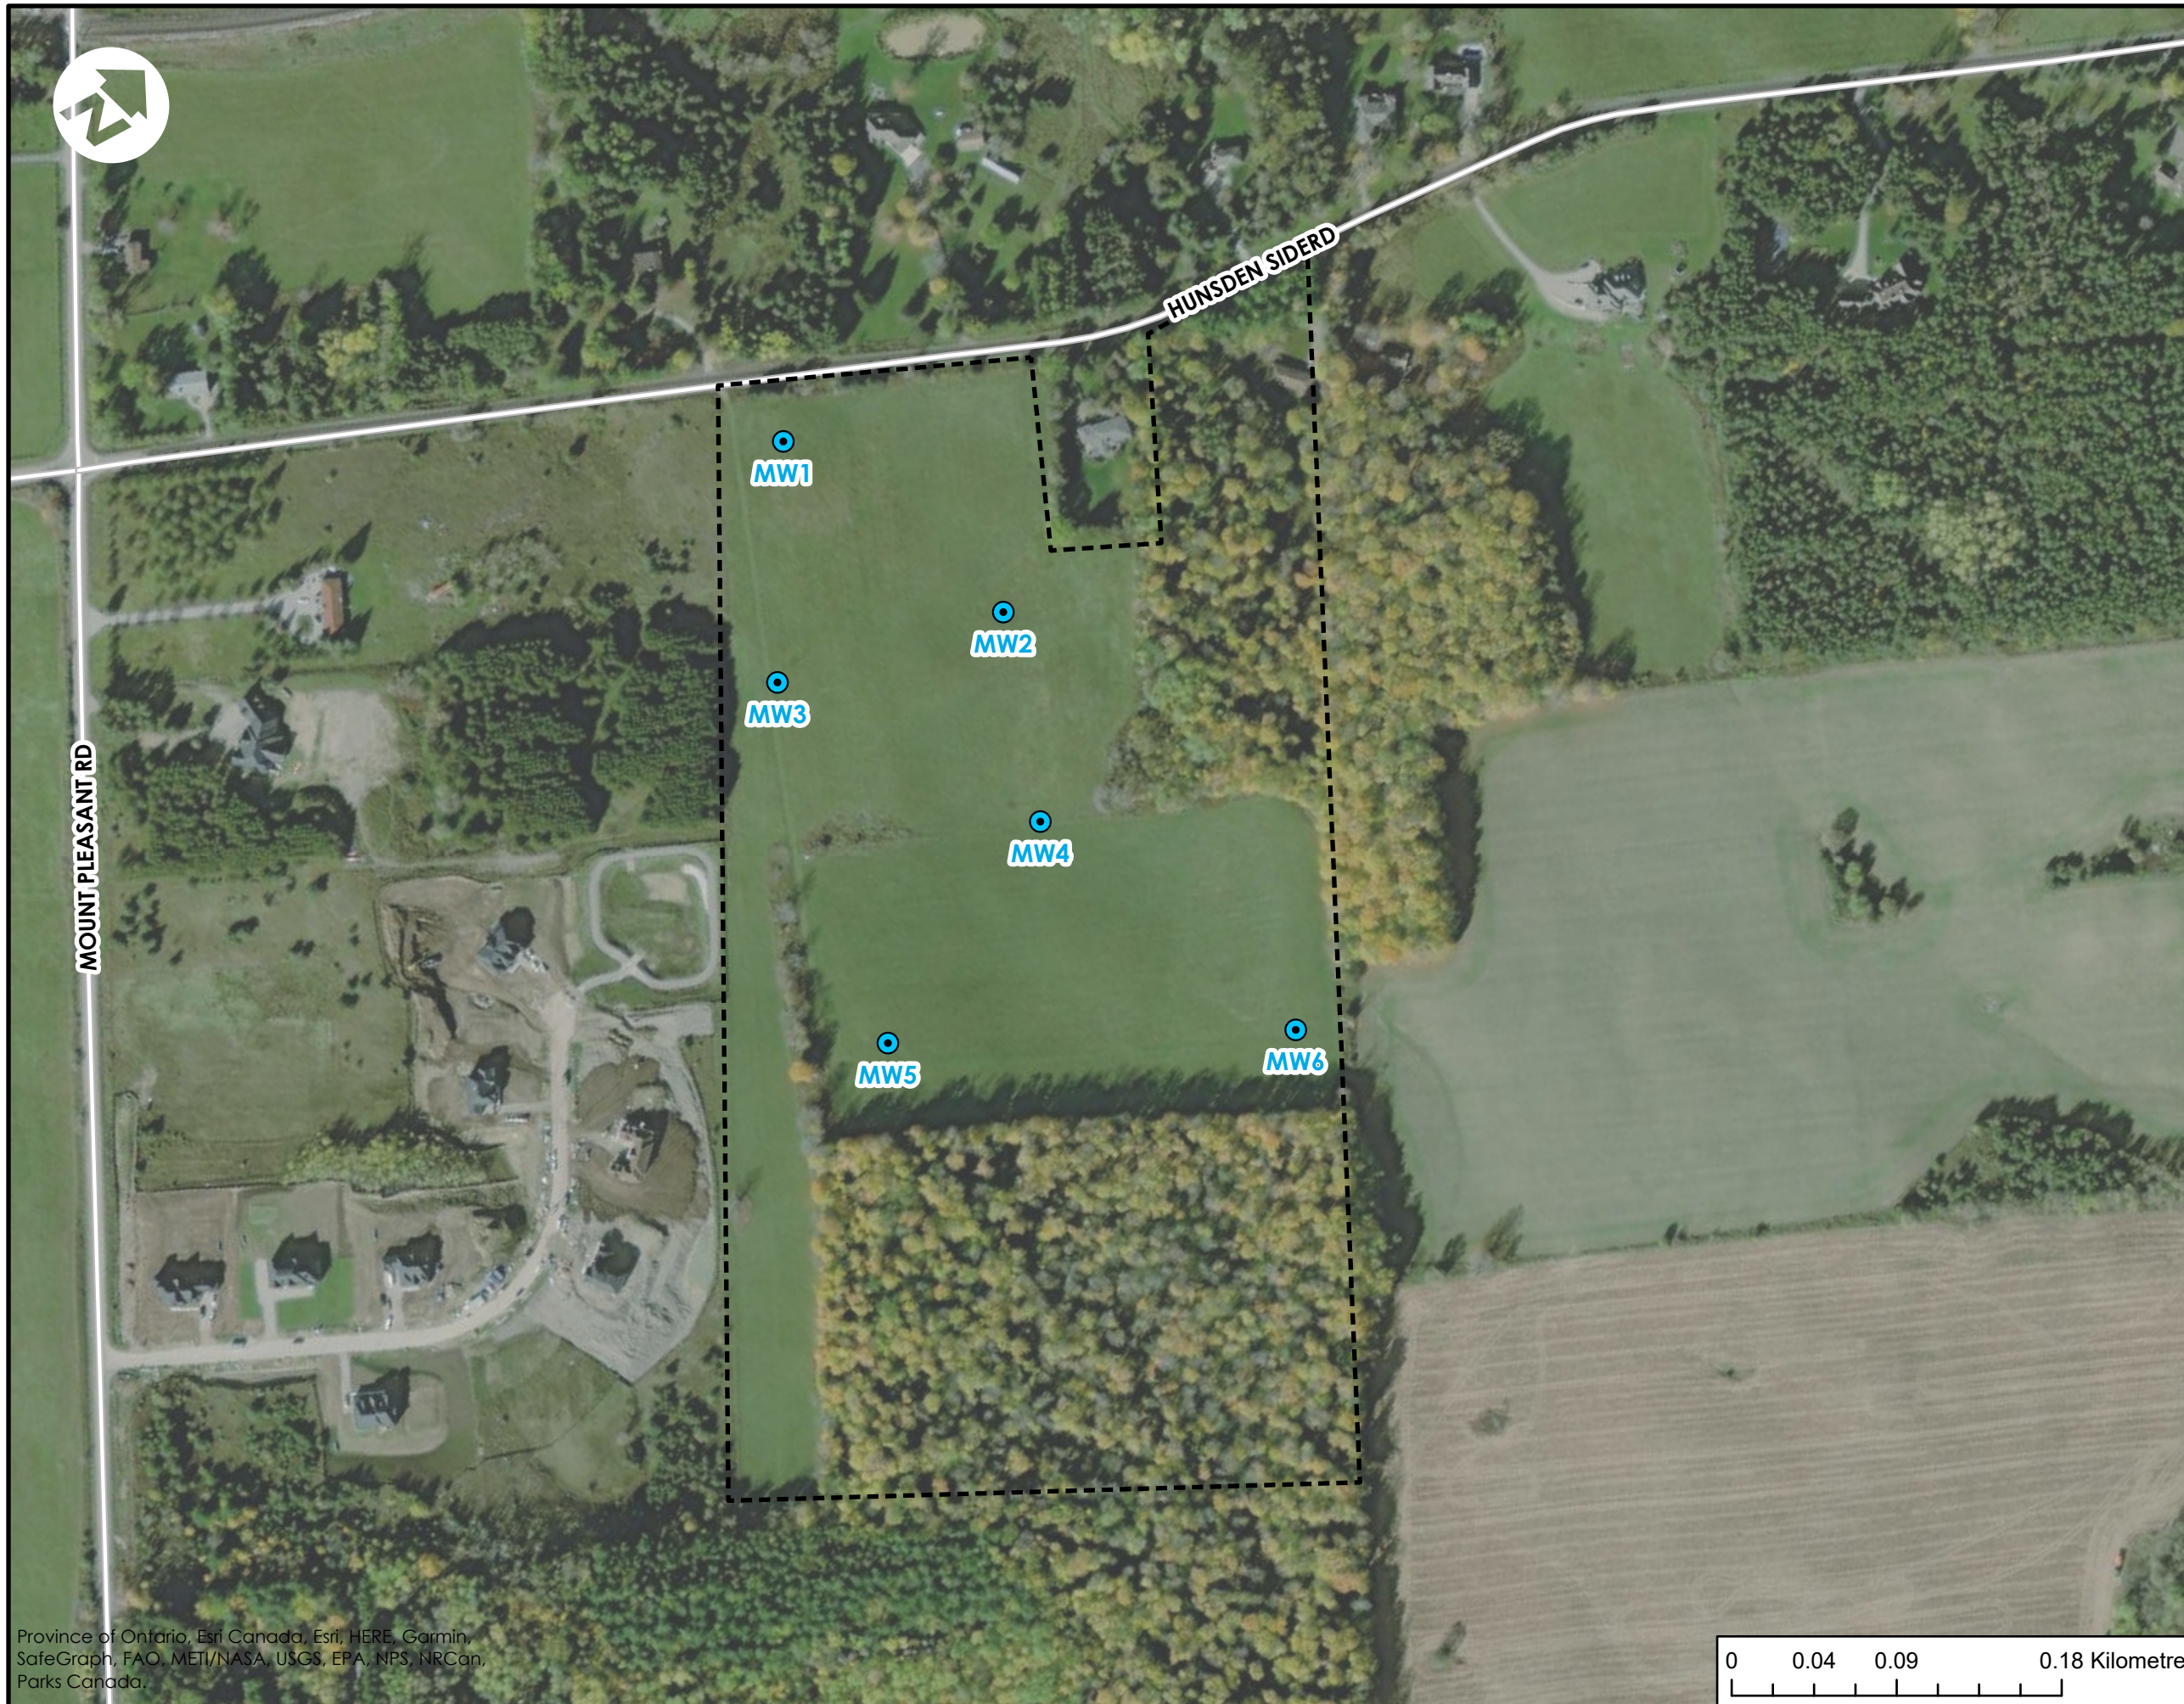
Drawing:
 Monitoring Well Plan

Soil Eng. and Crozier supervised the drilling and installation of six (6) monitoring wells at the site on March 9 and 10, 2022. The locations of the monitoring wells are presented in Figure 6. The monitoring wells were installed to establish subsurface and groundwater conditions for use in preliminary engineering design. Table 2 below provides a summary of the construction details of each well.

All constructed monitoring wells were installed with a 50 mm (2-in) diameter and 3.0 m polyvinyl chloride #10 slot screen. Soil Eng. noted that all monitoring wells were dry upon completion of drilling.

As illustrated in Table 3, only one (1) well (BH-04) contained water inside when measured by Crozier staff, and the remaining five (5) wells were dry. According to borehole logs provided by Soil Eng., water is being held in the sand layer that was only encountered in MW4. As this sand layer was not encountered anywhere else on site, this sand unit is interpreted to be limited in extent and localized to the area immediately surrounding MW4. Crozier considers this to be a perched aquifer system that, once exposed and dewatered, would not be recharged by groundwater below or surface water inputs via infiltration. Seasonally high groundwater elevations at the site are anticipated to be 287.35 masl and lower, considering that the groundwater elevation at MW4 is anomalous.
