Phase One Environmental Site Assessment

10249 Hunsden Sideroad, Caledon, Ontario

June 1, 2022
Project 2101948

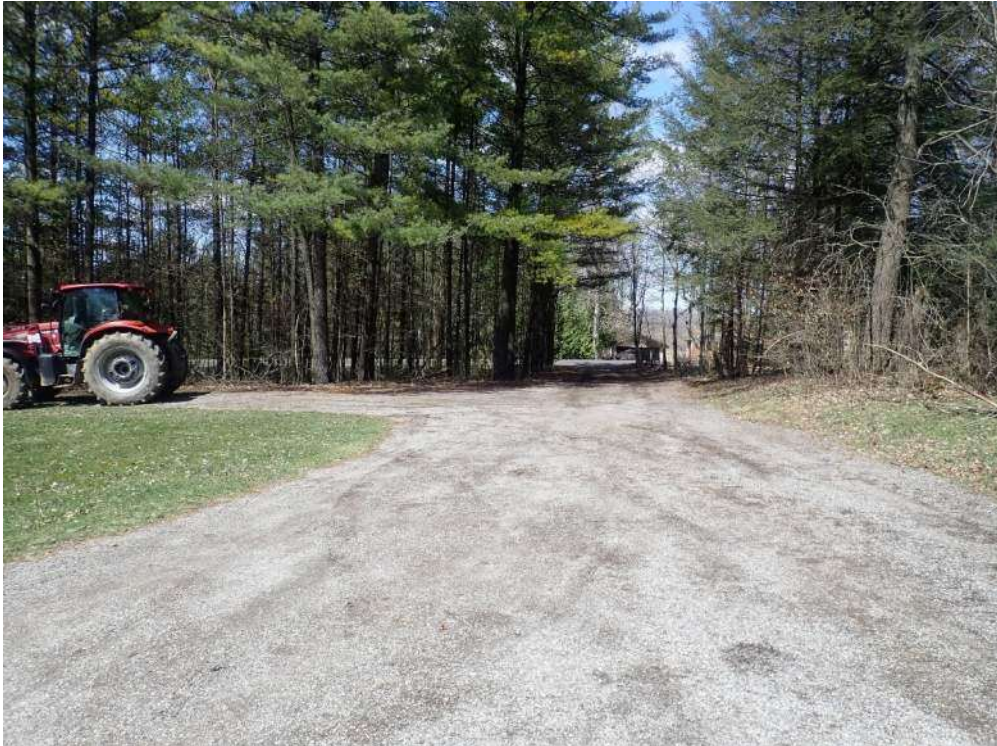
PHOTOGRAPH 1

Description:
Northeastern portion of the Site, picture facing northeast down the driveway towards Hunsden Sideroad.

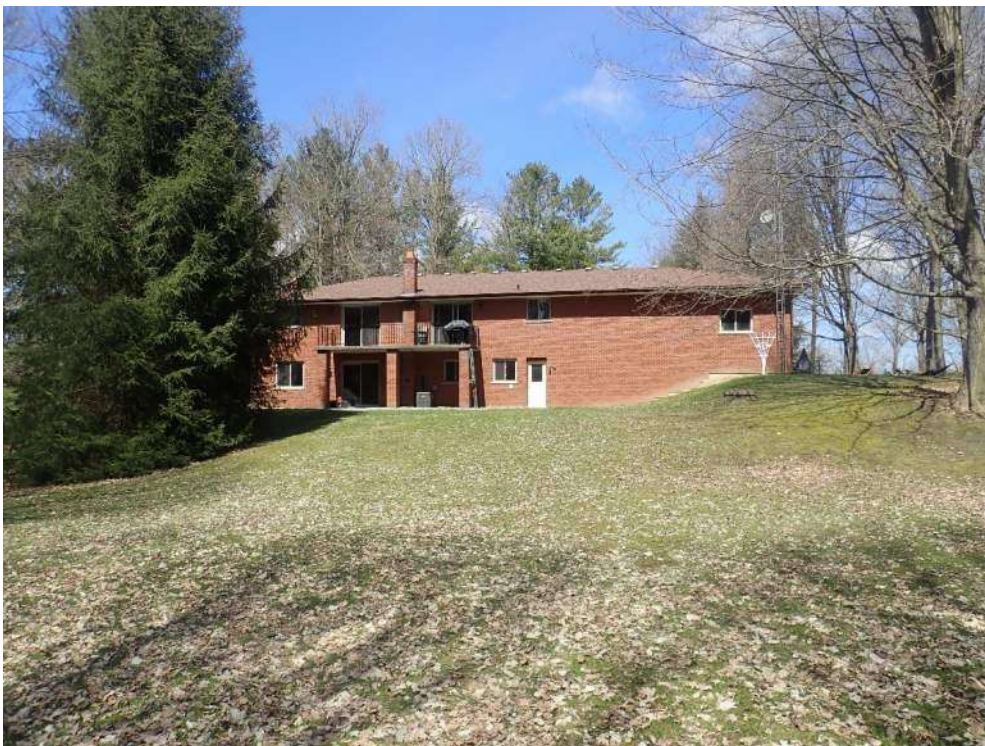
PHOTOGRAPH 4

Description:
Rear View of the
residential
dwelling on Site.
Picture facing
northeast.

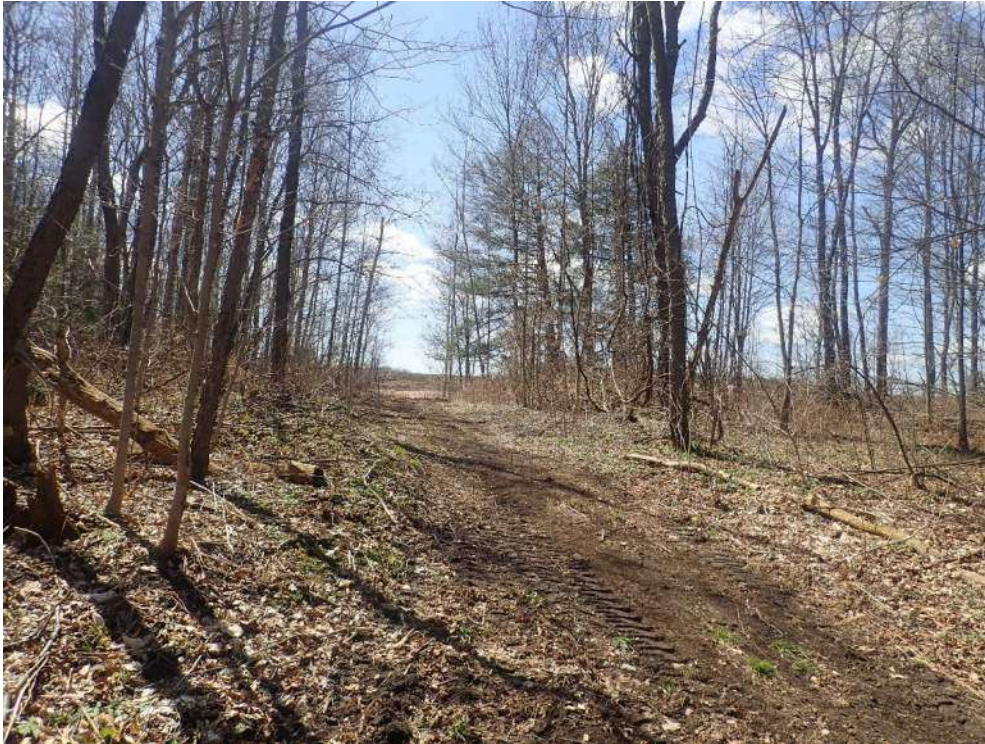
PHOTOGRAPH 5

Description:
Treed western portion of the Site with trail heading to southeast fields. Picture facing southeast.

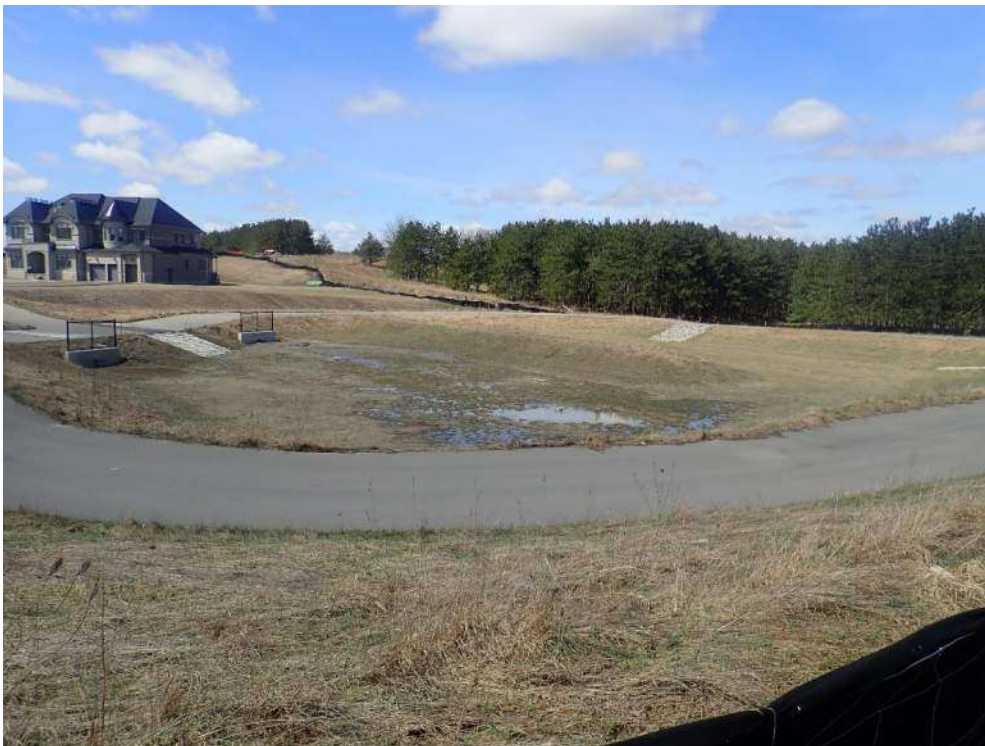
**PHOTOGRAPH
12**

Description:
Mostly dry
drainage pond
located off-site to
the west of the
property. Picture
is facing
northwest.

One (1) drainage pond was observed on site. Drainage ditches were observed on the northern adjacent roadway (Hunsden Sideroad). The nearest surface water body observed was Gibson Lake and several interconnected ponds are located approximately 1.55km southwest of the site.
