## **Phase One Environmental Site Assessment**

10795 Highway 9  
Caledon, Ontario  
L7E 0G5

Safetech Environmental Limited

April 18, 2019

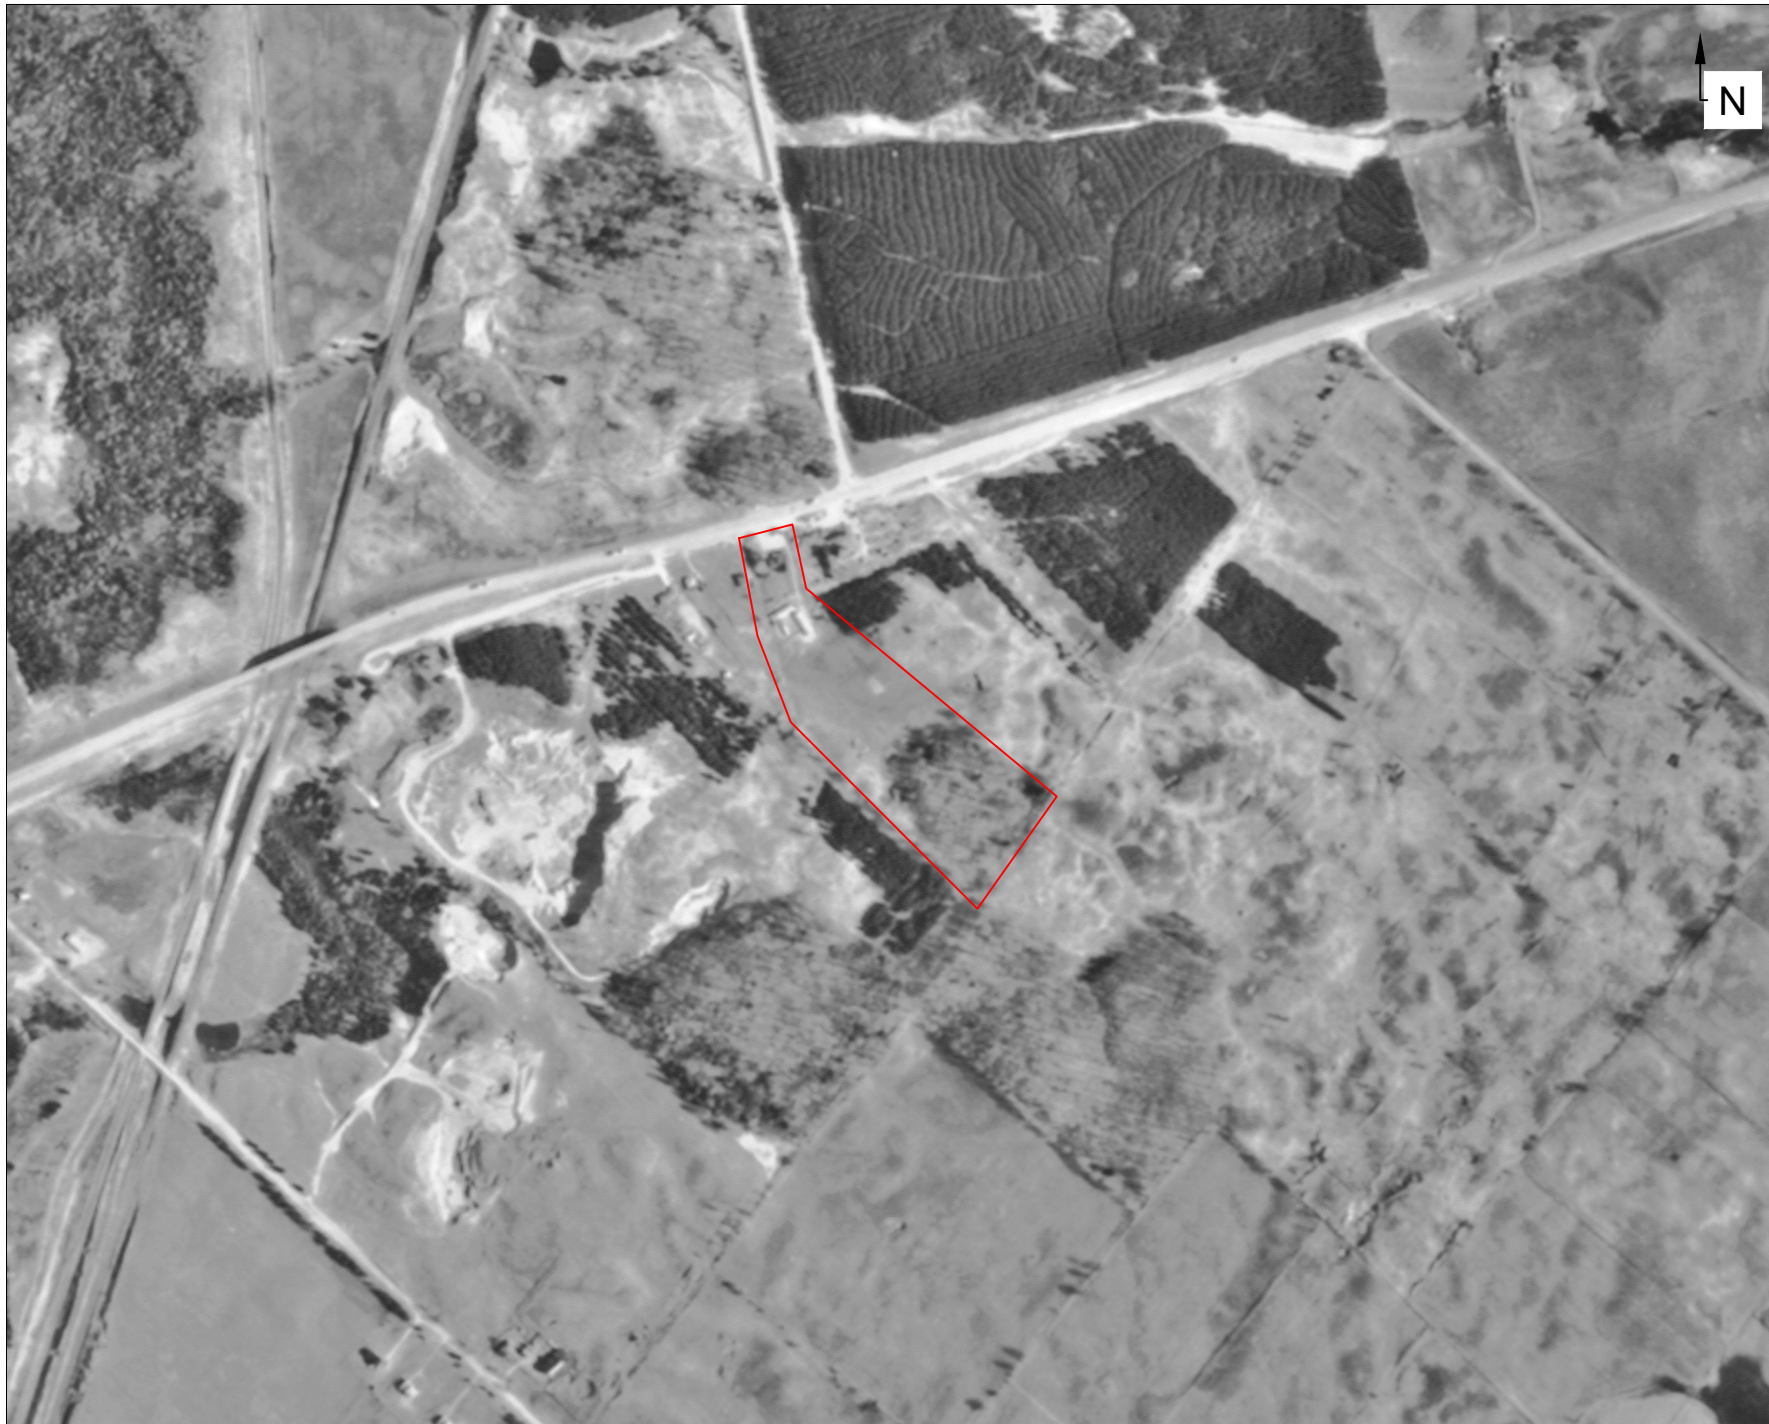
**Title:**  
Figure 8 - Historical  
Aerial Photograph  
1974

- 1964: The Site and surrounding area appeared to be consistent with the previous aerial photograph.
- 1974: Due to the low quality of the image, it was difficult to identify specifics of the aerial photograph. The land in the southern yard of the Site appeared to have been cleared at this time to expose the sandy clay/silt which was observed at the Site. There also appeared to be large objects located in the southern yard of the Site at this time. The object did not appear to be shaped the same as the current Site Building 2. There had been an increase in the number of trees in the surrounding area since 1964.

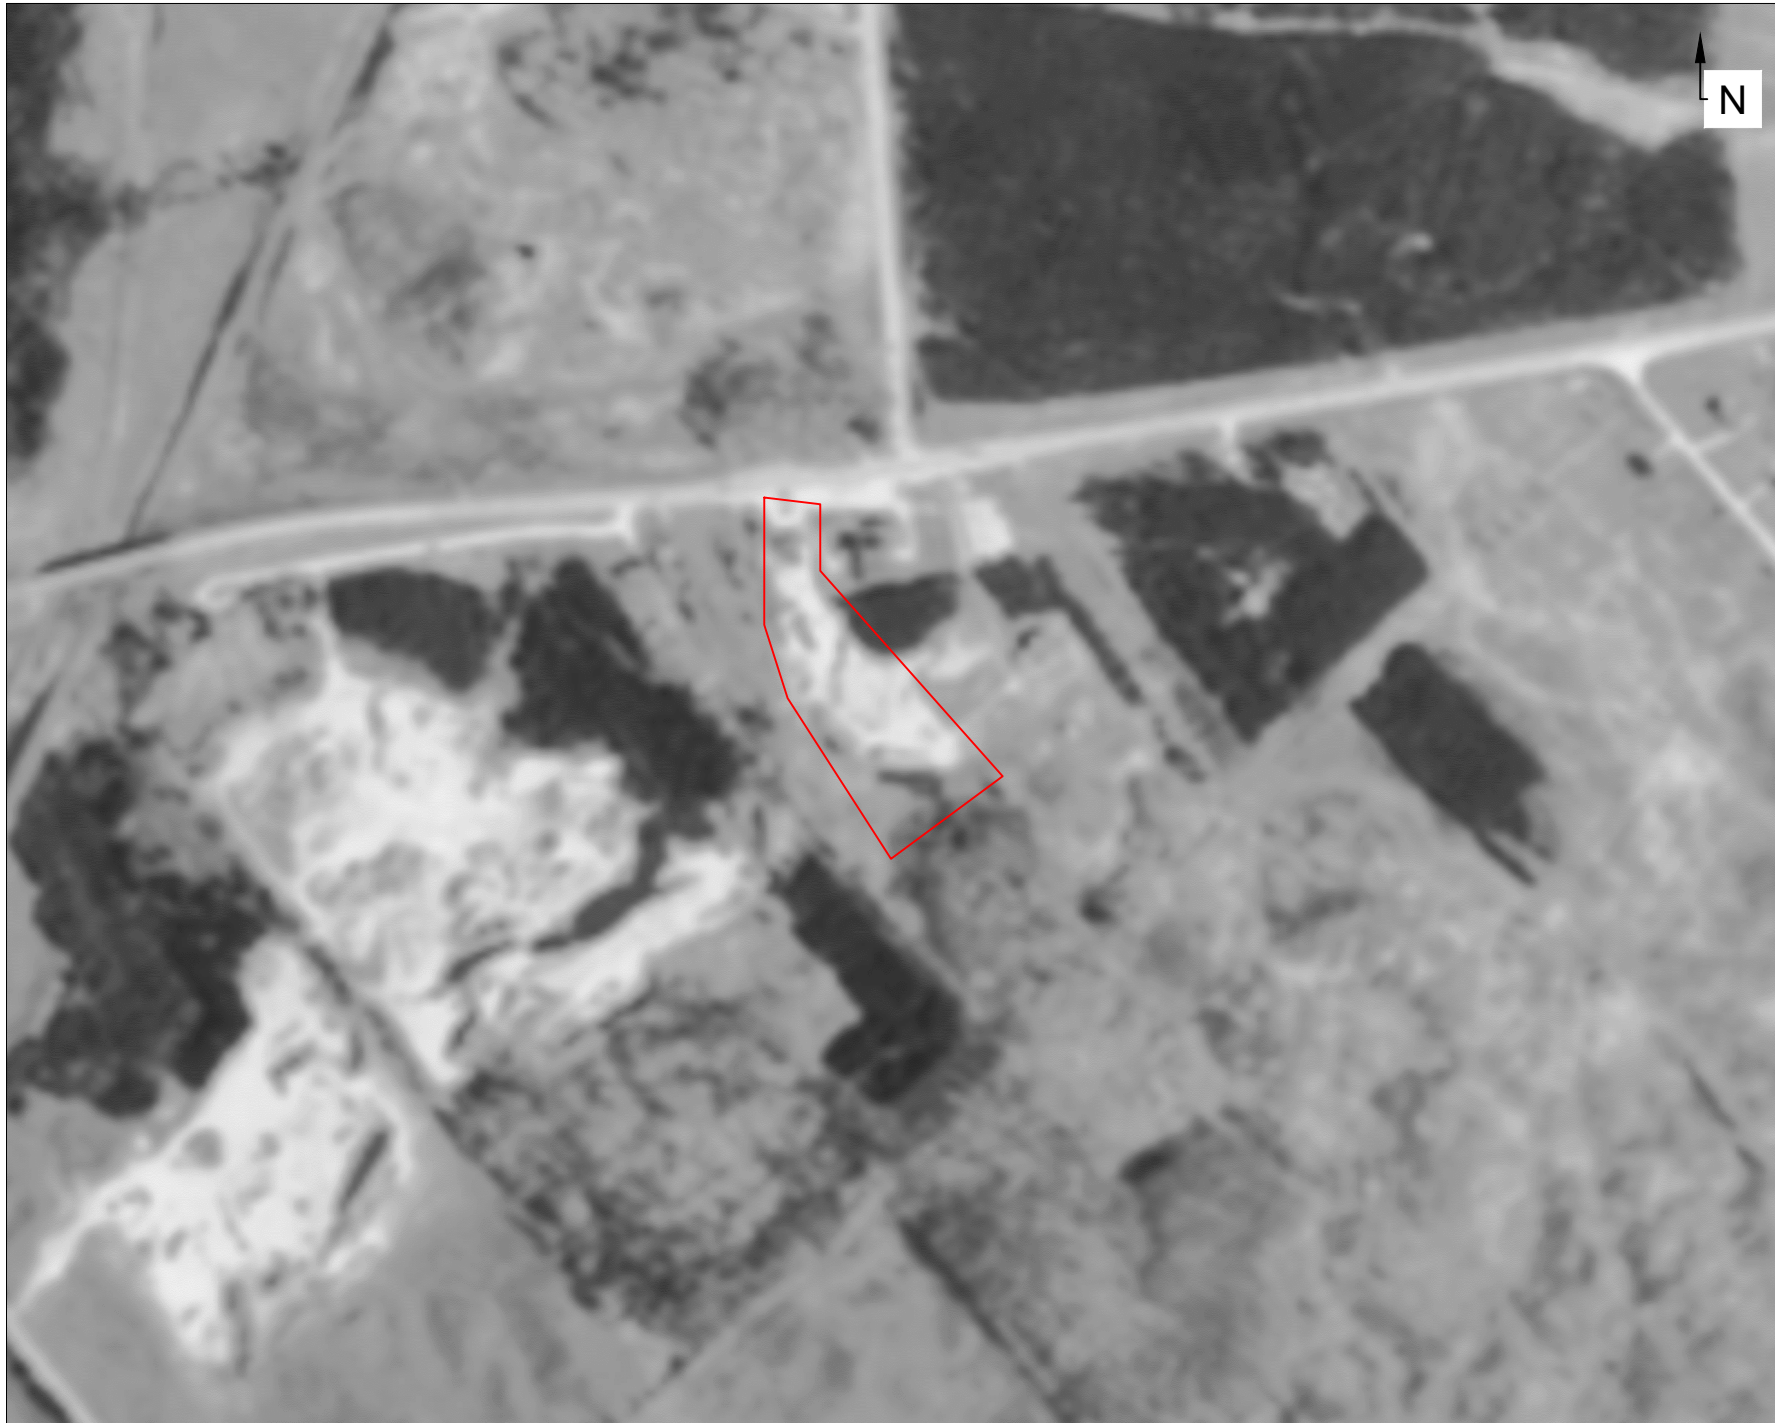
**Title:**  
Figure 9 - Historical  
Aerial Photograph  
1980

- 1980: The Site Building had been constructed at this time and the grass/greenery which was in the southern yard had been cleared out to show soil similar to its current day condition. Identification of Site Building 2 is difficult due to the low quality of the image.

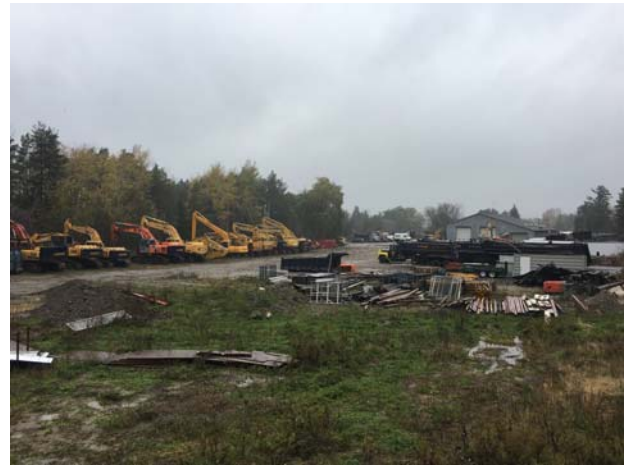
The majority of the outdoor portion of the Site was used for the outdoor storage of large construction equipment and vehicles. Vehicles and equipment observed outside included, but was not limited to, excavators, additional excavator buckets/attachments, medium and heavy trucks (MACK Trucks), medium and heavy truck trailers, bulldozers, additional bulldozer buckets/attachments, mobile elevating platform, large towable generators, shredded rubber tires, etc. There was also metal equipment observed on the yard including ladders, storage bins, building beams, ceiling support beams and piping. There was also a fenced in area where several miscellaneous gas tanks were observed. The specific types of gases were not identified.

**Photograph 2:** View of south yard of Site and Site Building 2 from south end of Site.

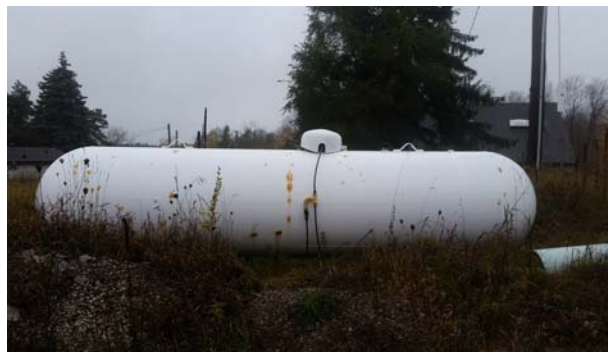
Heating of both Site Buildings was reportedly through propane powered ‘Goodman’ furnace systems. Site Building 1 appeared to have two heating units; one in the basement utility room and the other in a storage room accessed from the garage. Site Building 2 also appeared to have two heating units; one in the basement furnace room and the other near the stairs of the western section of the first floor. One propane tank was observed outside between the two buildings. There was an air conditioning unit observed on the south side of Site Building 1 which was reported to provide cooling to the entire building. There was no observed air conditioning unit outside of Site Building 2 and therefore cooling is assumed to be provided by opening doors/windows for increased airflow.

**Photograph 3:** Propane tank used for heating Site Buildings.

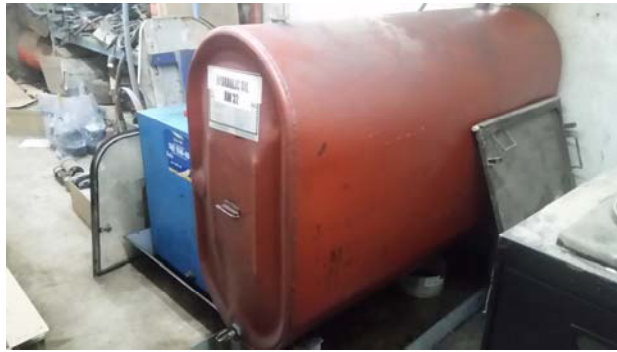
There were eight ASTs observed on the Site. Three of the ASTs were observed inside of Site Building 2 and five ASTs were observed outside on the Site. Below is a list and description of each AST observed on the Site.

**Photograph 7:** View AST 1 (right) and AST 2 (left).

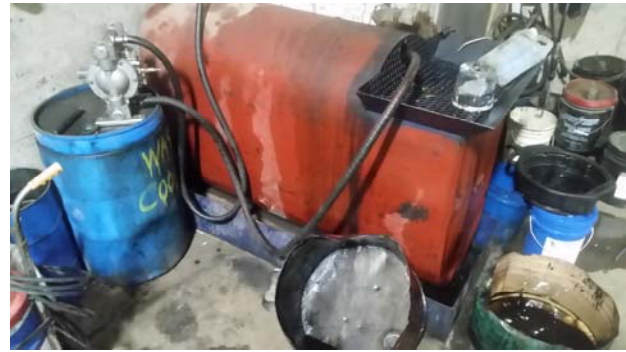
**Photograph 8:** View of AST 3.

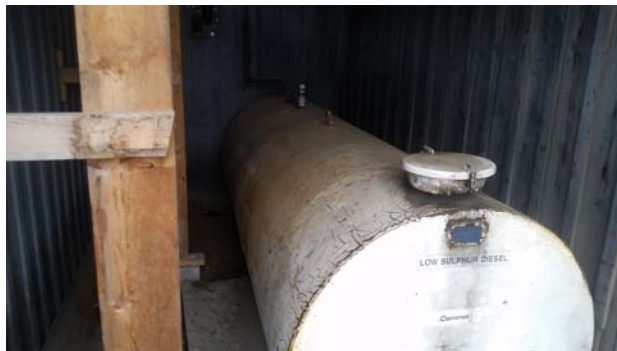
Review of the Ecolog ERIS database search identified records of waste oils and lubricants as well as PCBs being disposed of from the Site. The waste oils were reportedly collected on Site in AST 4 (see section 5.2.2 for AST identification) and were assumed to be a result of maintenance and repairs of the vehicles and equipment on the Site. The PCB waste generated was reported by Mr. Jay Hemming (Lions Demolition) to have been from materials collected from demolition projects which were brought to the Site for proper disposal. Examples of material brought to the Site as well as copies of the waste manifest documents were not provided. Manifests of the waste oils were provided to SEL from the Client and are described in section 3.4 of this report. Copies of the waste manifests are also included in Reference 9 in the Appendix.

**Photograph 9:** View of AST 4.

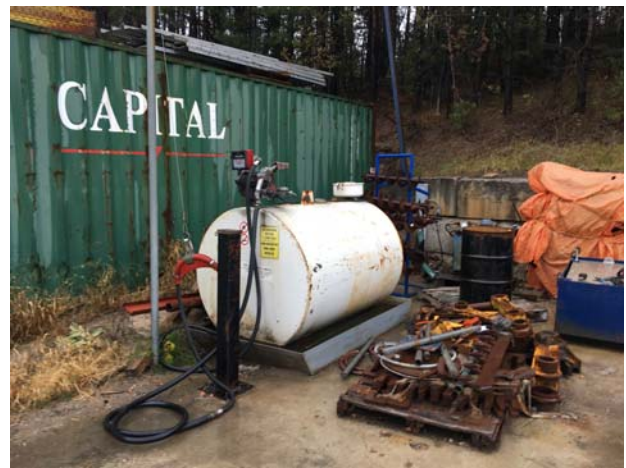
**Photograph 10:** View of AST 5 (left) and AST 6 (right).

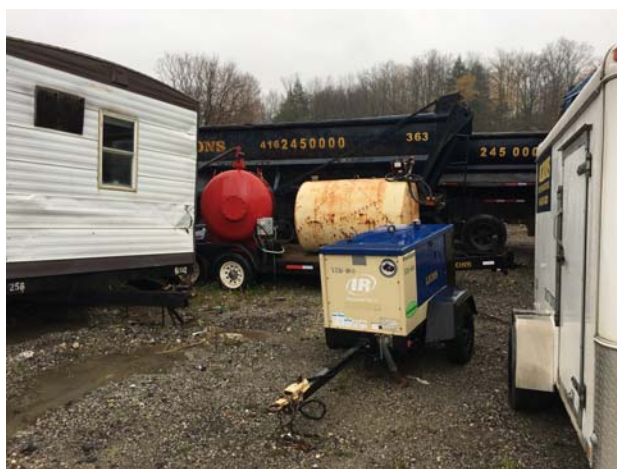
**Photograph 11:** View AST 7 (right) and AST 8 (left).

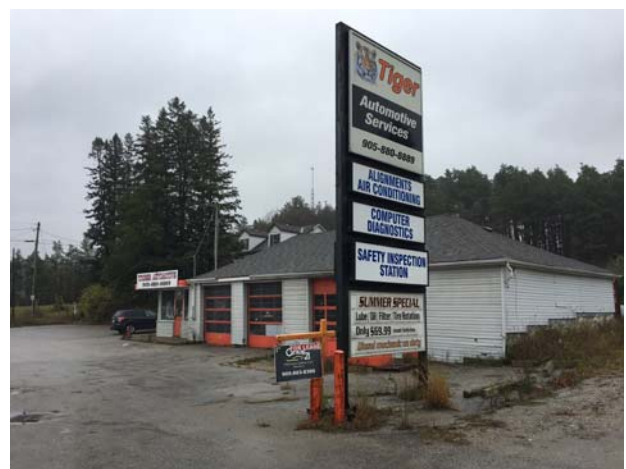
**Photograph 12:** View automobile garage adjacent to the east of the Site.

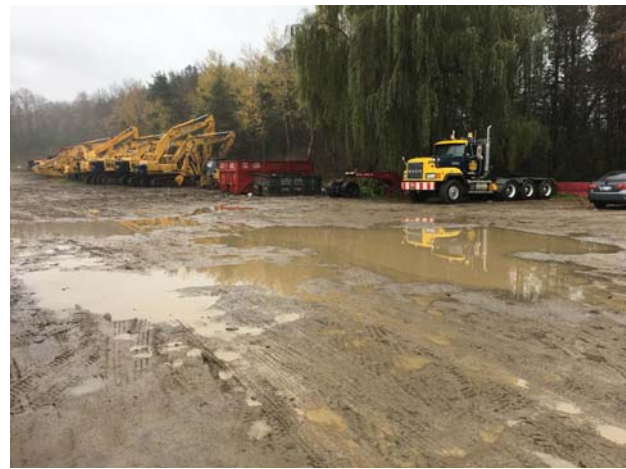
Directly west of Site Building 2, there was pooled surface water from the rainfall which occurred during and before the Site reconnaissance. This pooled water was observed to have a visible sheen throughout and was slowly draining off the Site into the property adjacent to the west.

At the time of Site reconnaissance, there had been consistent rainfall throughout the morning which led to pooled water observed in the directly west of Site Building 2 which appeared to drain off the Site to the west. No sign of a water body was reported or assumed to be present without any recent rainfall on the Site.

**Photograph 14:** View of water pooled on Site west of Site Building 2. The surface water flows off the Site downwards to the west behind the dumpsters shown in the photograph.
