12148 Albion Vaughan Road

Scoped Environmental Impact Study

Palmer Project #
160461

December 23, 2020

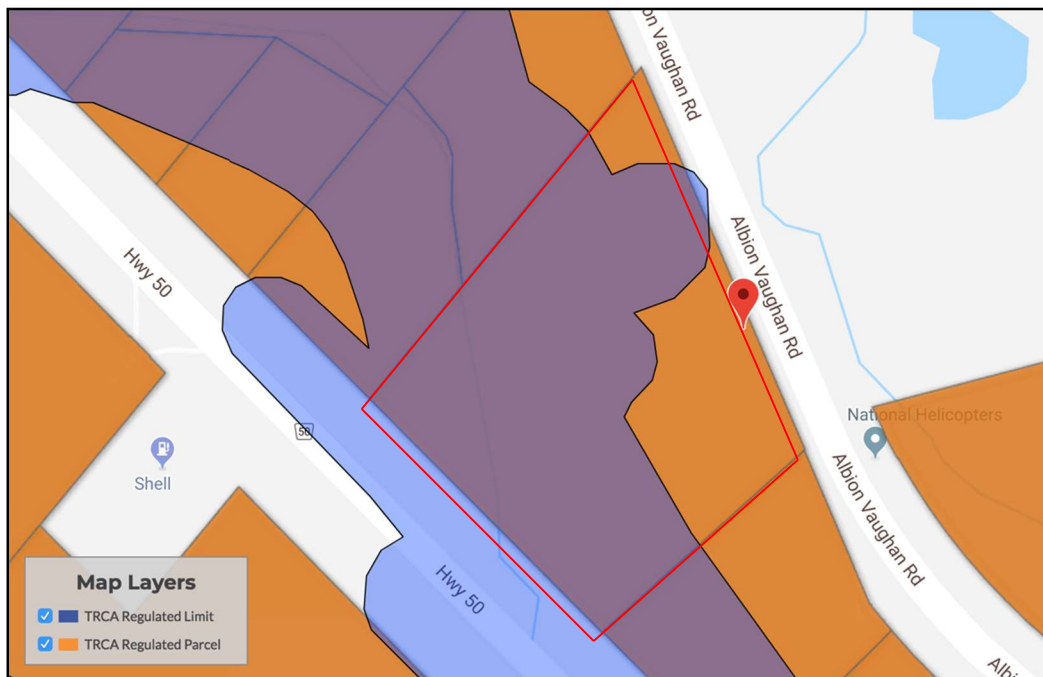
Map A. TRCA Regulated Area in the vicinity of the Subject Property

The Subject Property occurs within area regulated by TRCA in accordance with O. Reg. 166/06. The TRCA regulation limits are shown in **Map A** below, associated with the watercourse and its flood limit through the property.

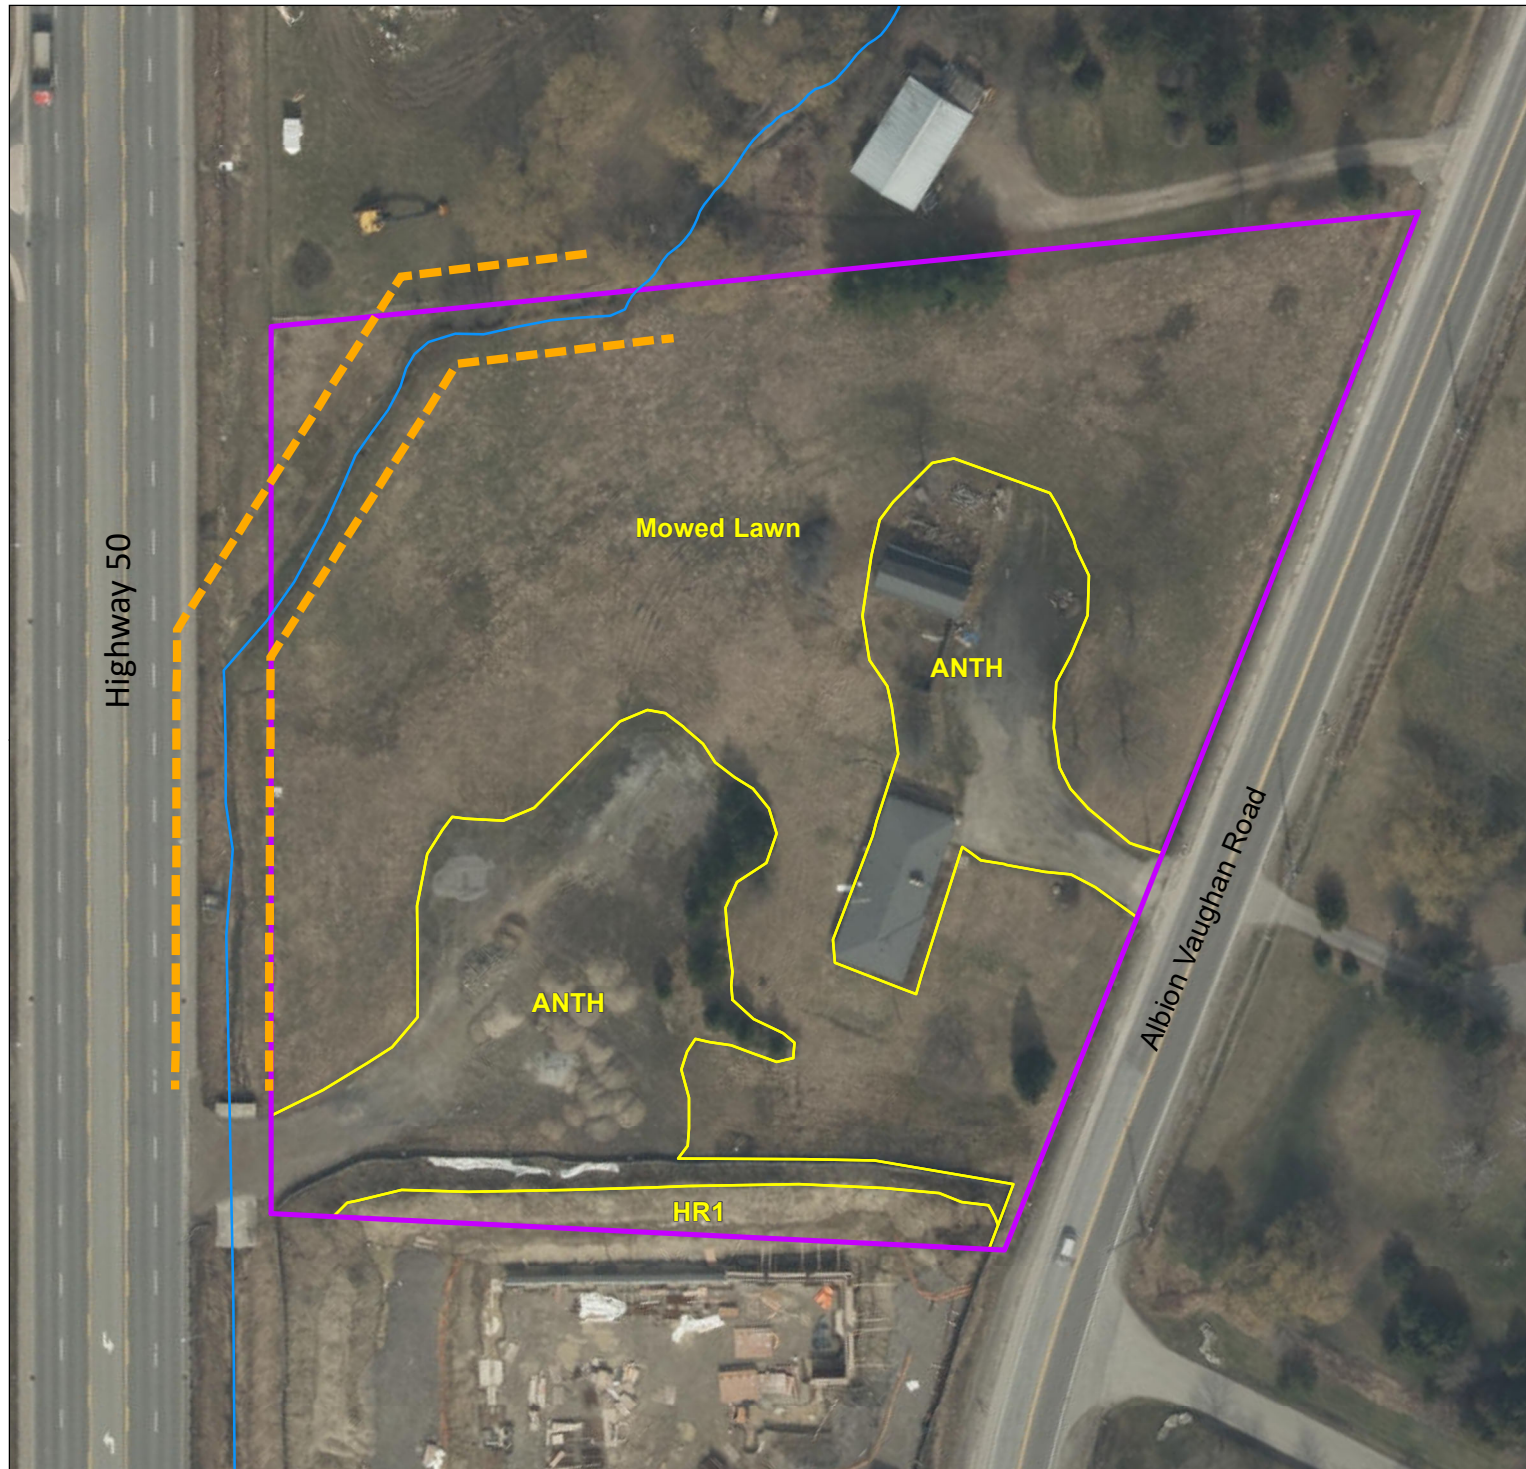
**Existing Environmental
Conditions**

- SUBJECT PROPERTY (1.57 ha)
12148 Albion Vaughan Road,
Bolton, Town of Caledon
- ELC COMMUNITY
- WATERCOURSE
- MEANDER BELT BOUNDARY

The aquatic assessment (Section 4.5) demonstrates that Robinson Creek provides limited opportunities for fish habitat. This section of the creek is characterized by low riparian cover and minimal in-stream features that provide refuge for fish. The erosion hazard assessment of the creek shows a history of anthropogenic re-alignment within the Subject Property (Palmer, 2018). The current limits of this stream feature are defined by the meanderbelt, as defined within the 2018 Palmer study and illustrated on **Figure 2**.

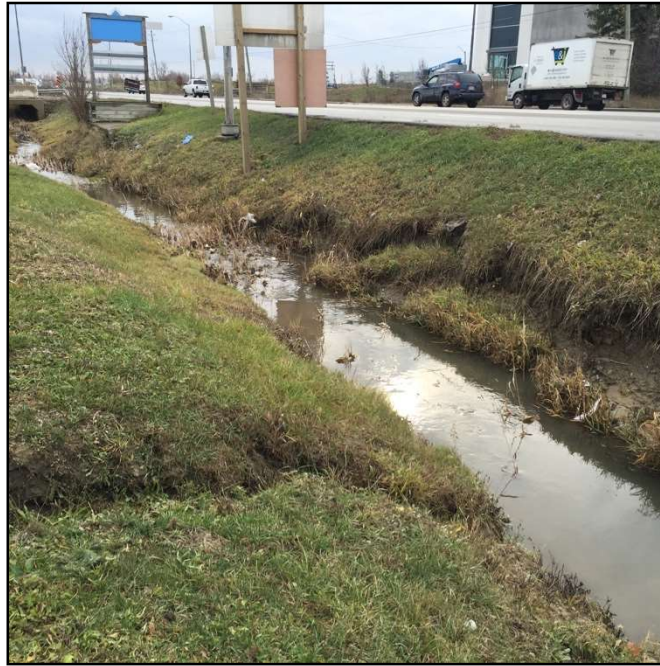
Photograph 1. Channel along Regional Road 50 showing slumping of the slopes and erosion gullies

The channel wetted width is uniform and approximately 1.5 metres (m) throughout the reach within the Subject Property (**Photo 1**). The bankfull width is greater in sections due to erosion and failing slopes, providing evidence of a "flashy" system (i.e., quick increase in flows following rain events/spring melt), see **Photo 2**. Erosion hazard assessment studies conducted for this project show a history of channel realignment within the Subject Property (Palmer Environmental Consulting Group, 2018). The limits of this channel are thus defined by the meanderbelt limit, as outlined in the aforementioned study (**Figure 2**). Within the property limits, there are observed instabilities along Robinson Creek that are a response to historical and recent channel realignments as well as upstream urban development (changes to flow regime and sediment supply).

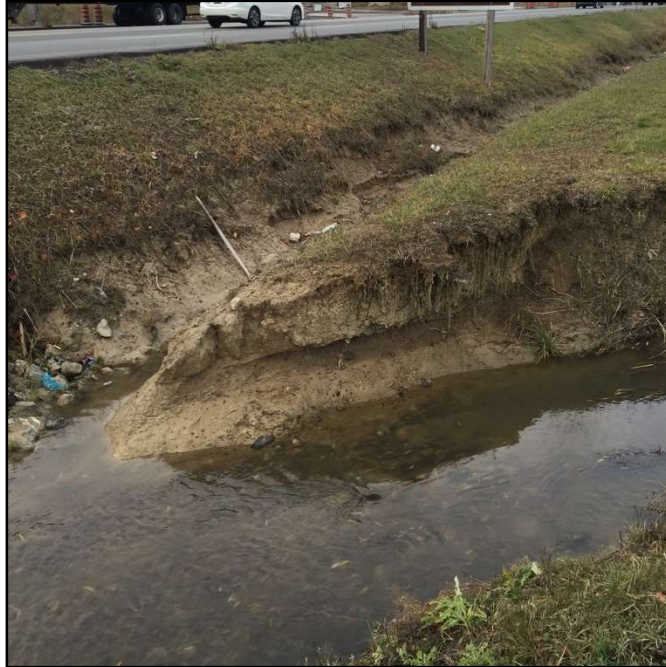
Photograph 3. Tributary as it joins the roadside drainage ditch, showing exposed sands and soil

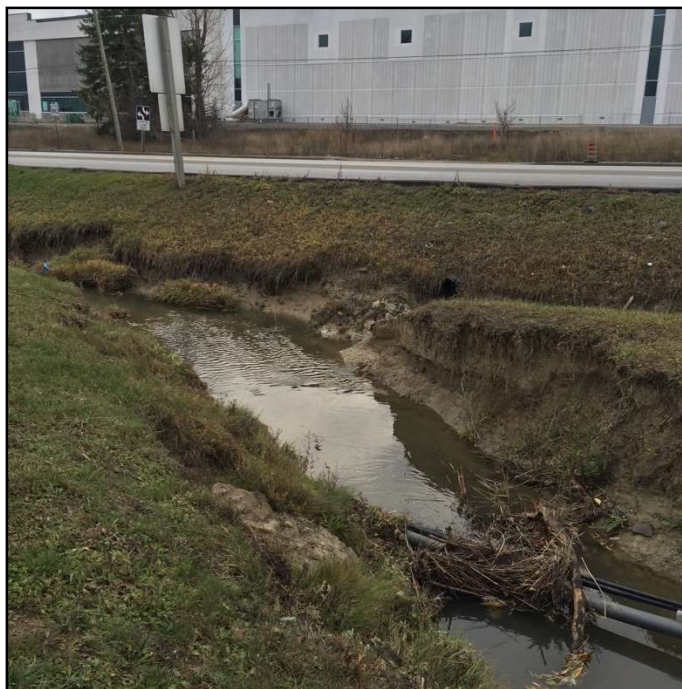
Photograph 4. Exposed service cables/pipes at the tributary as it joins the drainage ditch along Regional Road 50

There were little in-stream features that provided cover or refuge for fish. Substrate in the channel consisted of sand, gravel and some scattered rubble. There were localized areas (less than 10% of the area within the Subject Property) of in-stream aquatic vegetation – cattails. Leaf litter was present in the channel from the upstream wooded-area. No barriers to fish passage were observed, but low flow conditions are likely in the summer months. Evidence of the urban setting was present, with garbage along the stream from the adjacent road, as well as exposed service cables/pipes in one section (**Photo 4**).

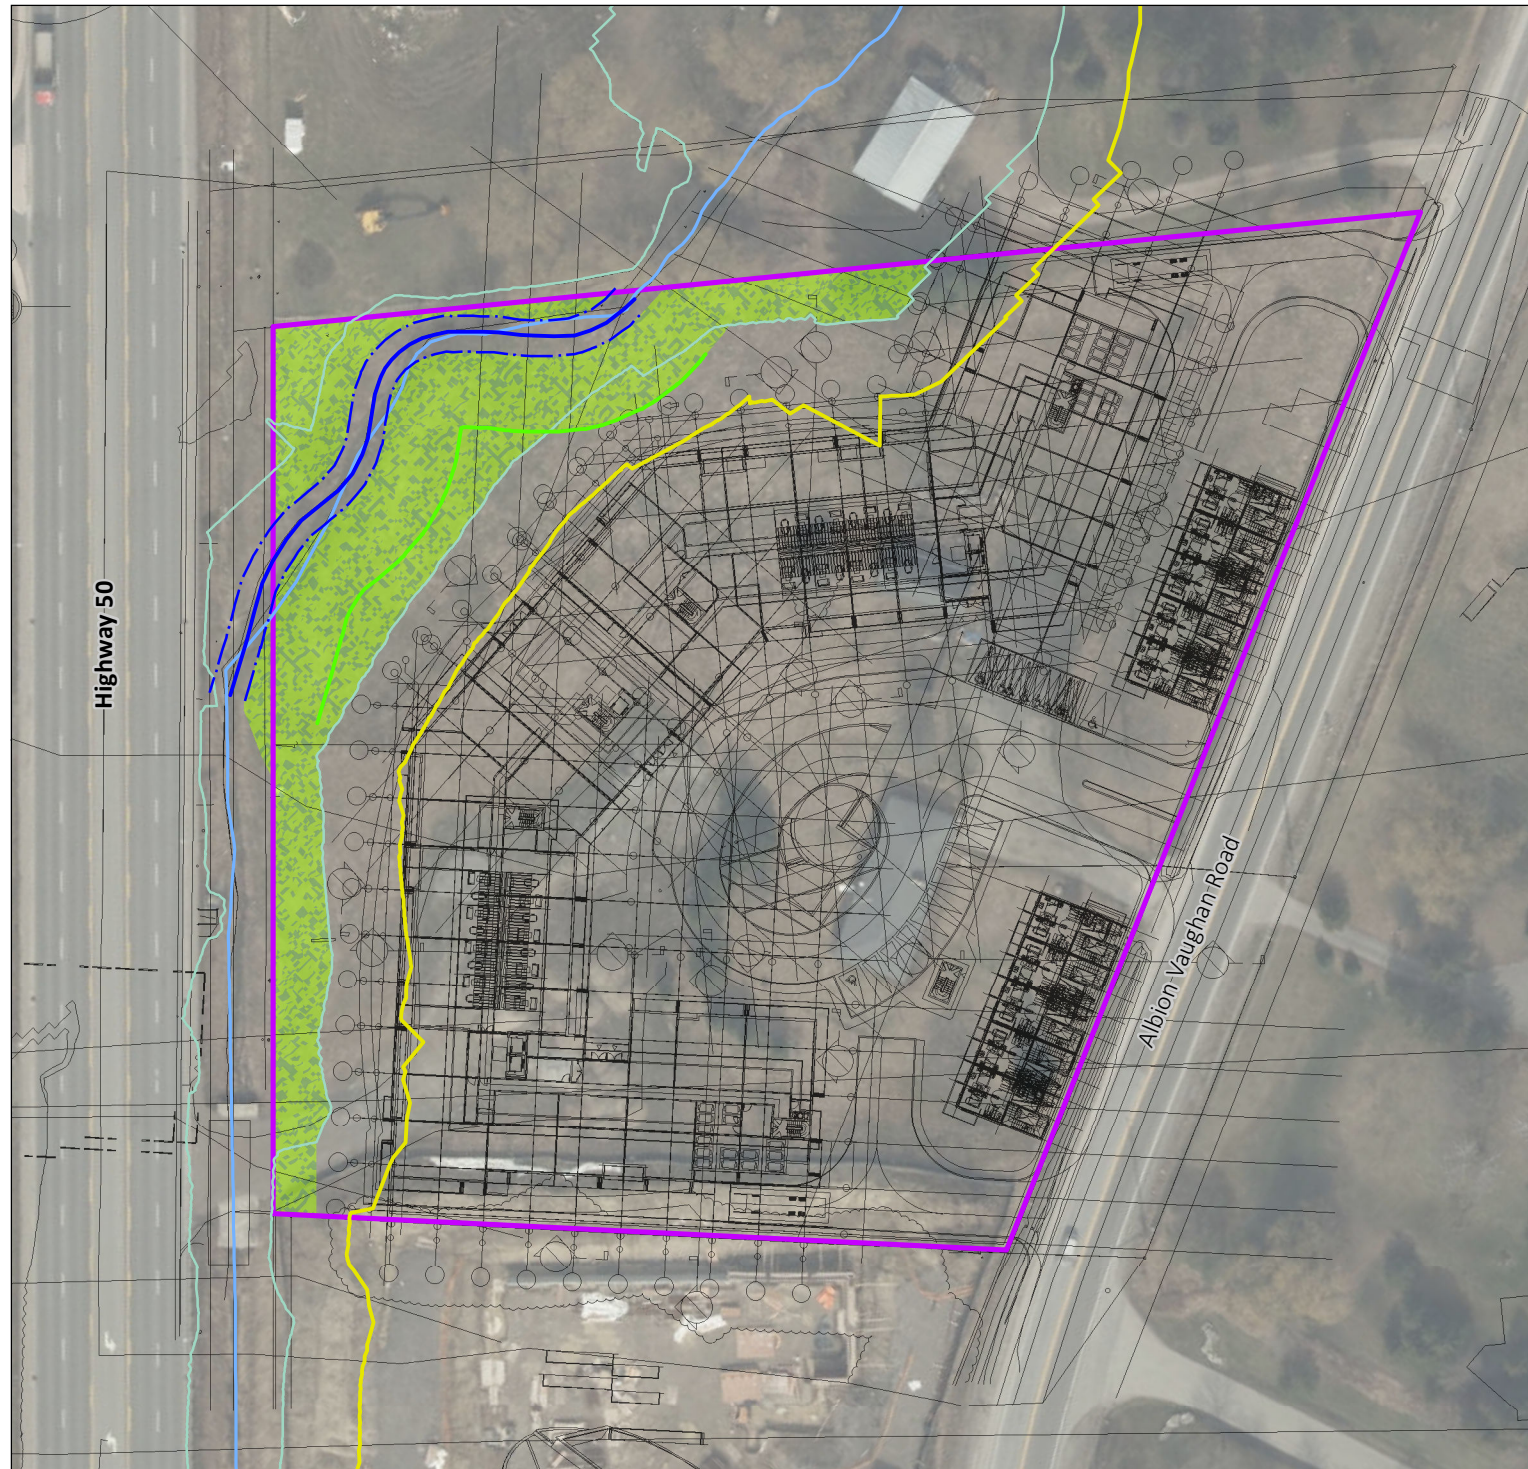
The portion of Robinson Creek within the property is proposed to be realigned in order to maximize the developable area and improve flood storage.

- RE-ALIGNED WATERCOURSE (CENTRELINE)
- - - BANKFULL CHANNEL WIDTH
- 10 M NATURAL FEATURE SETBACK
- FLOODPLAIN LIMIT
- 10 M FLOODPLAIN SETBACK
- EXISTING WATERCOURSE (CENTRELINE)
- SITE PLAN
- PLANTING AREA
- SUBJECT PROPERTY

In accordance with TRCA's *Living City Policies* (2014) and based on the findings of this EIS, a 10 m natural feature setback is recommended to buffer the realigned watercourse, as defined by the designed Bankfull Width in this instance (**Figure 3**). It is also recommended that the required 10 m natural feature buffer be expanded to include the re-designed floodplain to protect the re-aligned watercourse and its associated functions from impacts associated with the proposed development. This extension will also serve to increase the flood infiltration capacity and provide wildlife habitat potential of the area.

The 10 m natural feature setback and designed floodplain have been combined to create a proposed Planting Area (**Figure 3**). It is recommended that the buffer is planted and restored with *native, self-sustaining vegetation* in consultation with the agencies. In order to extend the potential natural area and functions, the 10 m flood and erosion hazard setback are proposed to be planted with native species, but allow for hazard access and recreational use of the area.

The Planting Area is to be seeded and planted to buffer the watercourse/natural features from the development (**Figure 3**). The setback is to be seeded at a rate of 25 kgs/ha with an early succession wet meadowseed mix that aligns with the TRCA *Seed Mix Guidelines* (Toronto and Region Conservation Authority, 2004; Credit Valley Conservation Authority, 2014). The recommended Early Succession Wet Meadow Mix (CVC 6) includes:

It is recommended that the 10 m flood/erosion access setback be seeded and planted to further buffer the Planting Area from the development, but also allow for maintenance, hazard access and recreational/passive use of the area (**Figure 3**). The flood/erosion access setback should be seeded at a rate of 25 kgs/ha with a native grass seed mix that aligns with the TRCA *Seed Mix Guidelines* (Toronto and Region Conservation Authority, 2004). A recommended grass seed mix includes:
