12197 Hurontario Street, Brampton, Ontario  
and 12211, 12213, 12231, and 12233  
Hurontario Street, Caledon, Ontario

Phase Two Environmental Site Assessment Update

Phase Two Environmental Site Assessment Update, 12197 Hurontario Street, Brampton, Ontario and 12211, 12213, 12231, and 12233 Hurontario Street, Caledon, Ontario

GTR-00257876-A0

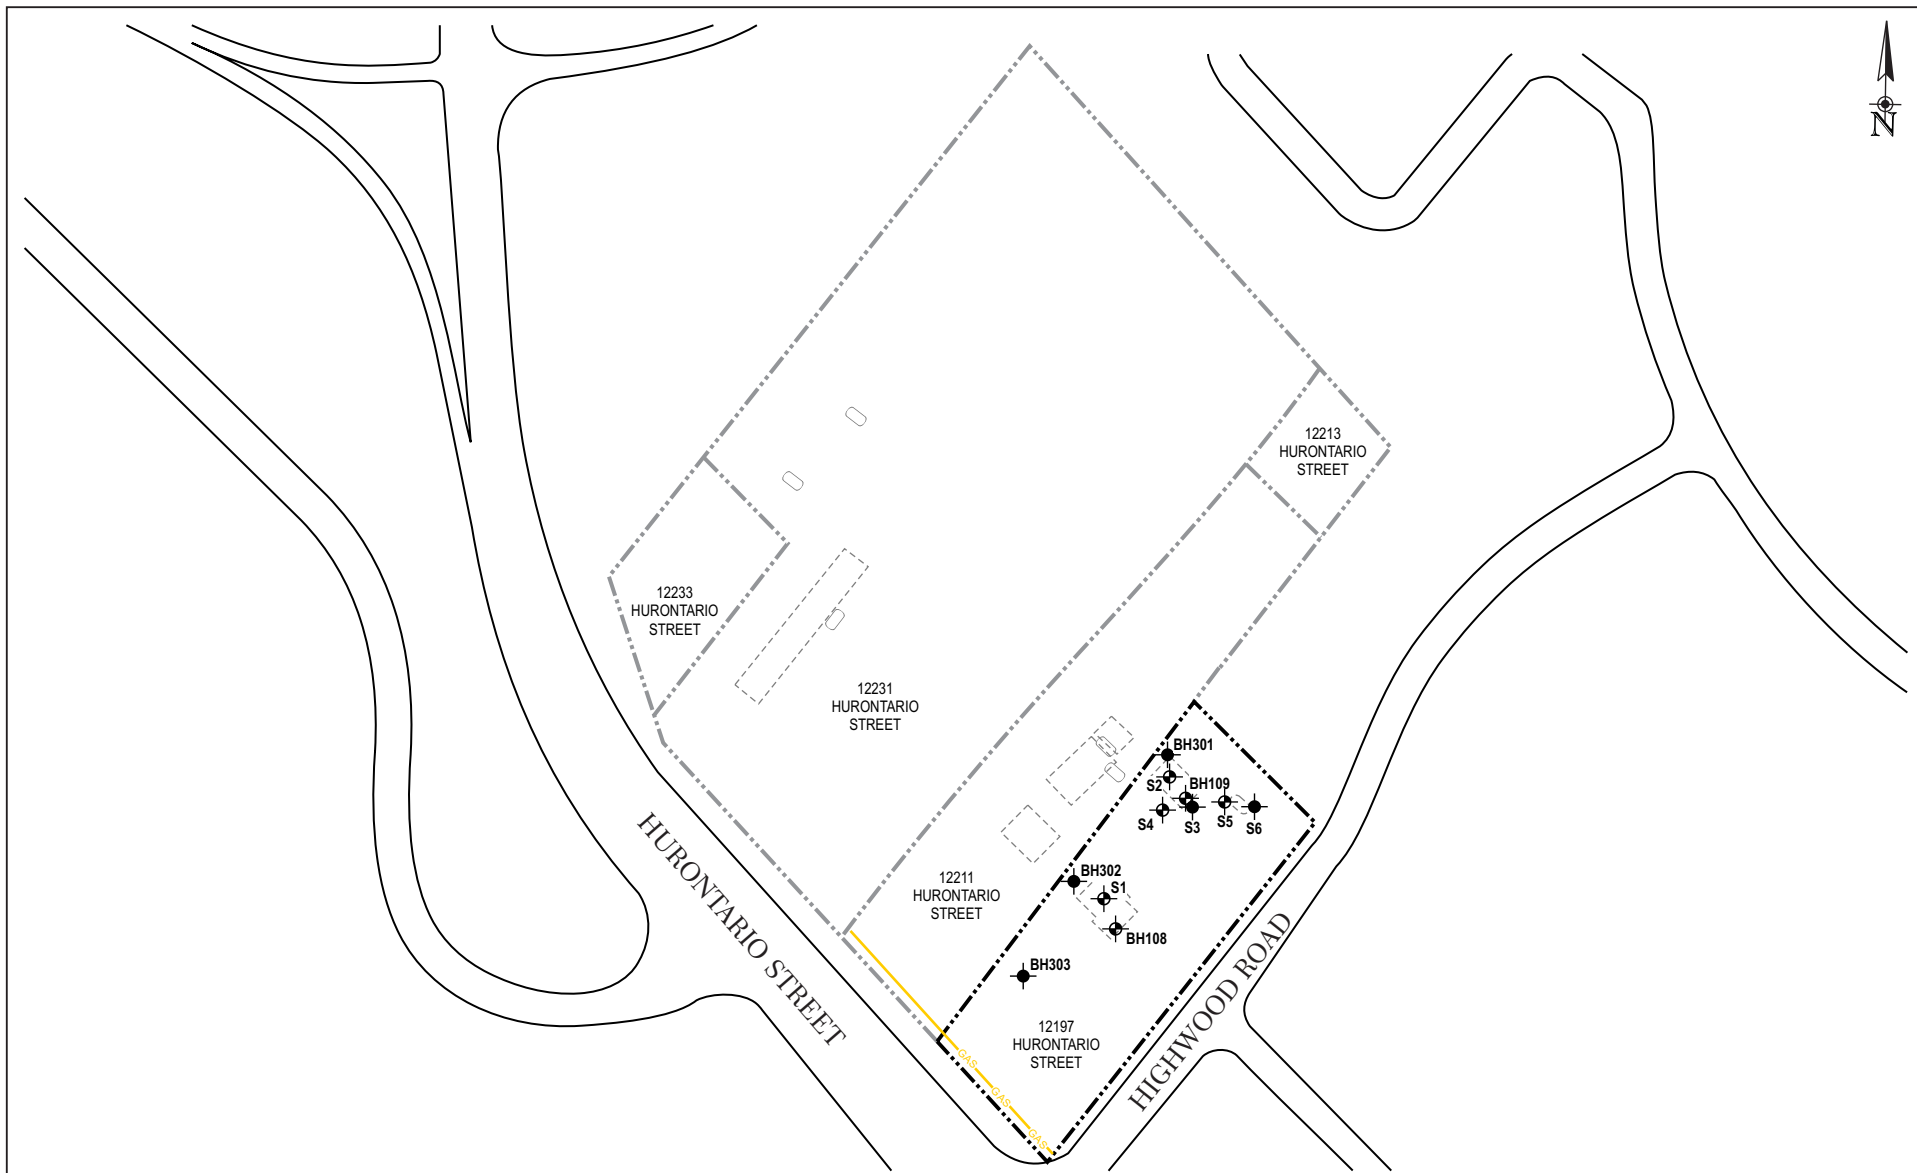
<b>SCALE:</b> 	<b>LEGEND:</b> <div> <div> <div>---</div> <div>SITE BOUNDARY EXTENT</div> </div> <div> <div>---</div> <div>LARGER PROPERTY BOUNDARY</div> </div> <div> <div>⊙</div> <div>TEST HOLE WITH MONITOR S SERIES(EXP, 2019) BH SERIES (EXP, 2021)</div> </div> <div> <div>⊙</div> <div>TEST HOLE S SERIES(EXP, 2019) BH SERIES (EXP, 2020)</div> </div> <div> <div>---</div> <div>FORMER FEATURES</div> </div> <div> <div>---</div> <div>FORMER ABOVE GROUND STORAGE TANK LOCATION</div> </div> <div> <div>---</div> <div>FORMER UNDER GROUND STORAGE TANK LOCATION</div> </div> <div> <div>---</div> <div>GAS</div> </div> </div>	<div> <div>SITE PLAN</div> <div>FIGURE 2</div> </div>
<b>SOURCE:</b> BASED ON GOOGLE EARTH IMAGE, DATED MAY 7, 2018 AND FIELD MEASUREMENTS BY EXP STAFF <div> <div>exp.</div> <div> <div>DRAWN BY</div> <div>K.G.</div> </div> <div> <div>CHECKED BY</div> <div>A.C.</div> </div> </div>		<div> <div>12197 HURONTARIO STREET, BRAMPTON, ONTARIO</div> <div> <div>PROJECT NUMBER: 257876</div> <div>DATE: JANUARY 2022</div> </div> </div>

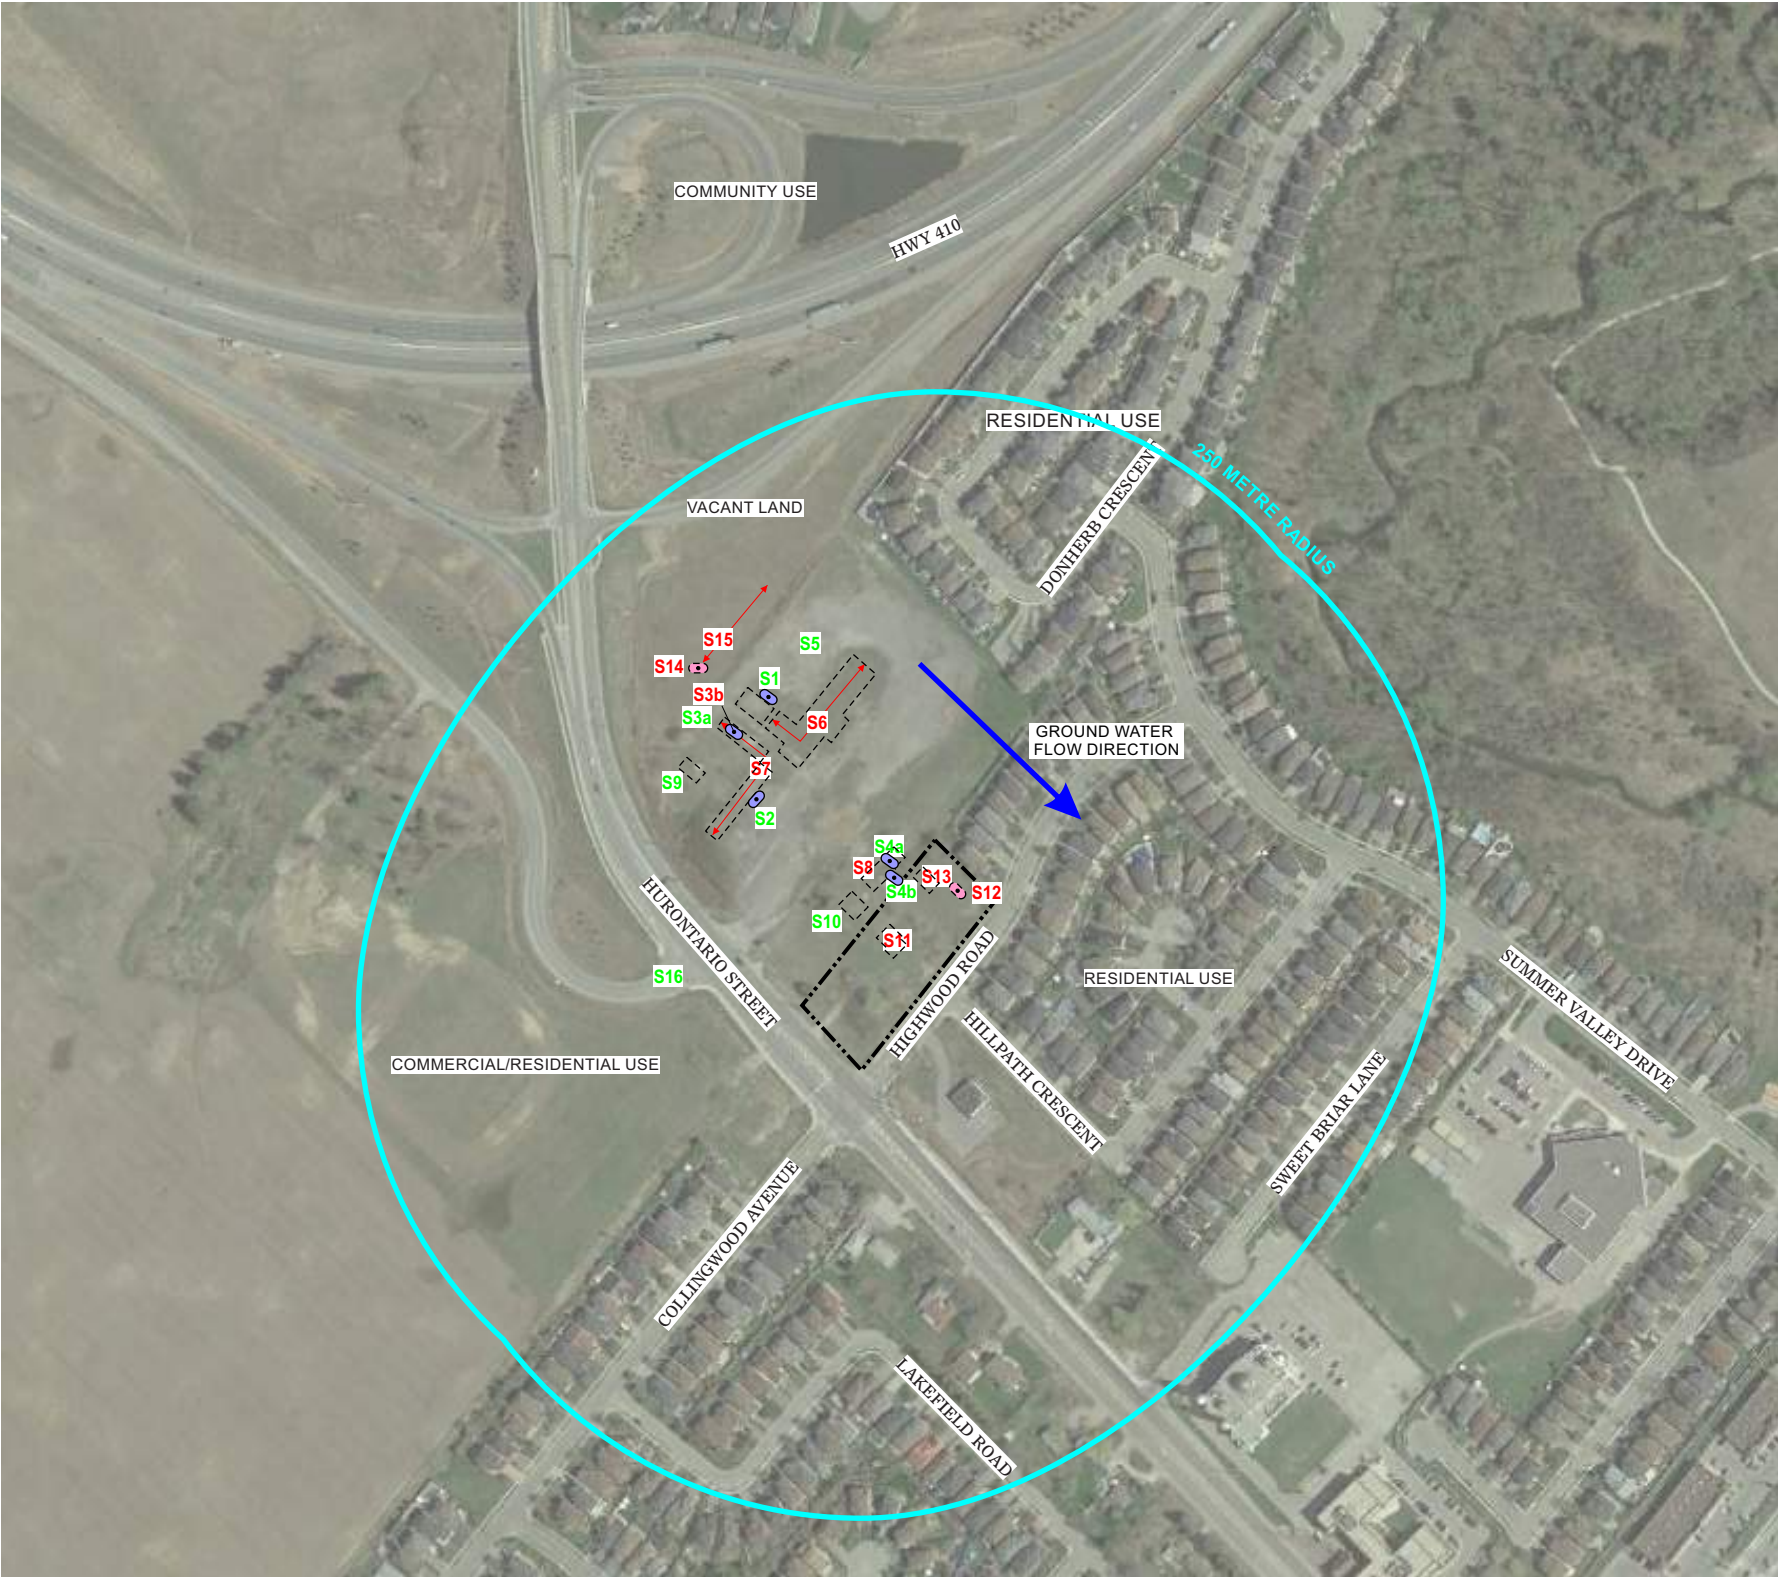
FIGURE 3A

PCA Source Number	Potentially Contaminating Activity (PCA)
S11	(30) Importation of Fill Material of Unknown Quality
S12	(28) Gasoline and associated products storage in fixed tanks
S13	(other) garage operations
S3b	(other) fuel leak
S6	(52) Storage, maintenance, fuelling and repair of equipment, vehicles, and material used to maintain transportation systems
S7	(52) Storage, maintenance, fuelling and repair of equipment, vehicles, and material used to maintain transportation systems
S8	(other) garage operations
S14	(28) Gasoline and associated products storage in fixed tanks
S15	(52) Storage, maintenance, fuelling and repair of equipment, vehicles, and material used to maintain transportation systems
De-minimis PCAs	
S1	(28) Gasoline and associated products storage in fixed tanks
S2	(28) Gasoline and associated products storage in fixed tanks
S3a	(28) Gasoline and associated products storage in fixed tanks

S4	(28) Gasoline and associated products storage in fixed tanks
S5	(Other) salt storage
S9	(30) Importation of Fill Material of Unknown Quality
S10	(30) Importation of Fill Material of Unknown Quality
S16	(30) Importation of Fill Material of Unknown Quality

Figure 3A illustrates all PCAs. Resulting APECs are shown on Figure 3B. The APECs are summarized below:

During the Phase Two investigation, EXP identified fill in the southern and northern portions of the site, including the footprint of a former residential structure. The importation of fill material of unknown quality was considered a PCA beneath former building footprints, as indicated in Figure 3A.

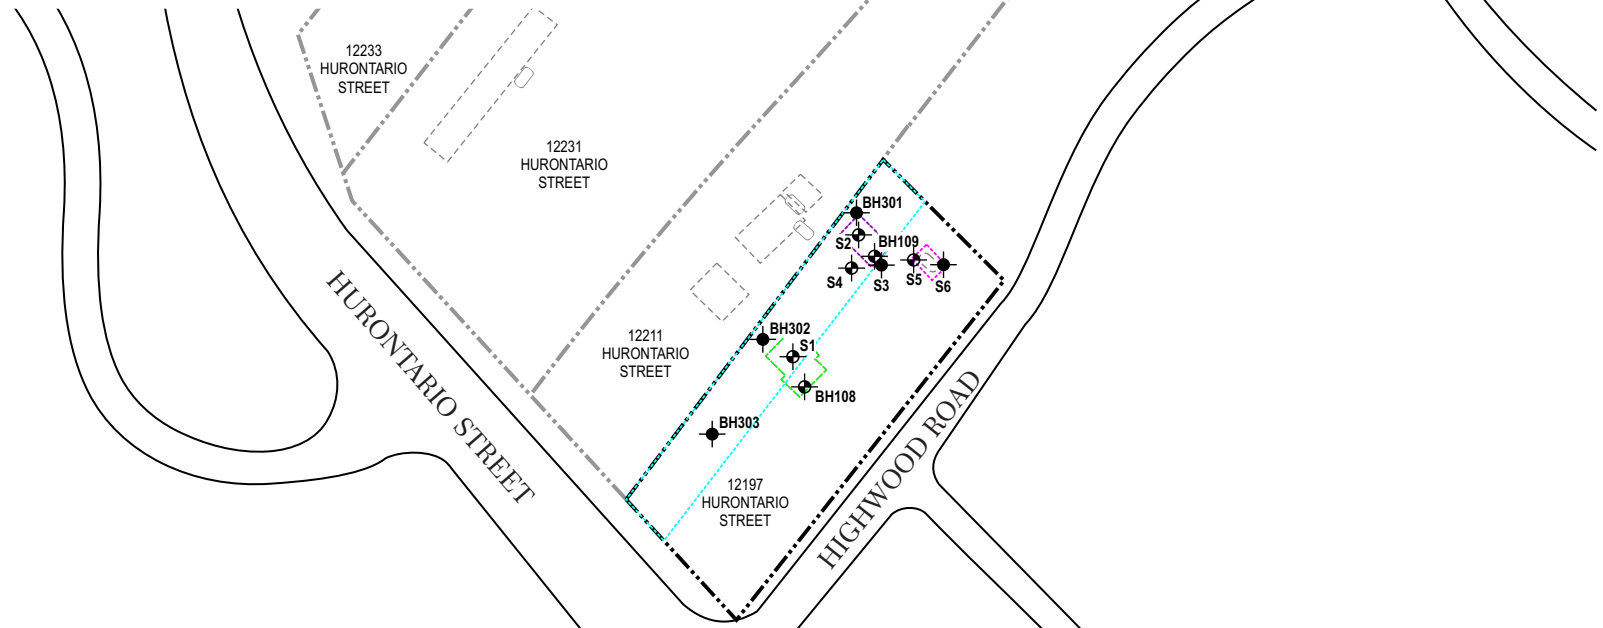
</div><div>FORMER UNDER GROUND STORAGE TANK LOCATION</div></div></div>		<b>CONCEPTUAL SITE MODEL -APECs</b>		<b>FIGURE 3B</b>	
<b>SOURCE:</b> BASED ON GOOGLE EARTH IMAGE, DATED MAY 7, 2018 AND FIELD MEASUREMENTS BY EXP STAFF		12197 HURONTARIO STREET, BRAMPTON, ONTARIO

APEC	PCA Source Number	Potentially Contaminating Activity (PCA)
A	S11	(30) Importation of Fill Material of Unknown Quality
B	S12	(28) Gasoline and associated products storage in fixed tanks
C	S13	(other) garage operations
D	S3b	(other) fuel leak
	S6	(52) Storage, maintenance, fuelling and repair of equipment, vehicles, and material used to maintain transportation systems
	S7	(52) Storage, maintenance, fuelling and repair of equipment, vehicles, and material used to maintain transportation systems
	S8	(other) garage operations
	S14	(28) Gasoline and associated products storage in fixed tanks
	S15	(52) Storage, maintenance, fuelling and repair of equipment, vehicles, and material used to maintain transportation systems

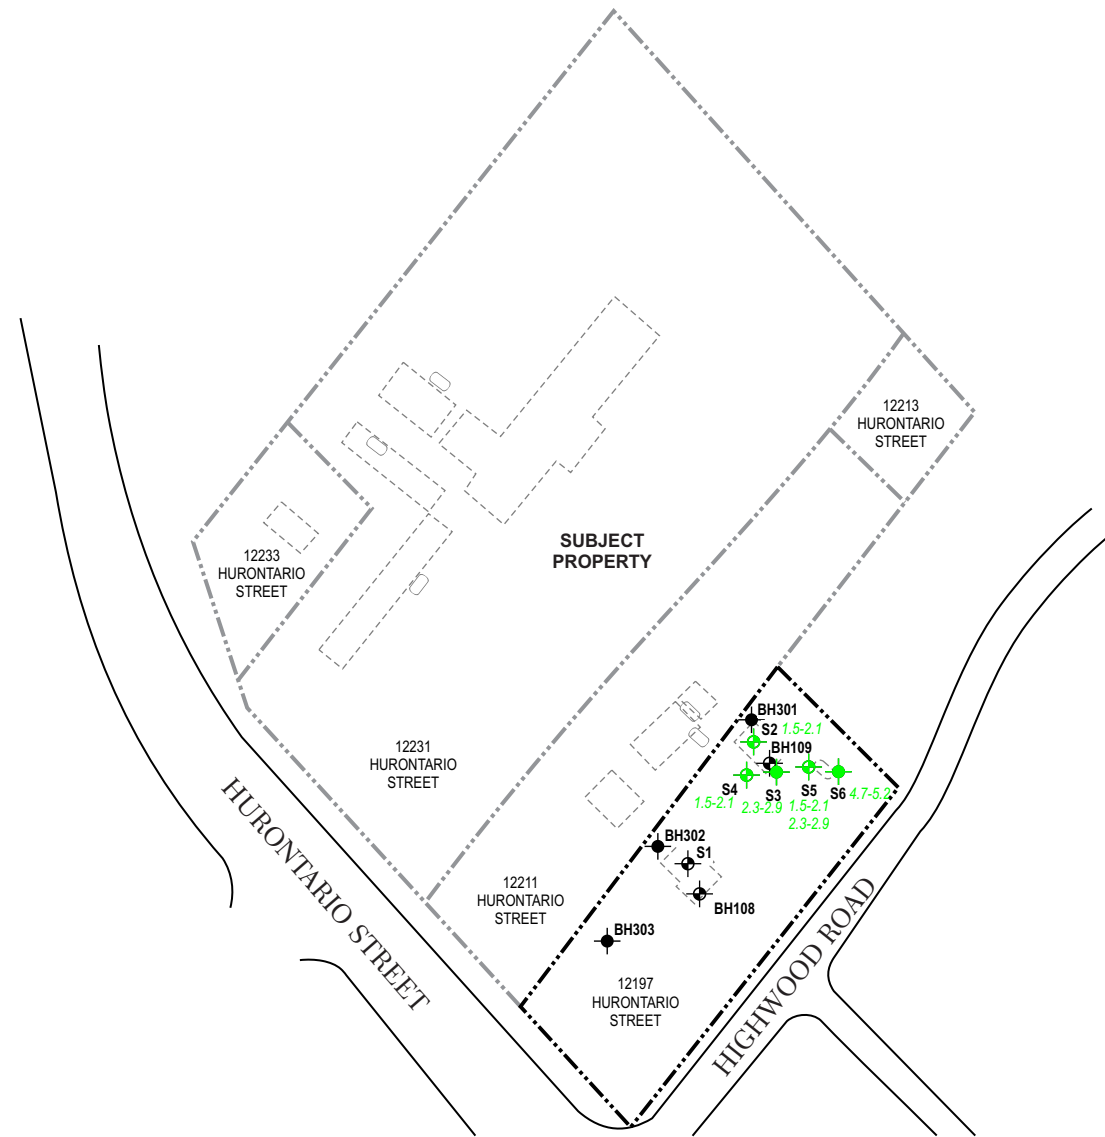
<b>SCALE:</b> <div><div></div><div>02550m</div></div>			<b>LEGEND:</b> <div><div><div></div><div>SITE BOUNDARY EXTENT</div></div><div><div></div><div>LARGER PROPERTY BOUNDARY</div></div><div><div></div><div>TEST HOLE WITH MONITOR S SERIES(EXP, 2019) BH SERIES (EXP, 2021)</div></div><div><div></div><div>TEST HOLE S SERIES(EXP, 2019) BH SERIES (EXP, 2020)</div></div><div><div></div><div>FORMER FEATURES</div></div><div><div></div><div>FORMER ABOVE GROUND STORAGE TANK LOCATION</div></div><div><div></div><div>FORMER UNDER GROUND STORAGE TANK LOCATION</div></div><div><div>3.0-6.0</div><div>SAMPLE DEPTH (mbgs)</div></div></div>			<div><div>*STANDARDS SHOWN ARE FOR A RESIDENTIAL/PARKLAND/INSTITUTIONAL PROPERTY USE AND MEDIUM/FINE TEXTURED SOILS ~ INDICATES FIELD DUPLICATE SAMPLE mbgs - METRES BELOW GROUND SURFACE ALL RESULTS IN UNITS OF µg/g, UNLESS OTHERWISE NOTED</div><div>LOCATION WHERE SAMPLE IS WITHIN O. REG. 153/04 TABLE 2 STANDARDSS FOR ALL PARAMETERS ANALYZED IS SHOWN IN GREEN CONCENTRATION OF CONTAMINANT WITHIN TABLE 2 STANDARDS SHOWN IN TEXT AS GREEN</div></div>			<div>SOIL ANALYTICAL RESULTS – PETROLEUM HYDROCARBONS</div> <div>FIGURE 7A</div>

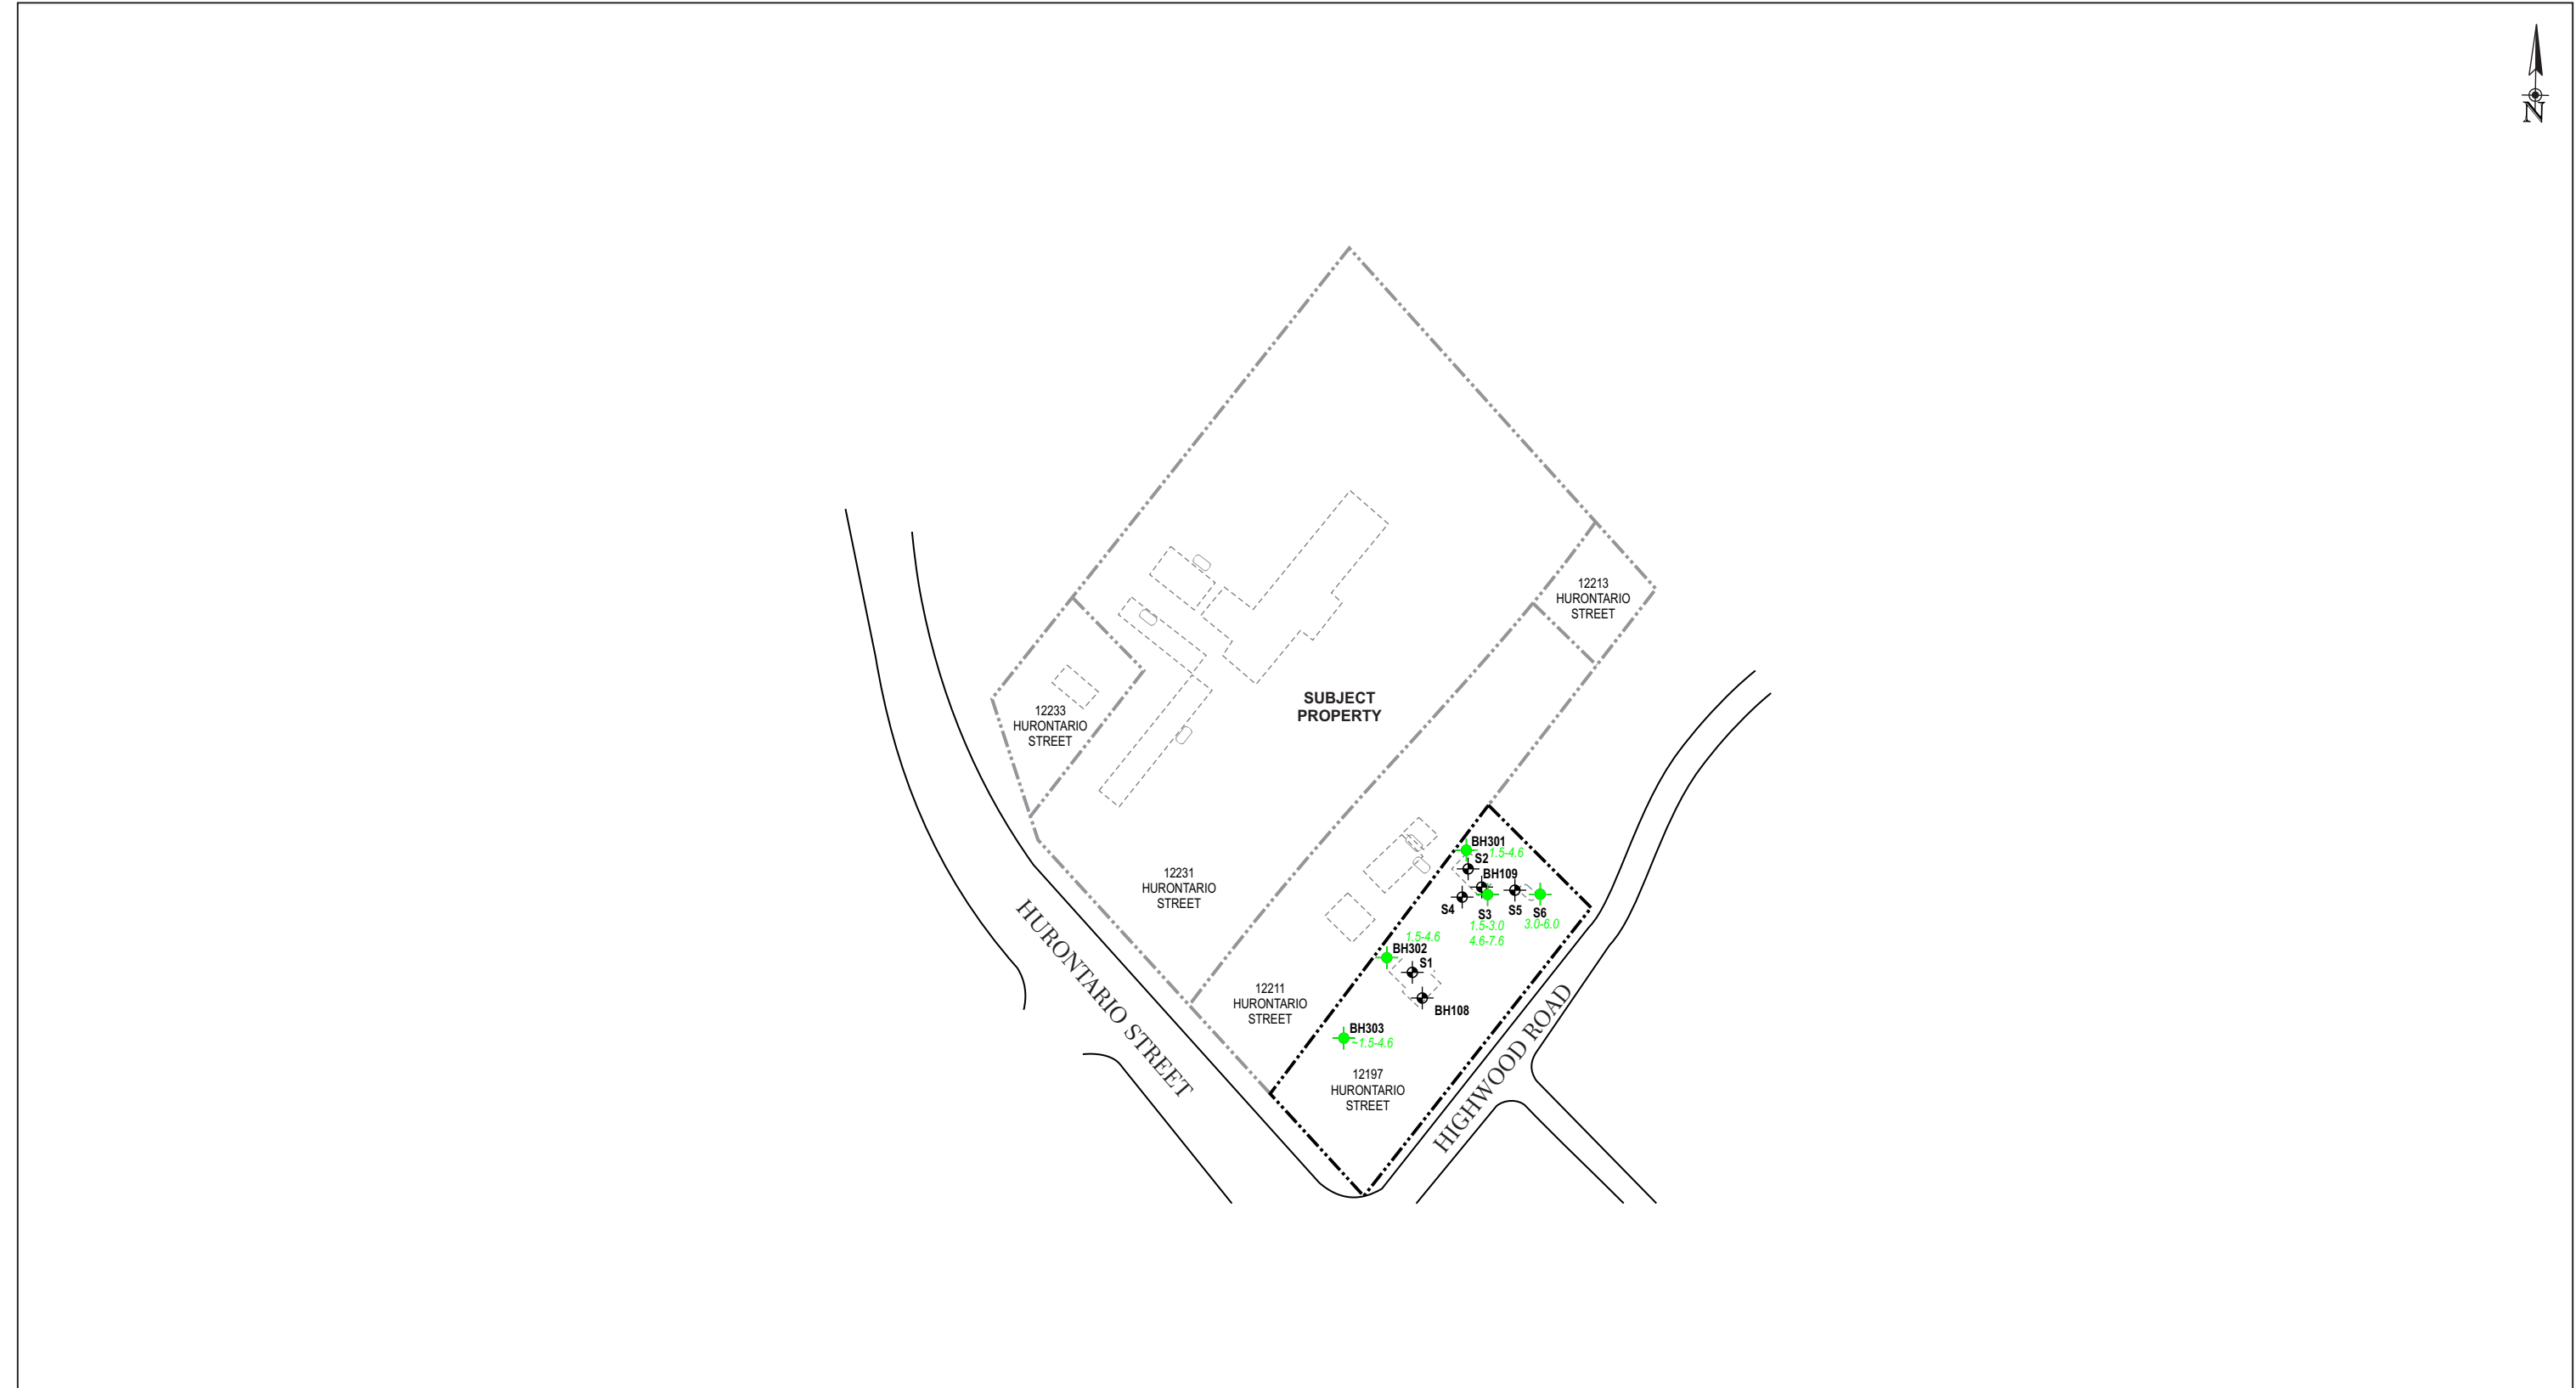
<b>SCALE:</b> 		<b>LEGEND:</b> <div><div><div><div></div><div>SITE BOUNDARY EXTENT</div></div><div><div></div><div>LARGER PROPERTY BOUNDARY</div></div><div><div></div><div>TEST HOLE WITH MONITOR S SERIES(EXP, 2019) BH SERIES (EXP, 2021)</div></div><div><div></div><div>TEST HOLE S SERIES(EXP, 2019) BH SERIES (EXP, 2020)</div></div></div><div><div><div></div><div>FORMER FEATURES</div></div><div><div></div><div>FORMER ABOVE GROUND STORAGE TANK LOCATION</div></div><div><div></div><div>FORMER UNDER GROUND STORAGE TANK LOCATION</div></div></div></div>		<p>*STANDARDS SHOWN ARE FOR ALL TYPE OF PROPERTY USE AND MEDIUM/FINE TEXTURED SOILS ~ INDICATES FIELD DUPLICATE SAMPLE mbgs - METRES BELOW GROUND SURFACE ALL RESULTS IN UNITS OF µg/L, UNLESS OTHERWISE NOTED</p> <p>LOCATION WHERE SAMPLE IS WITHIN O. REG. 153/04 TABLE 2 STANDARDSS FOR ALL PARAMETERS ANALYZED IS SHOWN IN GREEN CONCENTRATION OF CONTAMINANT WITHIN TABLE 2 STANDARDS SHOWN IN TEXT AS GREEN</p> <p>3.0-6.0 SCREEN INTERVAL (mbgs)</p>		<div>GROUND WATER ANALYTICAL RESULTS – PETROLEUM HYDROCARBONS</div> <div>12197 HURONTARIO STREET, BRAMPTON, ONTARIO</div> <div>PROJECT NUMBER: 257876   DATE: JANUARY 2022</div>		FIGURE <b>8A</b>

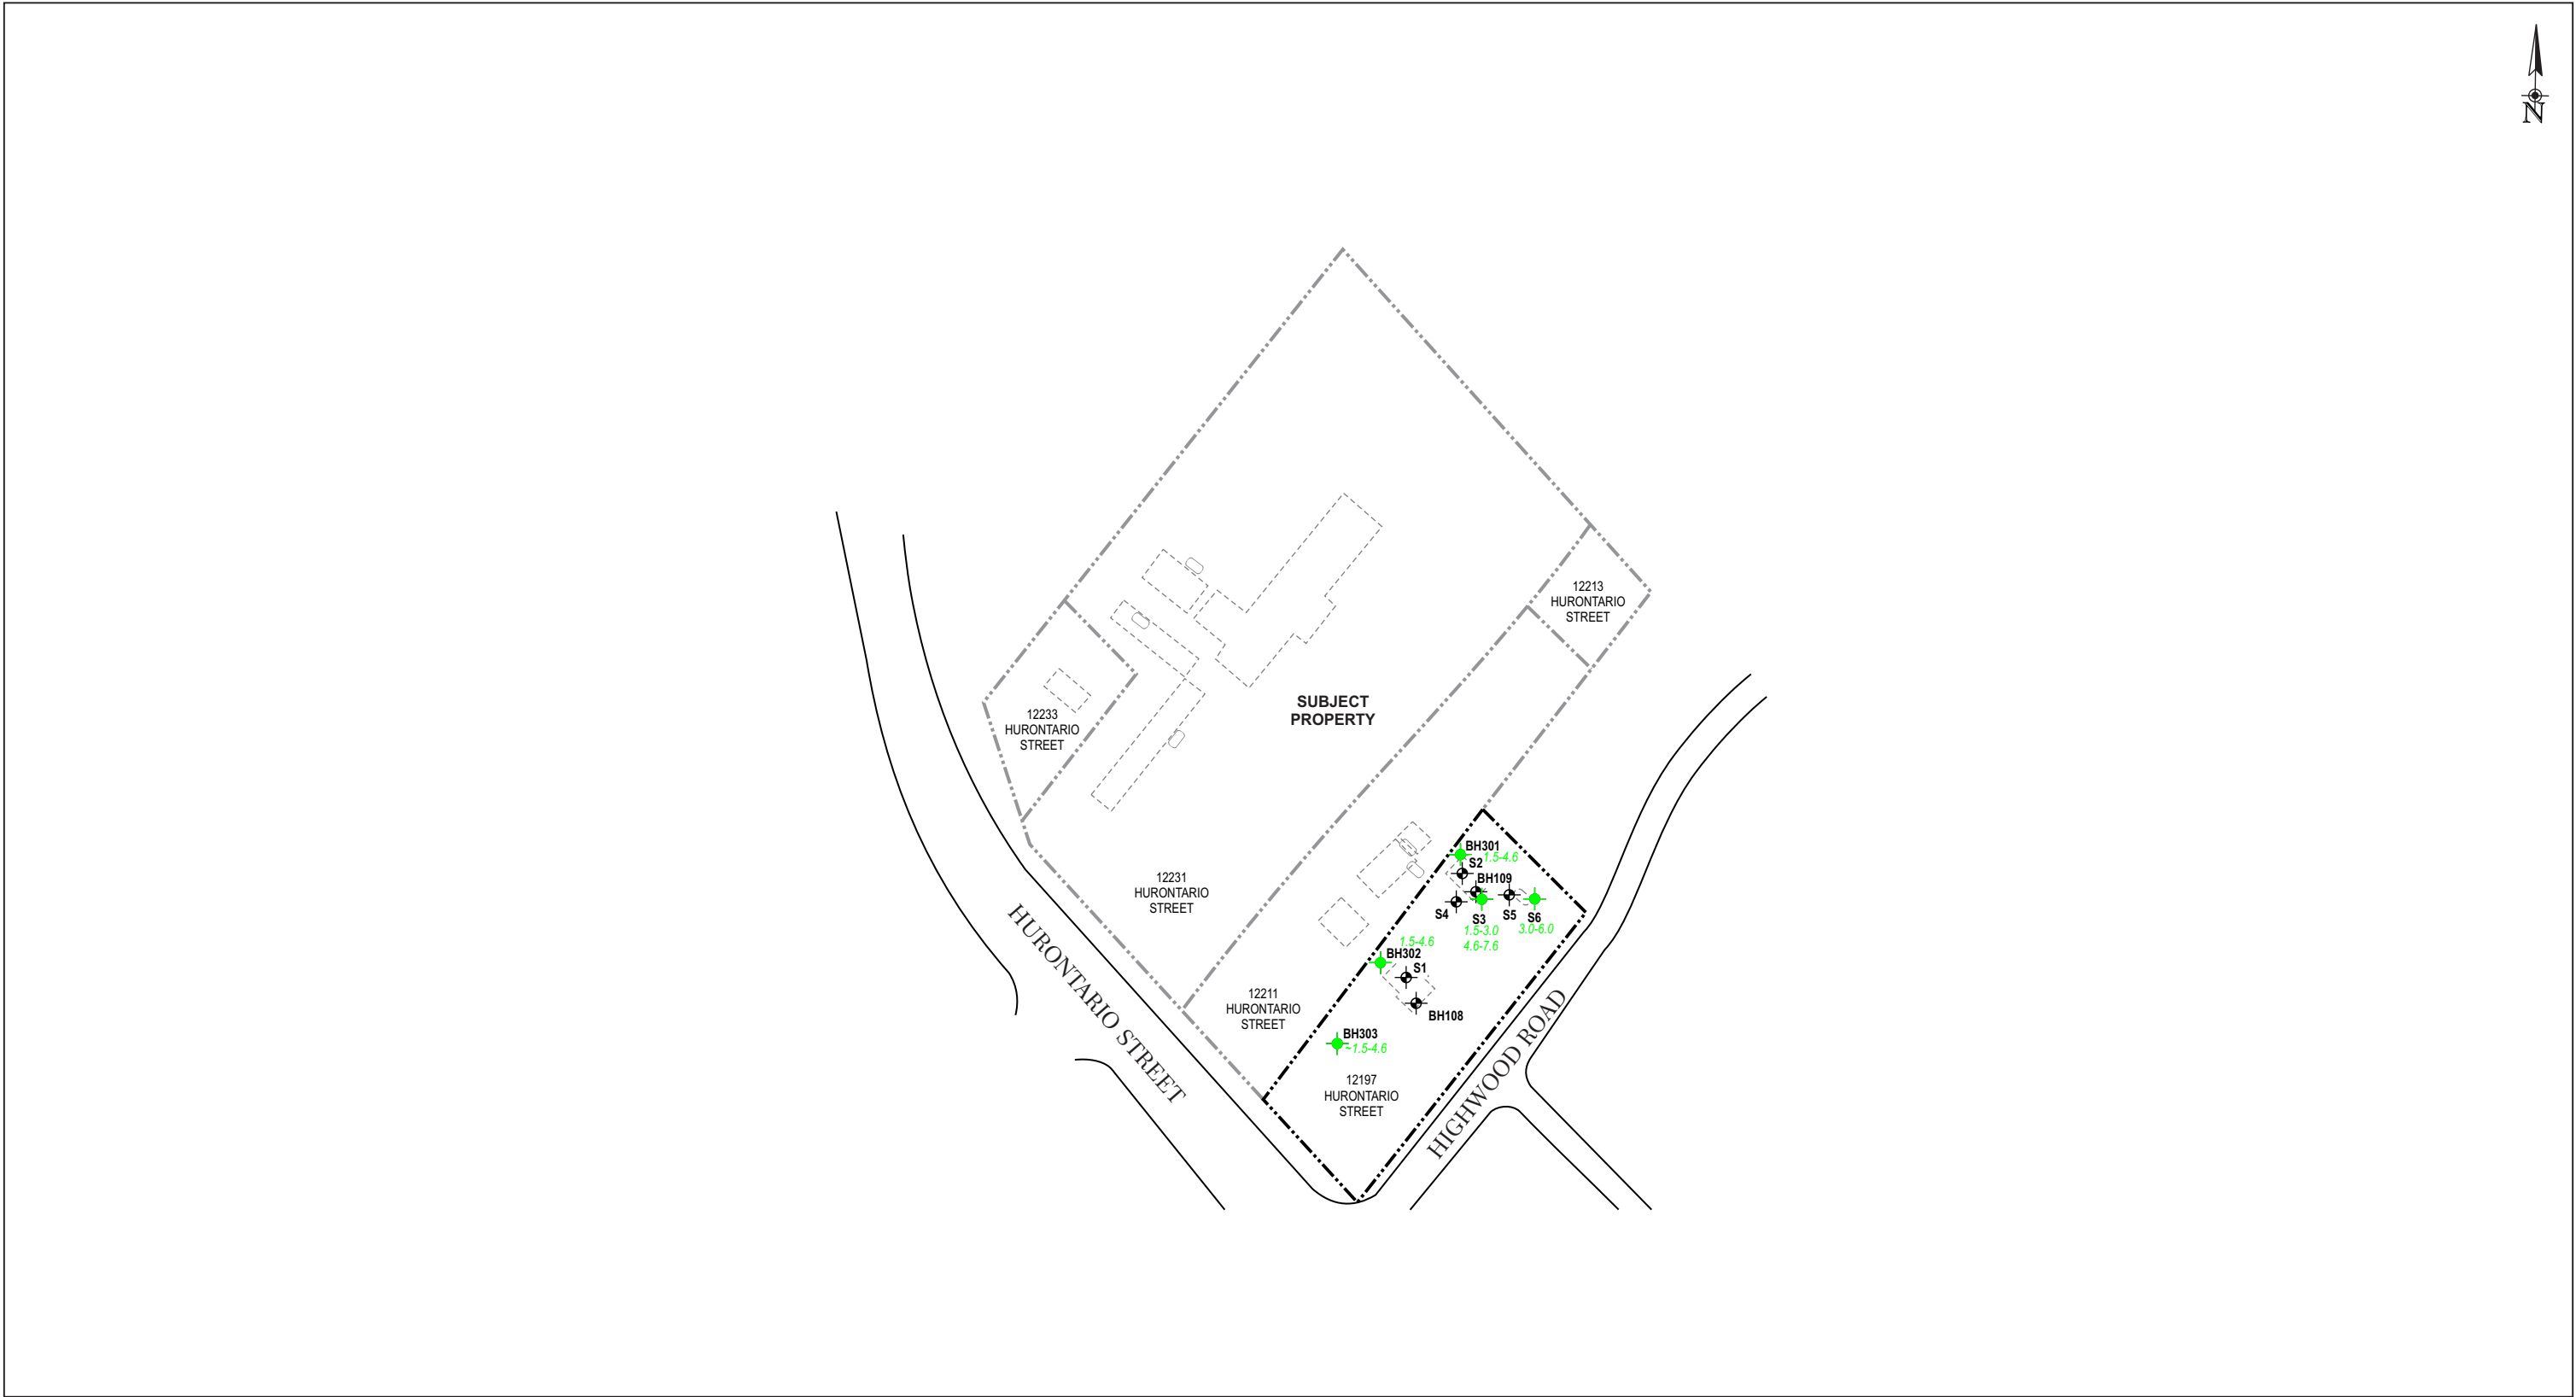
<b>SCALE:</b> <div></div>			<b>LEGEND:</b> <div><div><div><div></div><div>SITE BOUNDARY EXTENT</div></div><div><div></div><div>LARGER PROPERTY BOUNDARY</div></div><div><div><div></div><div>TEST HOLE WITH MONITOR S SERIES(EXP, 2019) BH SERIES (EXP, 2021)</div></div><div><div><div></div><div>TEST HOLE S SERIES(EXP, 2019) BH SERIES (EXP, 2020)</div></div></div></div><div><div><div></div><div>FORMER FEATURES</div></div><div><div></div><div>FORMER ABOVE GROUND STORAGE TANK LOCATION</div></div><div><div></div><div>FORMER UNDER GROUND STORAGE TANK LOCATION</div></div></div></div></div>			<p>*STANDARDS SHOWN ARE FOR ALL TYPE OF PROPERTY USE AND MEDIUM/FINE TEXTURED SOILS ~ INDICATES FIELD DUPLICATE SAMPLE mbgs - METRES BELOW GROUND SURFACE ALL RESULTS IN UNITS OF µg/L, UNLESS OTHERWISE NOTED</p> <p>LOCATION WHERE SAMPLE IS WITHIN O. REG. 153/04 TABLE 2 STANDARDSS FOR ALL PARAMETERS ANALYZED IS SHOWN IN GREEN CONCENTRATION OF CONTAMINANT WITHIN TABLE 2 STANDARDS SHOWN IN TEXT AS GREEN</p> <p>3.0-6.0 SCREEN INTERVAL (mbgs)</p>			<div>GROUND WATER ANALYTICAL RESULTS – VOLATILE ORGANIC COMPOUNDS</div> <div>12197 HURONTARIO STREET, BRAMPTON, ONTARIO</div> <div>PROJECT NUMBER: 257876   DATE: JANUARY 2022</div>		FIGURE 8B

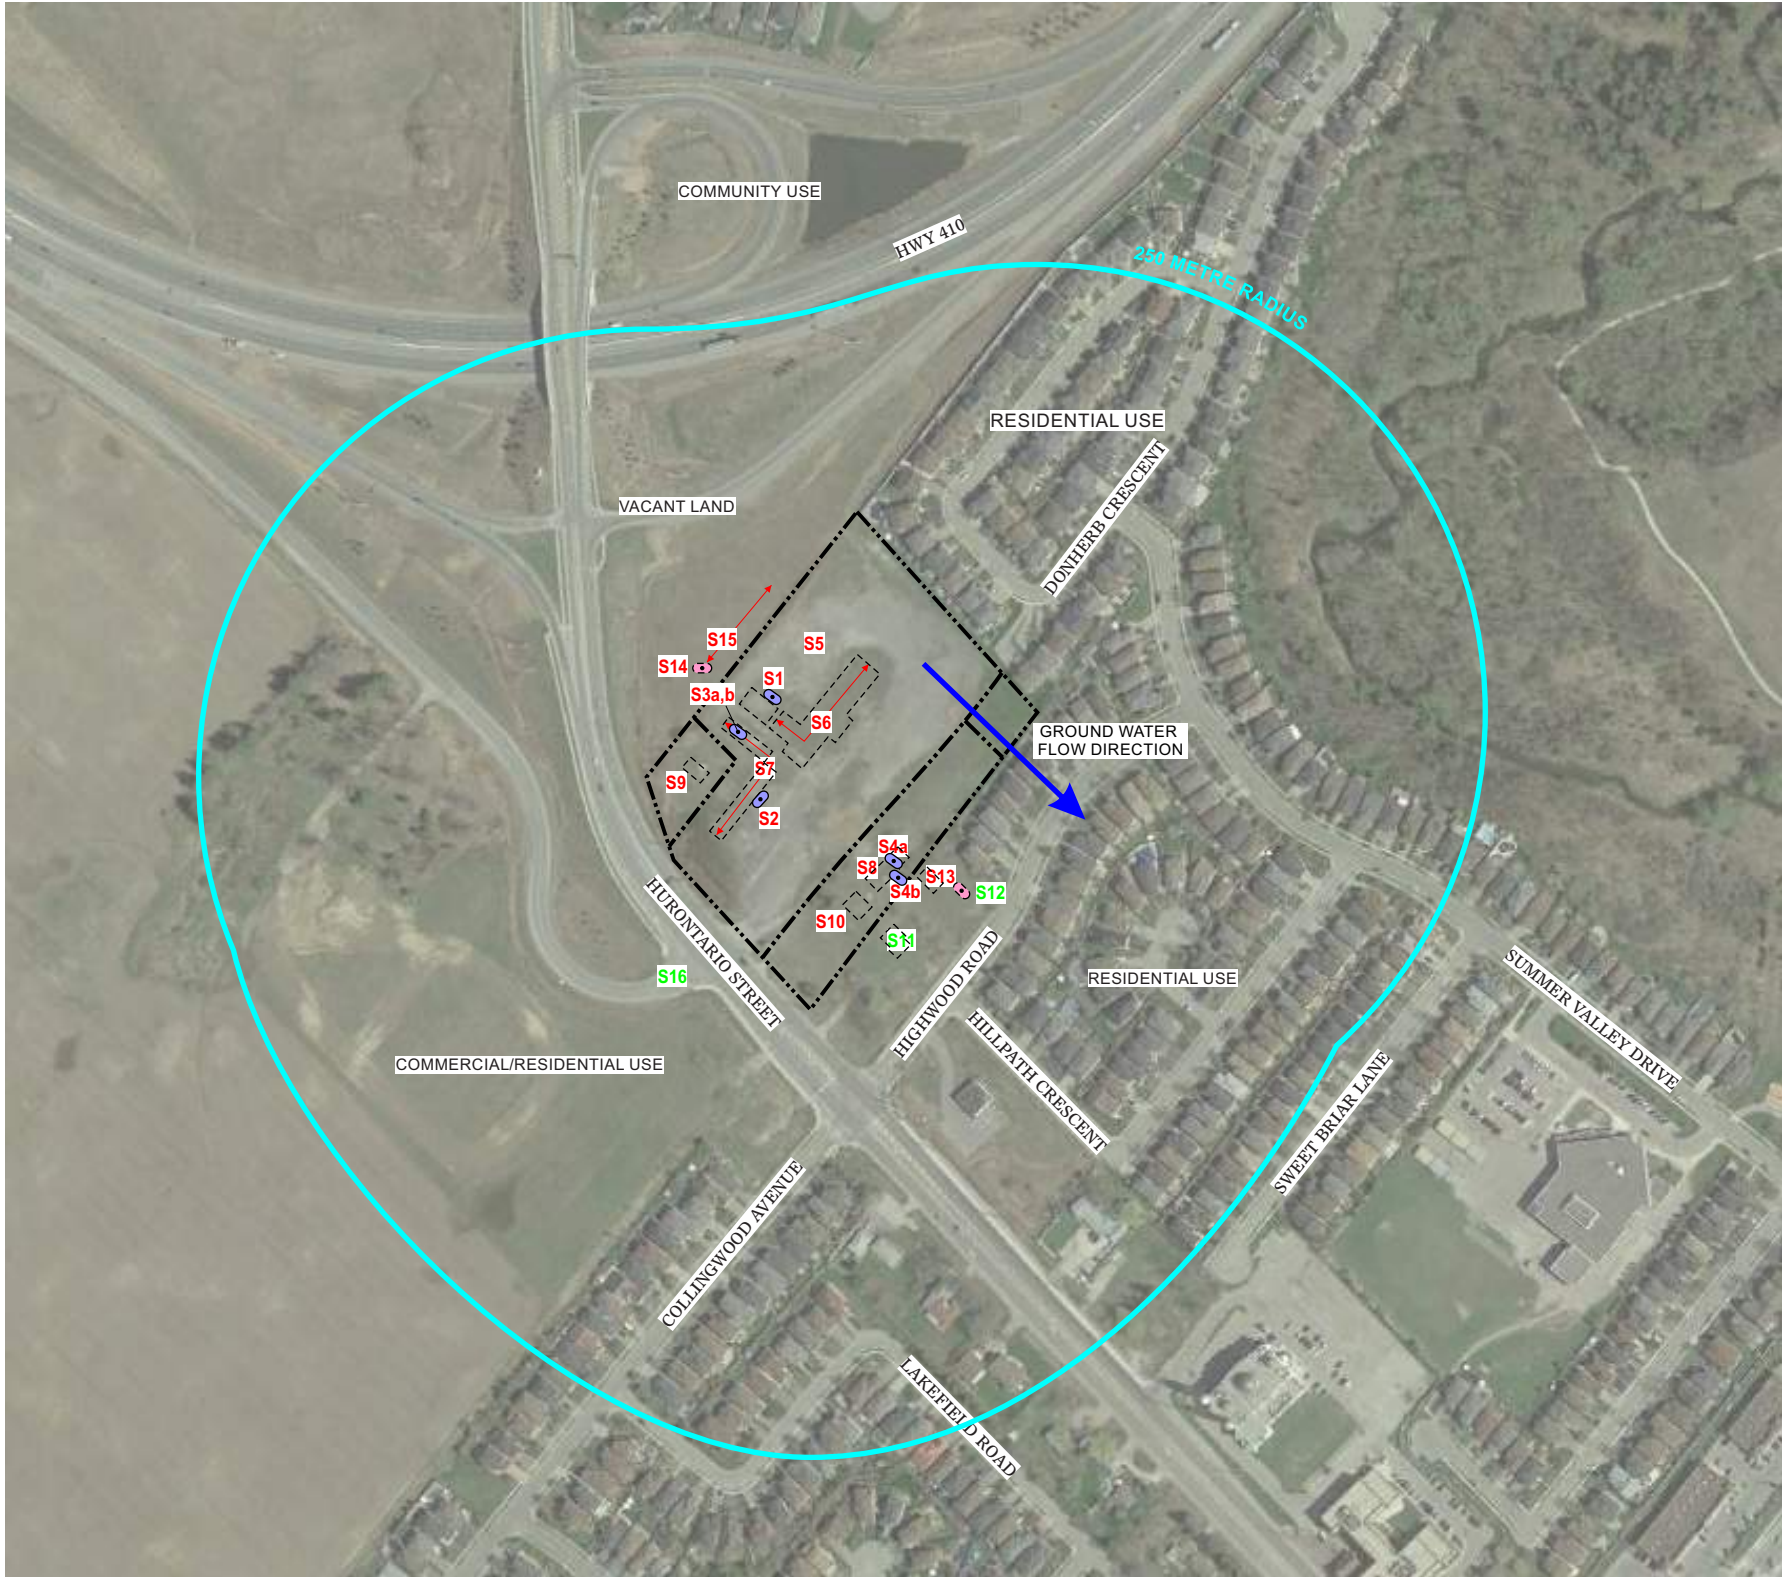
FIGURE 3A

PCA Source Number	Potentially Contaminating Activity (PCA)
S1	(28) Gasoline and associated products storage in fixed tanks
S2	(28) Gasoline and associated products storage in fixed tanks
S3a	(28) Gasoline and associated products storage in fixed tanks
S3b	(other) fuel leak
S4a	(28) Gasoline and associated products storage in fixed tanks
S4b	(28) Gasoline and associated products storage in fixed tanks
S5	(Other) salt storage
S6	(52) Storage, maintenance, fuelling and repair of equipment, vehicles, and material used to maintain transportation systems
S7	(52) Storage, maintenance, fuelling and repair of equipment, vehicles, and material used to maintain transportation systems
S8	(other) garage operations
S9	(30) Importation of Fill Material of Unknown Quality
S10	(30) Importation of Fill Material of Unknown Quality
S14	(28) Gasoline and associated products storage in fixed tanks
S15	(52) Storage, maintenance, fuelling and repair of equipment, vehicles, and material used to maintain transportation systems

De-minimis PCAs	
S11	(30) Importation of Fill Material of Unknown Quality
S12	(28) Gasoline and associated products storage in fixed tanks
S13	(other) garage operations
S16	(30) Importation of Fill Material of Unknown Quality

Figure 3A illustrates all PCAs. Resulting APECs are shown on Figure 3B.. The APECs are summarized below:

During the Phase Two investigation, EXP identified fill in the southern and north eastern portions of the site, including the footprints of the two (2) former residential structures. The importation of fill material of unknown quality was considered a PCA beneath former building footprints, as indicated in Figure 3A.
