12211, 12213, 12231 and 12233 Hurontario Street, Caledon, Ontario

Modified Generic Risk Assessment

GTR-00257876-C0

February 9, 2022

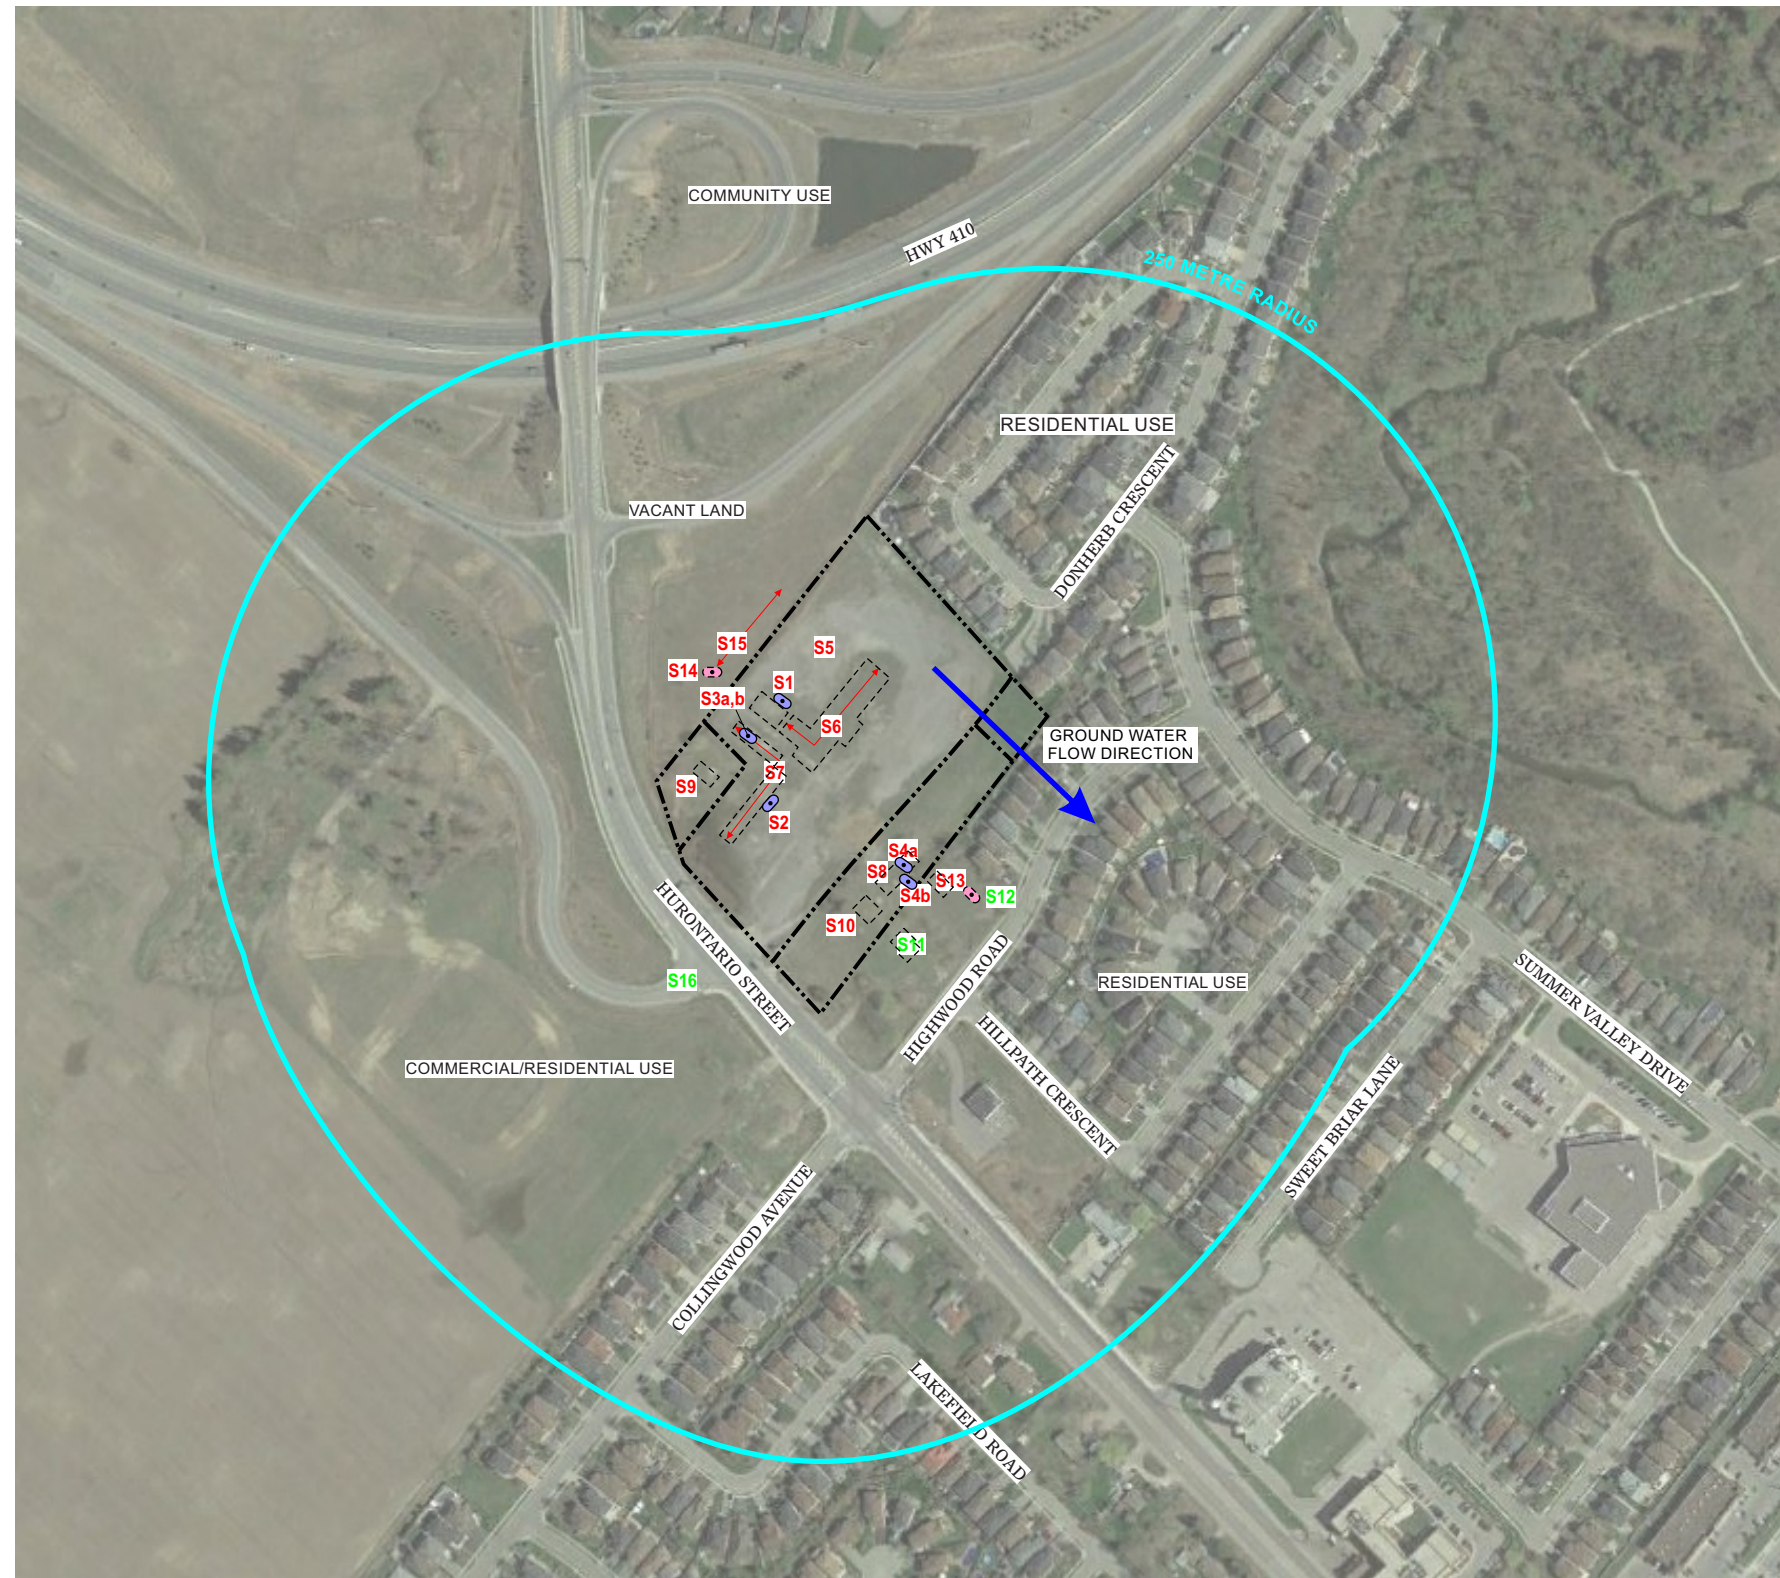
PCA Source Number	Potentially Contaminating Activity (PCA)
S1	(28) Gasoline and associated products storage in fixed tanks
S2	(28) Gasoline and associated products storage in fixed tanks
S3a	(28) Gasoline and associated products storage in fixed tanks
S3b	(other) fuel leak
S4a	(28) Gasoline and associated products storage in fixed tanks
S4b	(28) Gasoline and associated products storage in fixed tanks
S5	(Other) salt storage
S6	(52) Storage, maintenance, fuelling and repair of equipment, vehicles, and material used to maintain transportation systems
S7	(52) Storage, maintenance, fuelling and repair of equipment, vehicles, and material used to maintain transportation systems
S8	(other) garage operations
S9	(30) Importation of Fill Material of Unknown Quality
S10	(30) Importation of Fill Material of Unknown Quality
S14	(28) Gasoline and associated products storage in fixed tanks
S15	(52) Storage, maintenance, fuelling and repair of equipment, vehicles, and material used to maintain transportation systems

De-minimis PCAs	
S11	(30) Importation of Fill Material of Unknown Quality
S12	(28) Gasoline and associated products storage in fixed tanks
S13	(other) garage operations
S16	(30) Importation of Fill Material of Unknown Quality
