**PRELIMINARY
HYDROGEOLOGICAL INVESTIGATION
TULLAMORE LANDS
0 & 12245 TORBRAM ROAD
CALEDON, ONTARIO**

**REPORT NO.: 5552-21-HC
REPORT DATE: JUNE 30, 2021
REVISION NO.: 00**

**PREPARED FOR:
TULLAMORE INDUSTRIAL GP LIMITED
75 TIVERTON COURT
MARKHAM, ONTARIO
L3R 4M8**

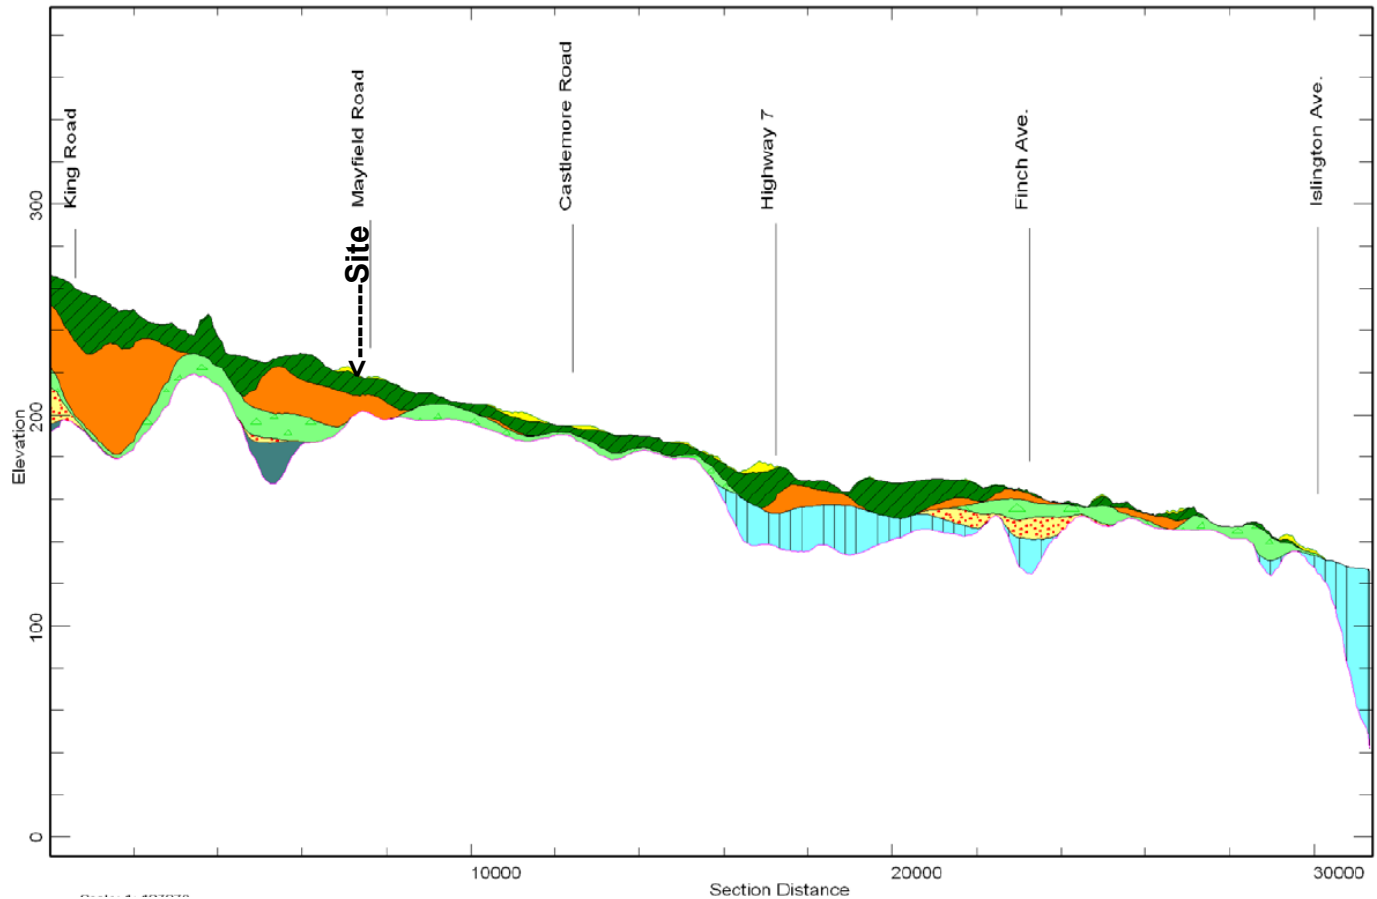
West Humber River Watershed Cross-Section

A conceptualization of the regional hydrostratigraphy through the subwatershed is depicted in **Figure 6**. The cross-section illustrates the hydrostratigraphic profile through the subwatershed which was adopted for regional groundwater flow modelling studies in the Humber River Watershed (Earthfx, 2006). A description of each hydrostratigraphic unit depicted in **Figure 6** and a determination of its presence in the study area is provided below:

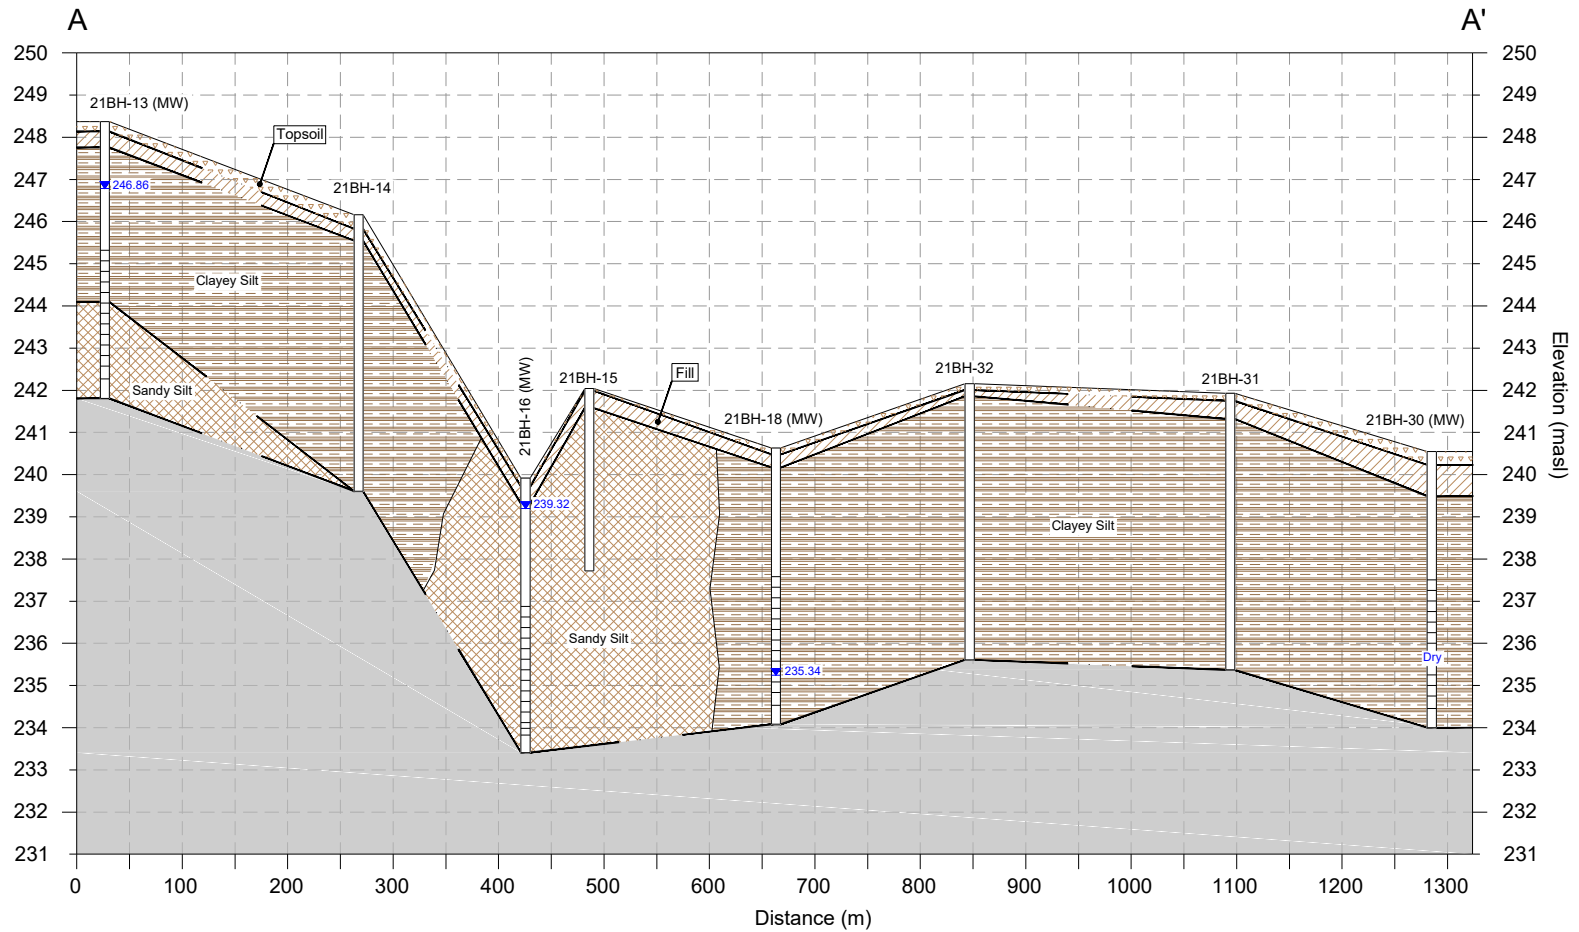
TITLE: Local Geological Section A-A'	
LOCATION: Tullamore Lands, Caledon, Ontario	
PROJECT NO. 5552-21-HC	DATE: June 2021
FIGURE NO: 8

- Topsoil
- Fill
- Clayey Silt
- Sandy Silt
- Inferred Geological Boundary
- Site Boundary
- Borehole and Monitoring Well Location
- Section A-A'
- Water Level Measurement (masl) measured on June 3, 2021
- Monitoring Well Screen

The overburden deposits at the Site were investigated to a maximum depth of 6.63 mbgs across the Site. From the discrete points of investigation, a top-course of soil/reworked fill from existing agricultural land uses was encountered generally within a depth of 1 mbgs. Underlying these was a laterally continuous fine-grained aquitard comprised fairly consistently of clayey silt textured materials in a stiff to very stiff consistency. Exceptions to this general observation of the underlying Site geology are found in areas slightly removed from the tributaries on-Site where deposits of sandy silt were encountered. Also, of note from the drilling investigation was a single instance of sand and gravel encountered below the clayey silt mantle at 21BH-6 at an approximate depth of 4.73 mbgs. Based on the spread of boreholes completed across the Site and the observations and characterizations of the soils from those boreholes, the deposit of sand and gravel encountered at 21BH-6 is anticipated to be isolated to this area. Considering the understanding of regional hydrostratigraphy from the previous section, the sand gravel deposits and like deposits of the ORMAC may become more prevalent in areas north of the Site where the deposits of the ORMAC may be expected at shallower elevations and in greater thicknesses.

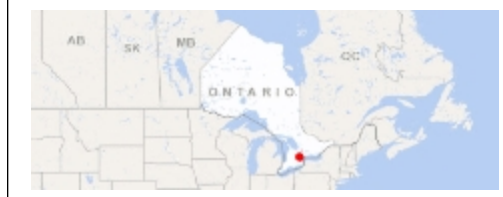
Figure 11 Vulnerable Drinking Water Areas

Based on a review of the CTC Source Protection Plan, the Site is not located within any vulnerable drinking water areas defined by the CWA. An export from the Source Water Protection Information Atlas is provided as **Figure 11** for illustration purposes.
