REPORT ON PHASE ONE ENVIRONMENTAL SITE ASSESSMENT BLOCKS 1 TO 37, PART OF LOTS 18, 19 AND 20, CONCESSION 6, EAST OF HURONTARIO STREET, PART OF LOTS THE ROAD ALLOWANCE BETWEEN LOTS 17 AND 19, CONCESSION 6 EAST OF HURONTARIO STREET, TOWN OF CALEDON, REGIONAL MUNICIPALITY OF PEEL

REPORT NO.: 5552-24-EQ REPORT DATE: OCTOBER 8, 2024

PREPARED FOR TULLAMORE INDUSTRIAL GP LIMITED

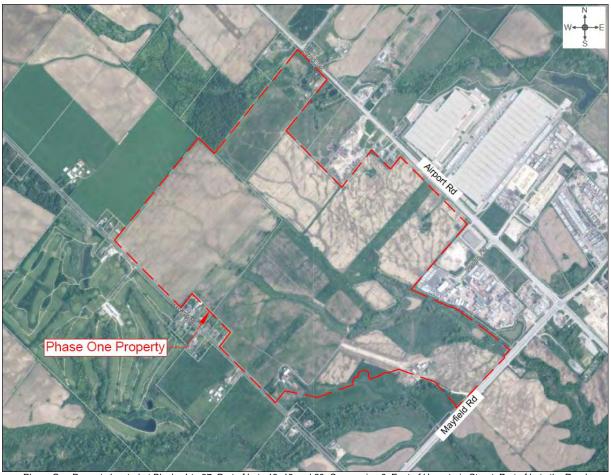
The layout of the Site is shown on Image 1, below.

Phase One Property located at Blocks 1 to 37, Part of Lots 18, 19 and 20, Concession 6, East of Hurontario Street, Part of Lots the Road Allowance Between Lots 17 and 18, Concession 6, East of Hurontario Street, Town of Caledon, Regional Municipality of Peel Source: Town of Caledon Interactive Map (2023)
