**Initial Comprehensive Environmental Impact Study  
and Management Plan & Scoped Subwatershed Study  
Tullamore Employment Lands**

Caledon, Ontario

October 2023  
Project 2100975  
Third Submission

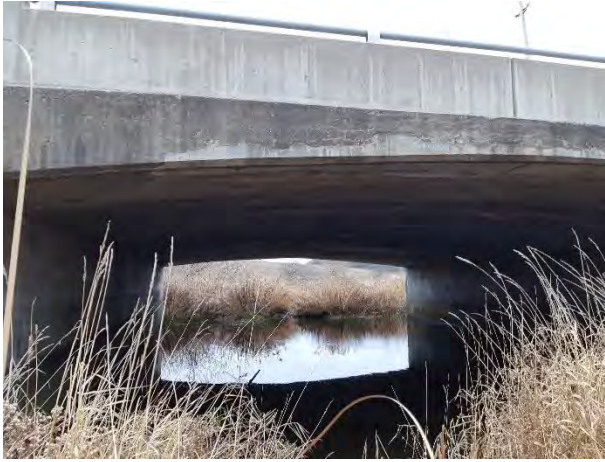
Photo 1 – Downstream view of Salt Creek, under the Airport Road crossing.

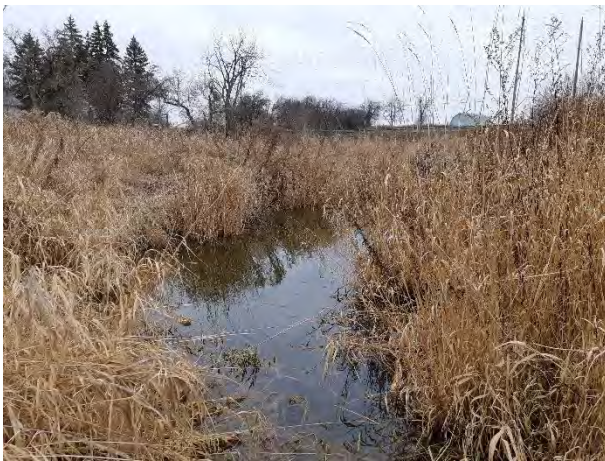
Photo 2 – General channel conditions, upstream of Airport Road. Photo taken facing upstream.

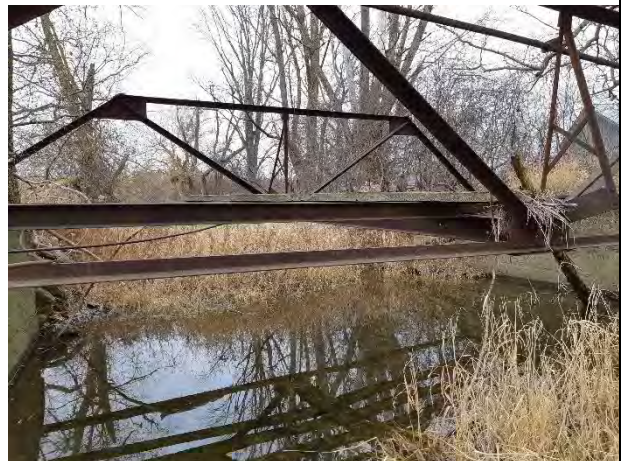
Photo 3 – Wide and deep pools were occasionally noted within the reach. Photo taken facing upstream.

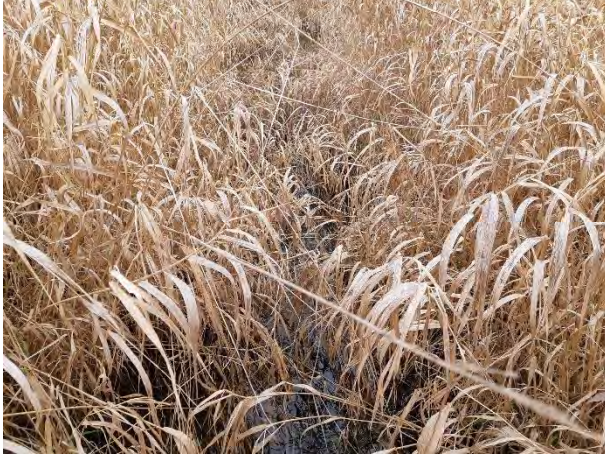
Photo 4 – An old crossing was noted within the property, which was in poor condition. The structure does not impede flow. Photo taken facing upstream.

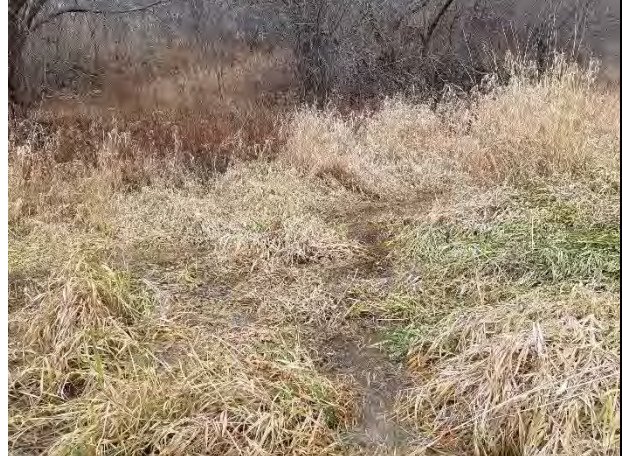
Photo 5 – General conditions of the channel, showing dense non-woody vegetation cover.

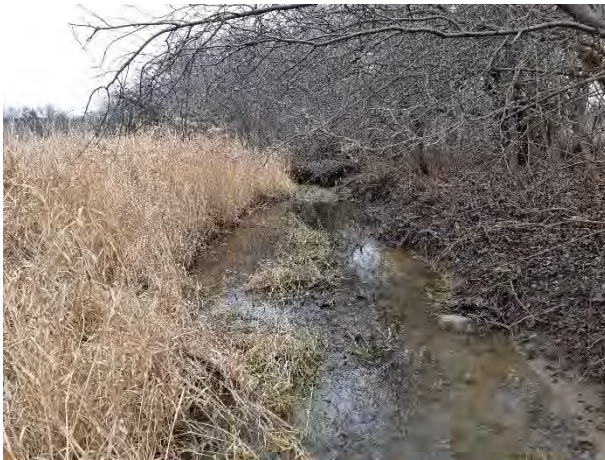
Photo 6 – Occasionally, multiple flow paths were present.

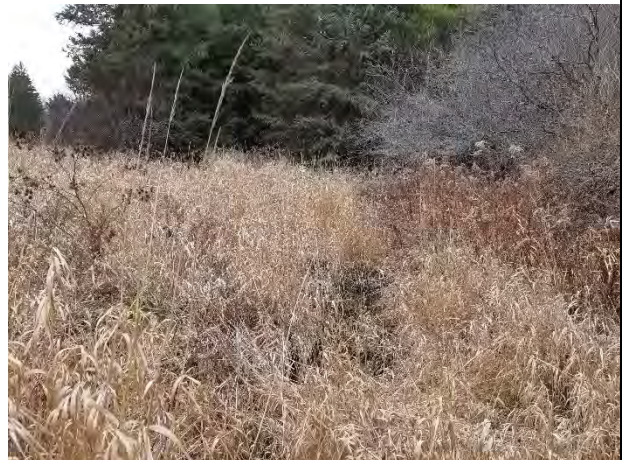
Photo 7 – The channel was found to be wide and shallow in some areas. Photo facing downstream.

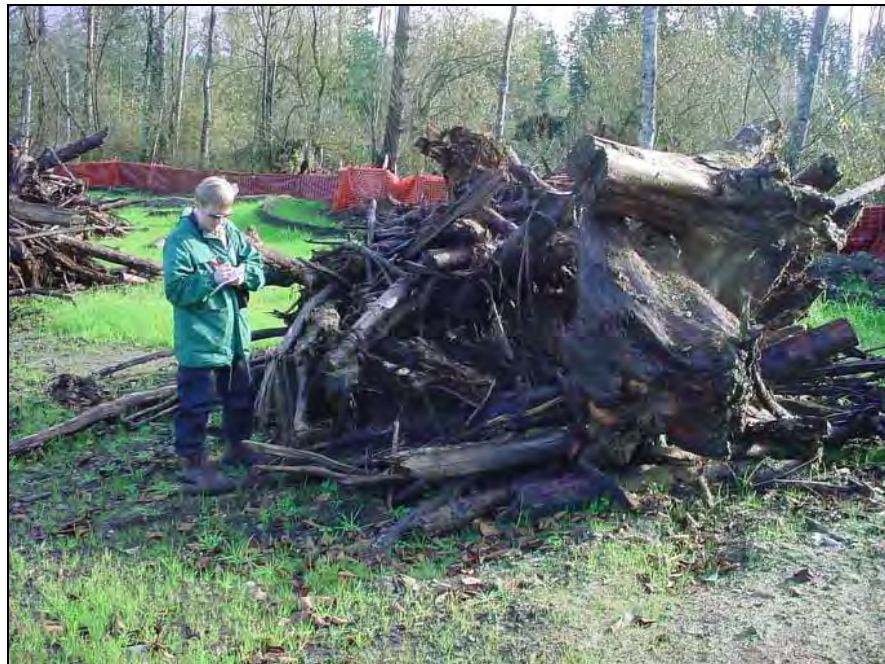
6. *Suitable example:*

4. *Quantity:* At least six brush piles per acre.
5. *Construction:* Wood accumulated by clearing live vegetation and downed trees should be salvaged and incorporated into piles. The center of the pile should be supported with substantial woody material (e.g. rootwads) to create and maintain loft. Stem sizes should be randomly mixed from twigs to large logs using any woody species available; however, conifers will likely last longer than other species. Branch tips or log ends should be directed skyward to create perch points. The piles should be approximately 20 feet wide by 10 feet high. Larger piles may have diminishing returns. There should be interstitial spaces in the brush pile unless stated otherwise on the plan sheets. Brush piles should be constructed by stacking the material and not dumped from a truck.

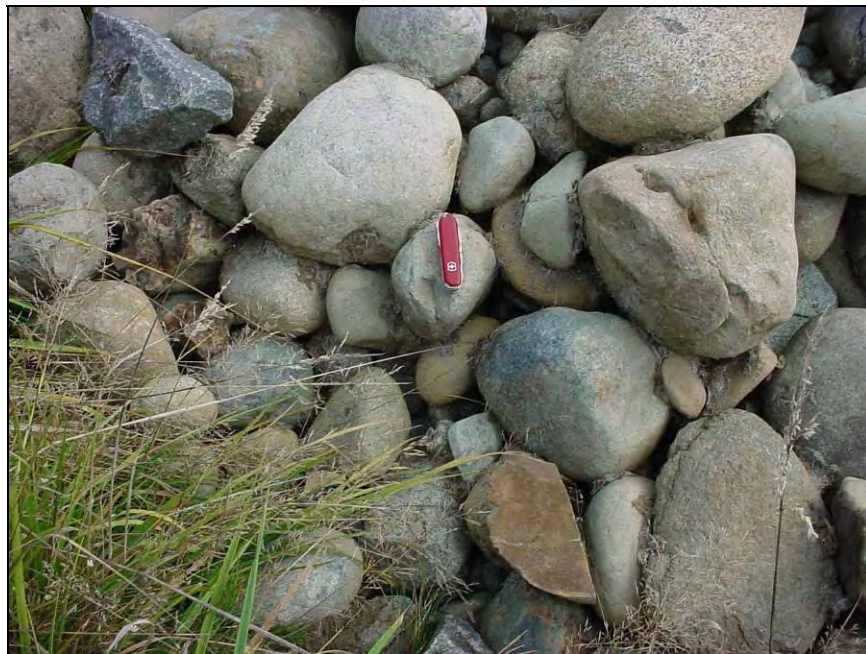
6. *Suitable example:*

4. *Quantity:* It is recommended to have at least five rock piles per acre.
5. *Construction:* Rocks should be cleaned and sized from two inch diameter to two man rock (approximately two square feet) with some jagged edges. Jagged edges are used by molting reptiles and provide secure footing for small mammals. It is important to maintain a variety of interstitial spaces not exceeding six inches. The piles should be at least five feet diameter and four feet tall. Partially bury piles below the ground surface in upland areas. A perch log can be added to expand habitat opportunities for birds. If large rocks are encountered on site they may be grouped and partially buried to create burrows (approximately one square foot or greater) for larger species such as coyotes.

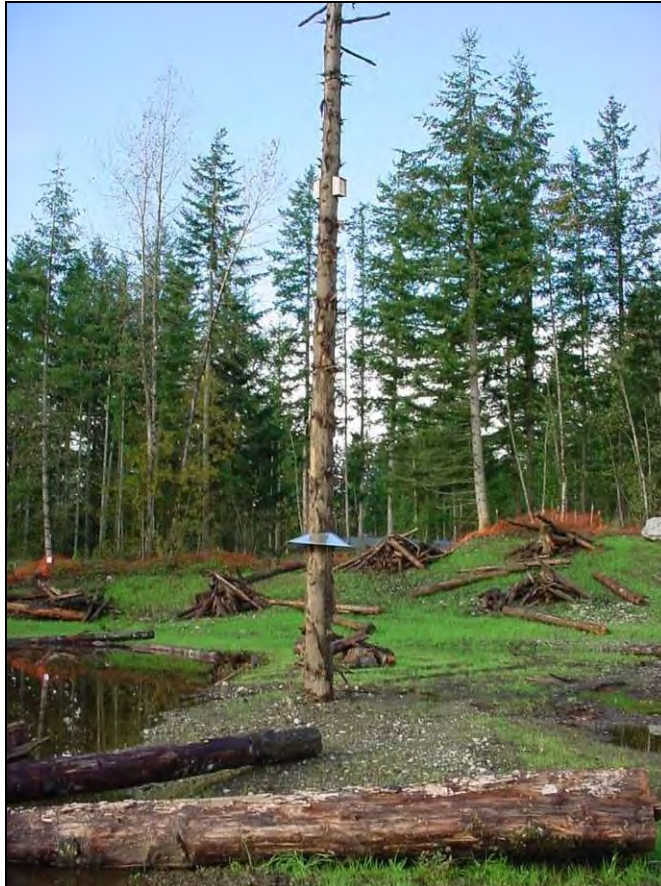
6. *Suitable example:*

5. *Construction:* The poles should be conifer tree trunks and have at least three naturally occurring side branches, at least two of which should be near the top. Manufactured side branches are not appropriate due to the varying construction techniques and insufficient results at replicating the intended habitat need. Ensure that at least 30 feet of the stem is above ground, at least 75 percent of the bark intact, and predator guard encircling the stem. Bat and bird houses can be attached to the upper third of the stem to provide cavities immediately.

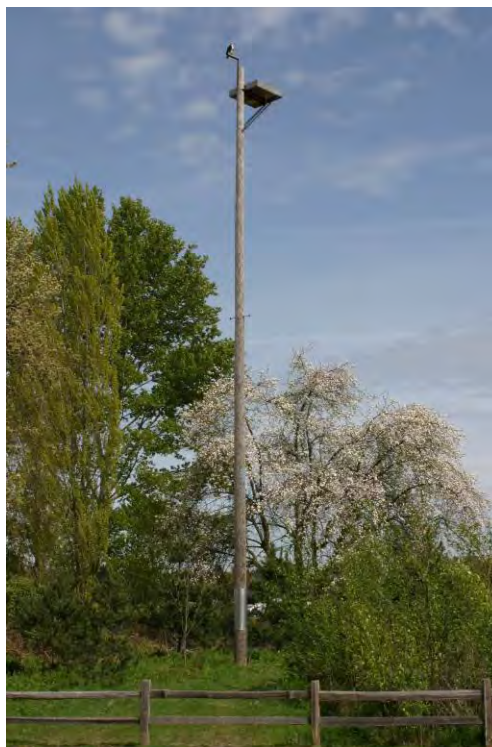
6. *Suitable example:*

4. *Quantity:* One platform per site due to large home ranges for the target species.
5. *Construction:* Flat, either circular or square constructed of untreated plywood or cedar boards and stoutly supported and offset near the top of a tall pole or topped tree. The plywood should be marine grade or exterior and all other wood should be cedar. It should be capable of supporting at least 200 pounds of accumulated nest material. Square platforms should be four-foot square dimensions (e.g. hardwood pallets). Circular platforms should have a diameter of at least four feet. The platform edges must have a three-inch tall rim with gaps to help contain nest material but allow water to flow off. Prep the platforms with attractant sticks to simulate old nest material. The platform should be at least 30 feet above the surrounding ground but taller is preferred. Try to keep the underground portion of the support pole above the water table to reduce premature rotting. Bat houses may be attached to the upper third of the pole to double up the usage and encircle the lower stem with a predator guard. Attach an offset perch board opposite and above the platform for attending adults.

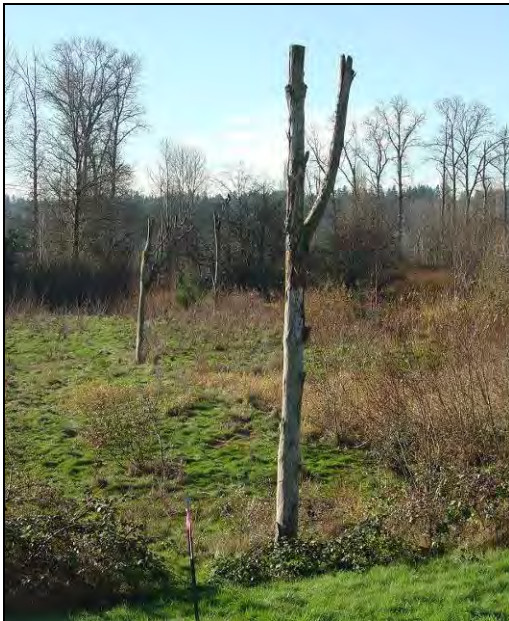
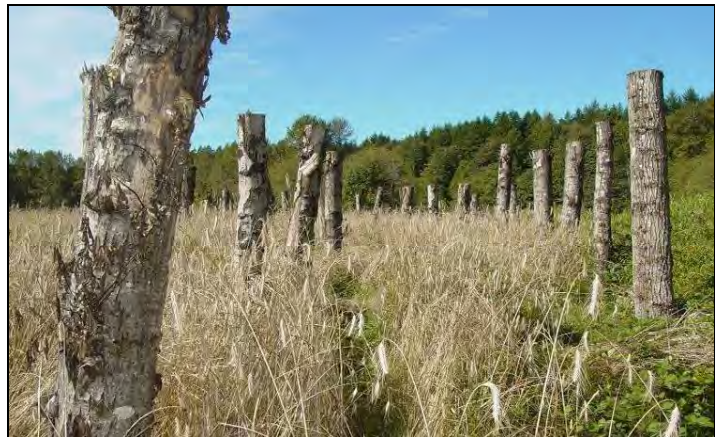
6. *Suitable examples:*

5. *Construction:* Upland and wetland snags: Snags should have at least 75 percent of the bark attached. Conifer species and larger diameter stems may last longer but any species and diameter is appropriate. Stem heights above ground can vary between 5 to 30 feet, or greater. These may double as perch poles, depending on the need and site conditions. Straight-up vertical installation is not necessary but the log should be sufficiently supported to avoid easily tipping over. Freshly cut black cottonwood can be placed in riparian areas to provide habitat for water-associated birds and small mammals. These may also serve a dual function of bank stabilization and LWD recruitment when placed in parallel rows along river banks.

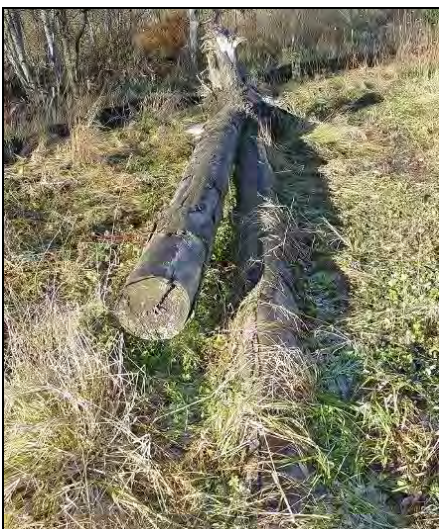
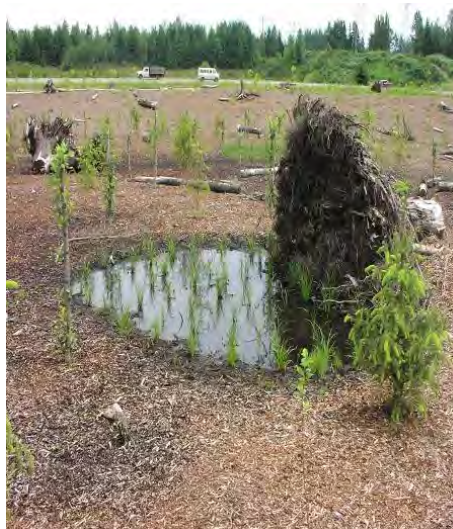
6. *Suitable examples:* (Log with bark attached and Rootwad with soil depression)

4. *Quantity:* As many as possible.
5. *Construction:* Can be quite varied for their size, shape, and arrangement and may include log stems, logs with rootwads, and rootwads. Log stems should have 75 percent tightly adhered bark and lie roughly horizontal on the ground. The portion of the log that lies on the soil should be longitudinally V-notched three inches deep to create small mammal tunnels and promote fungal growth. Lateral V-notches will allow additional access. Longitudinal slices into the ends will create amphibian and insect habitat niches. Larger diameter stems and conifer species will last longer but all species greater than six inches diameter may be used. Several stems with or without rootwads may be crisscrossed. Create depressions in the soil next to the rootwads to temporarily pond stormwater (i.e. to mimic lifted soil where the roots of the tree once were embedded.) and use logs that are as long as possible. Short pieces should be combined into piles or incorporated into bush piles. Distribute the logs throughout the site to minimize travel distances between structures for small mammals. Single stems without rootwads should be associated with other habitat structures (such as crisscrossed or incorporated into a rock pile) rather than individually distributed.

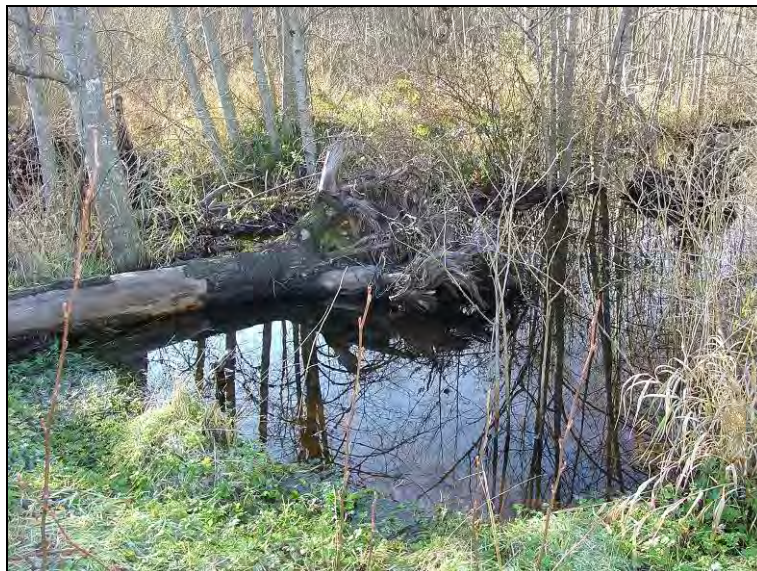
6. *Suitable example:*

1. *Intent:* In aquatic environments logs in the stream bed create channel complexity, direct water flow, control erosion, and provide forage and cover for aquatic species.

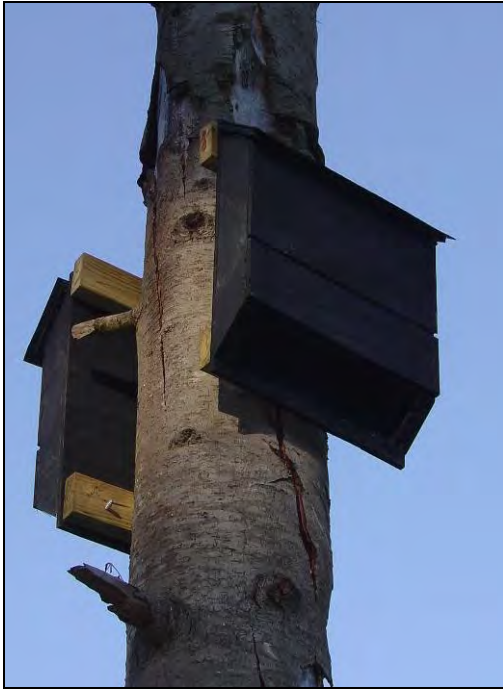
Chamber house

5. *Construction*: There are numerous sources of commercially constructed bat houses ranging from single to multiple chambers in a variety of designs and sizes. Constructing a bat house is not difficult but requires specific design and installation guidelines to be attractive to bats. Three commonly used designs include: chamber, rocket box, and Oregon wedge. Regardless of design, it is recommended that they be water tight and a dark color to absorb heat. Bats in Washington are not particularly numerous; therefore, two smaller structures per acre may be most appropriate. There are several information sources for the preferred installations and this document will refer the reader to these.

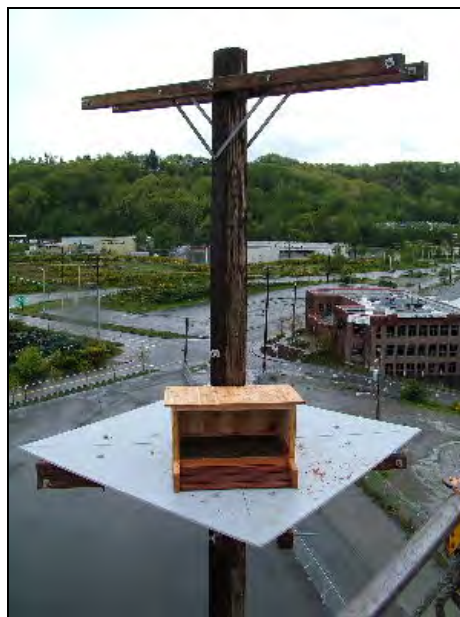
Peregrine nest box

5. *Construction*: Bird houses requiring annual maintenance are generally not recommended; however, several bird nest designs require little or no maintenance. Holes drilled in snags are attractive to several bird species; however, the hole should not compromise the structural integrity of the stem. Wire nest platforms are bowl-shaped and secured in a tree crotch. Snag holes, houses, and platform sizes and shapes are highly variable and are often species specific. The entrances, color, and design should be optimized to minimize use by invasive species such as English house sparrows, European starlings, and rock pigeons. There are numerous information sources for appropriate efforts on bird houses and species specific designs. Regional biologists and local special interest birding groups should be consulted to provide detailed assistance.

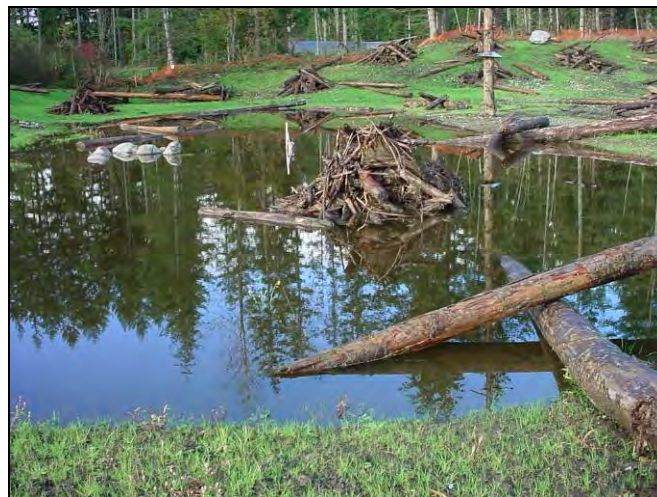
6. *Suitable example:*

5. *Construction:* Ponds may have a complexity of woody debris and live thin-stemmed vegetation. The ponds should dry out for at least two weeks during late July and August to reduce the establishment of a bullfrog population. In urban areas, persistent year round water should be avoided to reduce pestilent waterfowl; however, in rural areas year round water may be desirable where the likelihood of bull frogs is less likely. Isolated ponds should have a variety of depths whereas ponds hydrologically connected to fish bearing streams should be graded to drain as flood waters recede. Ponds should be shaded as much as possible to keep the water cool and minimize water temperature variation. Sandy soils surrounding the pond or used to construct islands within the pond may provide turtle egg laying habitat. Flowering and fruit bearing vegetation should be within sight of the pond and preferable at the waters edge.

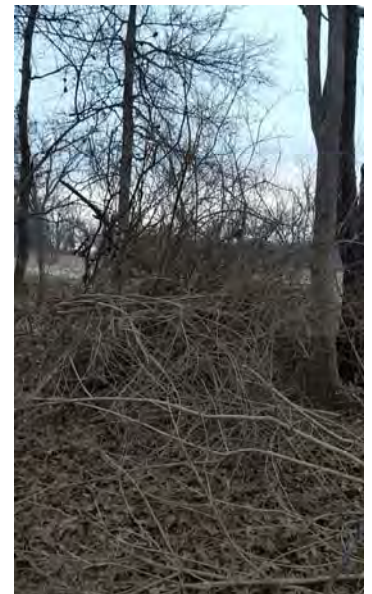
5. Start to stack larger pieces of brush around the core of the brush pile. Stack the brush in a pyramid around the center. This brush will not fit tightly together, leaving some opening and structure around it.

You will want to build several brush piles across the property in this manner. Place brush piles strategically so that they will be around and functioning well into the future. Escape cover should never be more than 150 ft. apart. Brush piles will eventually break down and fall in on themselves. It is a good idea to re-build or build new brush piles periodically

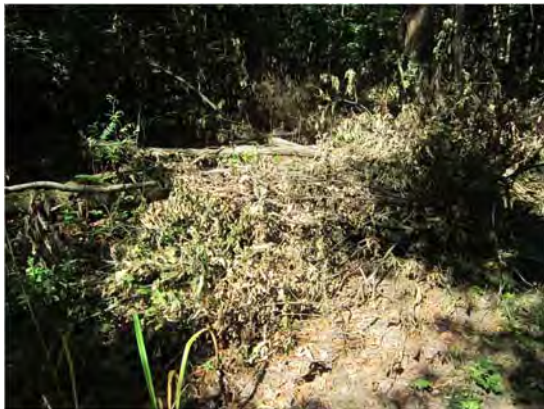
Pushing up brush with a tractor or other implement will make the brush roll up, making it too dense for wildlife to penetrate.

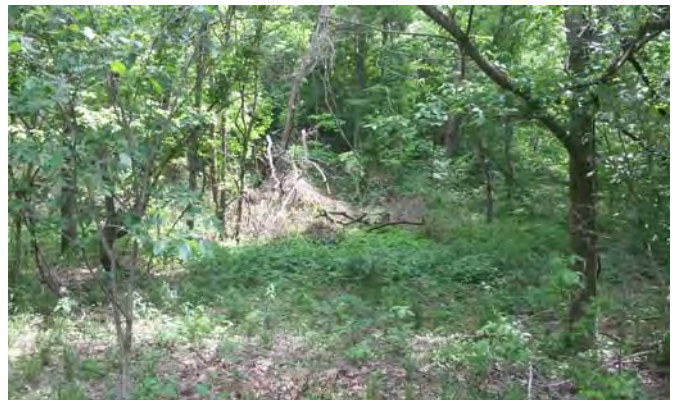
Brush piles can also be formed in the middle of the woods to make additional wildlife cover.

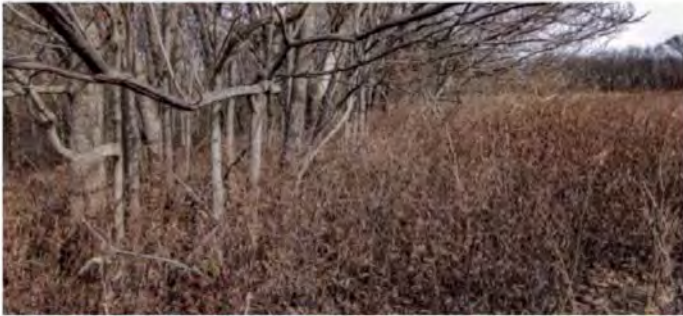
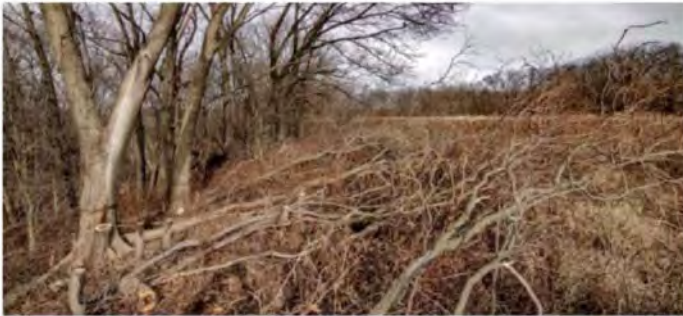
A feathered edge can also be created by natural regeneration. By not mowing or cutting along a forested edge, small trees and shrubs will start to grow and expand away from the forest edge. Special care should be taken to make sure the trees and shrubs using this space are not invasive and are desirable species.

Edge feathering can create escape cover and winter cover for a variety of wildlife species by trimming and cutting undesirable species along the edge.

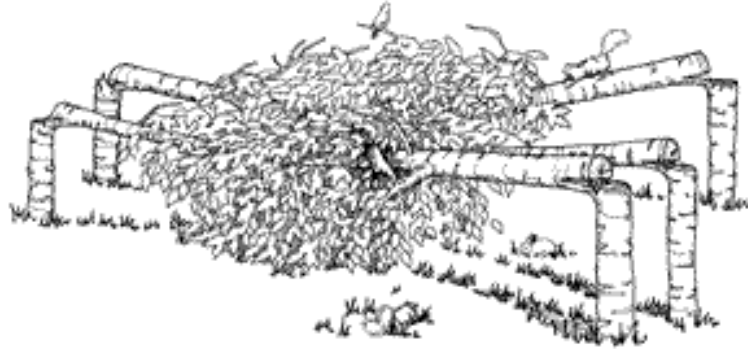
In an interior forest stand situation, brush piles and hinge cut brush piles can be formed. In an area where you have a surplus of trees, poor quality trees or undesirable species, you can cut/hinge cut the trees to fall on top of one another, creating a brush pile and adding light to the ground layer to stimulate herbaceous vegetation and oak/hickory regeneration. These areas will serve as escape cover while providing additional annual plant food resources.

It is not necessary to treat desirable species stumps unless you do not want them to re-sprout. Treating the stumps with herbicide may reduce the ability of the tree to continue to leaf out in the areas that are still connected in a hinge cut. Brush piles can also be formed from tree tops during harvest events on the property by having the logger drop the trees onto each other where possible.

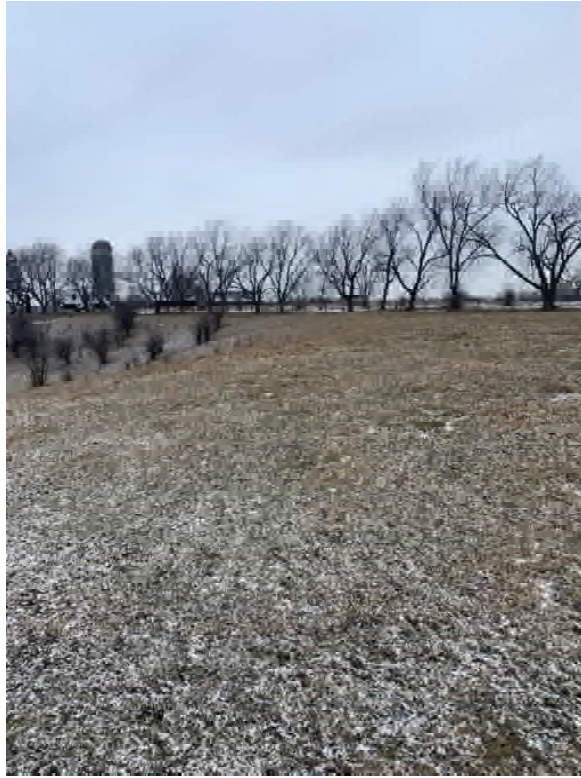
**PHOTOGRAPH 1**

A view of the west tributary northern slope crest near the driveway from Mayfield Road (confined valley system).

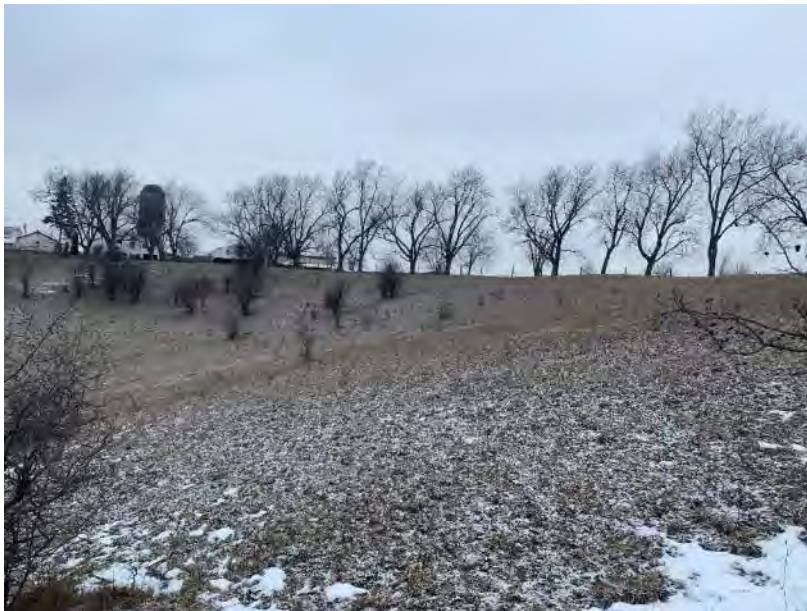
**PHOTOGRAPH 2**

A view of the west tributary northern slope profile.

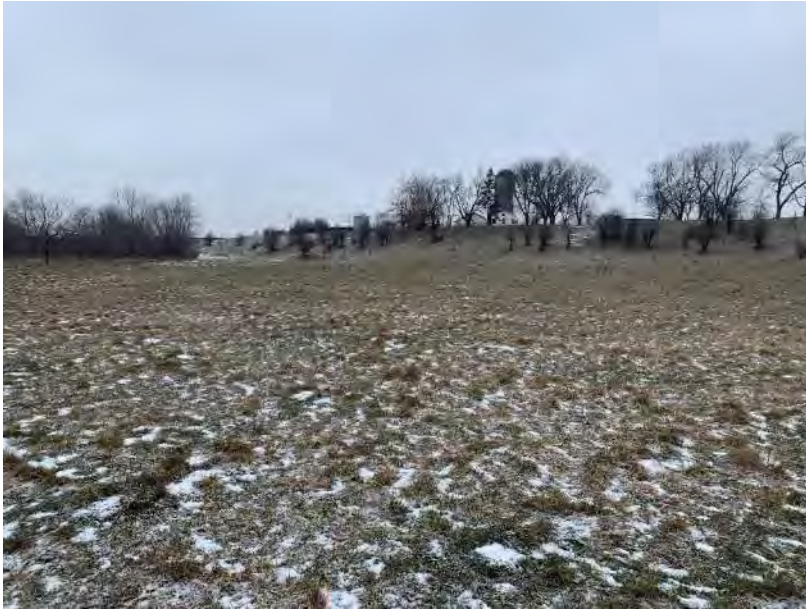
**PHOTOGRAPH 3**

A view of the wide floodplain between the slope and west tributary watercourse between Mayfield Road and the barns.

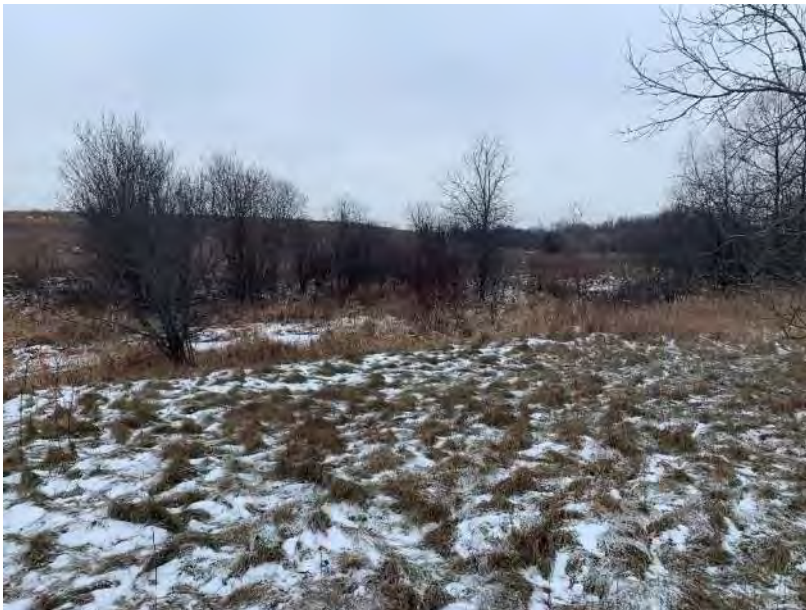
**PHOTOGRAPH 4**

A view of the west tributary watercourse near Mayfield Road.

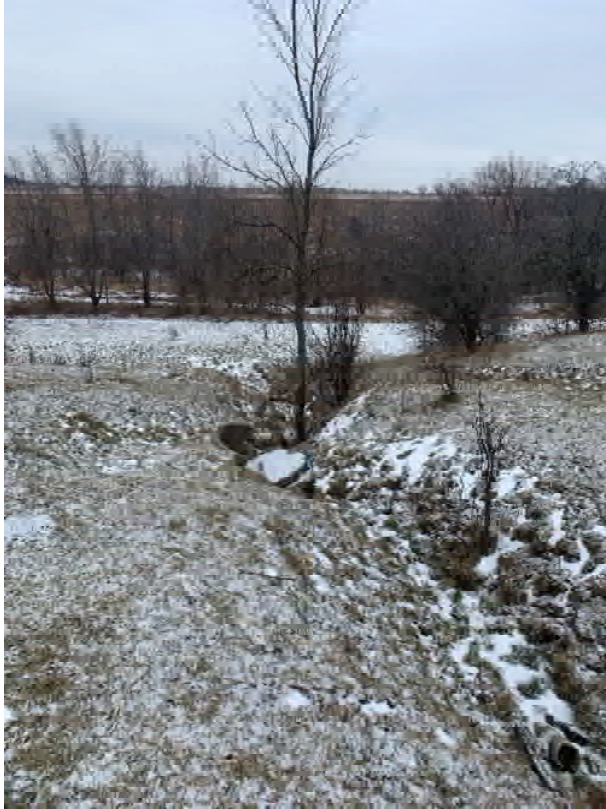
**PHOTOGRAPH 5**

A view of gully erosion extending down the slope face due to concentrated runoff from the barns and other structures.

watercourse is generally adjacent to the slope toe and active erosion was observed along the banks (undercutting, exposed roots, small scarps). There are localized marshy areas in the floodplain. The top of slope consists of farmland, but the slope is generally well vegetated with large trees (vertical to slightly leaning) and some undergrowth. There are two locations west of the barns that appear to be historic drainage features (large, shallow gullies) that likely convey concentrated runoff from the tableland to the north.

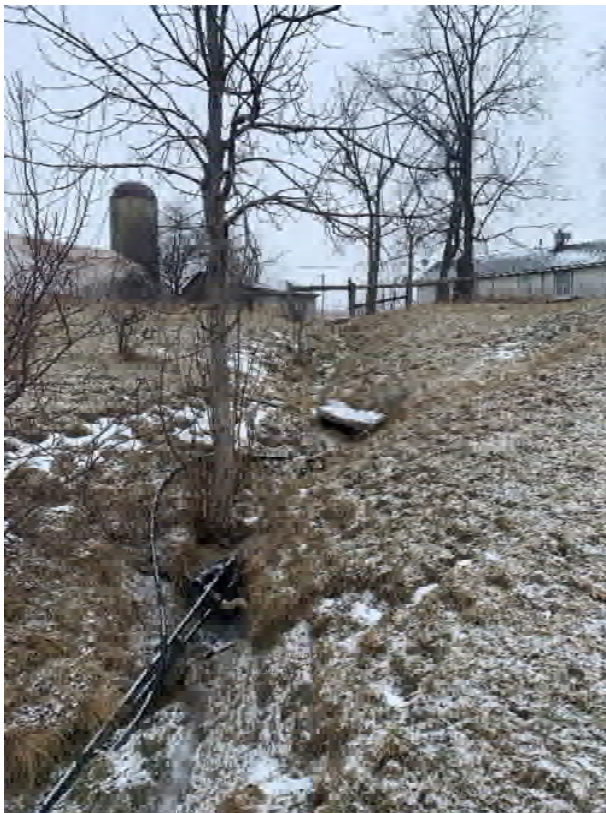
**PHOTOGRAPH 6**

Another view of gully erosion extending down the slope face due to concentrated runoff from the barns and other structures. Weeping pipes outlet partway down the slope.

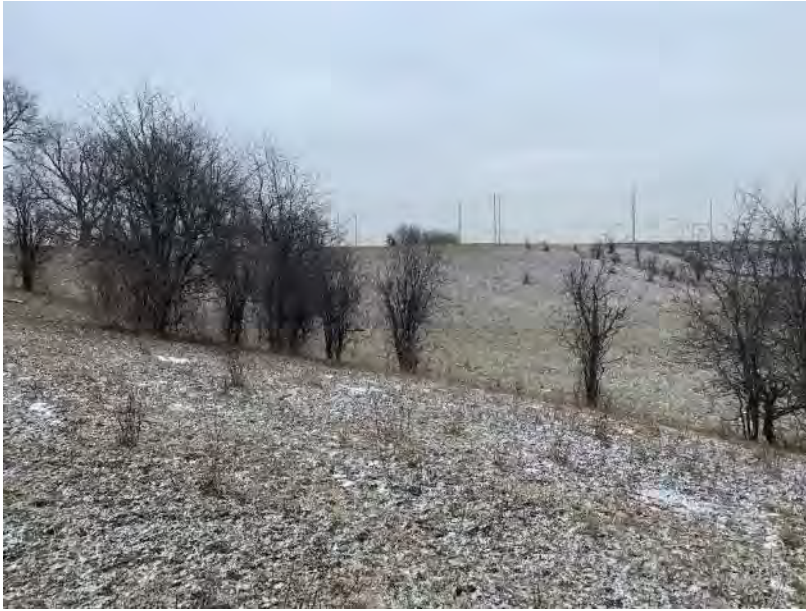
**PHOTOGRAPH 7**

Another general view of the northern slope of the western tributary confined valley system.

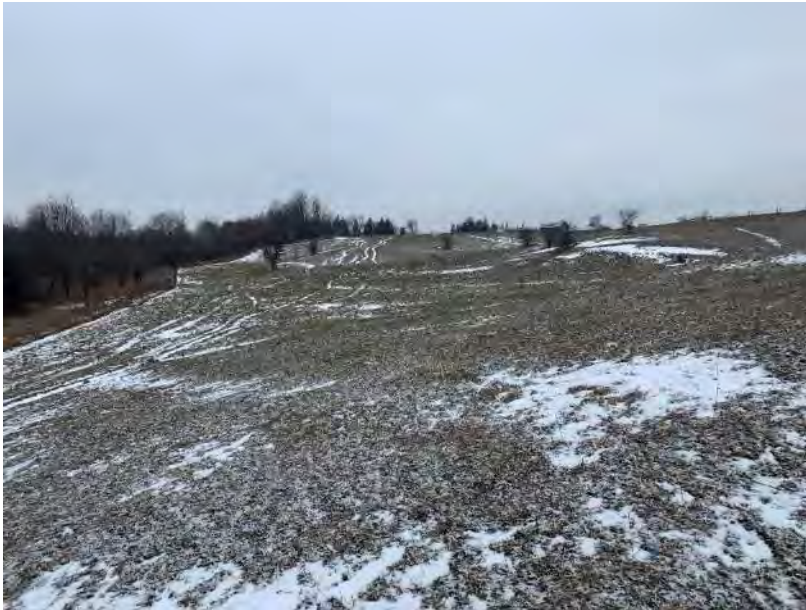
**PHOTOGRAPH 8**

A view of the tableland (farmland) north of the northern slope of the western tributary.

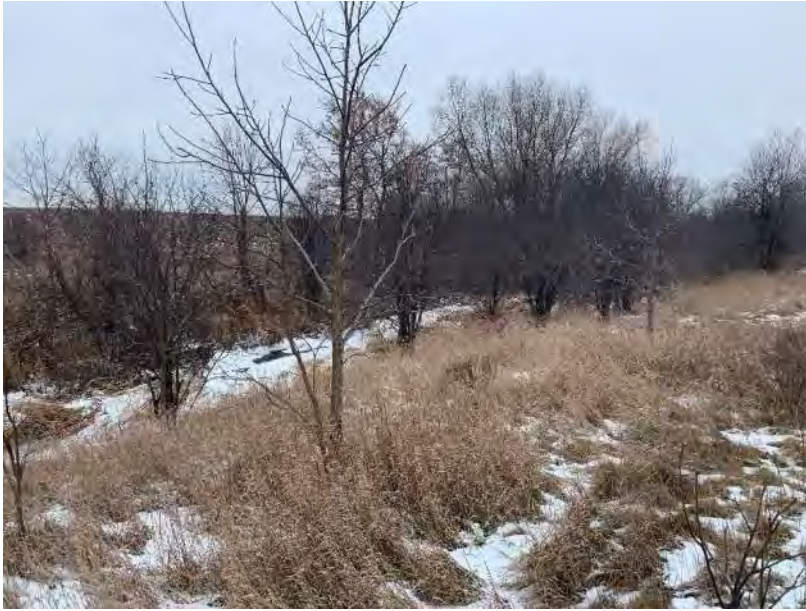
**PHOTOGRAPH 9**

**Description:**  
Another view of the west tributary watercourse.

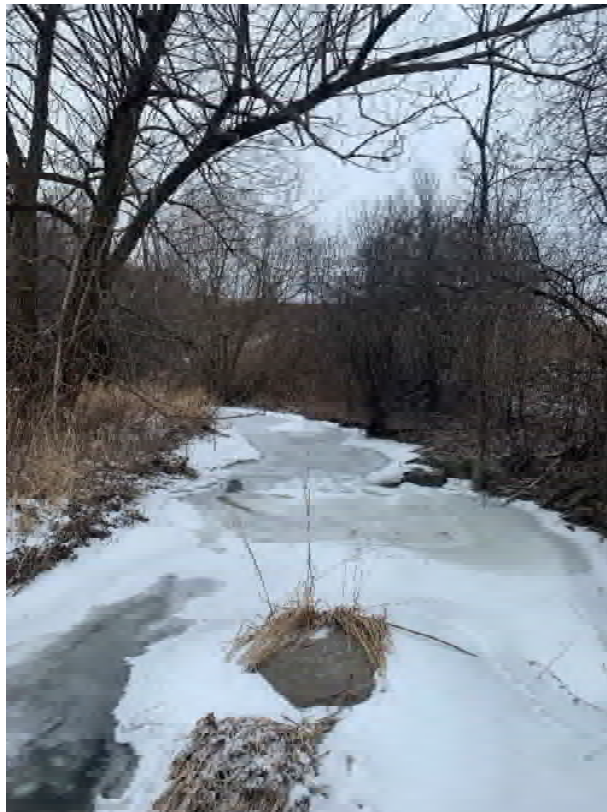
**PHOTOGRAPH 10**

**Description:**  
Another view of the west tributary watercourse. The watercourse is typically adjacent to the northern slope toe between the barns and Torbram Road.

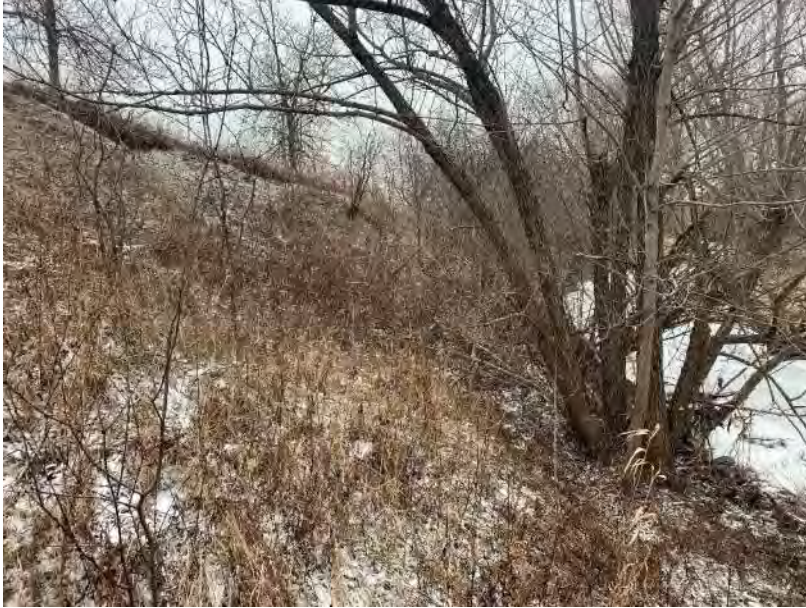
**PHOTOGRAPH 11**

A view of the well vegetated northern slope profile.

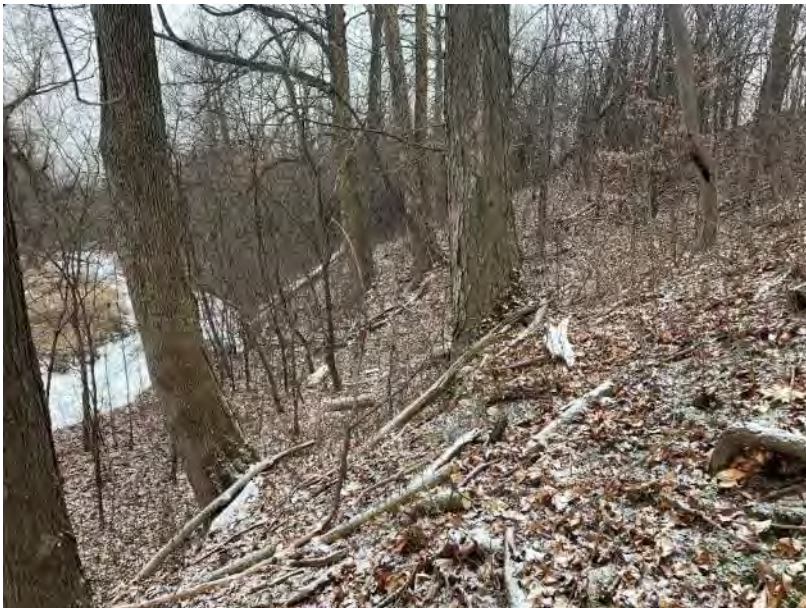
**PHOTOGRAPH 12**

Another view of the well vegetated northern slope profile. Some trees are partially tilting, likely due to long term slope creep.

Overall, there were no signs of slope instability. Some of the trees were leaning but this is likely from long-term creep of the slope. Active erosion was observed along the watercourse and the drainage gullies on the slope indicate there are areas of concentrated runoff flowing down the slope.

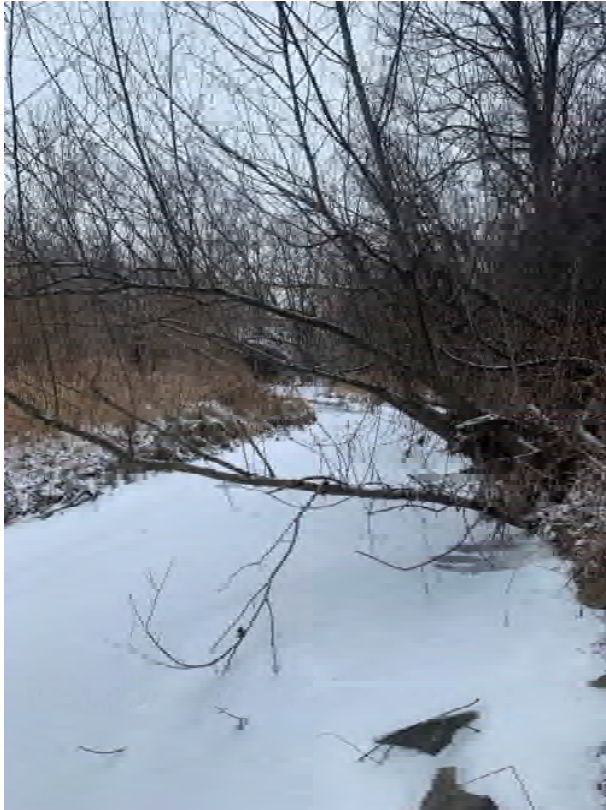
**PHOTOGRAPH 13**

Active erosion is occurring along the west tributary watercourse.

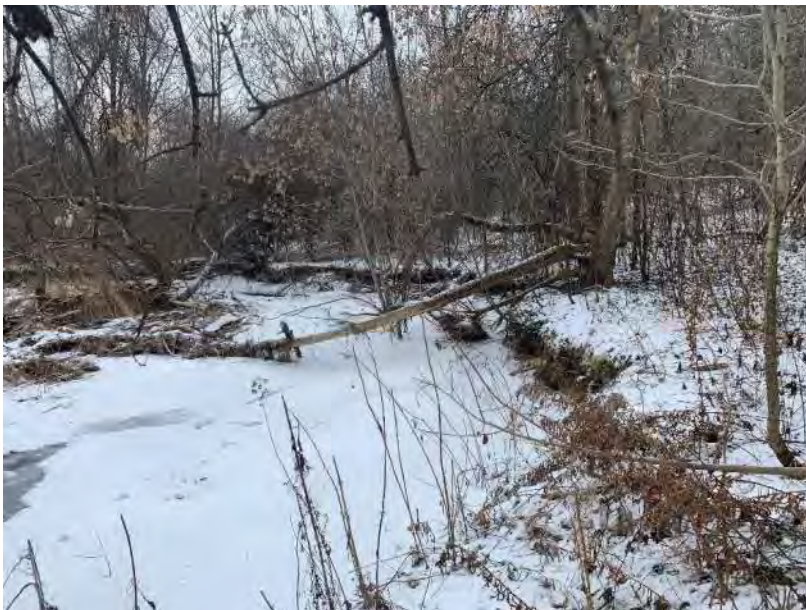
**PHOTOGRAPH 14**

Active erosion is occurring along the west tributary watercourse.

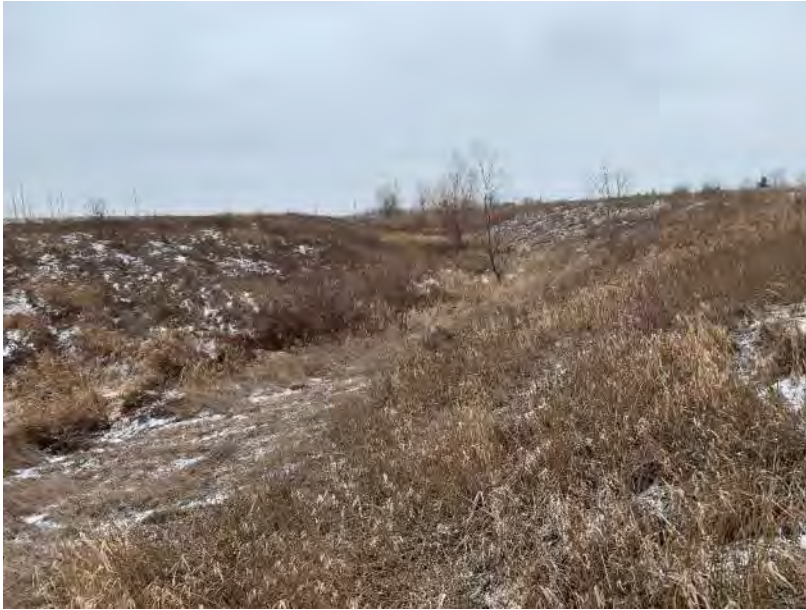
**PHOTOGRAPH 15**

A view of the southern drainage feature (confined valley system) that is expected to only contain intermittent flows during or after runoff events.

The south drainage feature is located in the west tributary but in the southern corner of the site near the intersection of Torbram Road and Mayfield Road. This is a confined system but it is assumed that it only conveys runoff during or after precipitation and snowmelt events. No flowing water was observed during the inspection but marshy vegetation was observed at the bottom of the slope. The slope height ranges from about 2 to 4 metres and the inclinations are typically 4 horizontal to 1 vertical or flatter. No structures were observed near the slope crest.

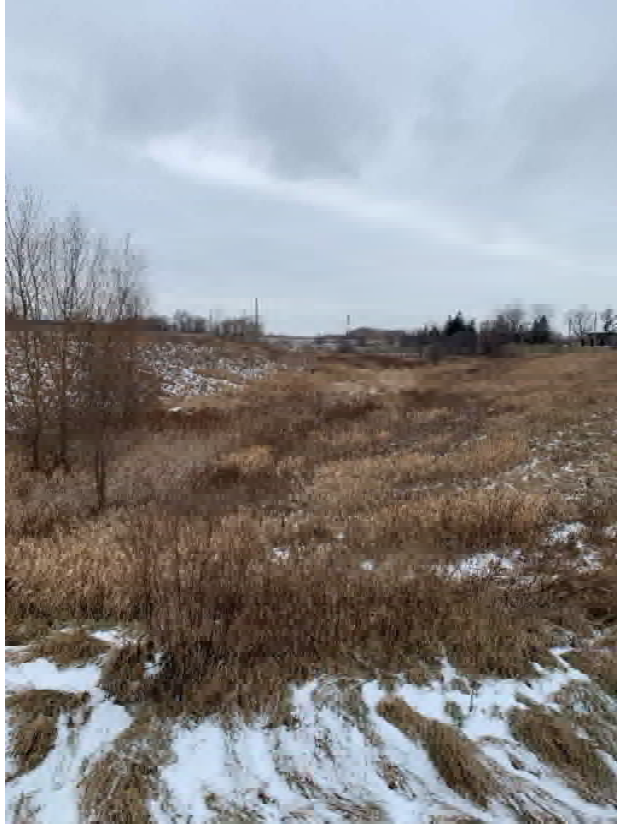
**PHOTOGRAPH 17**

A view of the south slope of the southern drainage feature. Some rilling was observed on the slope face, due to concentrated runoff.

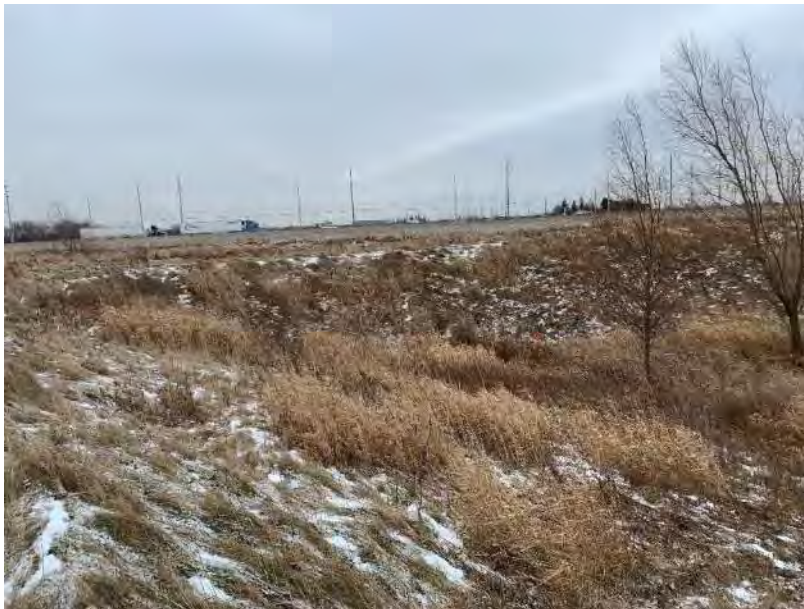
**PHOTOGRAPH 18**

Another view of the southern drainage feature (confined valley system) that is expected to only contain intermittent flows during or after runoff events.

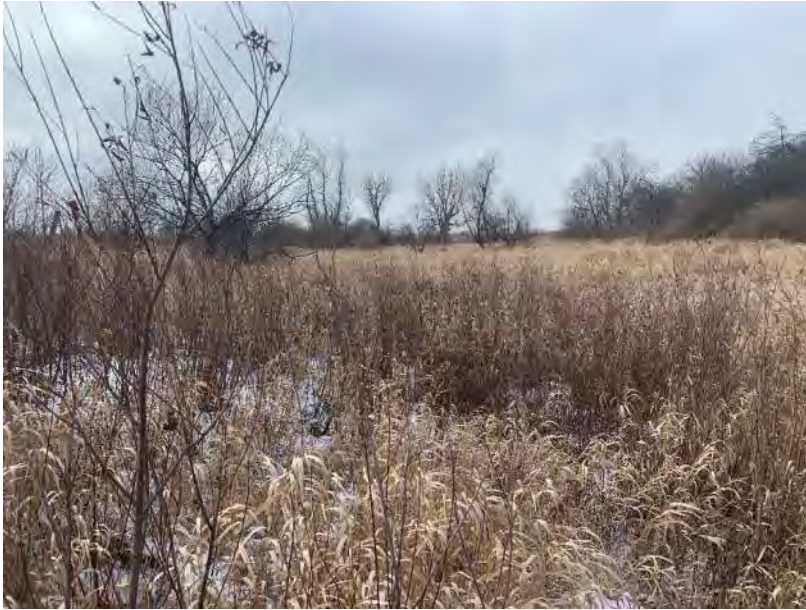
**PHOTOGRAPH 19**

A view of the unconfined feature that drains into the upper pond of the eastern tributary.

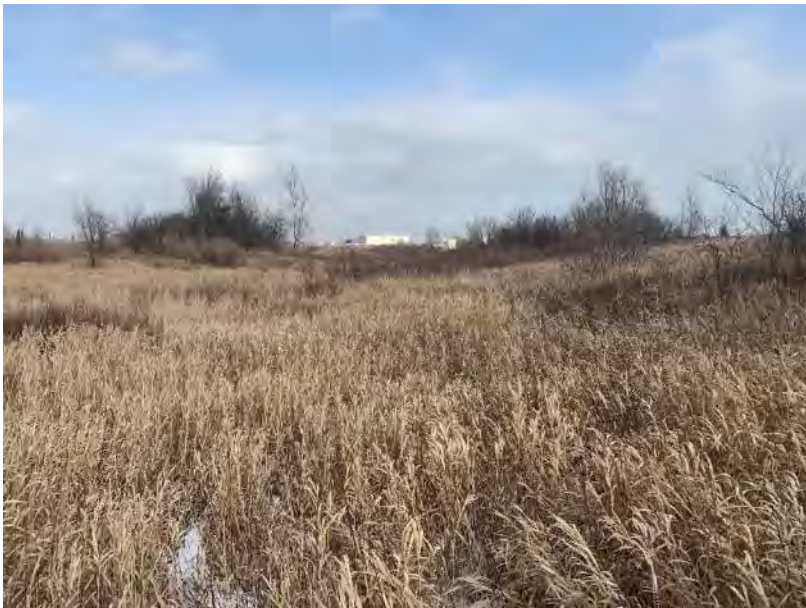
**PHOTOGRAPH 20**

Another view of the unconfined feature that drains into the upper pond of the eastern tributary.

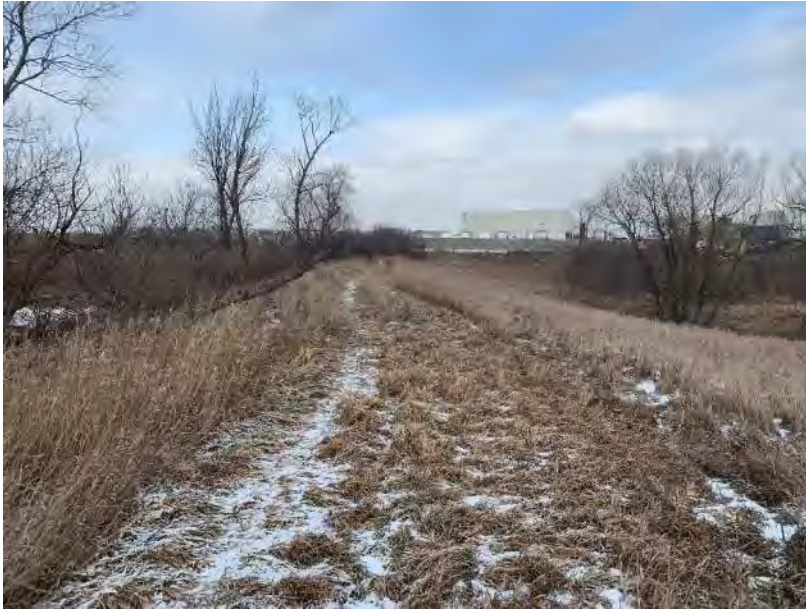
**PHOTOGRAPH 21**

A view of the northern embankment dam crest, at the upper pond location.

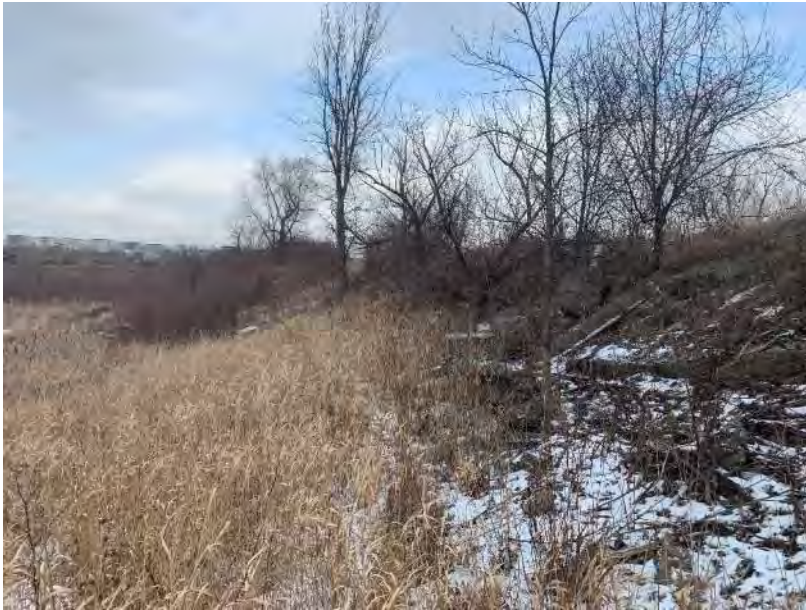
**PHOTOGRAPH 22**

A view of the side slope of the upper pond / embankment dam, containing some concrete and other debris.
