**Initial Comprehensive Environmental Impact Study  
and Management Plan & Scoped Subwatershed Study  
Tullamore Employment Lands**

Caledon, Ontario

October 2023  
Project 2100975  
Third Submission

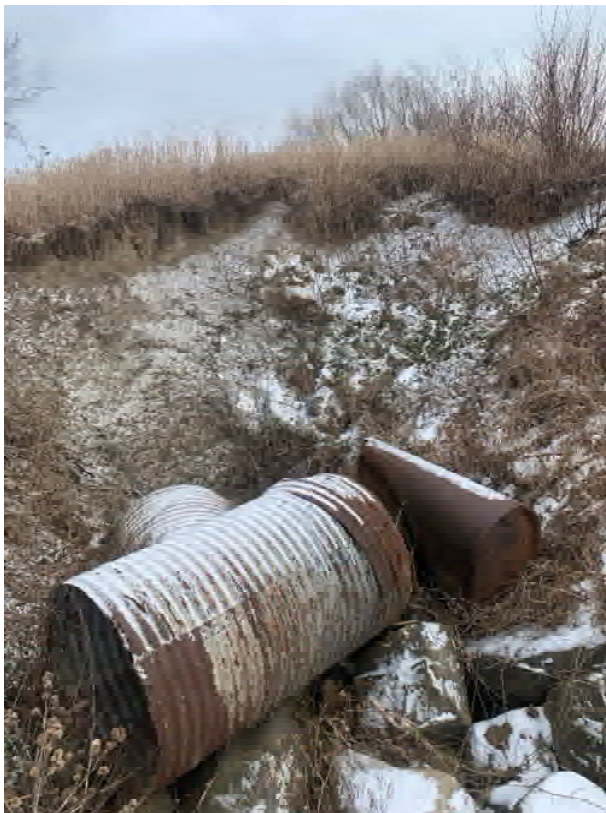
**PHOTOGRAPH 24**

A view of the upper pond and damaged / destroyed culvert inlet that extends below the berm (upstream side of the upper pond).

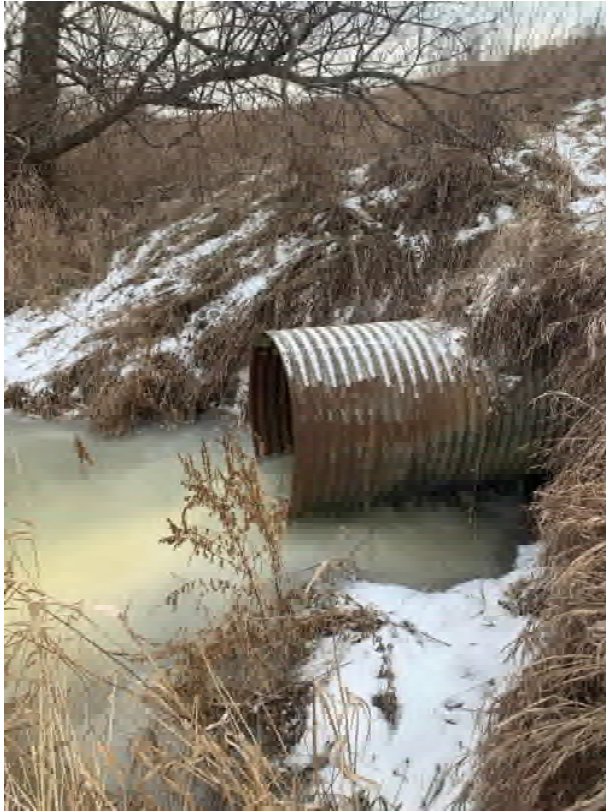
**PHOTOGRAPH 25**

A view of the damaged culvert and active erosion and slope failures (slumping) at the upstream face of the northern embankment dam (upper pond).

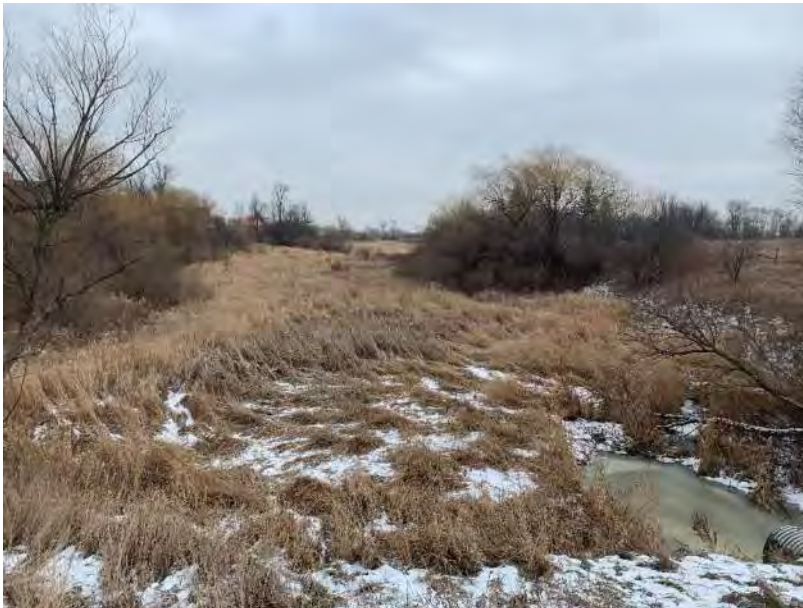
**PHOTOGRAPH 26**

A general view of the eastern tributary, looking south / downstream of the upper pond.

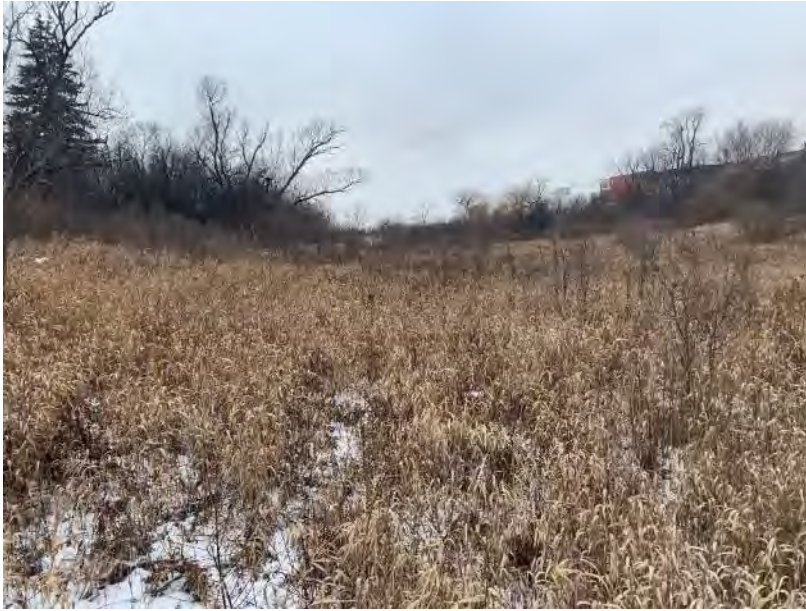
**PHOTOGRAPH 27**

A general view looking north along the eastern tributary.

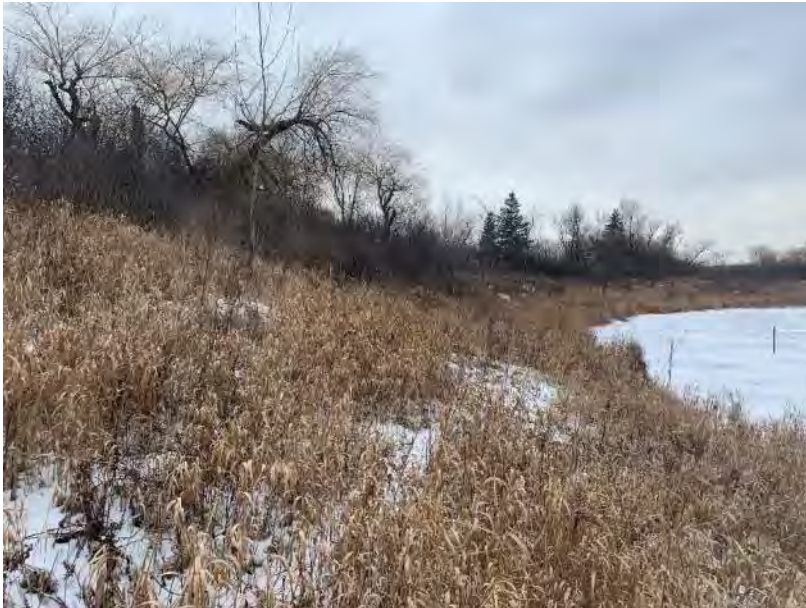
**PHOTOGRAPH 28**

A view of the western slope along the lower pond.

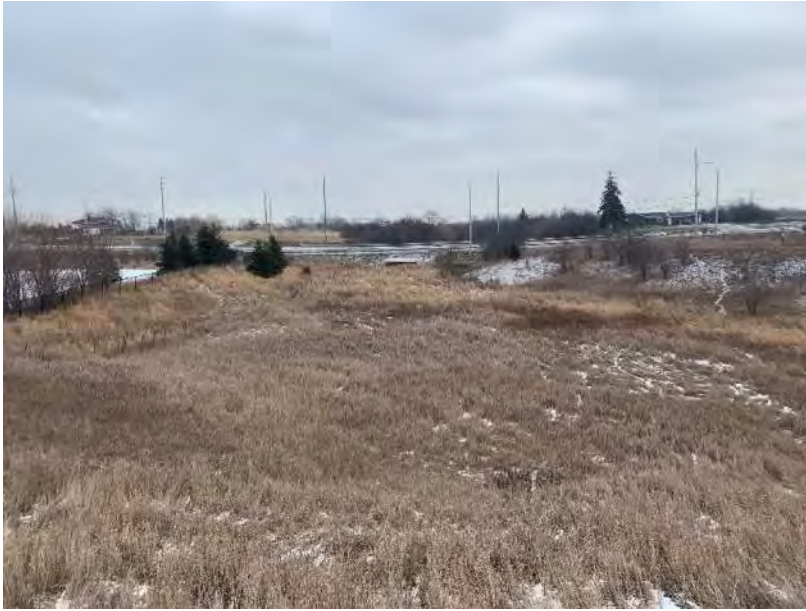
**PHOTOGRAPH 31**

A view looking south of the remaining section of the eastern tributary before it flows beneath Mayfield Road through a concrete box culvert.

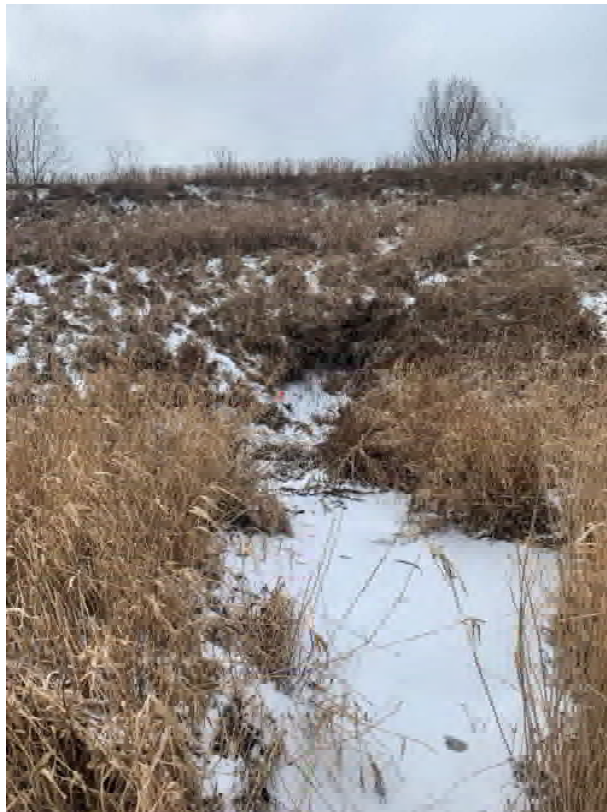
**PHOTOGRAPH 32**

A view of the assumed outlet (downstream side) for the culvert that passes beneath the lower pond embankment dam. There is erosion in the area.

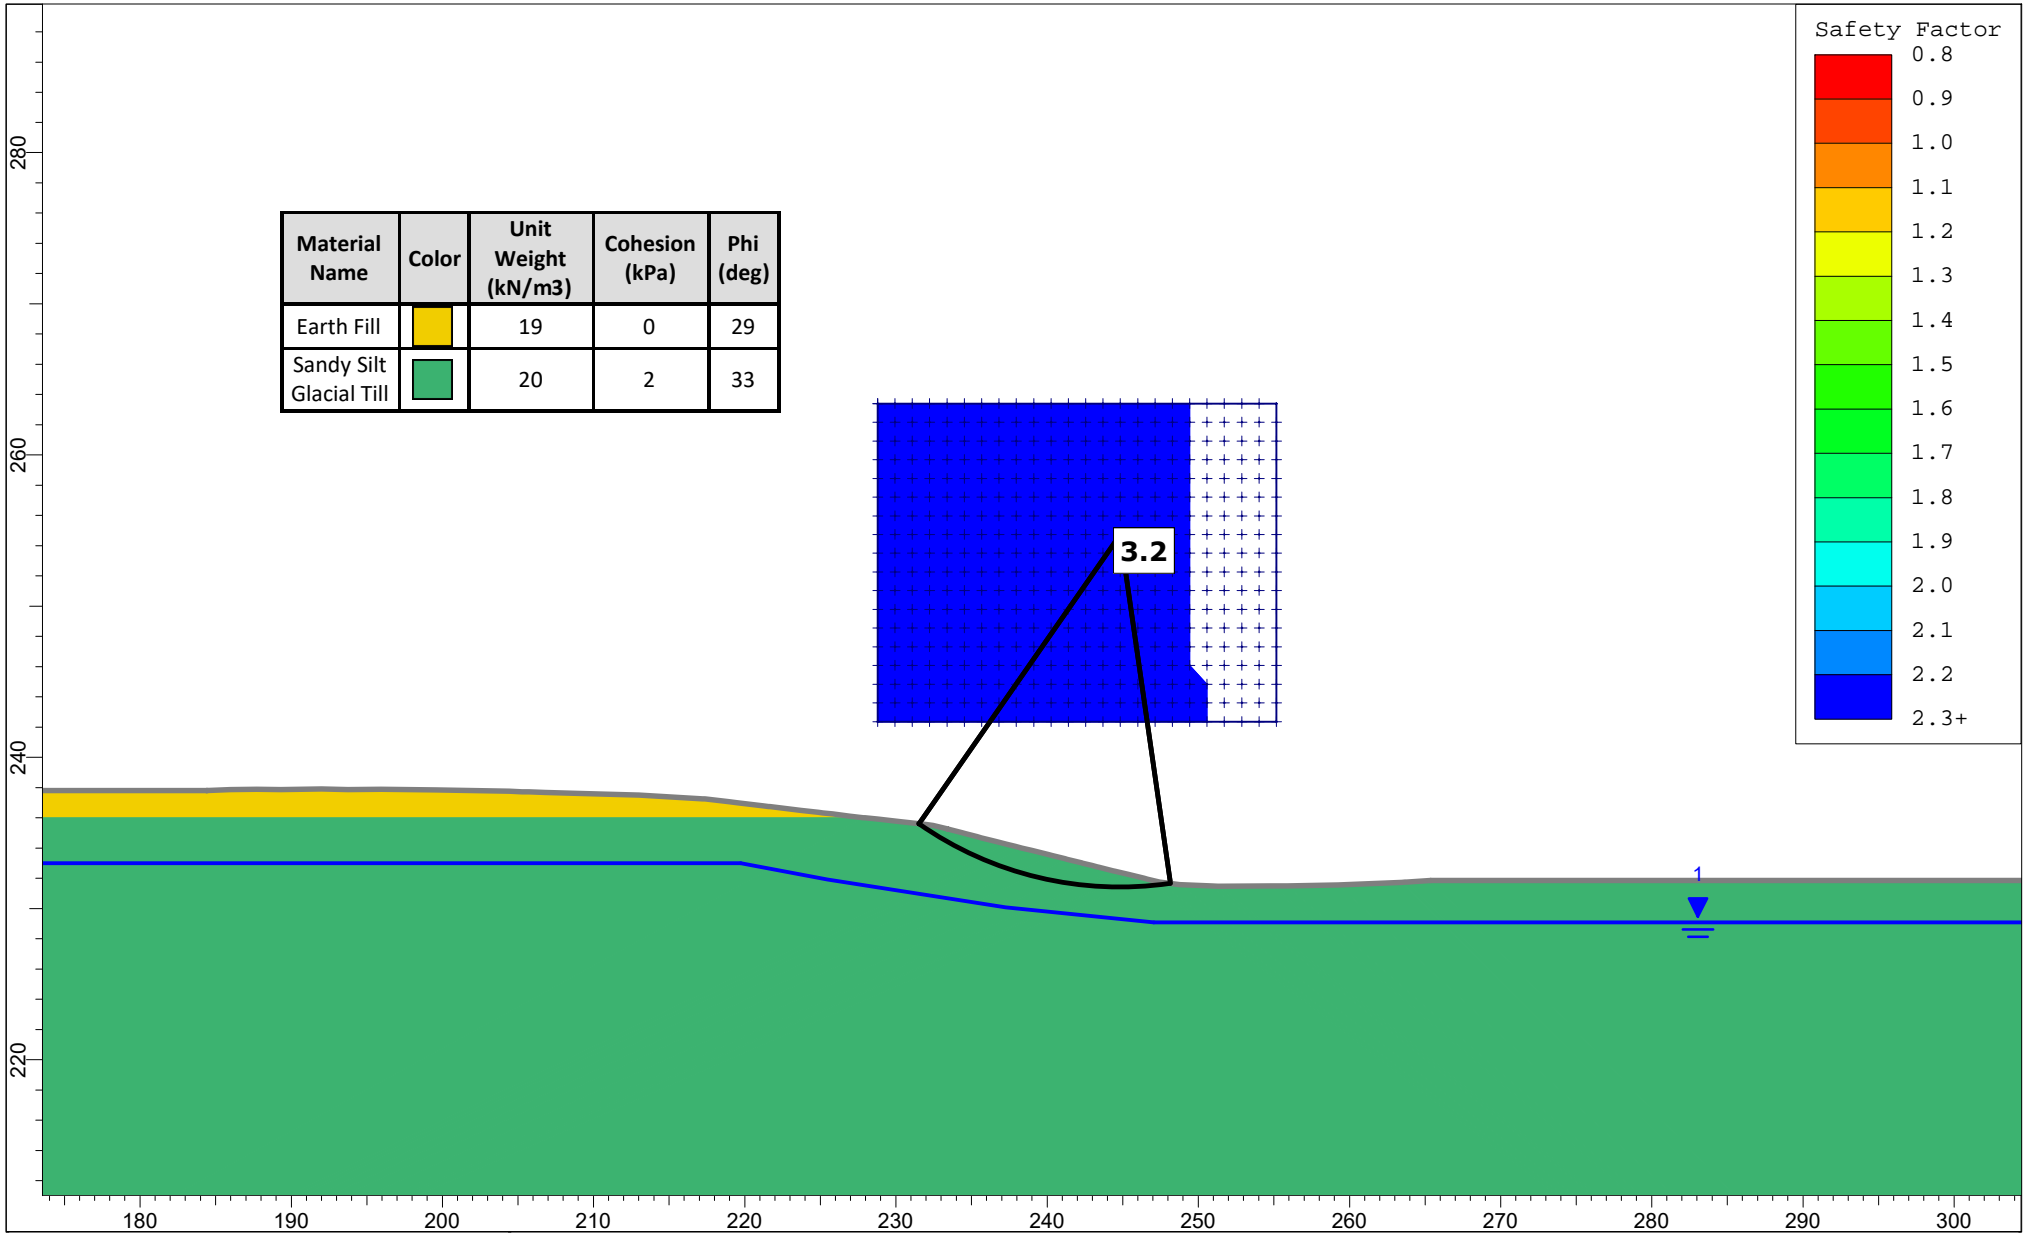
Project			Tullamore Employment Lands		
	Analysis Description			Section 1 - Existing Conditions		
	Drawn By	RW	Scale	1:500	Company	GEI
	Date	2/15/2022		Project No.	2100975

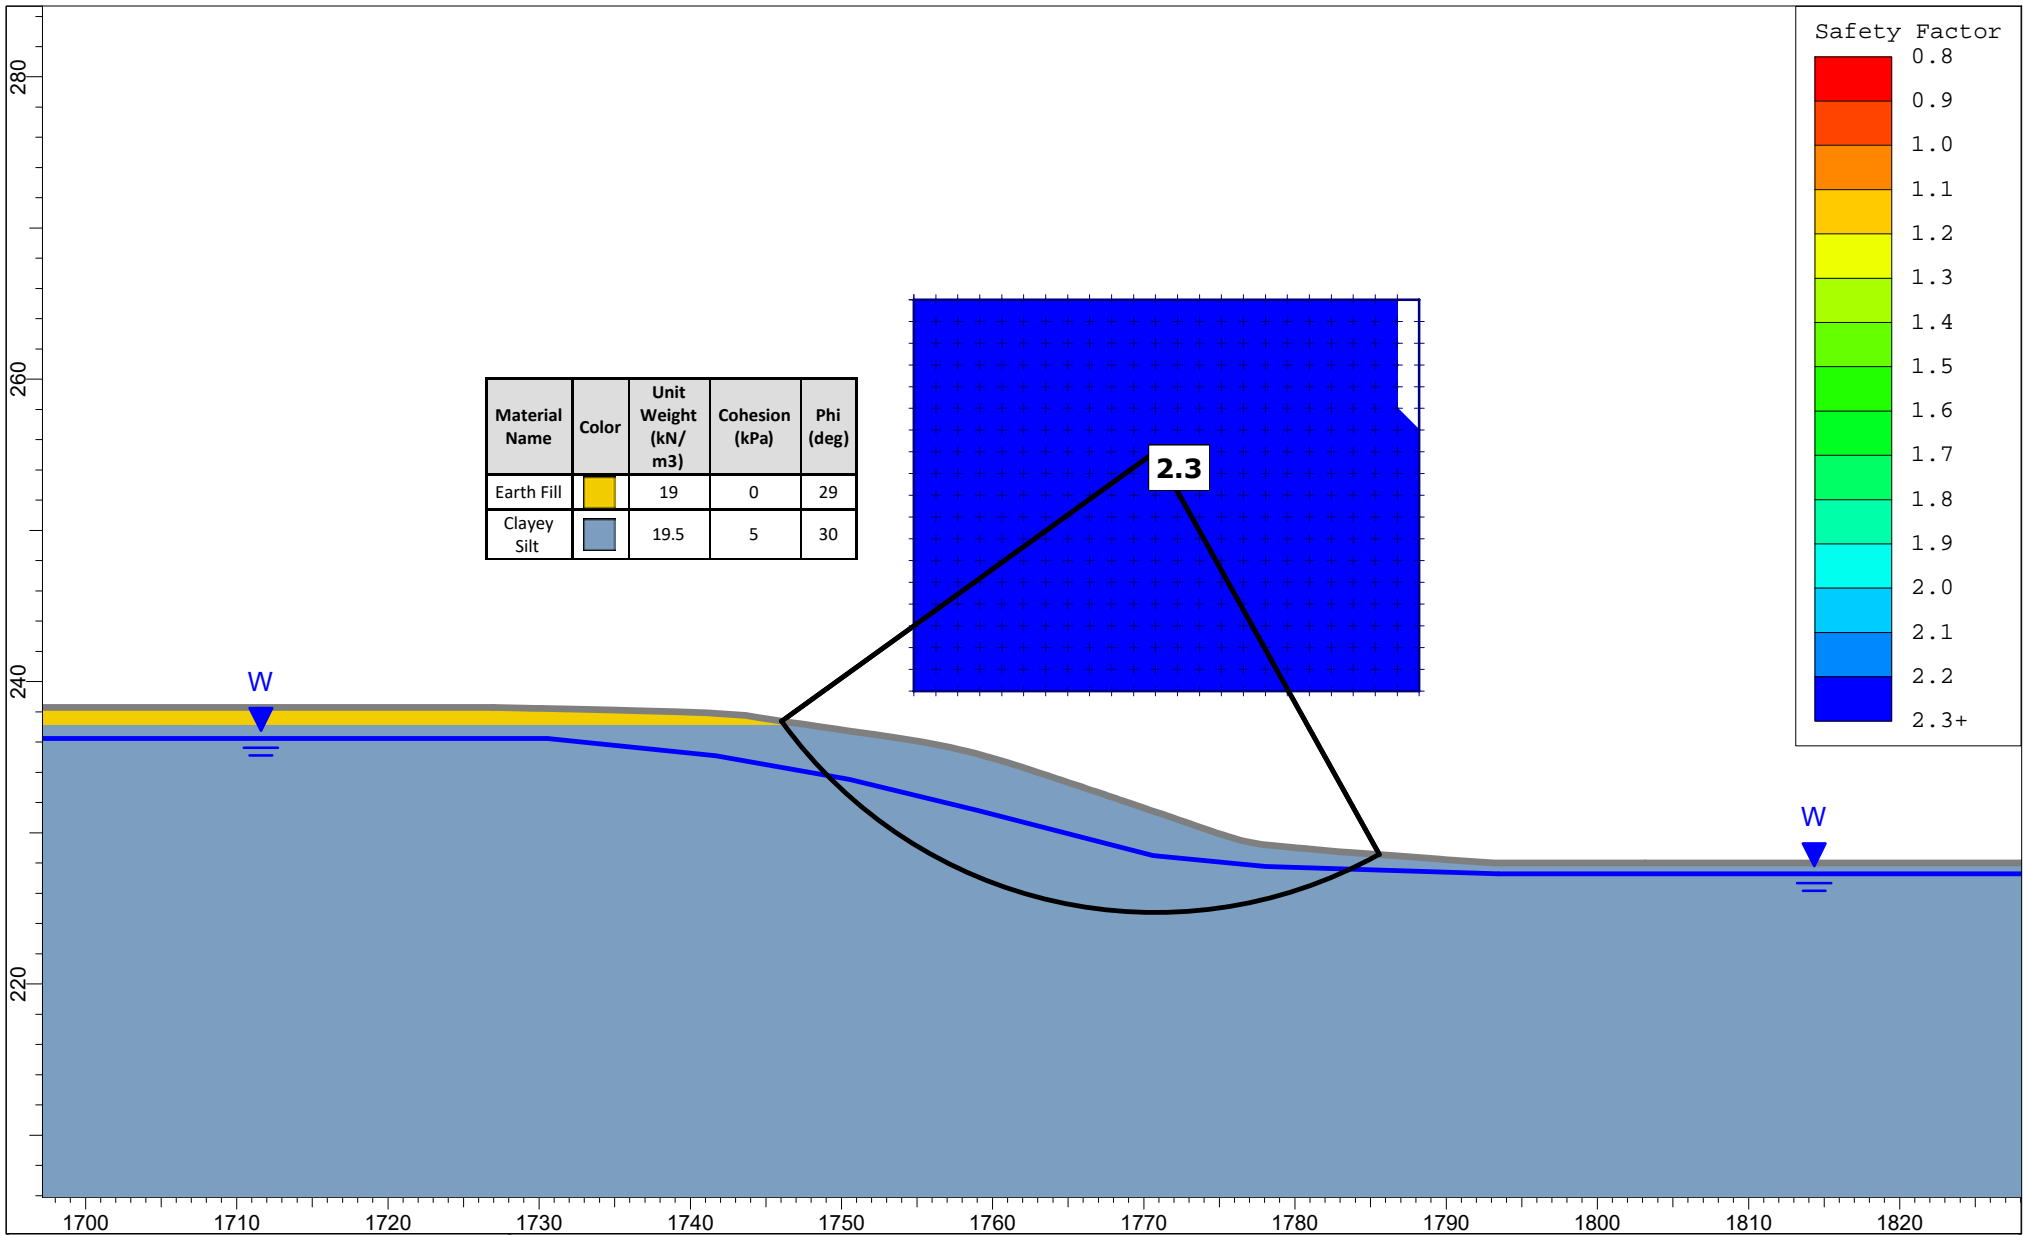
Material Name	Color	Unit Weight (kN/m <sup>3</sup> )	Cohesion (kPa)	Phi (deg)
Earth Fill	Yellow	19	0	29
Clayey Silt	Blue	19.5	5	30

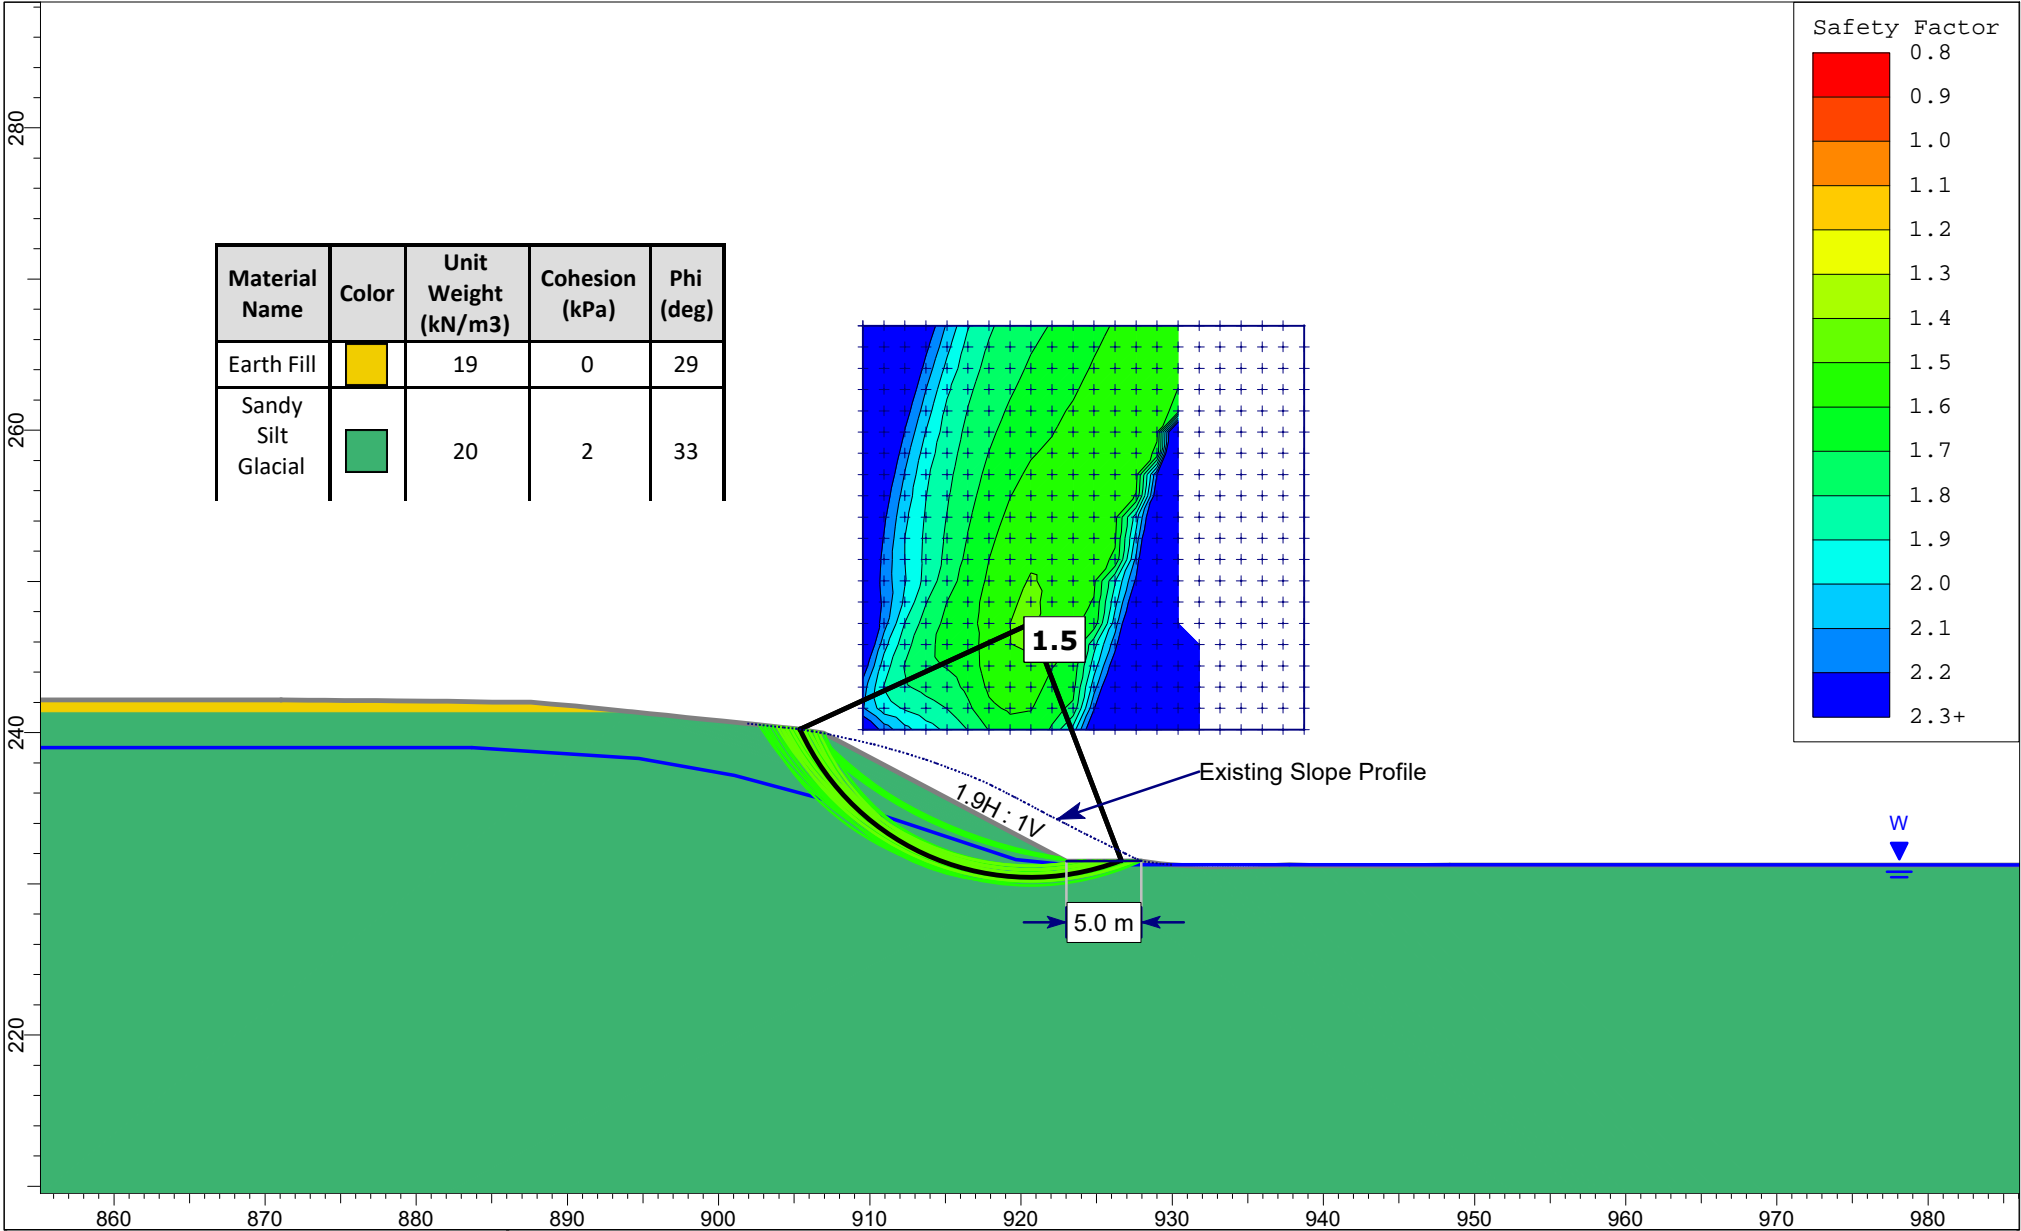
Material Name	Color	Unit Weight (kN/m <sup>3</sup> )	Cohesion (kPa)	Phi (deg)
Earth Fill	 	19	0	29
Sandy Silt Glacial	 	20	2	33
