Project No.: 5552-21-EE

**Re: Summary of Preliminary Findings of the Phase I Environmental Site Assessment
12542 Airport Road
Caledon, Ontario**

Phase I Environmental Site Assessment - Site Photographs
12542 Airport Road, Toronto, Ontario

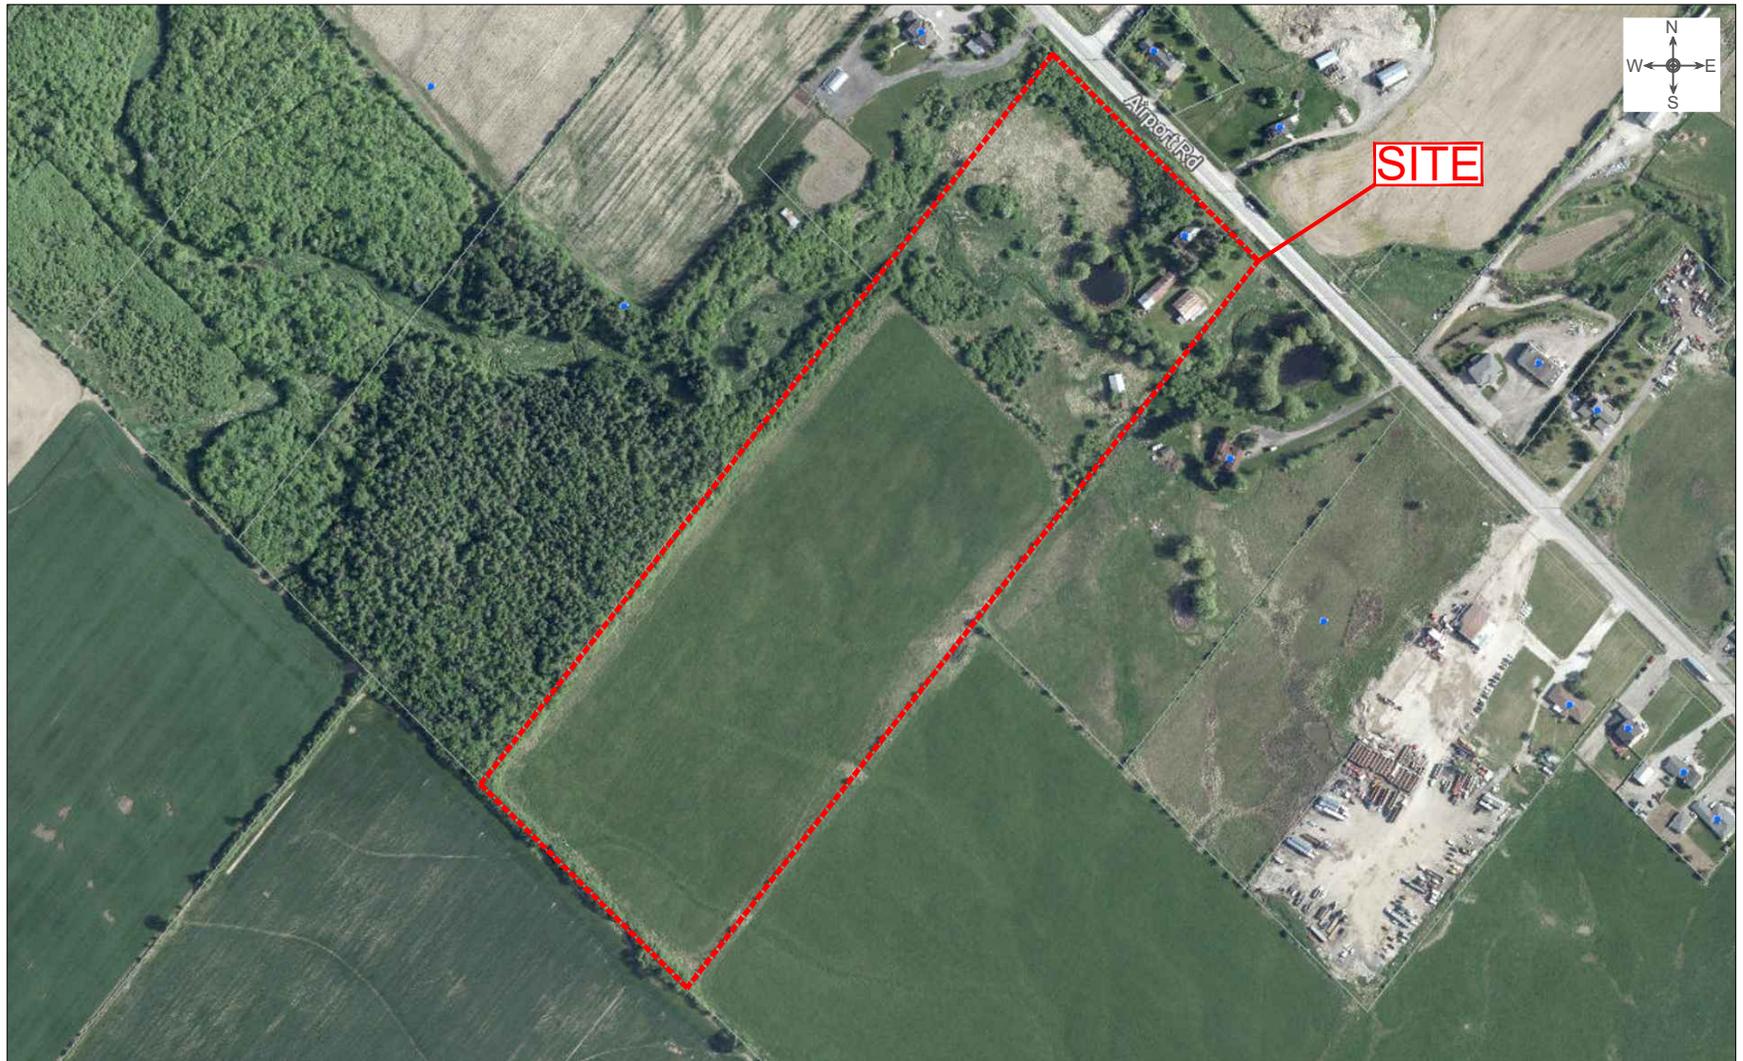
Figure No. 3 : Test Pit Location Plan

- The central and southern section of the Site was vacant, and it is likely that these areas of the Site were used for agricultural purposes in the past. No crops were observed on the Site at the time of the site reconnaissance. Two soils samples TP1 and TP2 were collected at the southern section of the Site and submitted to the Laboratory SGS for Organochlorine Pesticides (OCPs) and Metals and Inorganics (M&I) analysis. (See attached Figure 2 for the test pit locations)

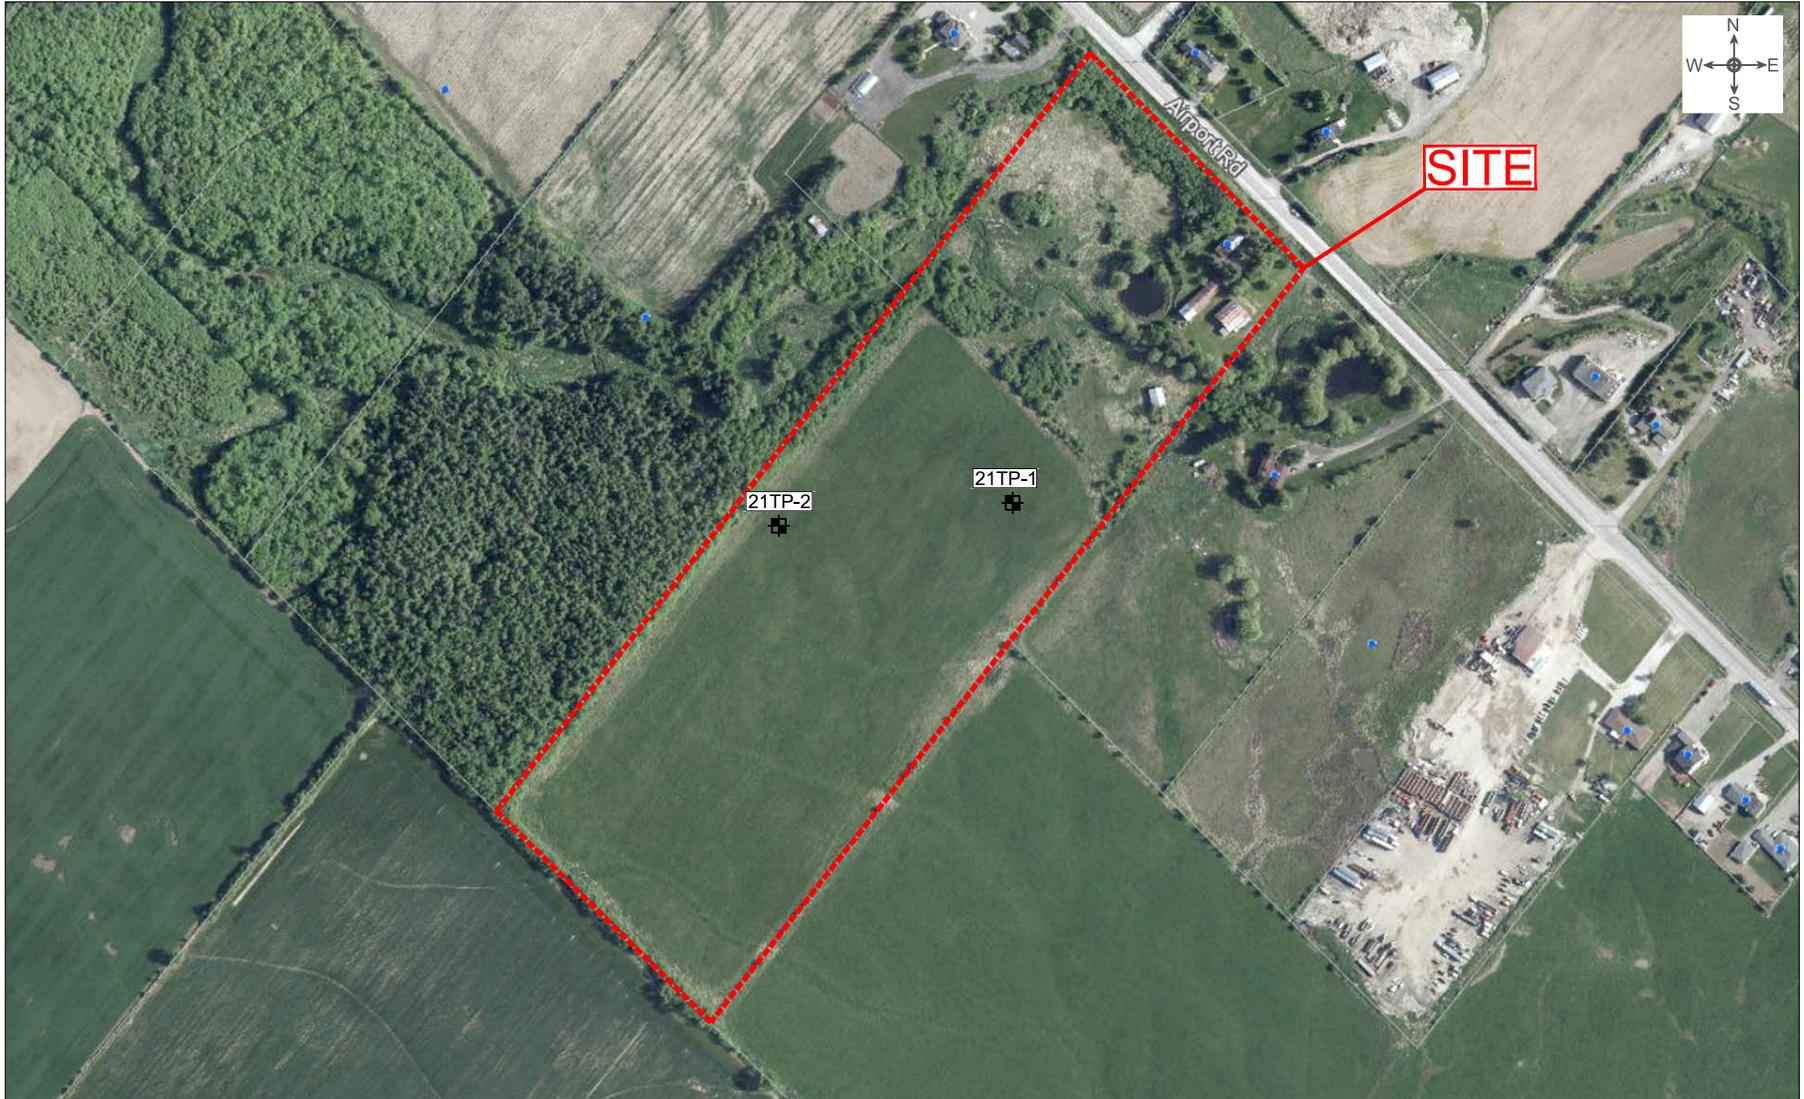
TITLE: Test Pit Locations	
LOCATION: 12542 Airport Road, Caledon, Ontario	
PROJECT NO. 5552-21-EE	DATE: November 2021
FIGURE NO: 2

- Two soils samples TP1 and TP2 were collected at the southern section of the Site and submitted to the Laboratory SGS for OCPs analysis. Based on the SGS chemical results, no exceedances for OCPs and M&I are present above the applicable regulatory limits (*See the chemical results attached*).

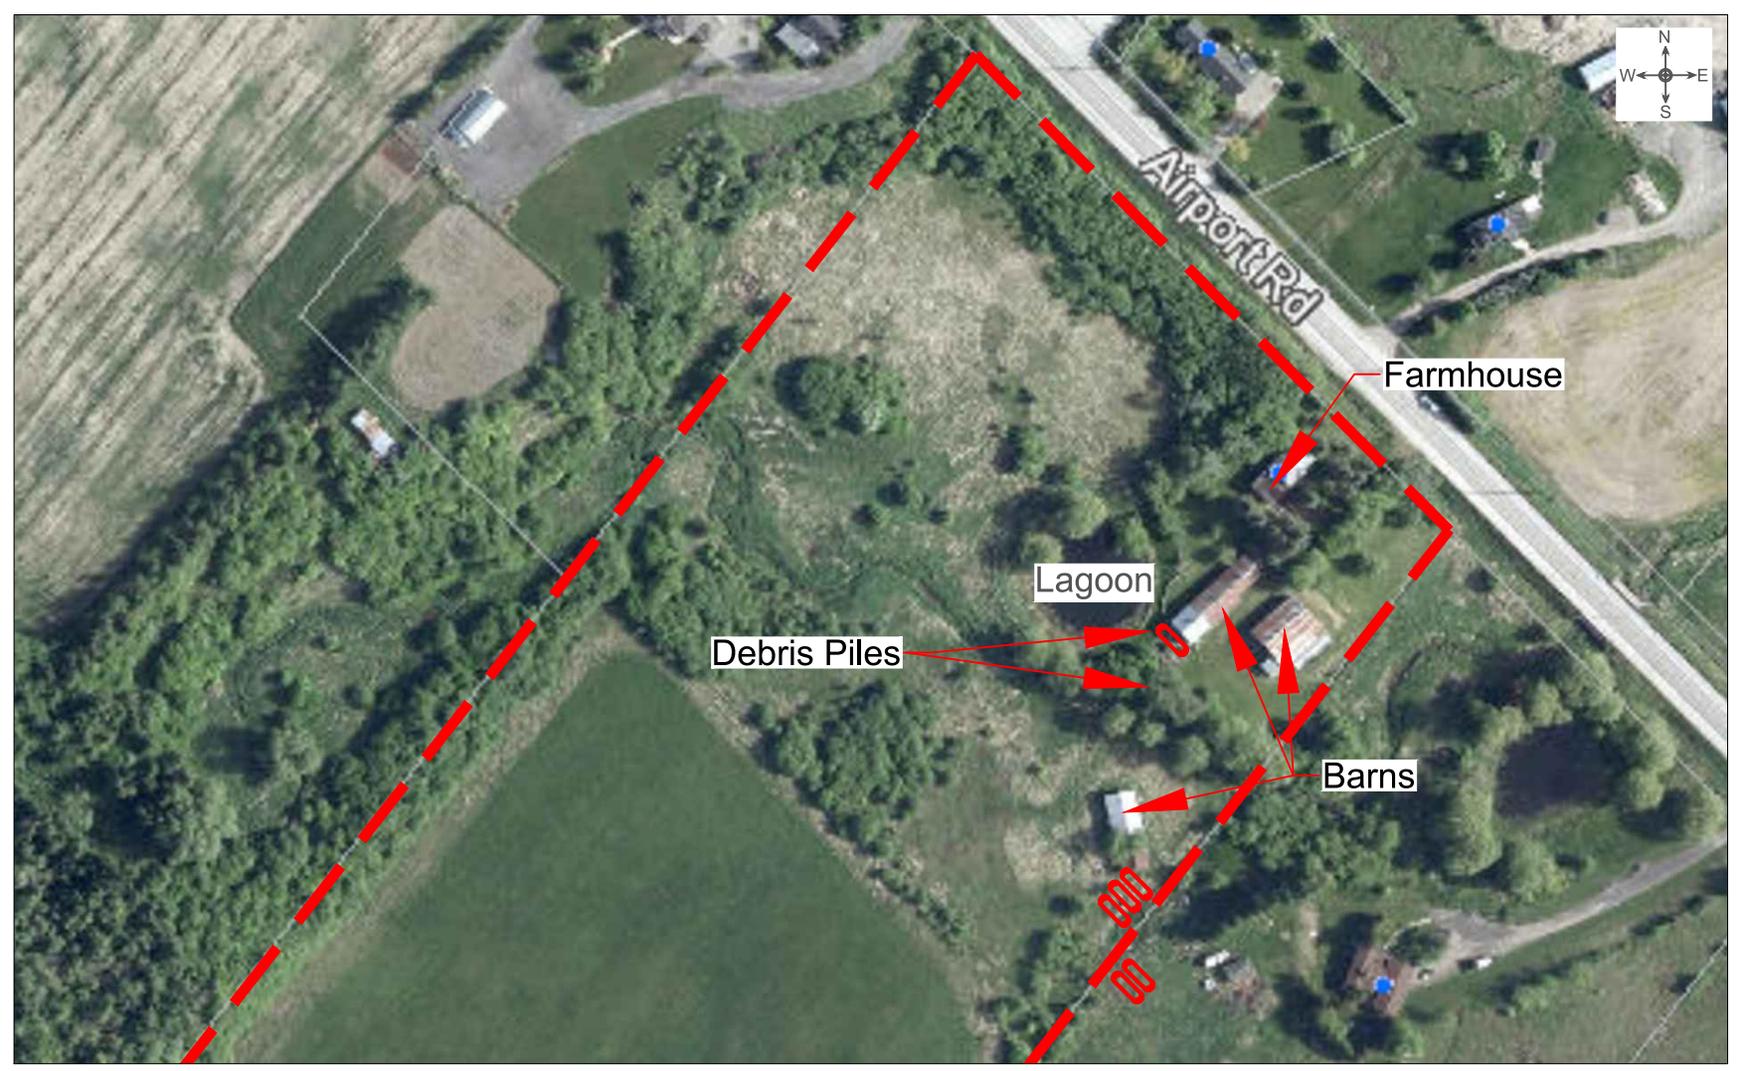
TITLE: Potential Environmental Concern		
LOCATION: 12542 Airport Road, Caledon, Ontario		
PROJECT NO. 5552-21-EE	DATE: October 2021	FIGURE NO: 3

Based on the information obtained through a records review, visual observations made during the site reconnaissance, and the interviews, the Phase I ESA has revealed the following potential environmental concerns which may impact the subsurface soil and/or groundwater at the Site (*The potential environmental concern locations are shown on Figure 2 attached*).

- A circular lagoon was observed approximately 40 m southwest of the farmhouse. The former use of the lagoon is unknown.
- Debris piles were observed in two different locations on the Site. One of the piles contained rusted material including an empty AST.
- Two additional ASTs were observed approximately 60 m southeast of Salt Creek.

- 12484 Airport Road (Adjacent east of Site) - Two empty ASTs were observed on the property.

It is *Toronto Inspection Ltd.*'s opinion that based on a review of the available information that a Phase II ESA is recommended for the Site.

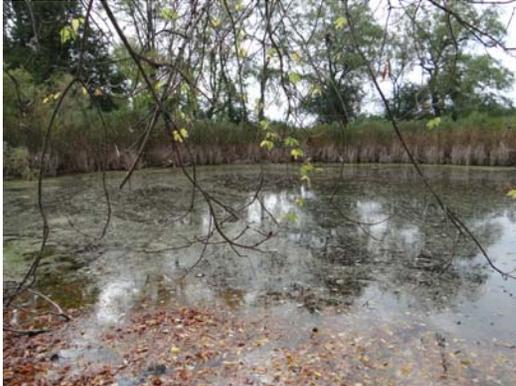
- At the time of the site reconnaissance, the Site was accessed through Airport Road, the northern section of the Site was occupied by a farmhouse and four barns (all locked at the time of the site reconnaissance). A circular lagoon was observed approximately 40 m to the southwest of the farmhouse. The former usage of the lagoon is unknown.

P1 - Circular lagoon located approximately 40 m from the farmhouse

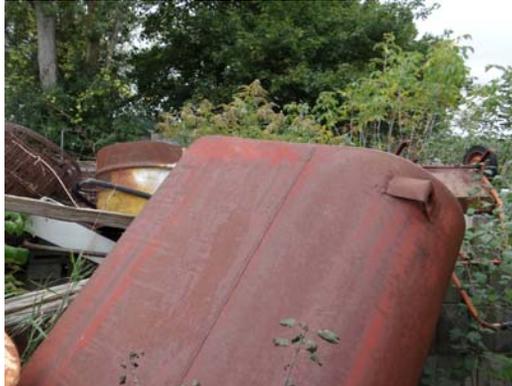
P2 - A debris pile located on the site containing scrap metal including an empty AST

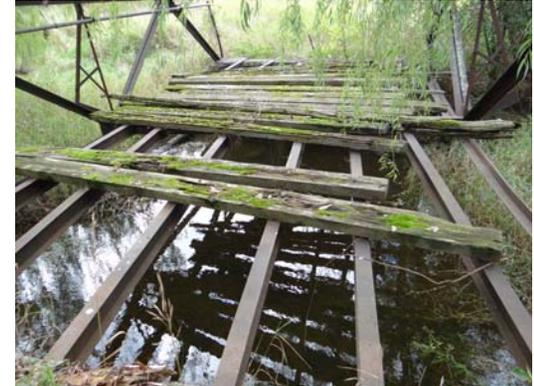
- Salt Creek was observed crossing the northern portion of the Site, and an old bridge was used to get access to the central and southern portion of the Site. A debris pile containing an old hot water tank, tires, and rusted barrels were observed at a close distance from the on-Site bridge.

P3 - An old on-site bridge crossing Salt Creek

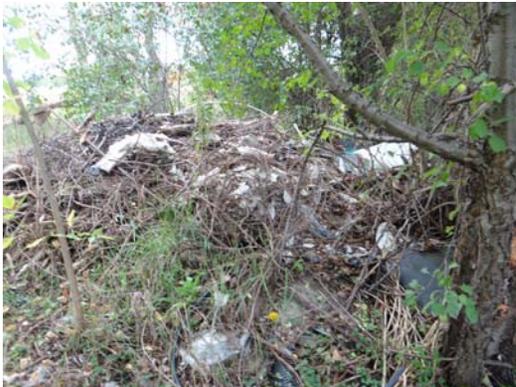
P4 - A debris pile located on the Site at a close distance from the on-site bridge

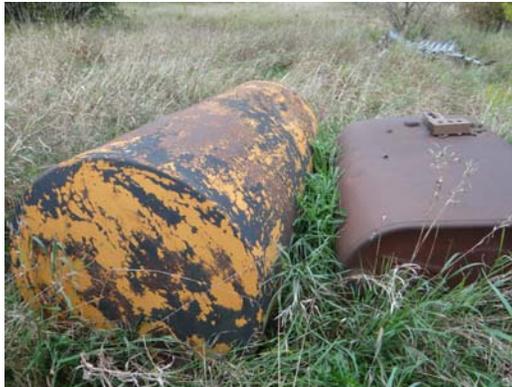
- Across Salt Creek, approximately 60 m in a southeast direction from the Creek, two empty Aboveground Storage Tanks (ASTs) were observed. No label was identified on the surface of the tanks; therefore, the capacity and age of the ASTs is unknown.

P5 - Two ASTs located on-site and approximately 60 m in a southeast direction from Salt Creek

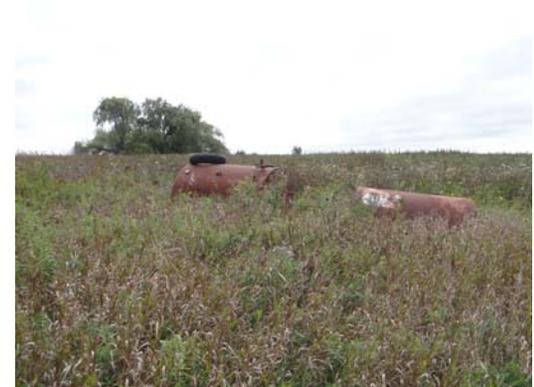
P6 - Two ASTs located at 12484 Airport Road, adjacent property to the east of Site
