Final Report

# ENVIRONMENTAL AND ENGINEERING SUMMARY REPORT - PHASE 2

12304 Heart Lake Road, Caledon

April 22, 2022

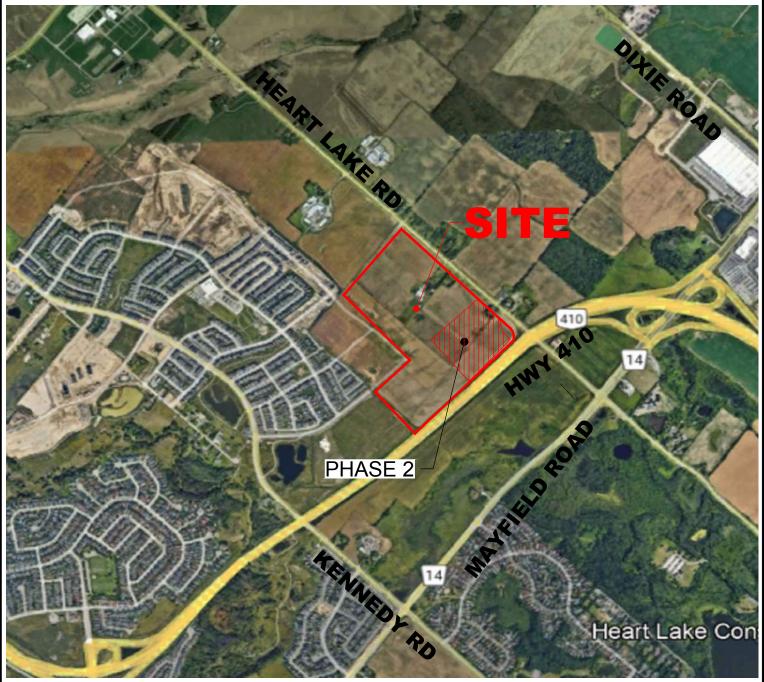
# Figure 2 – Aerial Plan

Located at 12304 Heart Lake Road in the Town of Caledon and Region of Peel, the overall subject site is approximately 37 ha in size, however, it should be noted that this report will only consider Phase 2 of the development, which consists of a 6.53 ha lot at the southeast corner of the site, bounded by the Abbotside Way extension to the north, Heart Lake Road to the east, Highway 410 to the south, and Phase 1 of the same development to the west. A vicinity map and an aerial exhibit can be found as **Figure 1** and **Figure 2** respectively following the report.
