Updated Hydrogeological Investigation and Water Balance Assessment
Report

12304 Heart Lake Road, Caledon, Ontario

BRM-21004344-D0

EXP Services Inc.

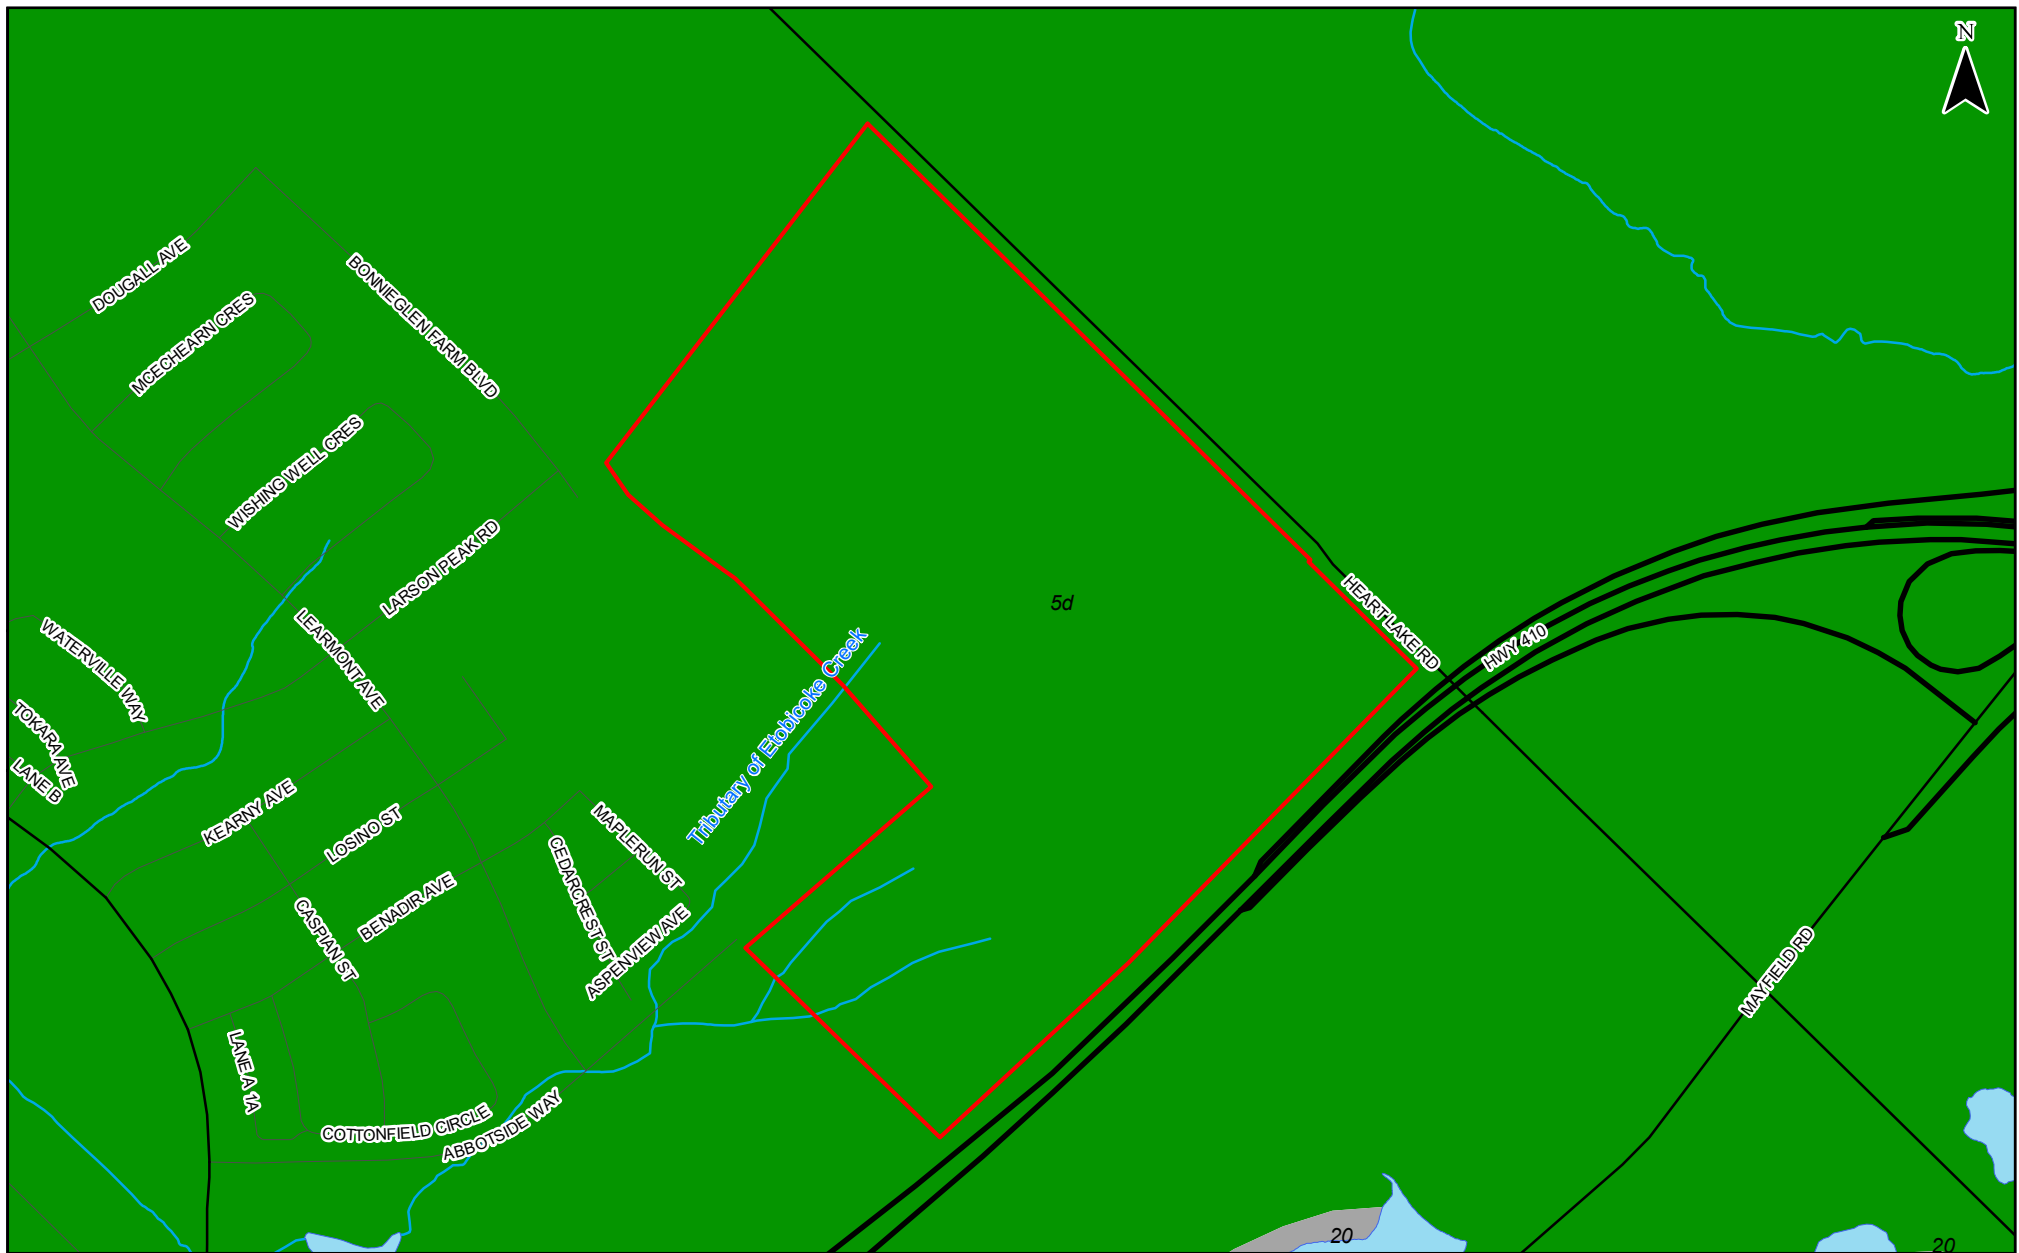
SOURCE:
BASED ON ONTARIO GEOLOGICAL SURVEY DATA PUBLISHED IN 2010

- LEGEND:
- APPROXIMATE SITE BOUNDARY
 - 20: ORGANIC DEPOSITS
 - 5D: GLACIOLACUSTRINE-DERIVED SILTY TO CLAYEY TILL

Using this method, a total infiltration factor for the Site was estimated by using the individual sub-factors, which are representative of the topography, soil type and land cover conditions (Figures 2, 7 and 9). Appendix F-3 provides a summary of the sub factors and total factor based on the Site conditions. The infiltration sub-factors were determined for estimating pre-development infiltration rates of the entire Site.

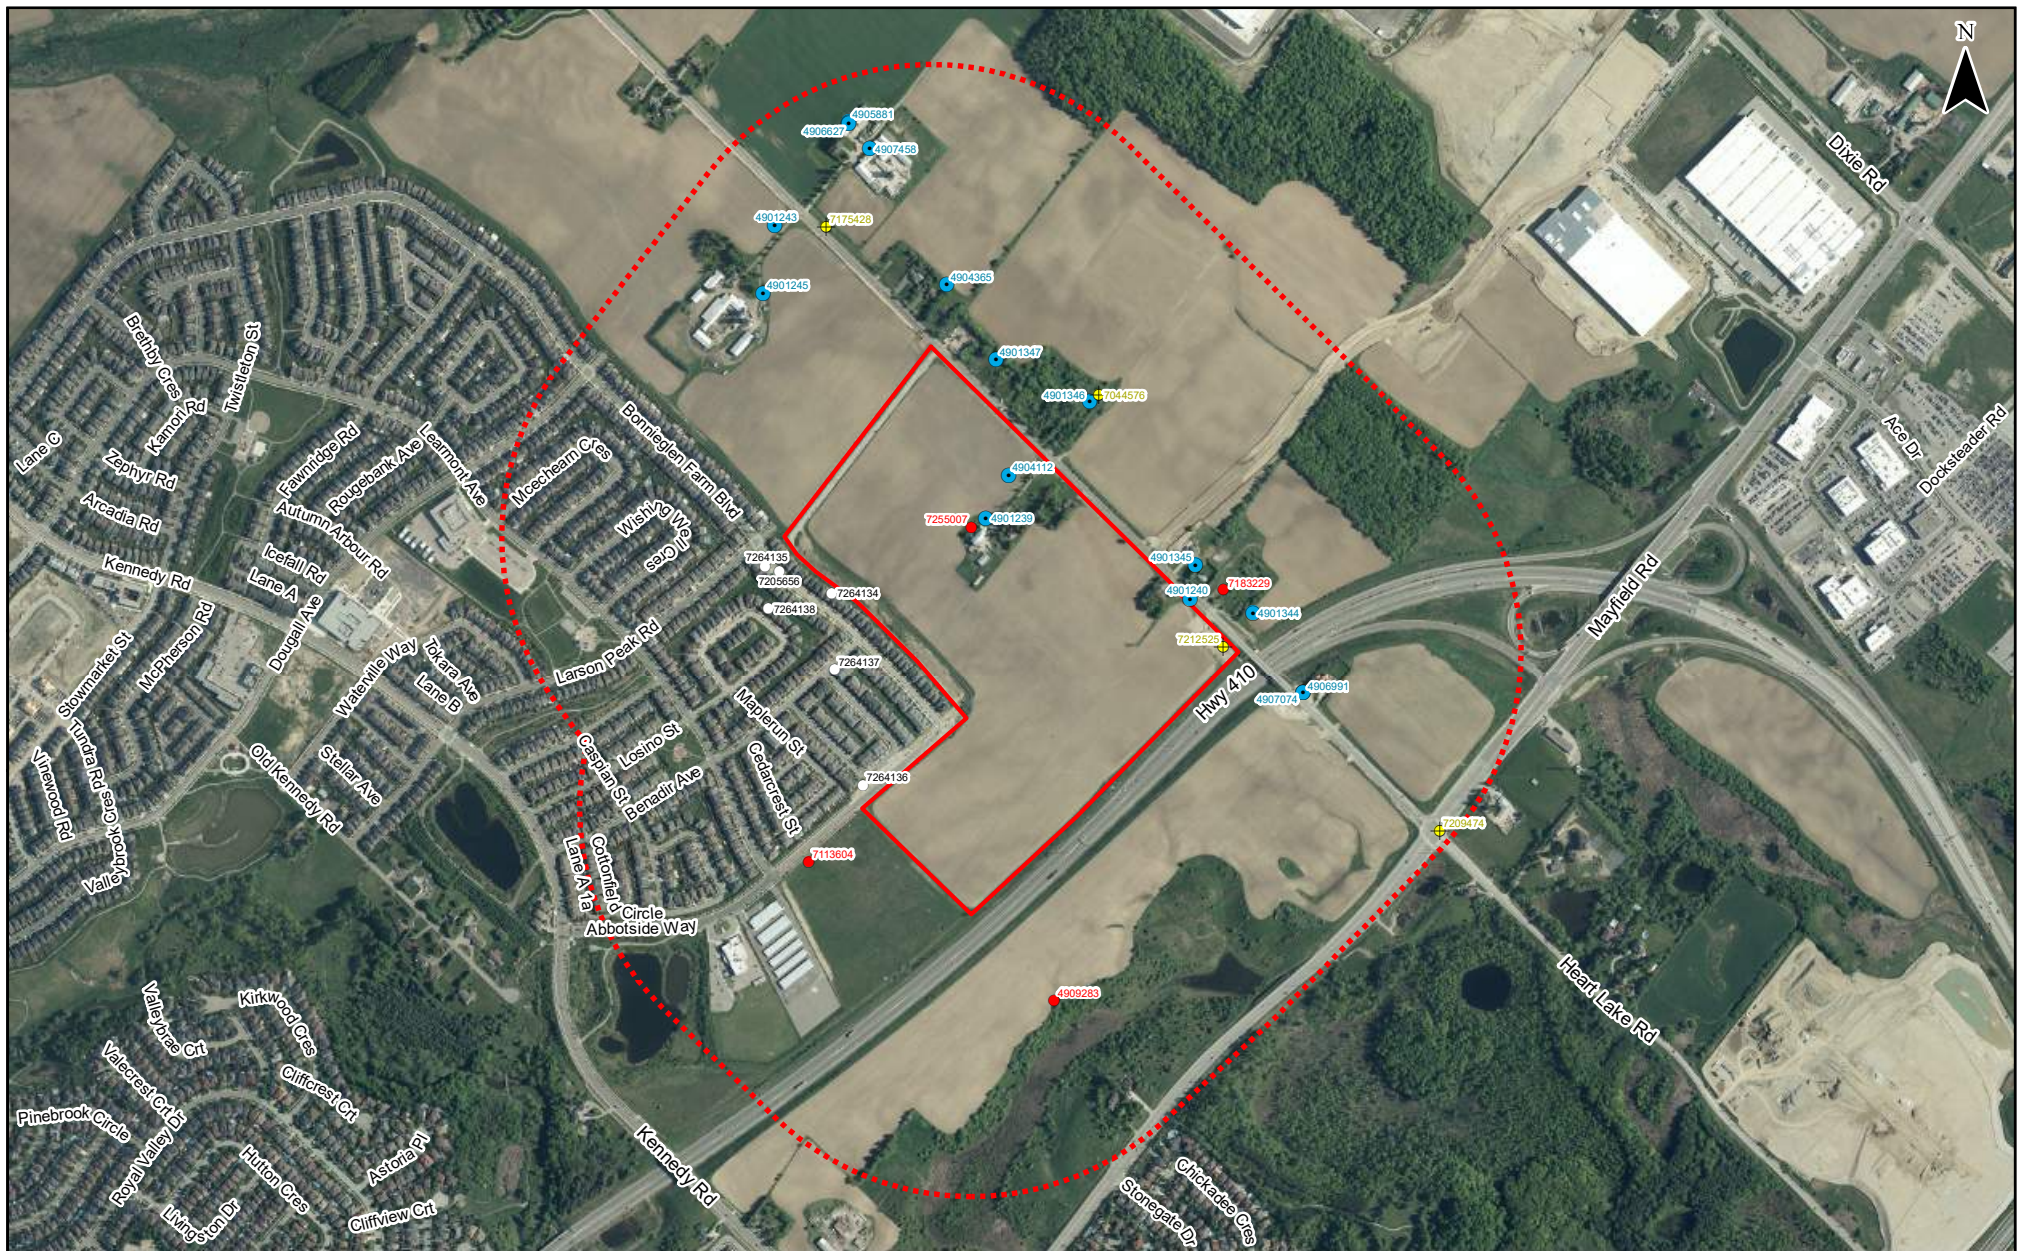
MECP WATER WELL RECORDS MAP		FIGURE: 3A
HYDROGEOLOGICAL INVESTIGATION AND WATER BALANCE ASSESSMENT 12304 HEART LAKE ROAD CALEDON, ONTARIO		
PROJECT NUMBER: BRM-21004344-D0	DATE: OCTOBER 2021

SOURCE:
BASED ON GOOGLE EARTH IMAGERY DATED 2020,
AVAILABLE WELL RECORD INFORMATION AS OF SEPTEMBER 2019

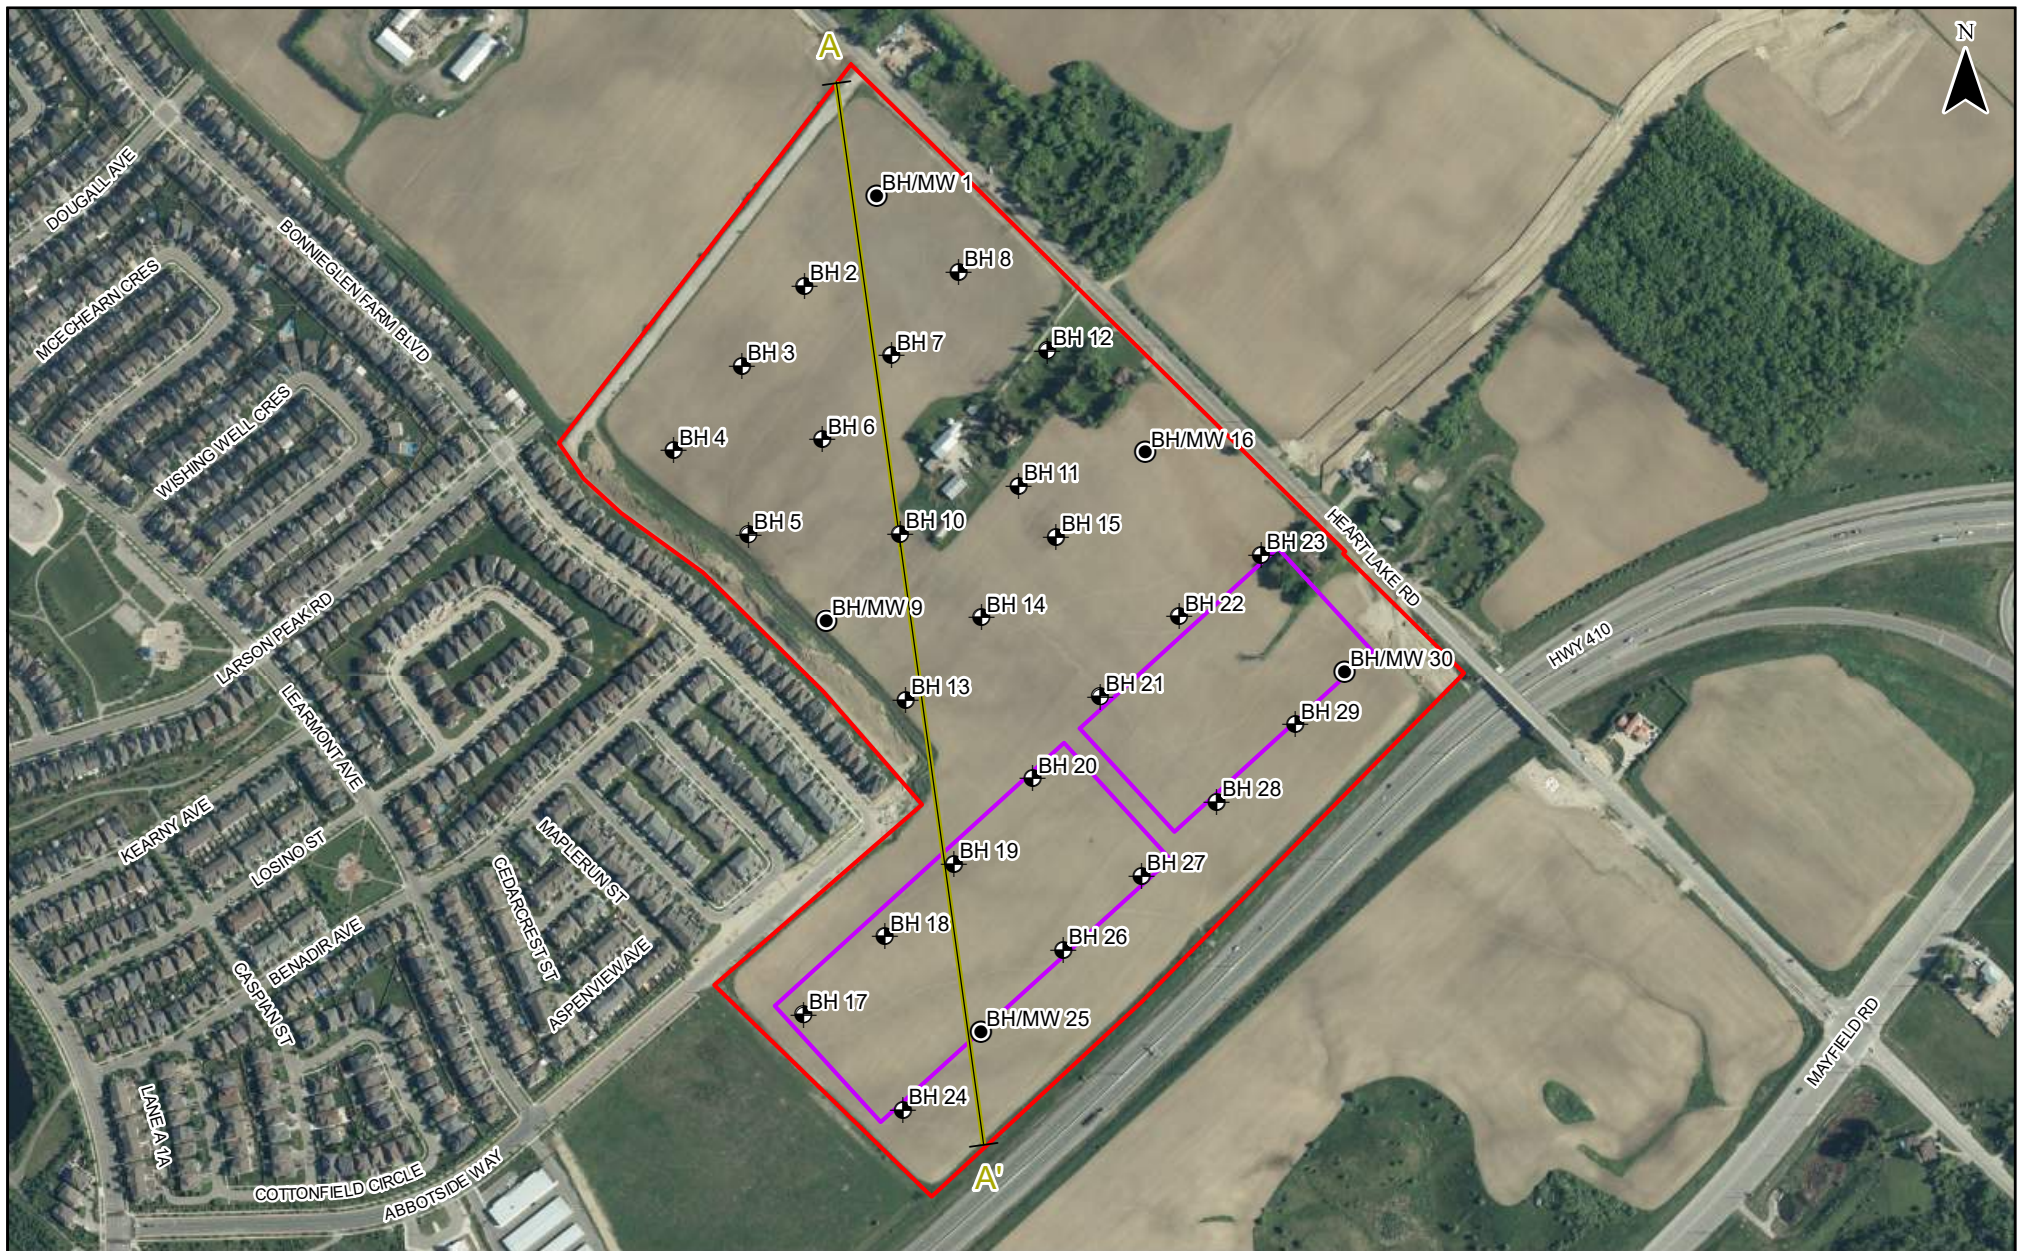
The borehole and monitoring well locations are shown on Figure 4. Geological cross-sections were generated based on the available borehole logs completed as part of the previous and current investigations and shown on Figure 5 (Cross section A-A'). The cross section shows a simplified representation of soil conditions and soil deposits may be interconnected differently than represented. Borehole logs used to generate both cross-sections are provided in Appendix B.

Infiltration rate testing locations are shown on Figure 4 and infiltration rate analysis is provided in Appendix E.

EXP completed four (4) infiltration rate tests (INF 1, INF 9, INF 25 and INF 30) within the Site area on October 7 and 12, 2021. These tests were conducted in proximity of selected monitoring wells: September 7, 2021, at BH/MW 1 (INF 1), BH/MW 9 (INF 9), BH/MW 30 (INF 30) and BH/MW 25 (INF 25).

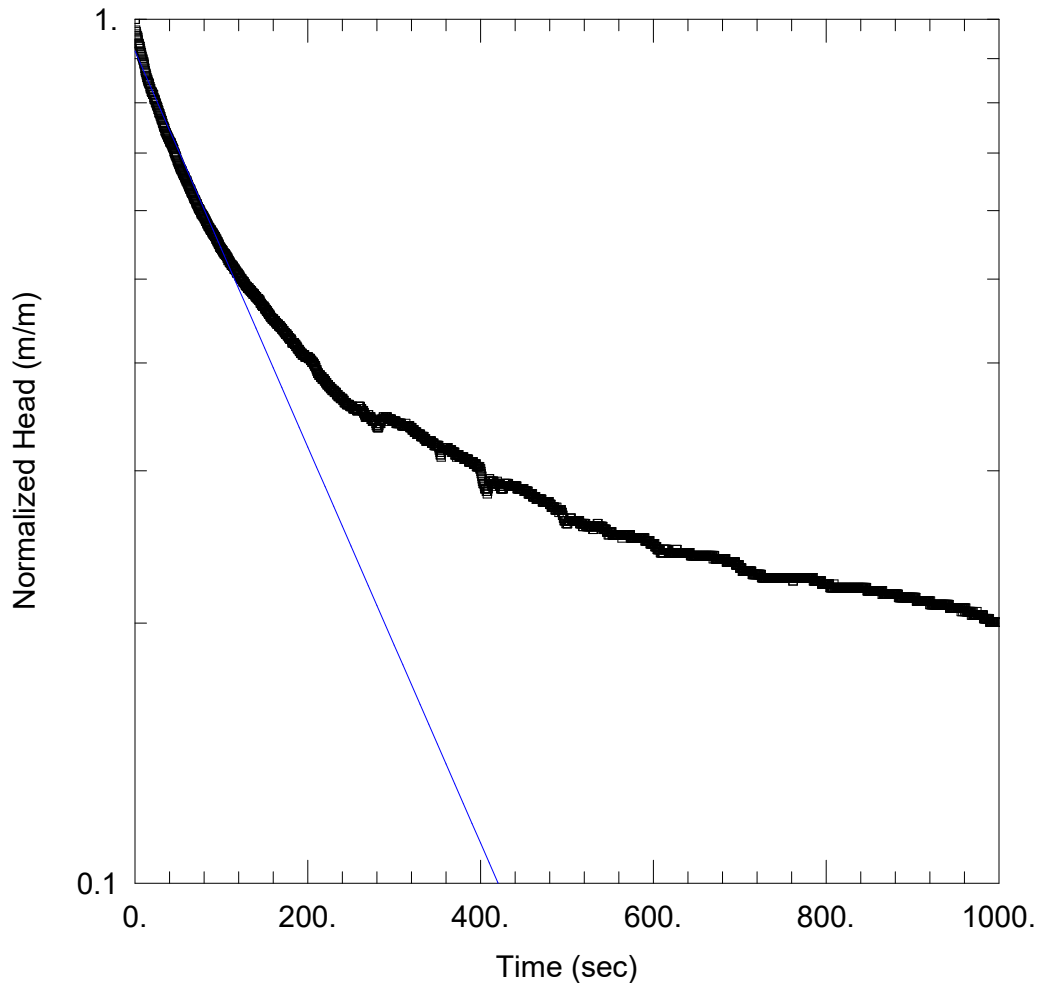
WELL TEST ANALYSIS

Aquifer Model: Unconfined Solution Method: Hvorslev
 K = 3.058E-6 m/sec $y_0 =$ 1.417 m

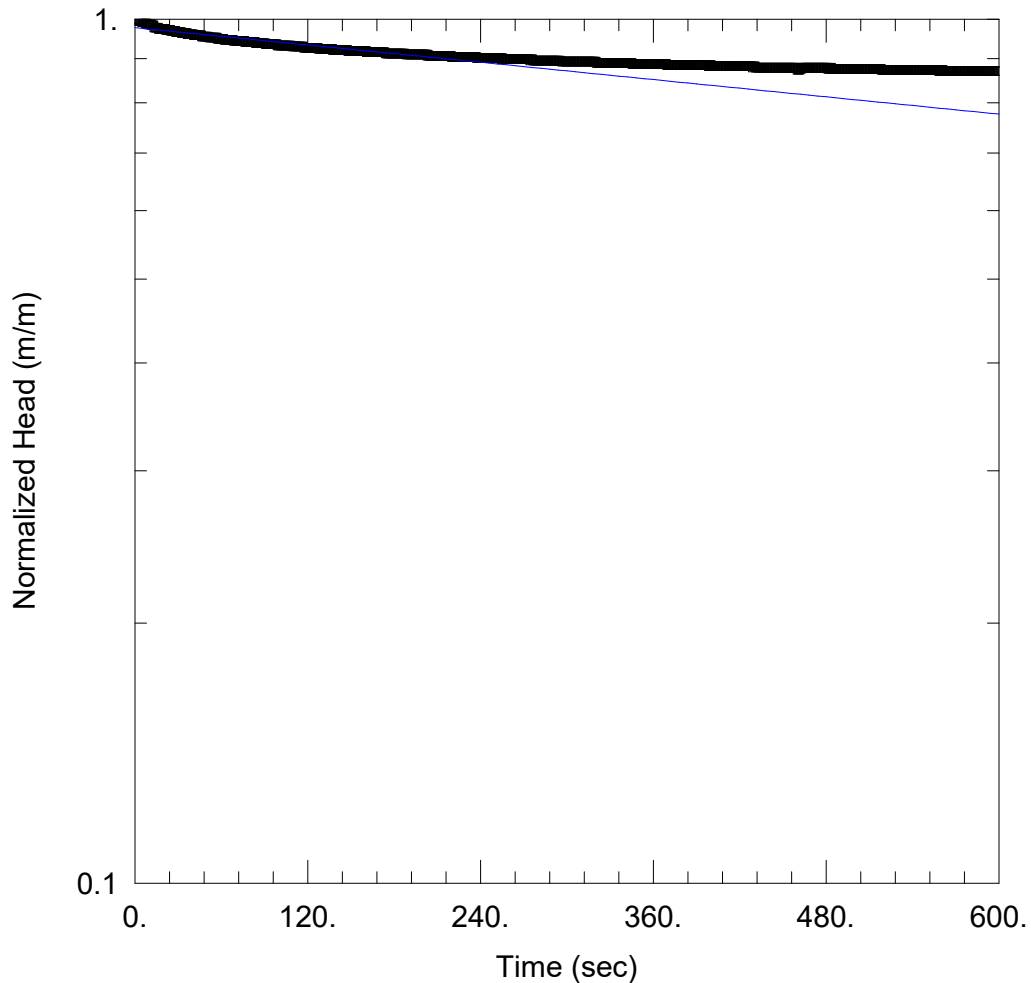
WELL TEST ANALYSIS

Aquifer Model: Unconfined Solution Method: Hvorslev
 K = 3.976E-7 m/sec y_0 = 1.041 m

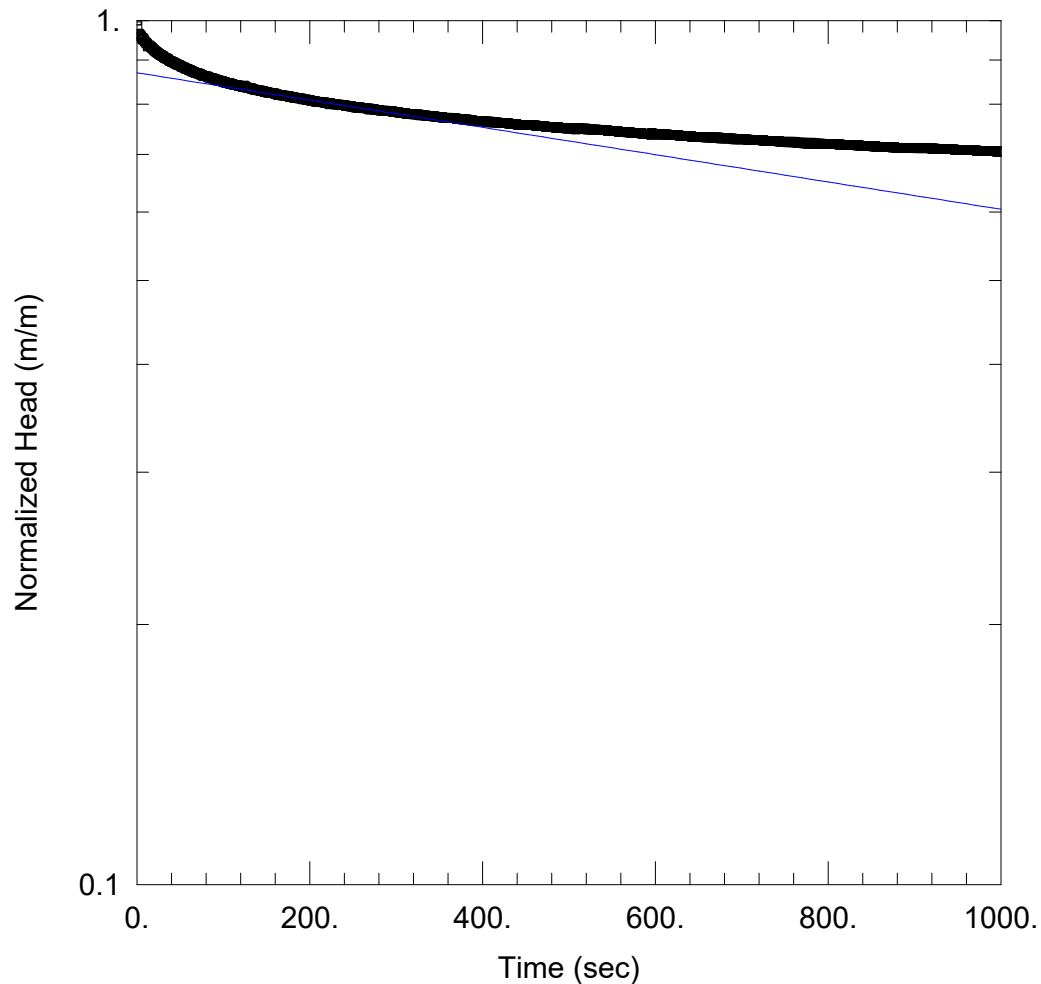
WELL TEST ANALYSIS

Aquifer Model: Unconfined Solution Method: Hvorslev
 $K = 3.288E-7$ m/sec $y_0 = 1.626$ m

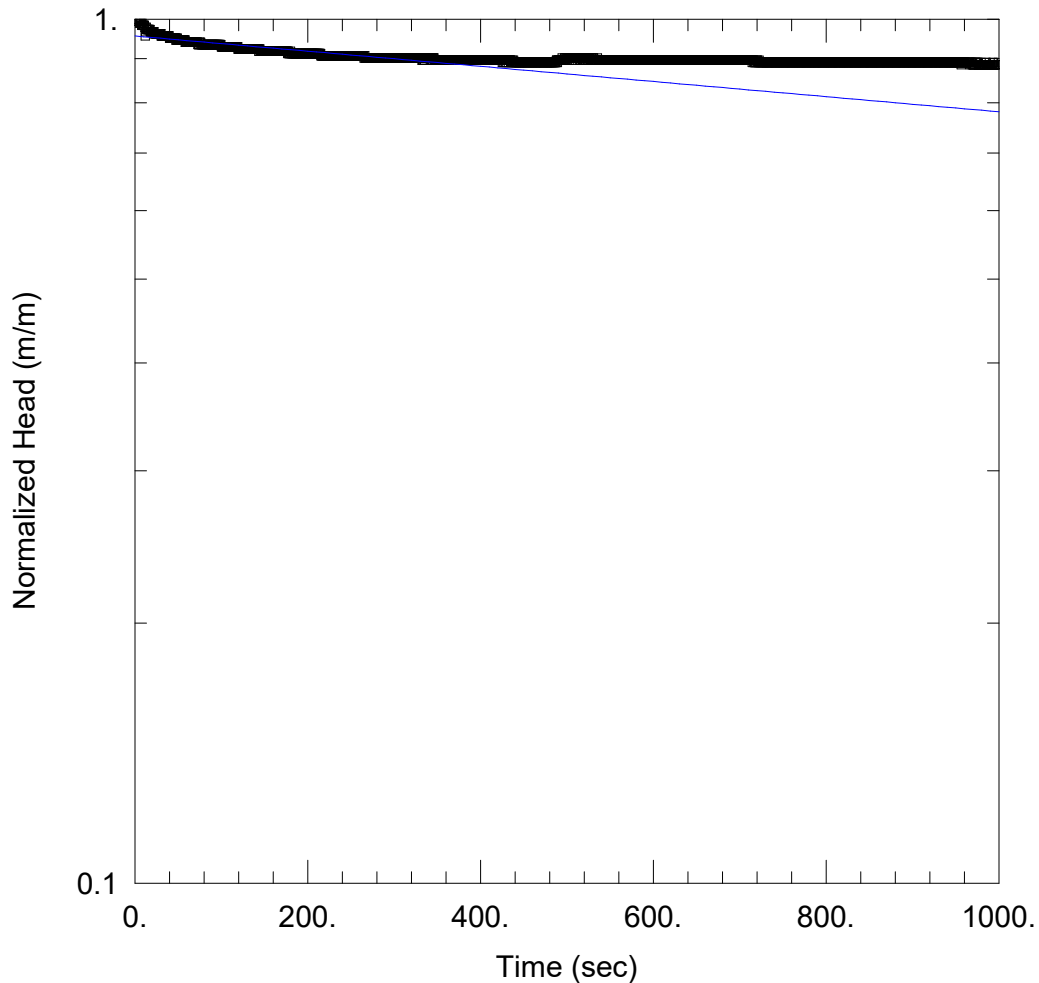
WELL TEST ANALYSIS

Data Set: E:\BRM\BRM-21004344-D0\50 Input\Field Work\SWRT\Working File\BH 25.aqt
 Date: 10/14/21 Time: 15:06:38

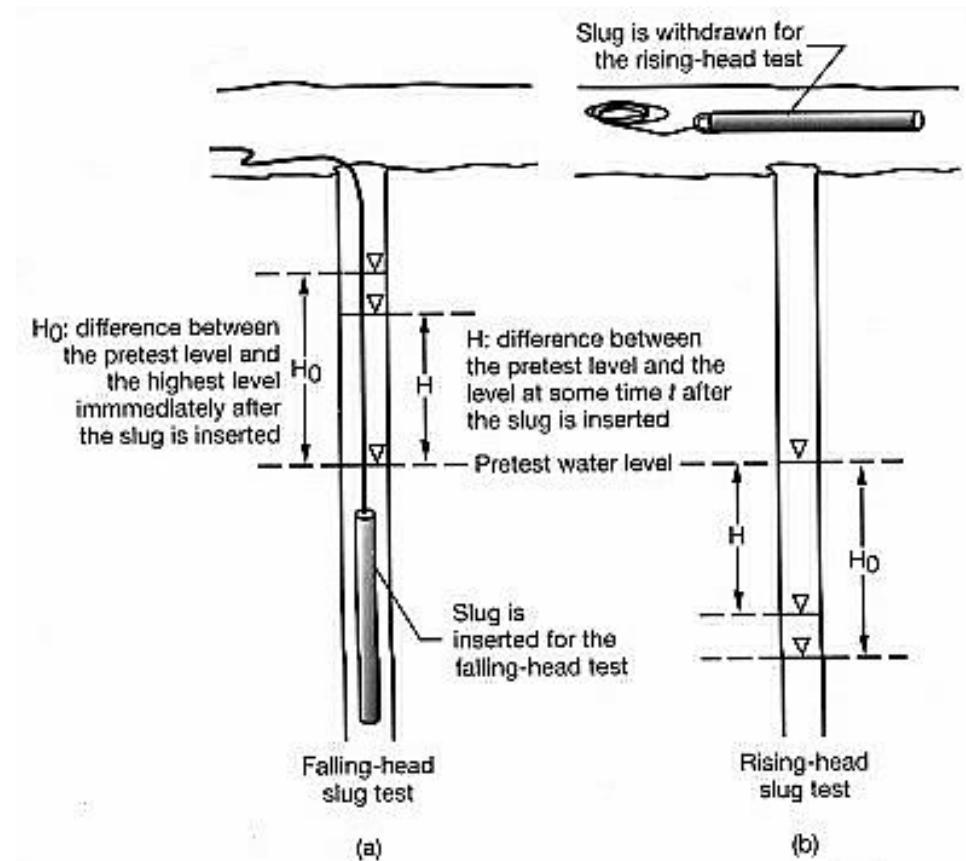
The figure below depicts a schematic of a slug and bail test and the respective water level changes.

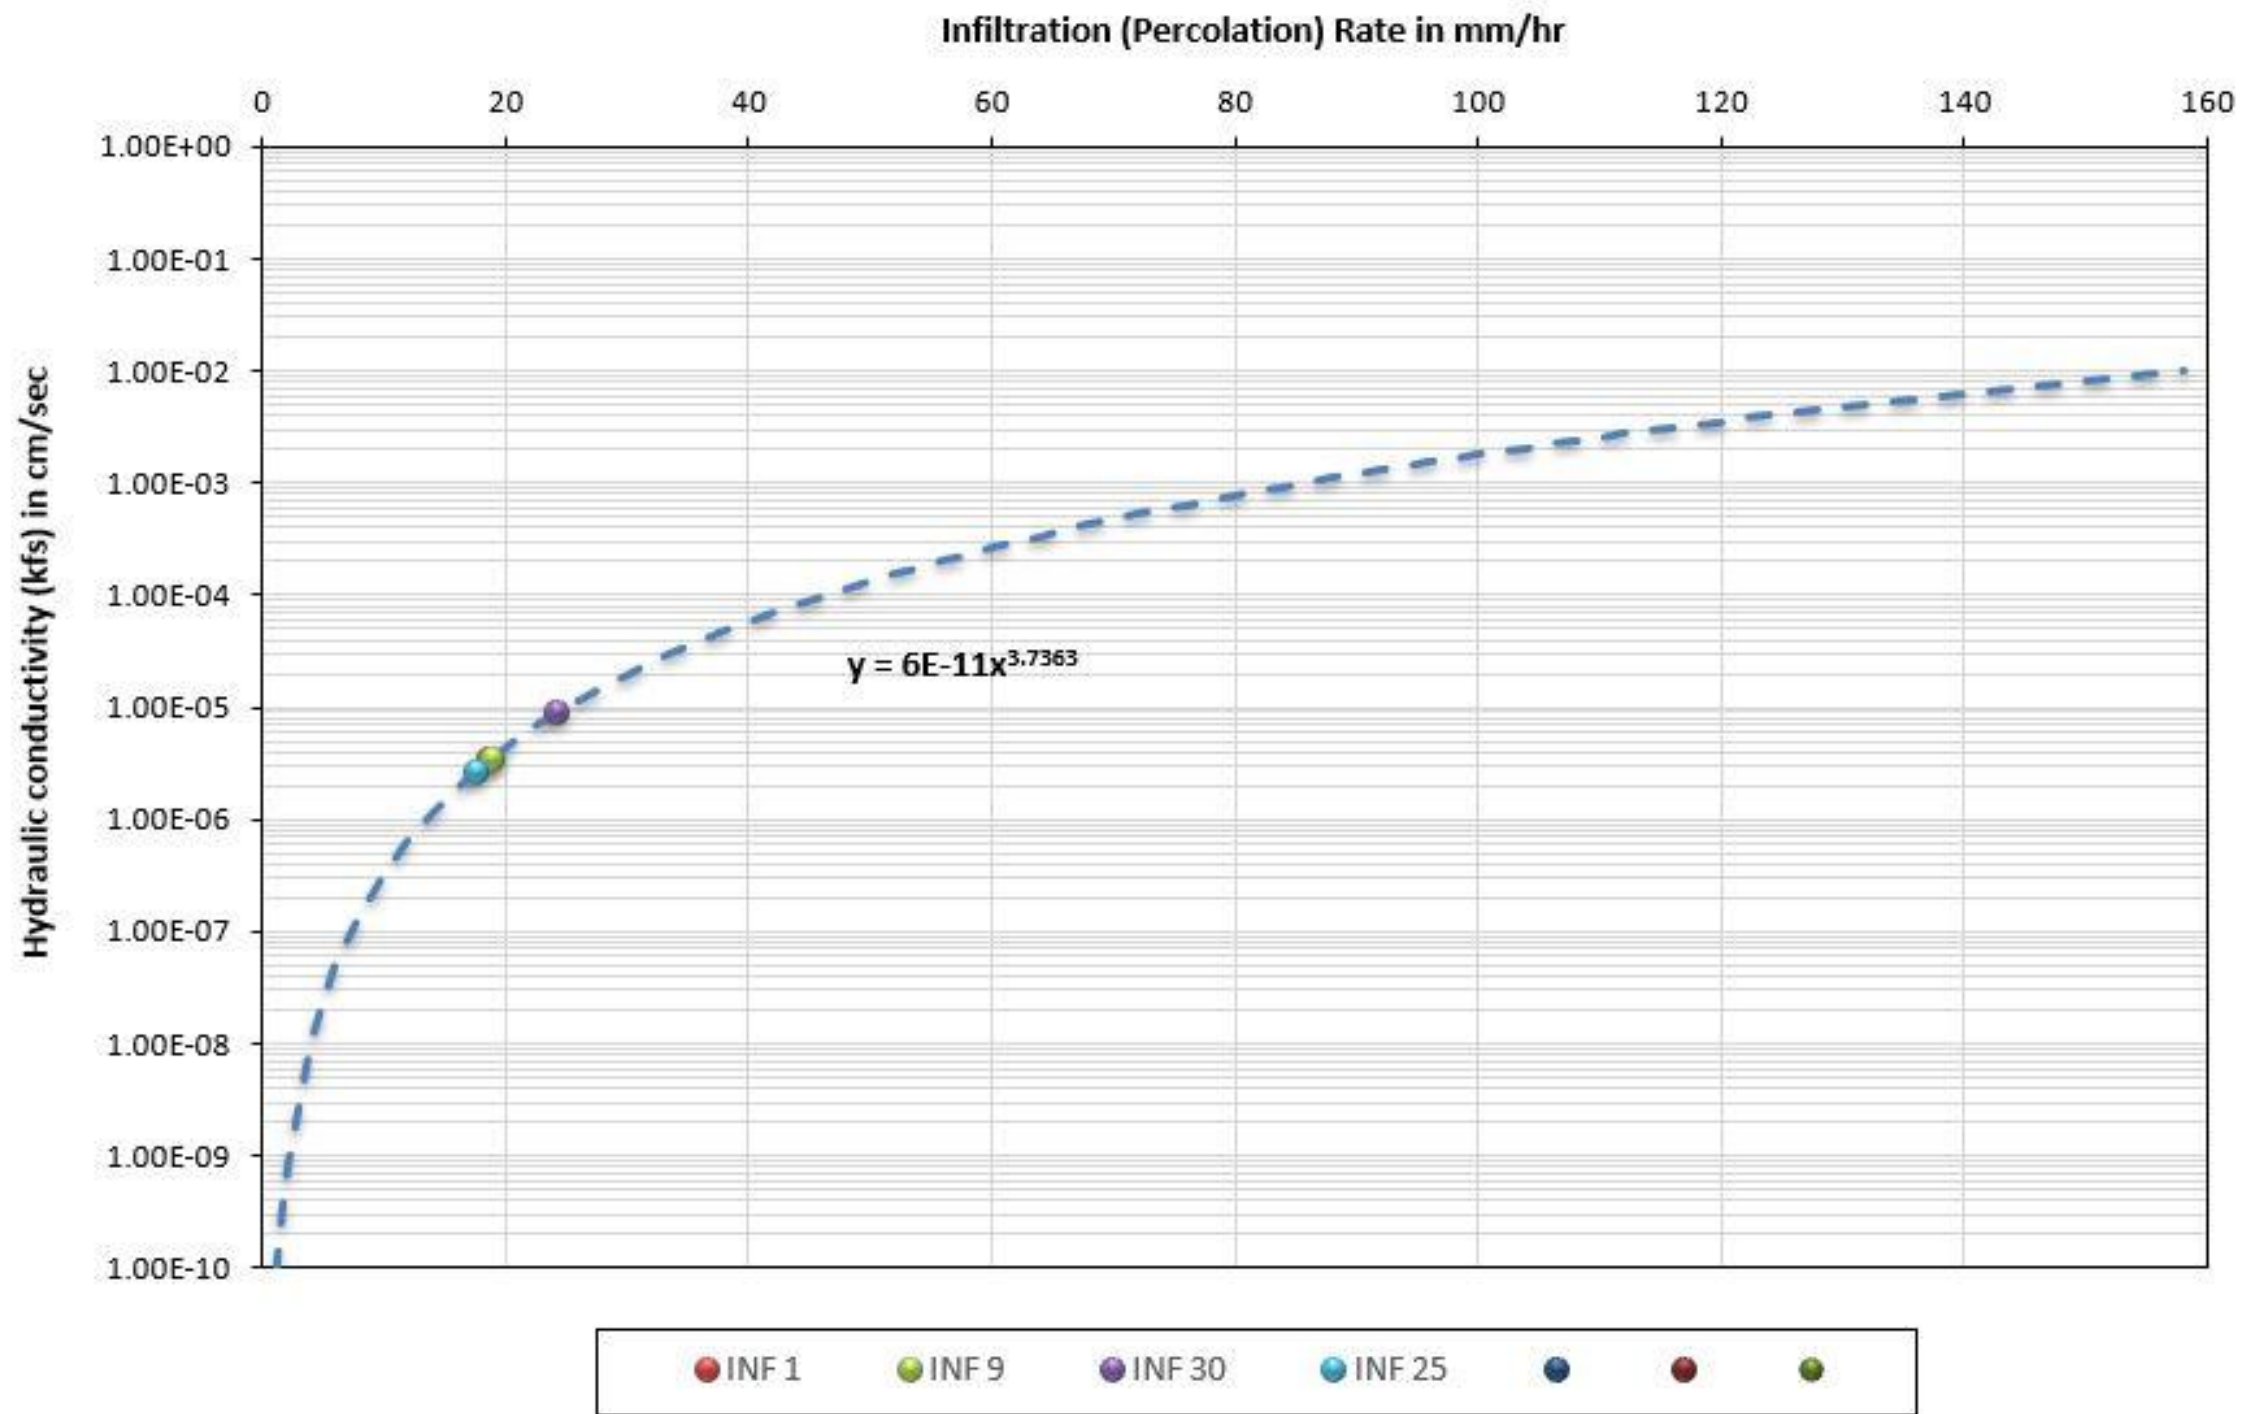
Kfs: hydraulic conductivity (cm/sec)
IR: infiltration rate (mm/hr)
DIR: design infiltration rate (mm/hr)
SCF: Safety Correction Factor (based on the chart recommended by CVC and TRCA, 2010)

**Figure : Approximate relationship between infiltration rate and hydraulic conductivity
(LID SWM planning and Design Guide, Appendix C1)**

The stratigraphy of the shallow subsurface comprises a silt/sand with some pebbles. Table 3.5 below shows a summary of field saturated hydraulic conductivity (Kfs) testing and design infiltration rates, as per the Low Impact Development (LID) Stormwater Management Planning and Design Guide, CVC – TRCA, 2010, Appendix G. The estimated field saturated hydraulic conductivities were correlated to infiltration rates based on the relationship provided in Appendix D of the guideline.
