June 14, 2022

## Phase I Environmental Site Assessment 12210, 12280 and 12304, Heart Lake Road, Caledon, Ontario

BRM-21004344-A0

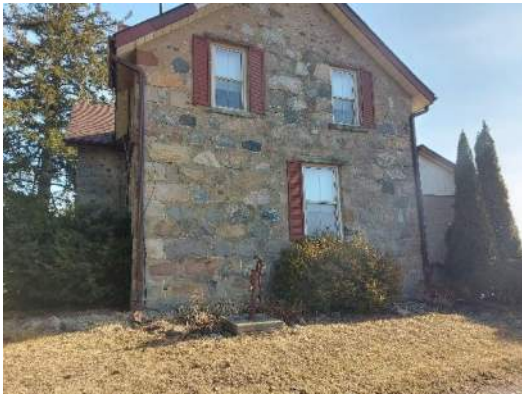
Three (3) domestic water supply wells were observed by EXP at the time of the Site visit. One well was located west of Building A and another located north of Building C, both are reportedly still in operation. Another well was located southwest of Building B. However, this well was reportedly decommissioned.

**Photograph No. 1**  
**View of Building A and water well**  
**(Looking east)**

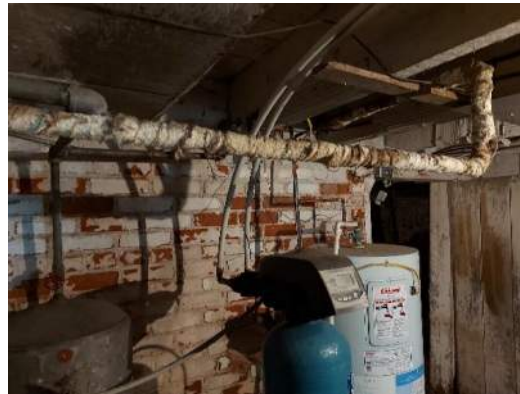
Based on the approximate ages of the on-Site structures (constructed between 1867 and 1953) it is considered possible that ACMs are present in the building materials. At the time of the site visit, vinyl floor tiles and pipe fitting insulation were observed in Building A. Drywall was observed in Building B and Building C.

**Photograph No. 2**  
**Suspected ACM pipe insulation**  
**(Basement of Building A)**

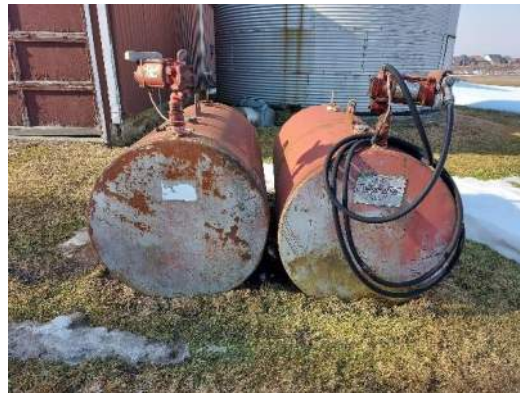
Two (2) aboveground storage tanks (ASTs) were observed on the exterior landscaped area to the east of the silo, each with approximately 300 to 400-gallon capacity. Reportedly one of the ASTs is empty and the other contains a small amount of diesel fuel. The ASTs were observed to be in good condition, with no obvious staining.

**Photograph No. 4**  
**View of two exterior diesel-containing ASTs**  
**(Looking west)**

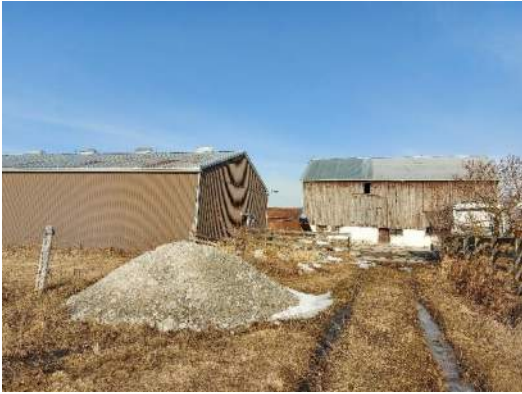
One stockpile was observed on the Site at the time of the Site visit. The stockpile was approximately 9 m<sup>3</sup> in size and was located south of the farming structures. A sample of the stockpiled material was tested as part of the Geotechnical investigation carried out in conjunction with this Phase I ESA. Chemical quality of the sample was found to be in conformance with the MECP criteria applicable to the Site.

**Photograph No. 7**  
**View of stockpile**  
**(Looking north)**

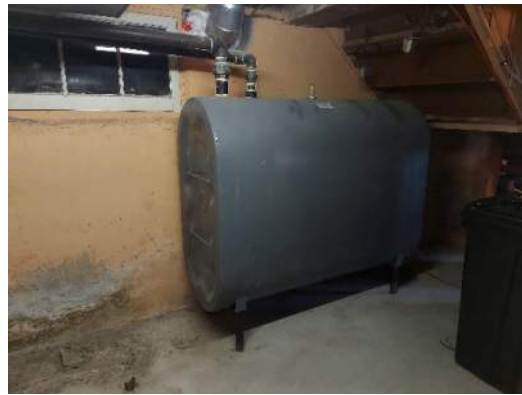
One (1) AST was observed in the basement of Building B and was reportedly installed in 2003. The AST holds diesel fuel for heating and was observed to be in good condition, with no obvious associated staining.

**Photograph No. 10**  
**View of the interior AST**  
**(Basement of Building B)**
