Phase I Environmental Site Assessment 12210, 12280 and 12304, Heart Lake Road, Caledon, Ontario

Phase I Environmental Site Assessment

BRM-21004344-A0

April 14, 2021

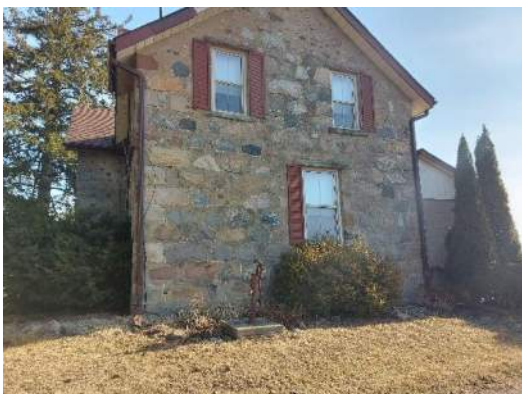
Photograph No. 1
View of Building A and water well
(Looking east)

Three (3) domestic water supply wells were observed by EXP at the time of the Site visit. One well was located west of Building A and another located north of Building C, both are reportedly still in operation. Another well was located southwest of Building B. However, this well was reportedly decommissioned.

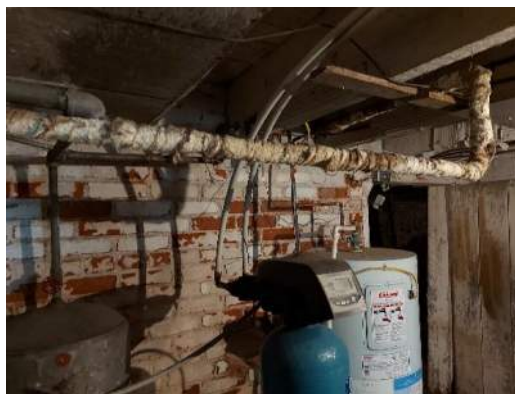
Photograph No. 2
Suspected ACM pipe insulation
(Basement of Building A)

Based on the approximate ages of the on-Site structures (constructed between 1867 and 1953) it is considered possible that ACMs are present in the building materials. At the time of the site visit, vinyl floor tiles and pipe fitting insulation were observed in Building A. Drywall was observed in Building B and Building C.

| Issues Identified | Recommendations | Rationale |
|---|--|---|
| Regulated Building Materials (ACMs, UFFI, Lead and/or Mercury, ODSs) | For building demolition, it is recommended that these materials be managed in accordance with the applicable regulations and guidelines. Conduct a Designated Substances Survey (DSS) prior to any demolition or renovation activities. | Once disturbed, these materials may be released into the environment and pose environmental and/or health concerns. |

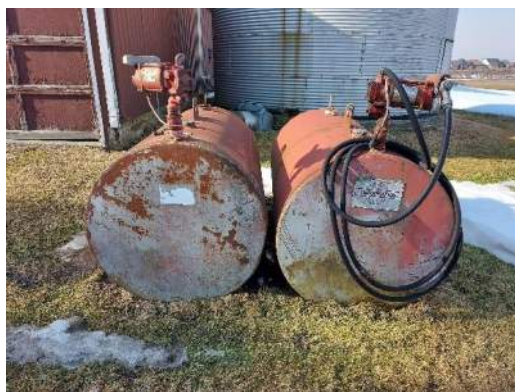
Photograph No. 4
View of two exterior diesel-containing ASTs
(Looking west)

Two (2) aboveground storage tanks (ASTs) were observed on the exterior landscaped area to the east of the silo, each with approximately 300 to 400-gallon capacity. Reportedly one of the ASTs is empty and the other contains a small amount of diesel fuel. The ASTs were observed to be in good condition, with no obvious staining.

| Issues of Potential Environmental Concern | Media and Potential Contaminants of Concern | Comments | Relative Degree of Environmental Risk |
|---|--|---|---|
| Two exterior diesel-containing ASTs located east of farmhouse structures | Soil and Groundwater PHCs, BTEX | Two ASTs were observed on the Site and for diesel storage for farming equipment use. | Low No staining was observed in the areas surrounding the ASTs. The ASTs were observed to be in good condition. |

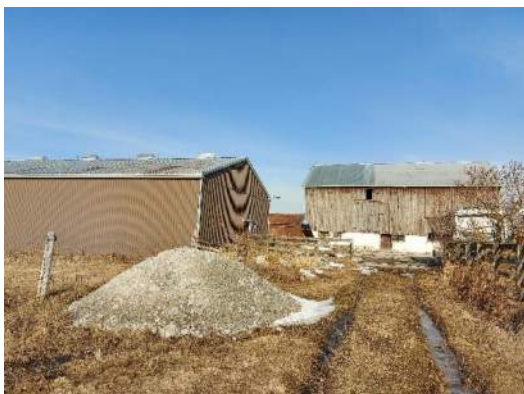
Photograph No. 7
View of stockpile
(Looking north)

One stockpile was observed on the Site at the time of the Site visit. The stockpile was approximately 9 m³ in size and was located south of the farming structures. A sample of the stockpiled material was tested as part of the Geotechnical investigation carried out in conjunction with this Phase I ESA. Chemical quality of the sample was found to be in conformance with the MECP criteria applicable to the Site.

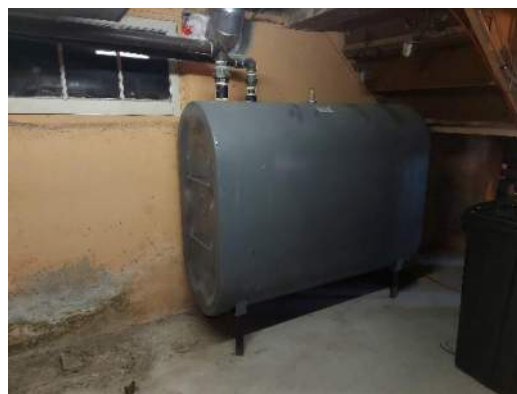
Photograph No. 10
View of the interior AST
(Basement of Building B)

One (1) AST was observed in the basement of Building B and was reportedly installed in 2003. The AST holds diesel fuel for heating and was observed to be in good condition, with no obvious associated staining.

| Issues of Potential Environmental Concern | Media and Potential Contaminants of Concern | Comments | Relative Degree of Environmental Risk |
|---|--|---|---|
| One diesel-containing AST in the basement of Building B | Soil and Groundwater PHCs, BTEX | One AST was observed in the basement of Building B associated with building heating. | Low The AST was reportedly installed in 2003 and no staining associated with it was observed. The AST and concrete floor were observed to be in good condition. |
