CULTURAL HERITAGE IMPACT ASSESSMENT

12434 DIXIE ROAD

TOWN OF CALEDON, ONTARIO

February 2022
(updated March 2022)

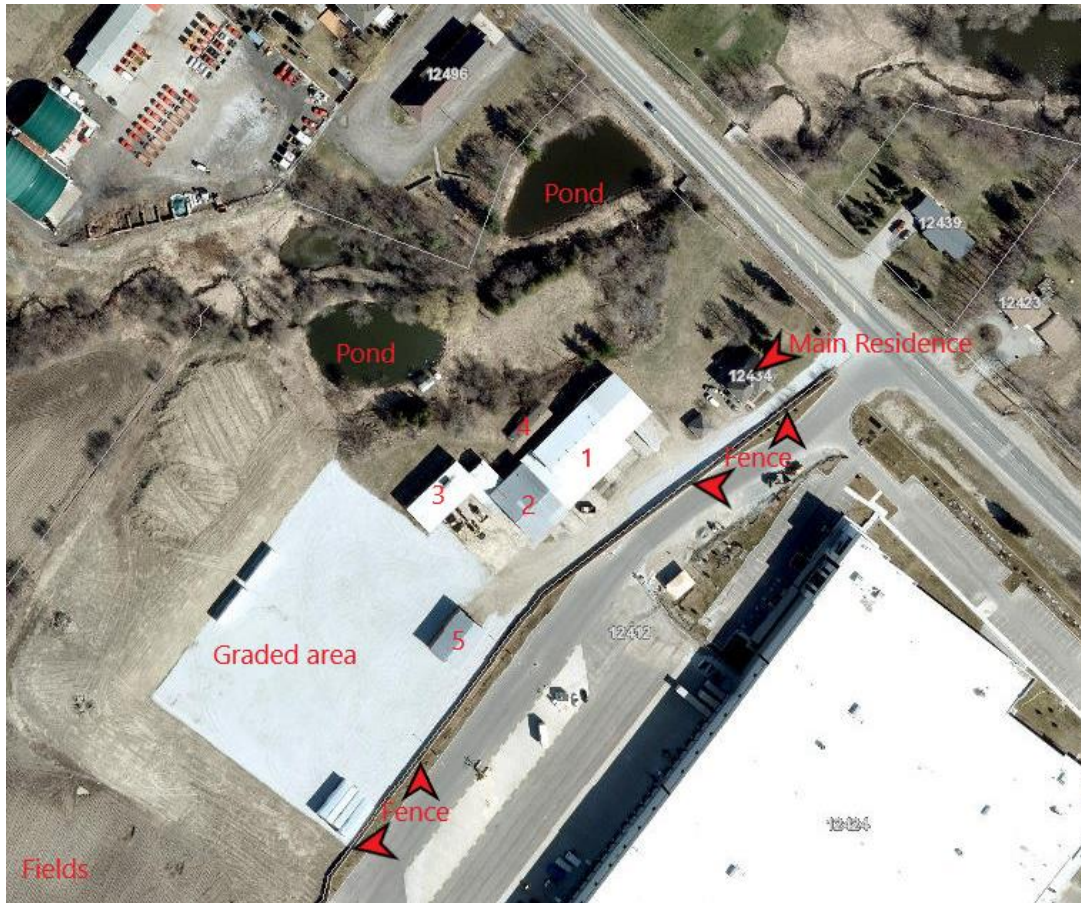
Figure 3: Site plan of the eastern portion of the subject property (Town of Caledon 2022)

All outbuildings on the subject property are located west of the main residence and have been numbered 1 to 5 for ease of description (see Figure 3). Due to the extremely icy conditions of the property, not all outbuilding interiors were accessed during ASI's site visit. Outbuilding No. 1 is a low and long single storey structure with brown aluminum siding and a gabled roof (Plate 59). Its function is for shifting truck loads (cross docking), though it was formerly used for apple processing. Outbuilding No. 2 is attached to the west side of Outbuilding No. 1. It features brown aluminum siding, a gabled roof, and two large garage doors on the west side, providing access for vehicles into the large and primarily open interior (Plate 60 and Plate 61). Its current function is unknown. Both Outbuildings No. 1 and 2 appear to have been constructed between 1954 and 1974. Outbuilding No. 3, located northwest of Outbuilding No. 2, is a rectangular-shaped structure with brown siding and a large garage door (Plate 62). The interior was empty at the time of ASI's visit (Plate 63). Outbuilding No. 4 is a rectangular-shaped structure with windows facing all directions and a south-facing door (Plate 64). This structure may have provided temporary living accommodations for workers on the former apple orchard, possibly from the 1970s to the early 2000s. Outbuilding No. 5 is a large garage with reddish-brown aluminum siding (Plate 65). The interior includes a large parking pad as well as a room in the rear with a loft area above (Plate 66). Outbuildings No. 3 to 5 were likely constructed between 1974 and 1994.

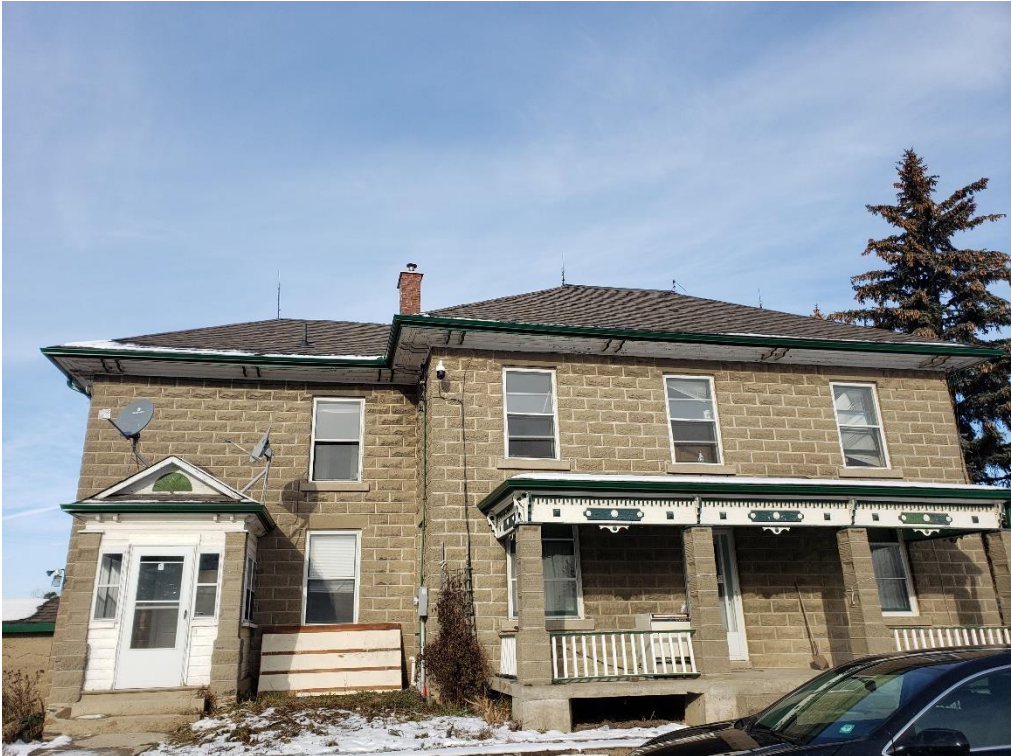
Plate 8: Southern elevation of 12434 Dixie Road (ASI 2021)

All windows on the main and second floors, which consist of large 1/1 wooden windows, feature concrete lintels and sills, and all have aluminum storms (Plate 16). All doors appear to have been updated. The entire house is clad in rusticated concrete block, an early example of this material for residential construction, since it only started being produced around the turn of the twentieth century (Simpson 1989). *The Globe* first noted the sudden prevalence of concrete block as a building material in Canada in a 1905 article that highlighted the ease in which it could be moulded into various styles, shapes and design. It was also thought to be desirable as a frost-proof, damp-proof, and fire-proof material (The Globe 1905) (Plate 17).⁴ The residence features primarily cut stone foundation, though field stone foundation is evident underneath the porches (Plate 18 and Plate 19). The secondary entrance is found within an enclosed porch featuring wooden siding and concrete block pillars (Plate 20) on the south elevation. Finally, there is an internal brick chimney, which extends out of the residence.

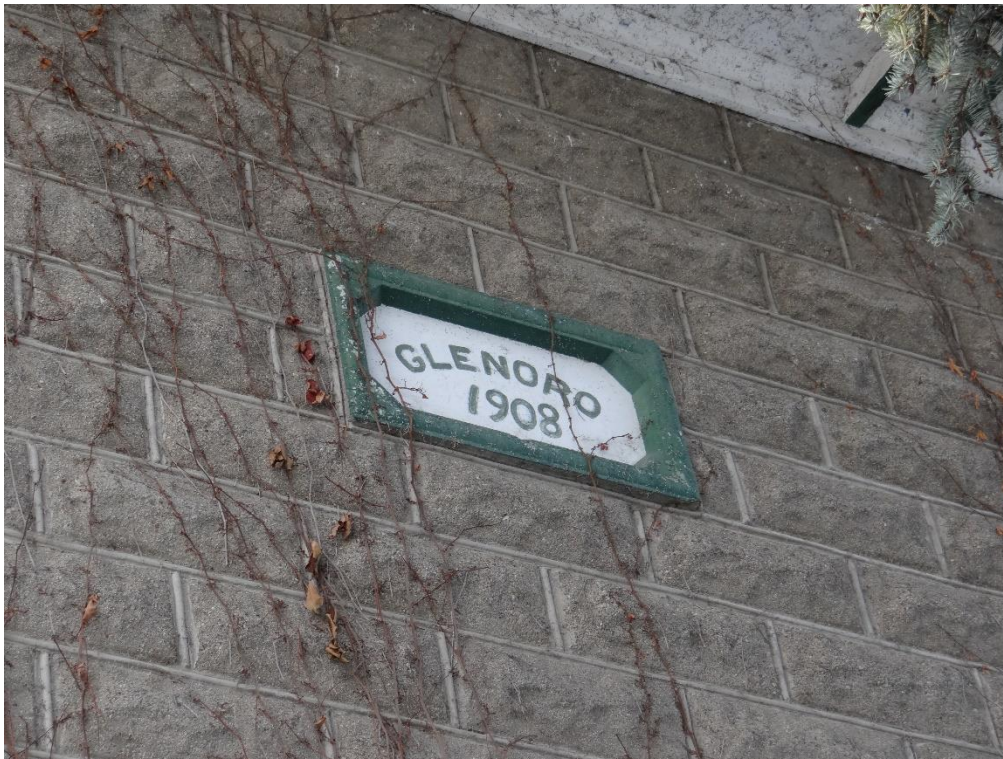
Plate 12: Date plate on second storey of east façade (ASI 2021)

The subject residence has a dateplate that states “Glenoro 1908” which signifies the house’s date of construction, as well as what was likely the farm’s name. As such, the house was erected under the ownership of John Speirs. John Speirs was a Liberal in politics, and a lifelong member of the Mayfield Presbyterian Church, even serving as its caretaker during the 1909-10 years (PAMA; Mayfield United Church Committee 1980). The 1911 census (Library and Archives Canada 1911) identifies John Speirs as 56 years of age and a farmer, married to Martha, and with six children who lived in the subject residence, all of whom were between the ages of 13 and 22. The full family is pictured below (Figure 8).

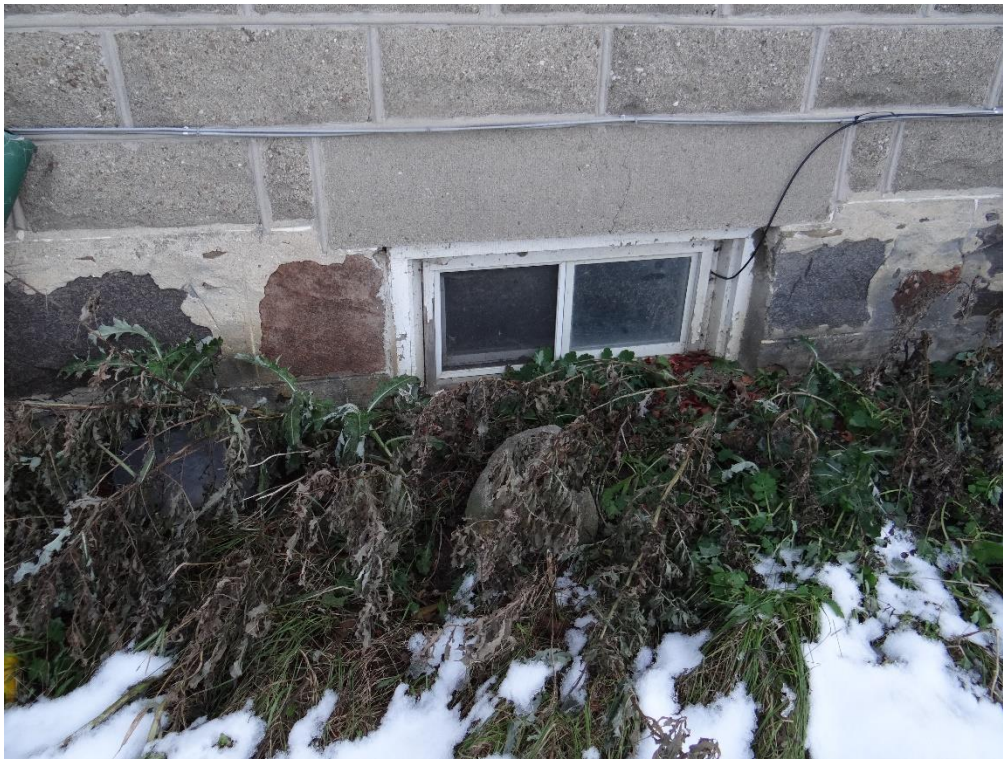
Plate 18: Basement window with concrete lintel and cut stone foundation (ASI 2021)

The basement of 12434 Dixie Road consists of four large rooms and features stone foundation and walls with parging and a concrete floor. The foundation walls are most clearly visible in the most eastern room, which extends the width of the house and features one north-facing and one south-facing window (Plate 21). The middle of the basement is occupied by two separate rooms. The northern room is a storage area and consists of built-in cabinets and one north-facing window (Plate 22). The southern room of the basement includes the furnace, hot water tank, and electrical panel. Wood support beams are visible, as is one south-facing window (Plate 23). Wooden doors provide access between the middle rooms and the basement's most western room. This room provides access to the main floor via a wooden staircase along its northern wall, as well as access to the exterior via a metal door and enclosed concrete staircase. The room also features wood and steel beams, laundry facilities, and one west-facing window (Plate 24 and Plate 25).

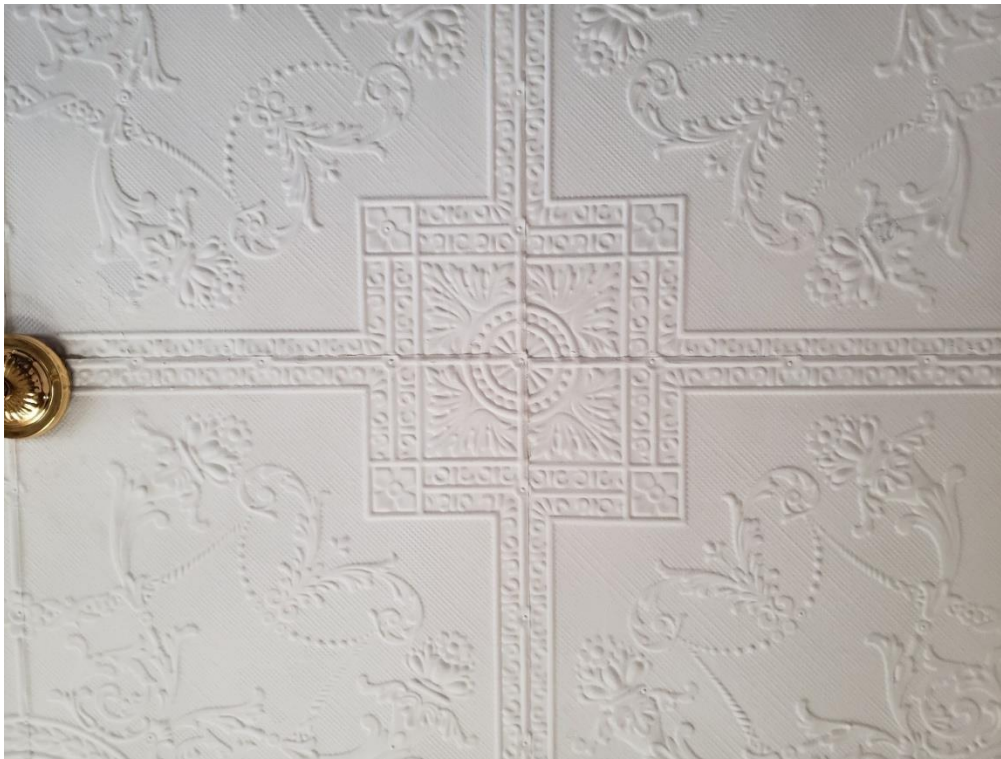
Plate 28: Decorative tin ceiling in main floor living room area (ASI 2021)

The main part of the house is composed of a small entrance foyer and four large separate rooms. The two eastern-most rooms have decorative tin ceilings and are separated by a large opening with woodend surrounds and wooden sliding doors (Plate 26 to Plate 28). A chandelier hangs in the southeastern room. Wallpaper covers the walls in the southeastern room while paint is used in the northeastern room. The dining room is located west of the northeastern living room and features painted walls, wooden door and window surrounds, and a door with access to the north (rear) balcony (Plate 29). The main floor’s front room accessed through the foyer, includes a spiral staircase that may be a newer addition, wood pannelled ceiling with wooden cross beam, chandelier, original or old air vents, and original door and window surrounds (Plate 30). The kitchen is located at the western side of the residence, in the “tail.” It has been newly renovated, including new floors, cabinets, and sink (Plate 31). Off the kitchen and along its north wall is a staircase down to the basement, a second staircase up to the second floor, and a newly renovated bathroom. A doorway to the enclosed secondary entrance is found on the south wall.

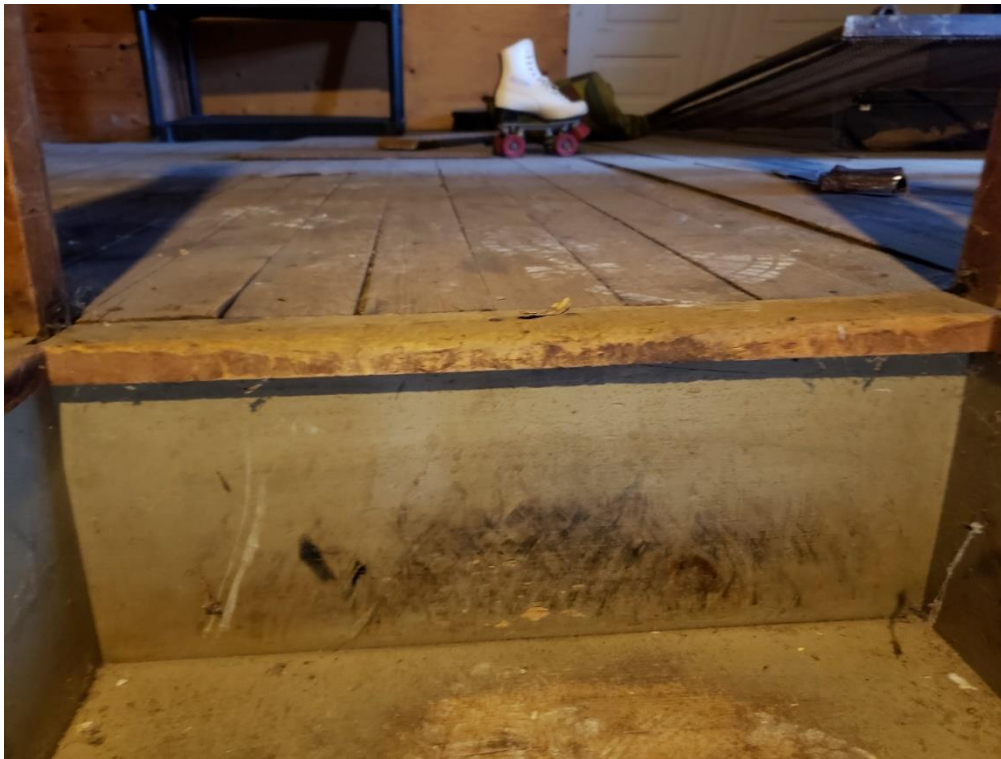
Plate 44: Wood flooring in attic (ASI 2021)

The attic is one large single room oriented along an east-west axis. The flooring is made of wood (Plate 44). The staircase down to the second floor is made of wood and has a wood bannister and wooden railings (Plate 45). Wood beams and framing support the hipped roof throughout the attic (Plate 46). A brick chimney is evident, the only visible remnant of a former fireplace and chimney combination that extended down through to the basement (Plate 47).

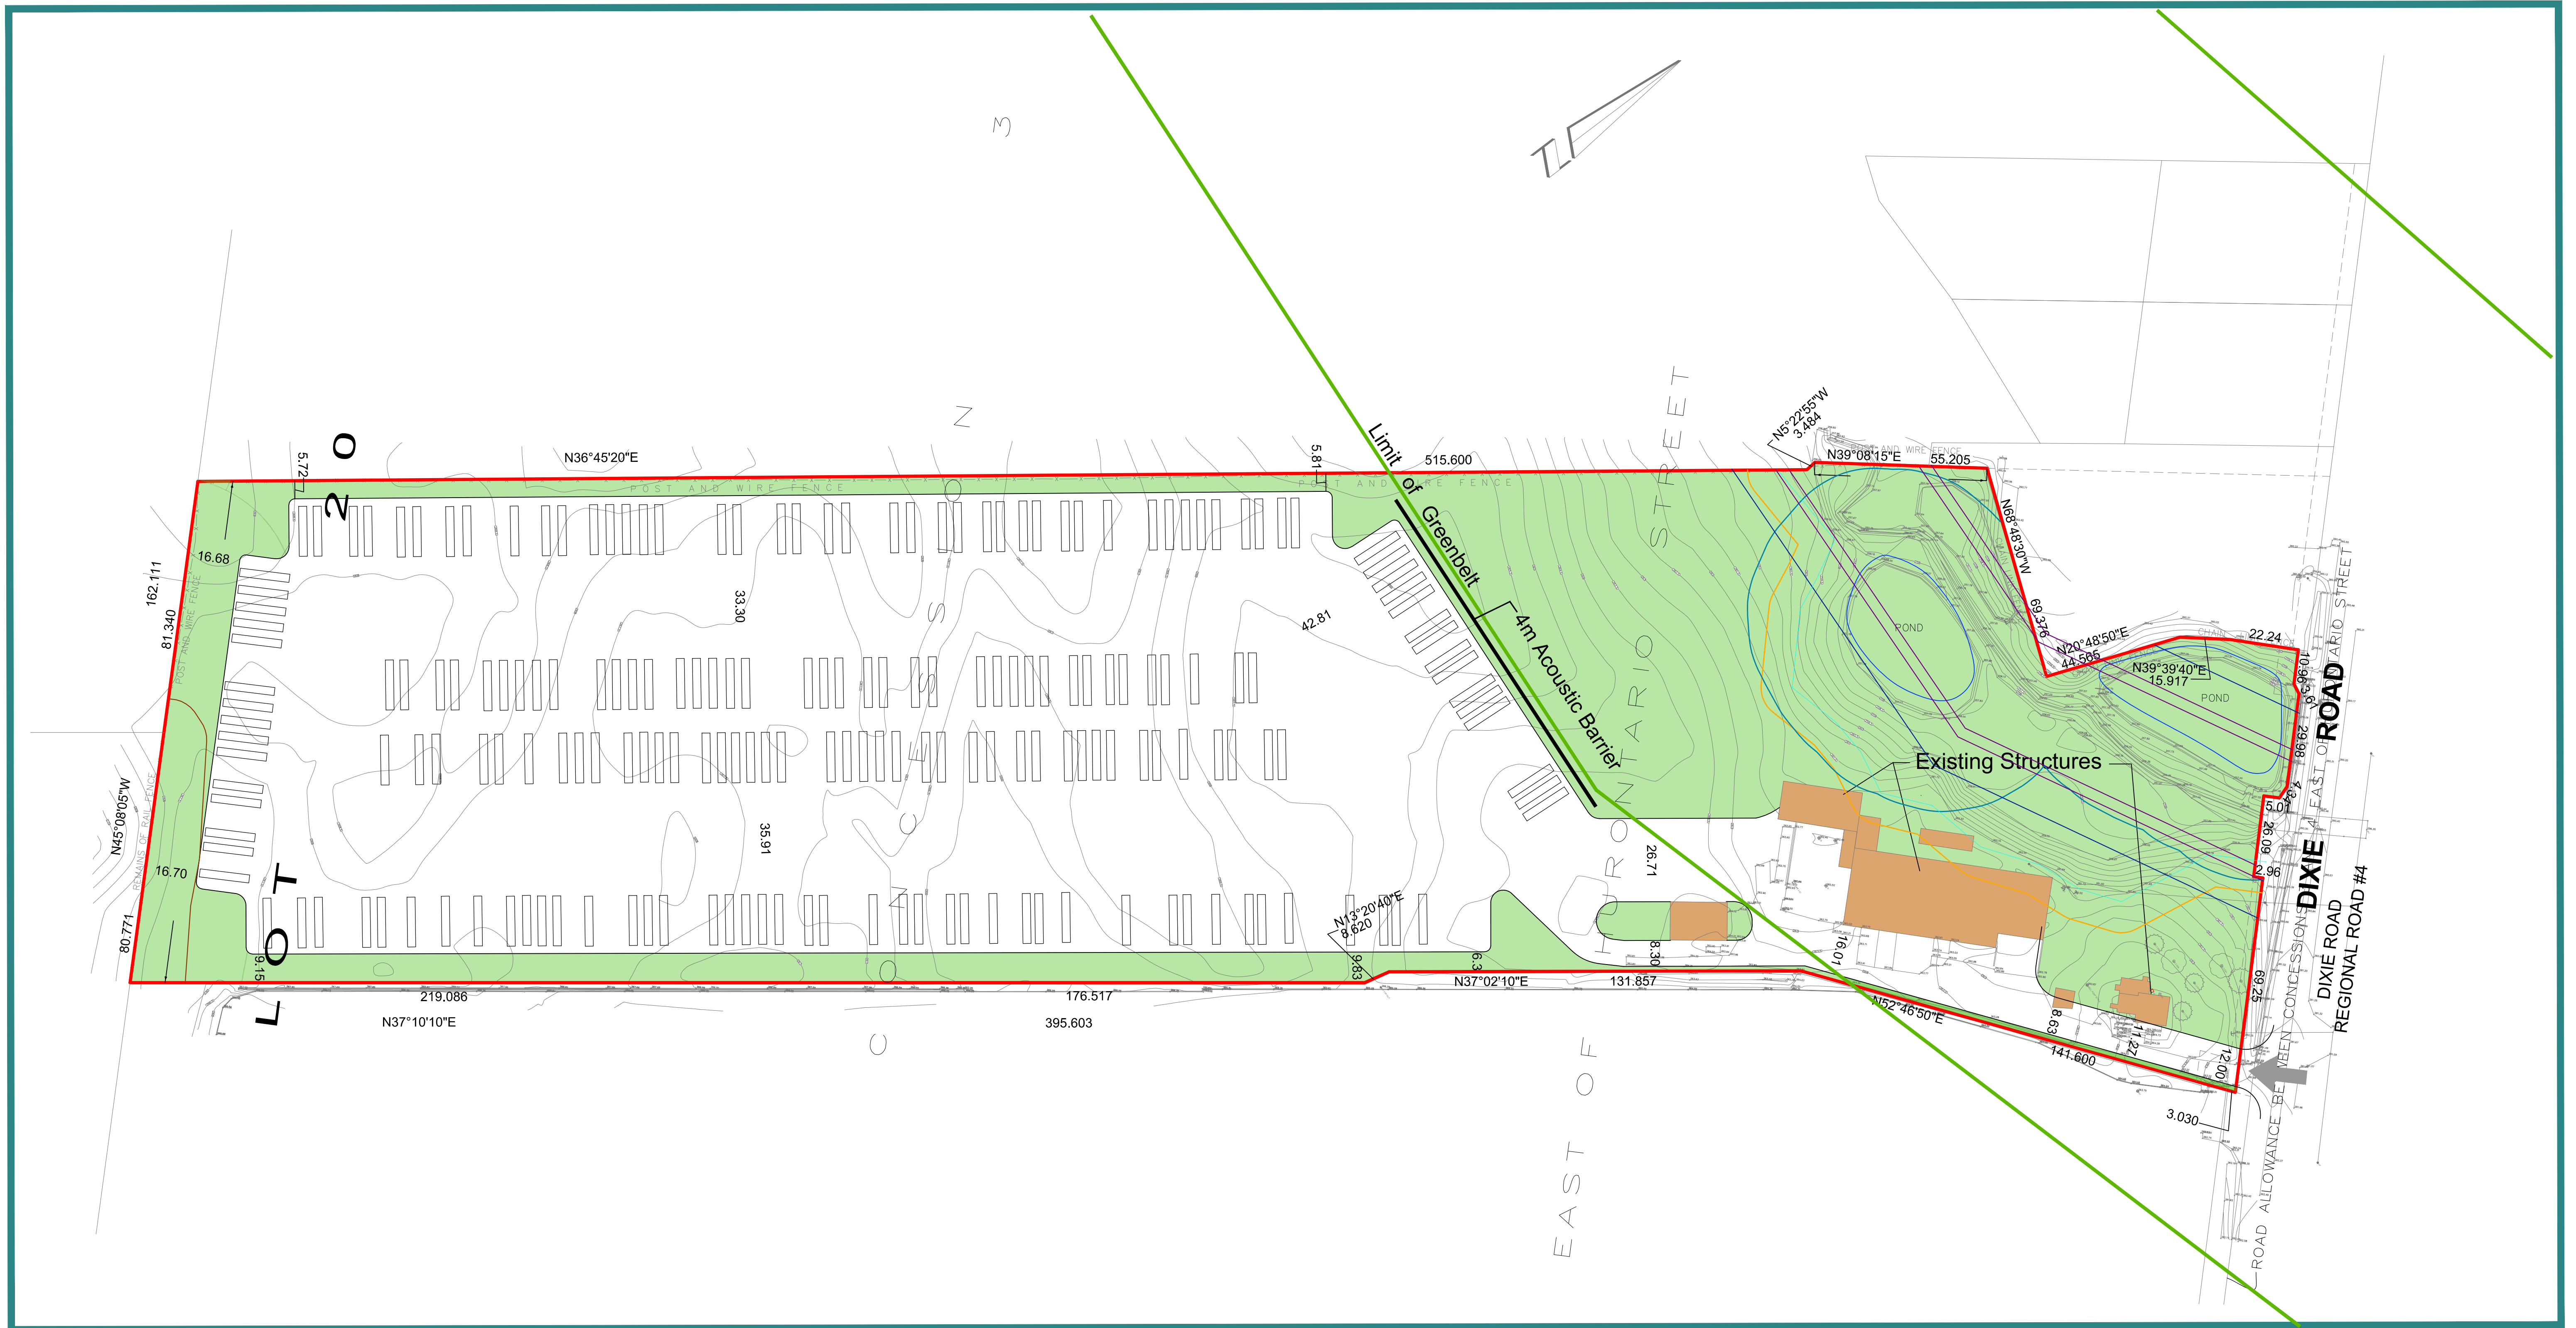
The site plan for the conceptual transport truck/trailer parking layout for the project identifies the eastern part of the property, including the residence, most outbuildings, and ponds as being part of the Greenbelt (see Appendix A).
