**Cultural Heritage Impact
Statement - 12489 Dixie Road,
Town of Caledon**

Final Report

December 6, 2024

Project Number: 160623114

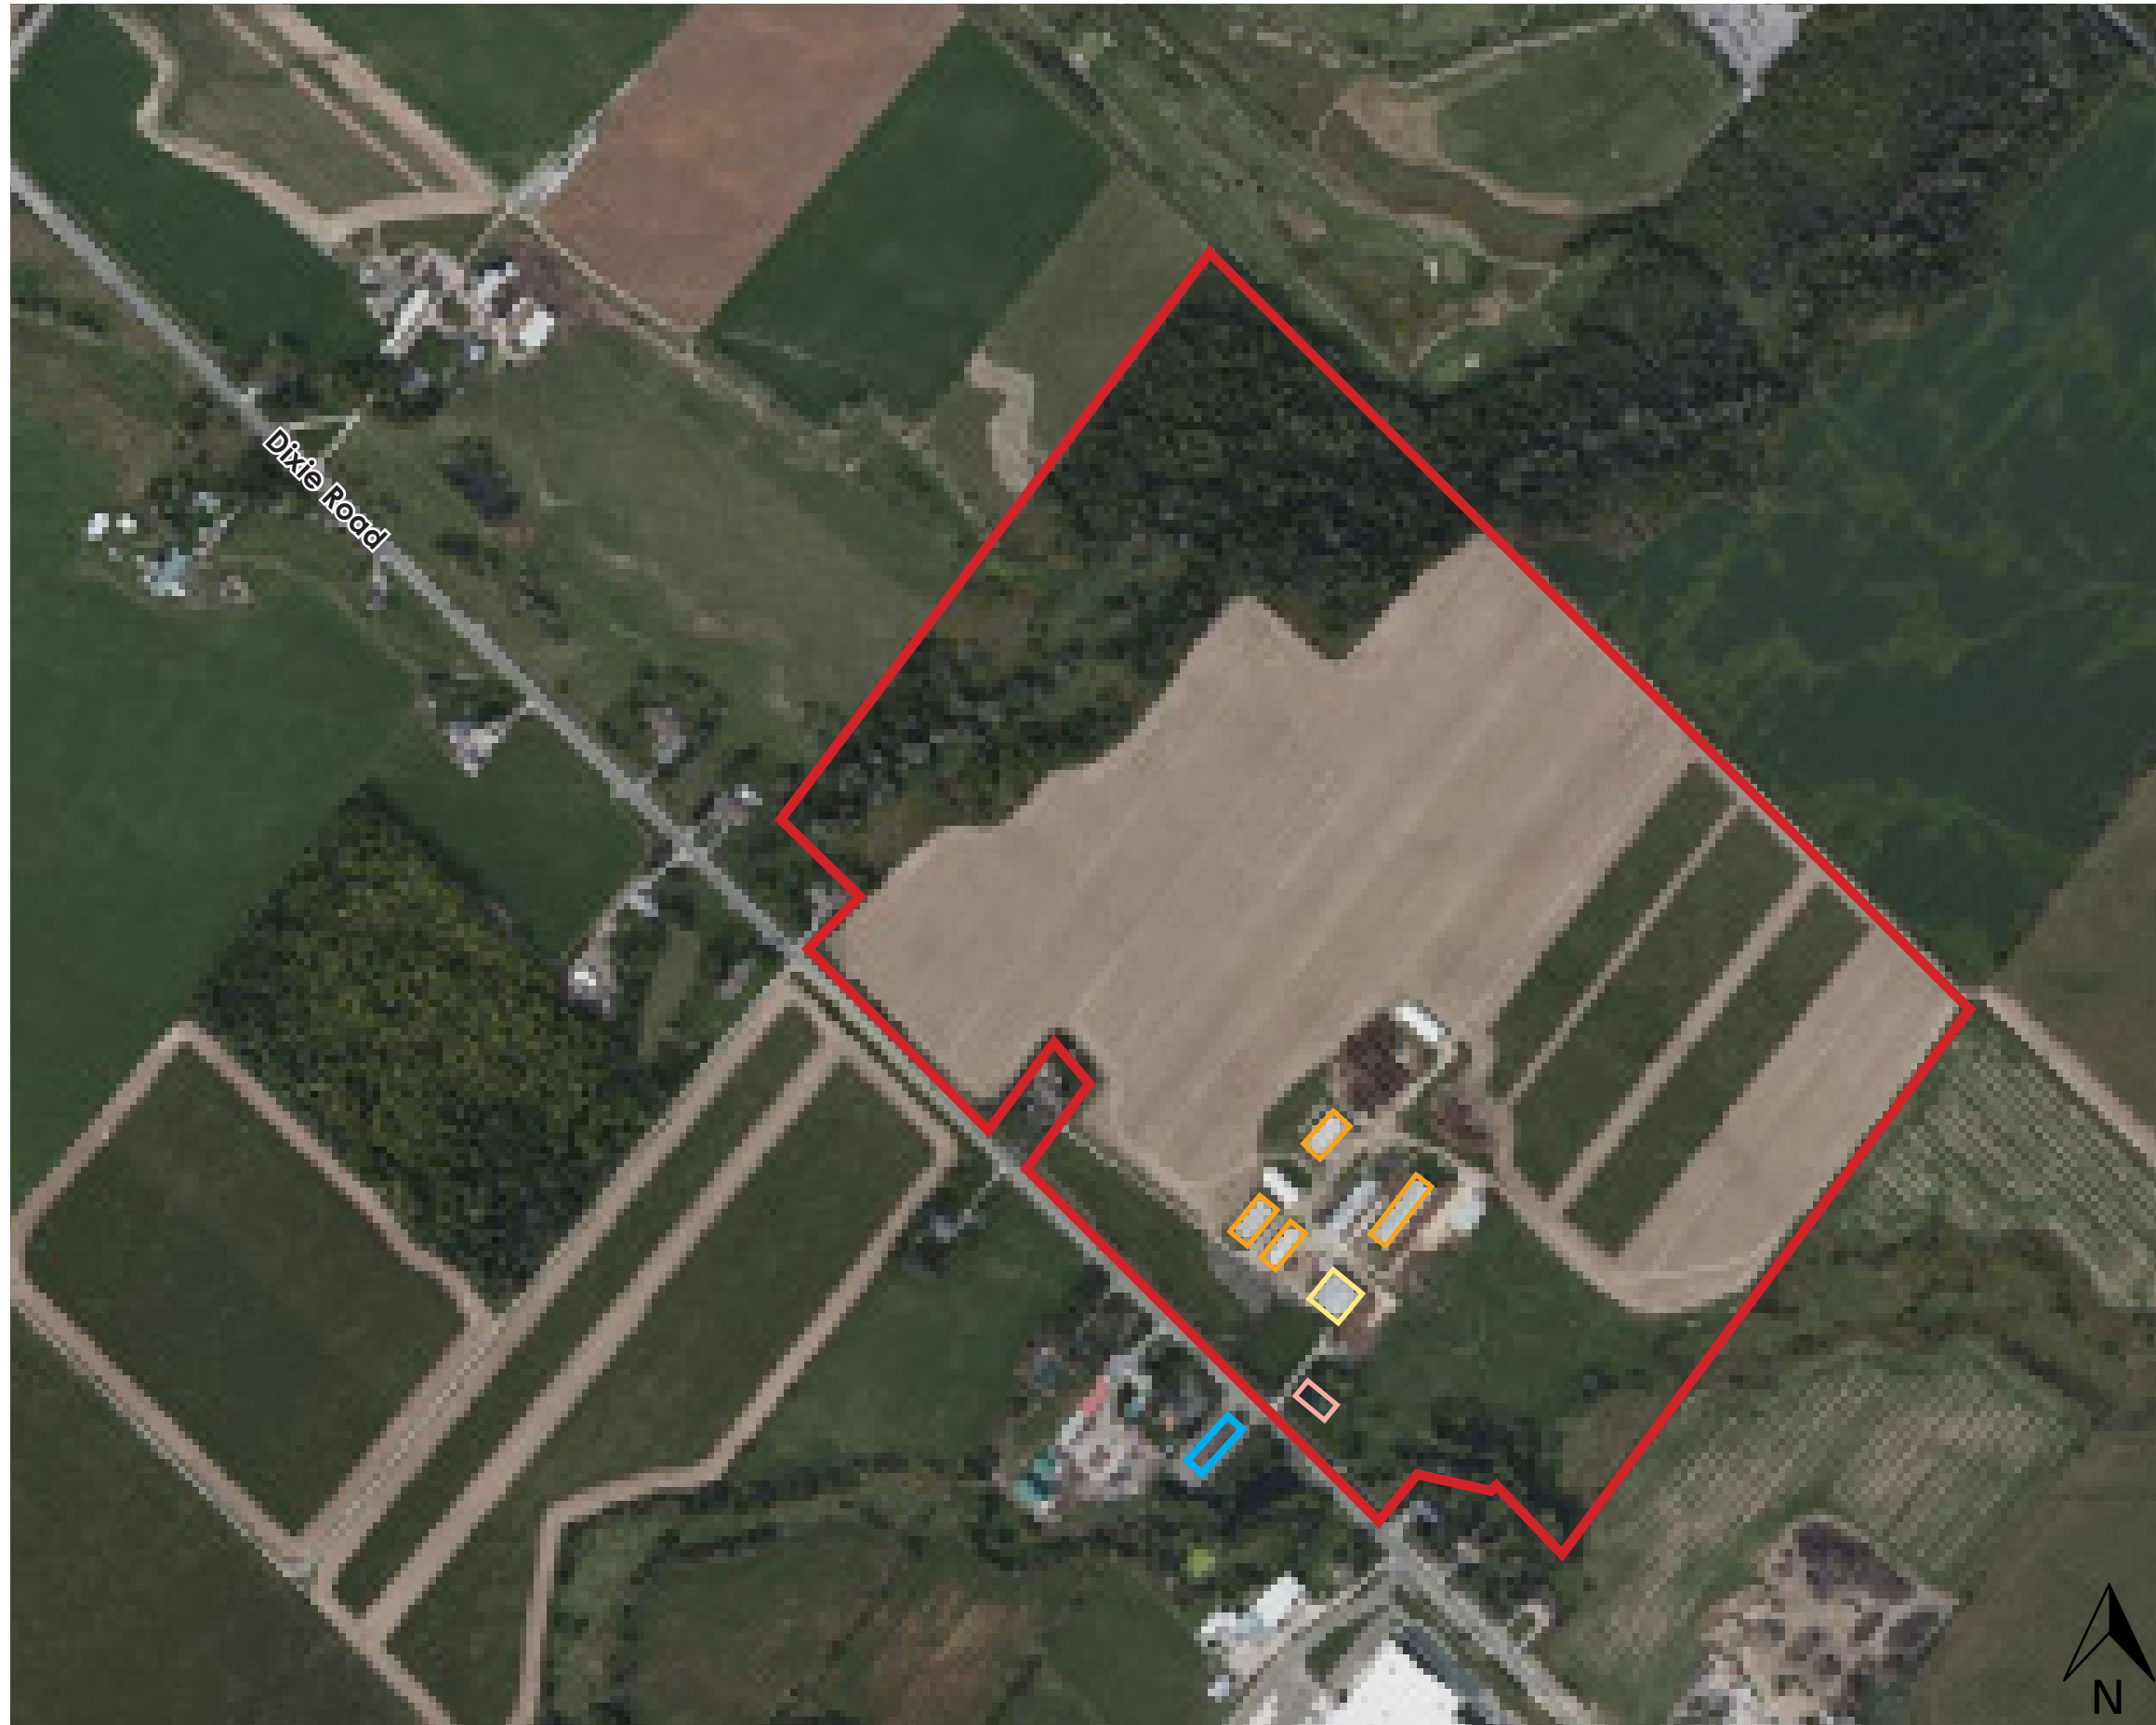
Legend

- Study Area
- MayField United Church
- Existing Outbuildings
- Residence
- Barn

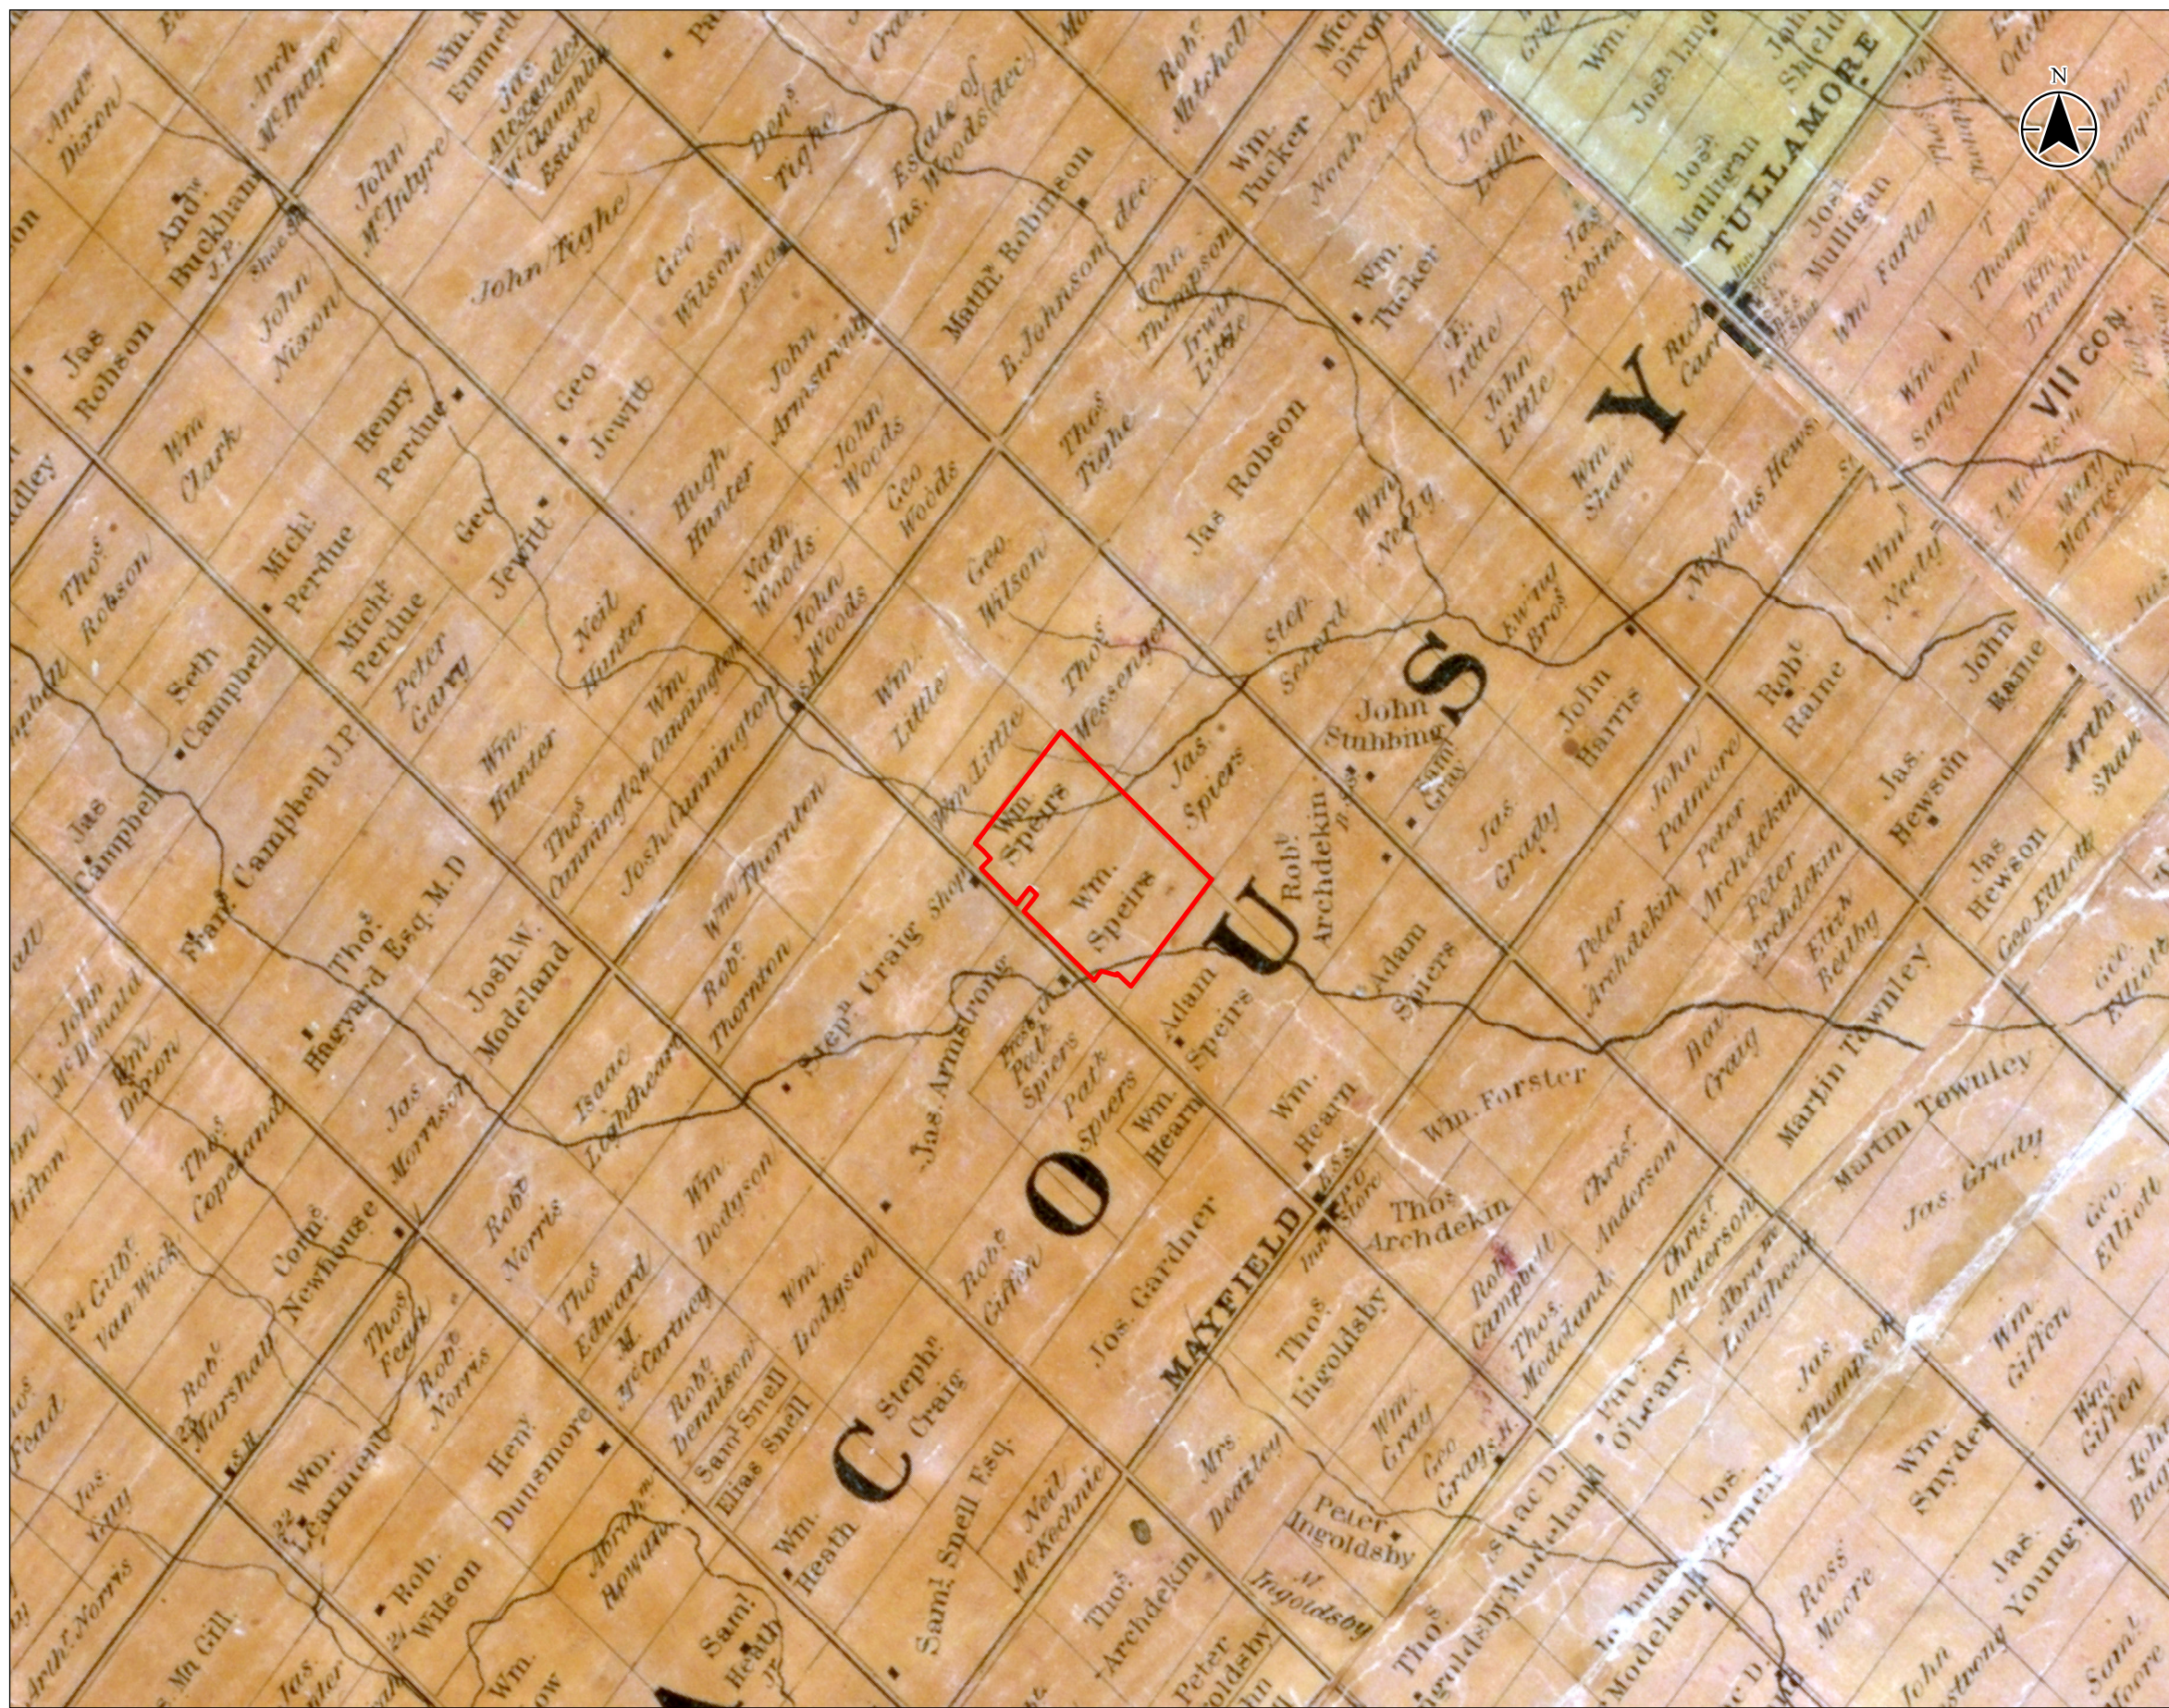
Figure No.
2
Title
County of Peel, 1859

Legend
[Red Box] Study Area (Approximate)

Notes
1. Historic image not to scale.
2. Source: Tremaine, George R. 1859. Tremaine's Map of the County of Peel, Canada West. Toronto: G.R. & C.M. Tremaine.

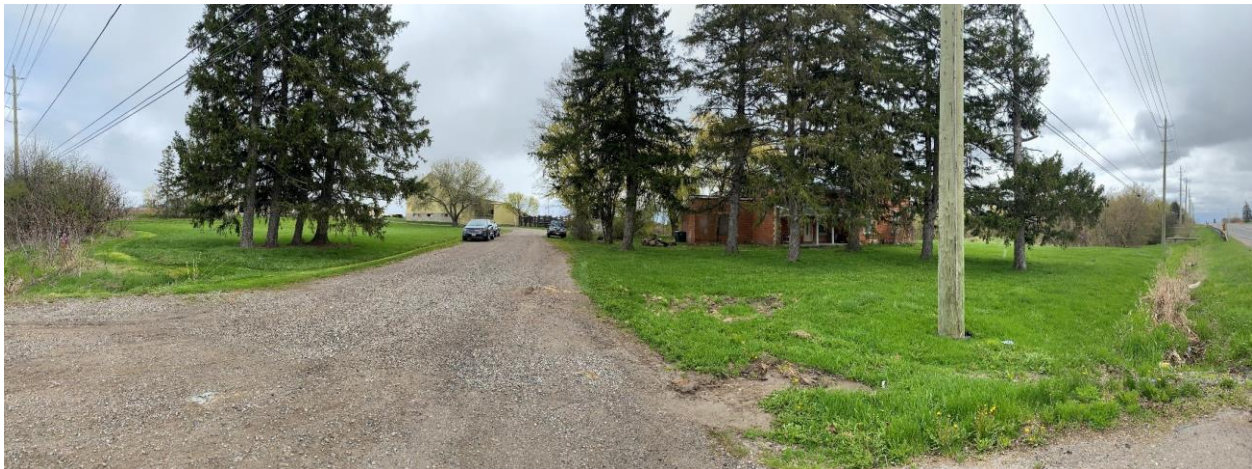
The property is located on the northeast side of Dixie Road, between Old School Road and Mayfield Road (Photo 1). The residence on the property faces south fronting the watercourse to the south, a meandering creek associated with the West Humber River watershed. The property is situated in a rural area of the Town just north of the City of Brampton (Photo 2 and Photo 3). Dixie Road, adjacent to the property, is currently transitioning from a rural area to contemporary industrial structures, commercial structures, and residences. To the south, near the intersection of Dixie Road and Mayfield Road, are two remaining 19th century residences related to the former village of Mayfield, at 12035 Dixie Road and 4585 Mayfield Road. Directly adjacent to 12489 Dixie Road are agricultural fields, rural mid-20th century and contemporary residences, and two listed properties at 12496 Dixie Road (Mayfield United Church) and 12434 Dixie Road. The church and cemetery are directly opposite the property, on the southwest side of Dixie Road at 12496 Dixie Road (Photo 4). The church was built in 1874 and is listed on the Town's *Heritage Register* (Mayfield United Church 2019; Town of Caledon 2022).

Photo 1: Study Area looking east from Dixie Road

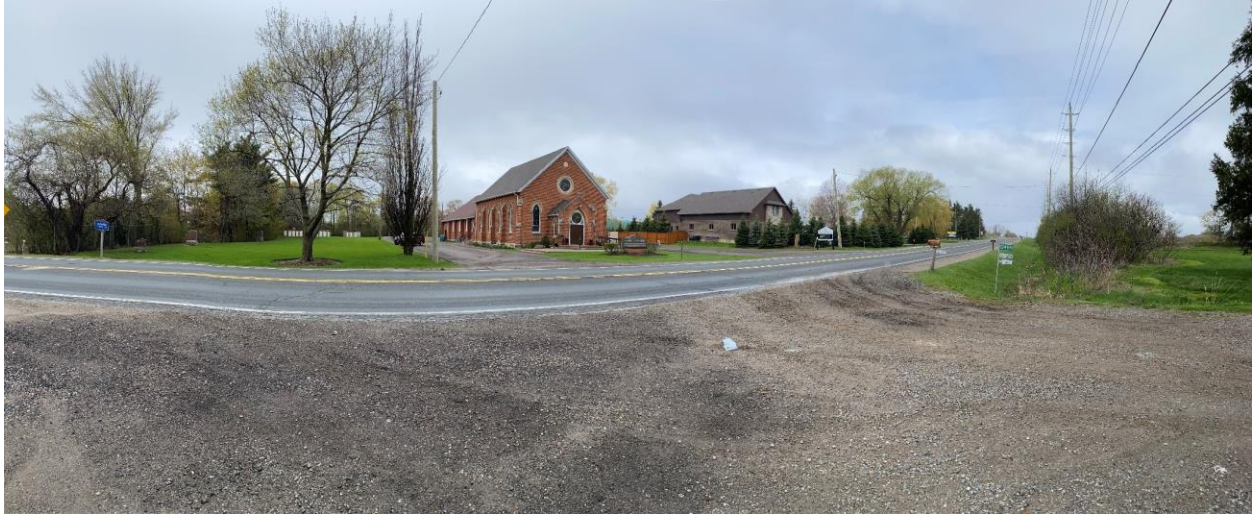
Photo 4: Adjacent Mayfield United Church, looking northwest from Study Area

The property is visually and historically linked to the adjacent Mayfield United Church and its cemetery. Patrick and Mary Spiers donated the land to construct a church in 1842. This structure was later replaced in 1874 with the existing Mayfield United Church. Eleven members of the Spiers family are buried in the cemetery adjacent to the church, including Patrick and Mary Spiers, William Spiers, and his two wives, Ann (Hunter) Spiers and Janet (Scott) Spiers. The property is also historically linked to the former hamlet of Mayfield, which developed at the intersection of present-day Dixie Road and Mayfield Road. William, Janet, and John Spiers all served as postmasters in the hamlet between 1853 and 1897. While William was listed on late 19th century census records as a storekeeper. The residence is one of three remaining mid-19th century properties connected to the former hamlet. The property is also historically connected to 4585 Mayfield Road, 4848 Mayfield Road, and 12434 Dixie Road. The residences on these three properties are related to the ownership of the Spiers family. The residences at 4585 Mayfield Road and 12434 Dixie Road were constructed under the ownership of William Spiers' children. The residence at 4585 Mayfield Road was constructed under the ownership of Peter Archdekin, who was married to Mary Spiers, the daughter of William and Ann Spiers. The residence at 12434 Dixie Road was constructed under the ownership of John Spiers, the son of William and Janet Spiers. The residence at 4848 Mayfield Road is related to William Spiers' brother Adam Spier's family.

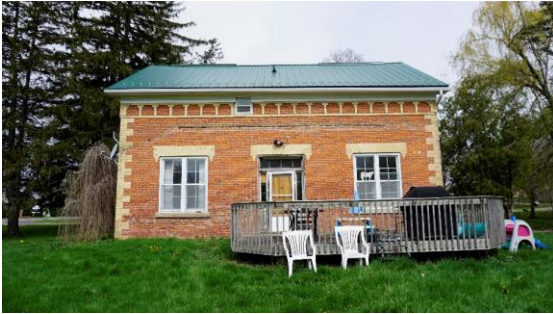
Photo 5: Front façade looking north

The three-bay front façade has a central entrance with a wood-panelled door, metal storm door, wood sidelights, and wood transom (Photo 5 and Photo 6). The entrance is inset with wood side panelling. The entrance has a buff brick voussoir with drip moulds. Paired 4/4 wood sash windows flank the entrance with contemporary storm windows. The windows have buff brick voussoirs with drip moulds and cut stone sills. Below the roofline is a contemporary small window, an addition to the bathroom on the second floor of the interior when the bathroom was added. Below the roofline there is projecting buff brick banding below the fascia. The front façade has corner quoins and shows remnant staining of a former covered front porch. This structure currently has a contemporary wood partial porch.

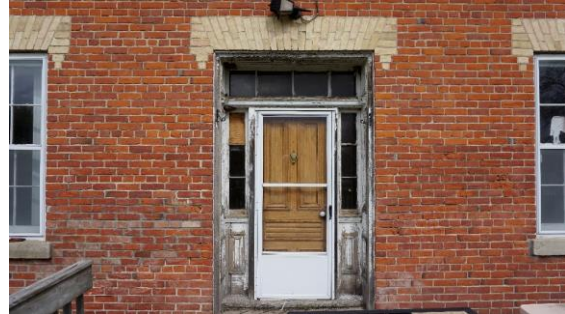
Photo 6: Front façade central entrance

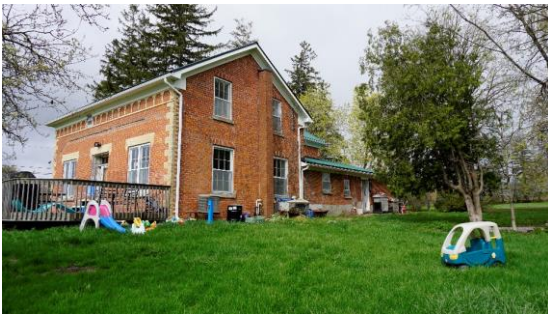
Photo 7: Front façade and east elevation looking northwest

The east elevation of the gabled end includes four 6/6 wood windows with cut stone sills and brick voussoirs (Photo 7 and Photo 8). This section has a contemporary brick chimney that does not extend above the roofline. The east elevation of the rear tail has two 1/1 contemporary windows on its second storey (Photo 9). The east elevation of the rear shed roof portion has a contemporary entry door with a cut stone sill. Adjacent to the entrance is a wood sash window with stone cut sill and brick voussoir. This section also has a second contemporary window with a cut stone sill. The brick on this section has the etchings of family names and dates (Photo 10). The name Spiers is legible, but other names and dates have been weathered and unclear.

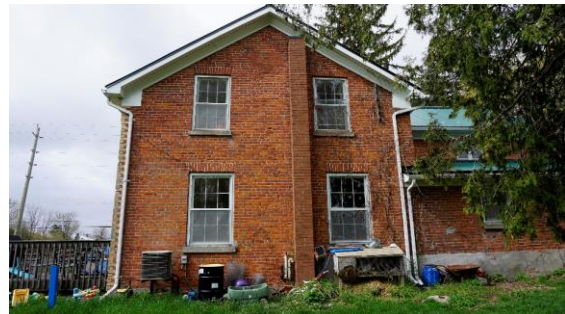
Photo 8: East elevation looking west

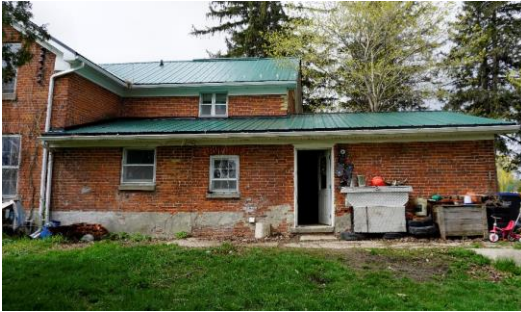
Photo 9: East elevation looking west

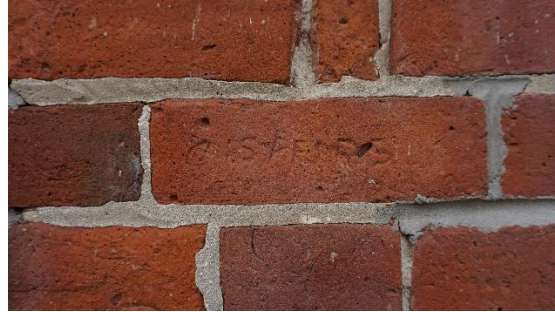
Photo 10: Name etchings on the east elevation

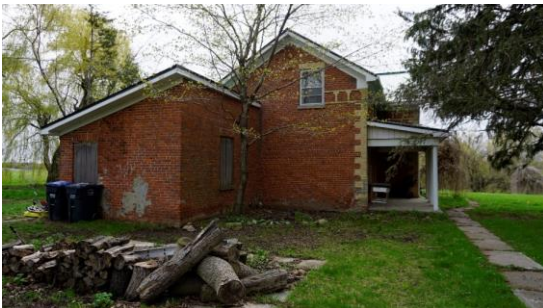
Photo 11: North elevation looking south

The north elevation of the rear tail has a 6/6 wood window with a cut stone sill and buff brick voussoir (Photo 11 and Photo 12). From the northwest corner buff brick quoin is a projecting buff brick band that extends to the window. The north elevation of the shed roof section has a boarded-up window with a brick voussoir. The west elevation of the gabled end has four 6/6 wood windows with cut stone sills (Photo 13 and Photo 14). The first-storey windows have buff brick voussoirs with drip moulds, and the second-storey windows have buff brick voussoirs. Basement windows have brick voussoirs. The gabled end below the roofline has a buff brick diamond pattern and three buff brick crosses. The west elevation of the rear tail has a covered concrete porch with contemporary wood columns (Photo 15). The first storey has a contemporary entry door with a brick voussoir and cut stone sill (Photo 16). Two 6/6 wood windows with brick voussoirs and cut stone sills flanked the entry. The second storey has two contemporary 1/1 windows.

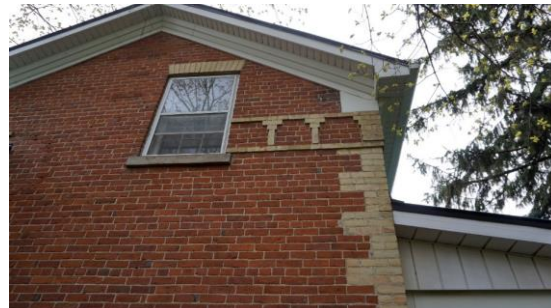
Photo 12: North elevation rear tail window

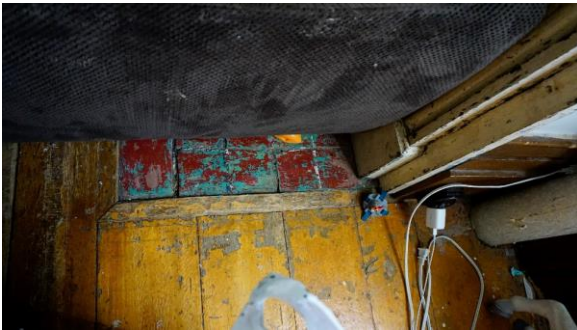
Photo 23: Original fireplace tile and wood floor

The first floor within the front portion of the residence contains a kitchen, a living room, a dining room, and access to the basement and second floor. The rear tail contains a living room, a kitchen, a laundry room, and access to the second floor. The rear shed roof portion is a storage area. The interior walls and ceilings of the residence are a mixture of lathe and plaster and drywall. From the front entry is a small vestibule hallway that provides access to the living room on the west and the kitchen on the east (Photo 17 to Photo 19). This area has a contemporary tile floor, wood trim, and mouldings around the doorways. The living room has original wood flooring, wide wood trim, and window and door mouldings (Photo 20). Below the windows is the original wood panelling. The room also has drywalled walls and ceilings. On the east wall of the living room is a built-in wooden cupboard (Photo 21). On the west wall is a former fireplace that has been drywalled over (Photo 22 to Photo 23). The fireplace has a wood mantle and a tiled hearth. The kitchen has contemporary tile flooring, wide wood trim, and mouldings around the windows and doors (Photo 24 to Photo 25). Kitchen cupboards are a blend of contemporary and mid-20th century cupboards. On the west

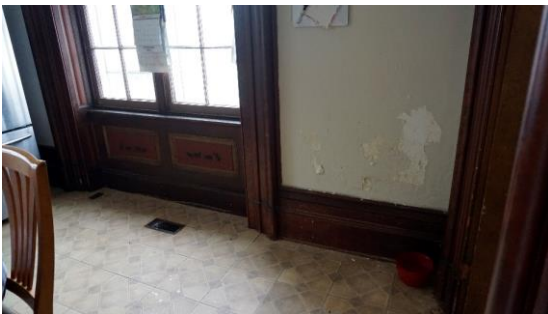
Photo 25: Front kitchen wood mouldings and panelling

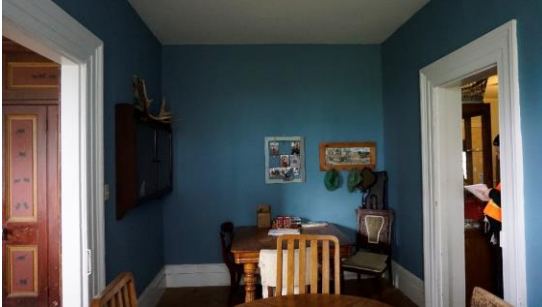
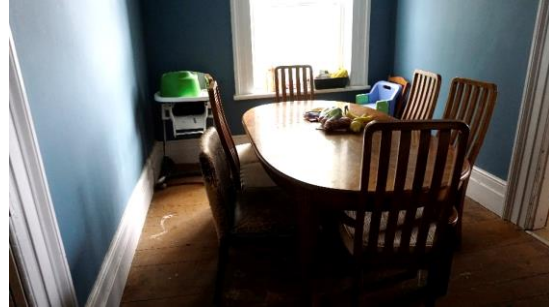
Photo 27: Dining room looking west

Photo 28: Dining room looking southeast

wall of the kitchen are built-in wooden cupboards (Photo 26). The dining room has original wood flooring, wide wood trim, and wood mouldings around the window and doors (Photo 27 to Photo 28).

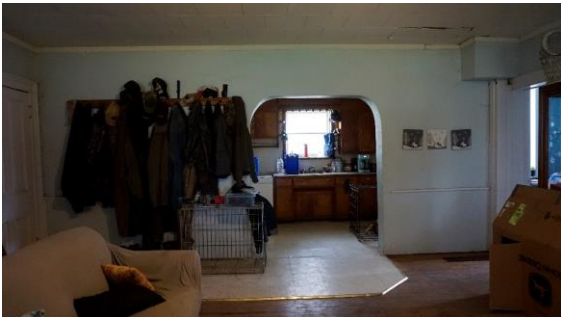
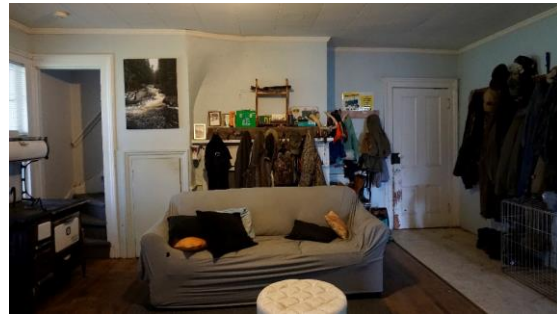
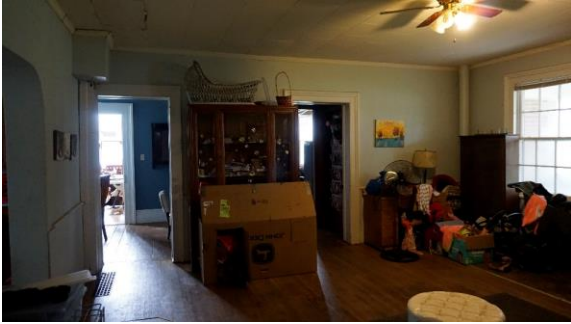
Photo 29: Rear tail living room area looking east

Photo 30: Rear tail living room looking northeast

Photo 31: Rear tail living room looking southwest towards front portion of the residence

The rear tail has a living room with a mixture of original wood and contemporary tile flooring and an asbestos tile ceiling (Photo 29 to Photo 31). On the north wall of the living room is a former fireplace that has been drywalled over. The fireplace has a wood mantle and surround. Adjacent to the fireplace is a stairwell that has a winder staircase. To the east of the living room, through an arched opening, is a small kitchen area with contemporary tile flooring and a plaster ceiling (Photo 32 and Photo 33). The wood cupboards appear to date to the mid to late 20th century. North of the kitchen is a small laundry room with contemporary tile flooring, late 20th century faux wood panelling, and Styrofoam ceiling tiles (Photo 34).

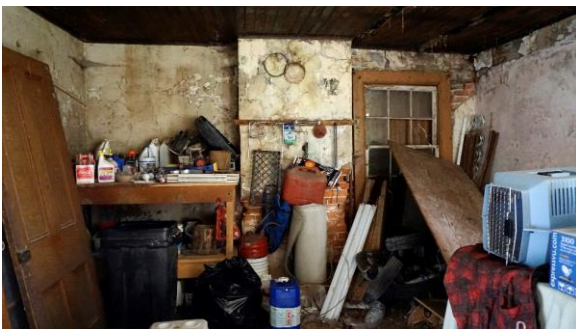
The rear shed roof portion was possibly a summer kitchen as it contains a former brick fireplace on its north wall (Photo 35). This portion is set on brick with no full foundation. It has original narrow wood flooring and a beadboard ceiling (Photo 36). The walls are a mixture of brick and lathe and plaster.

Photo 35: Rear addition looking north

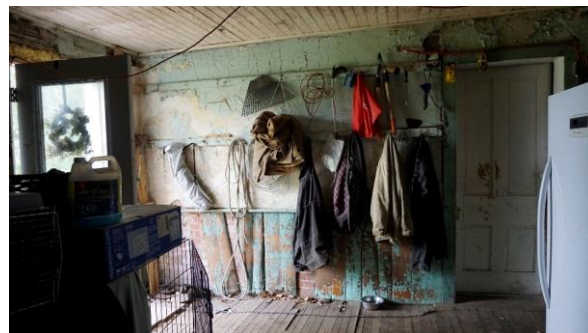
Photo 36: Rear addition looking south

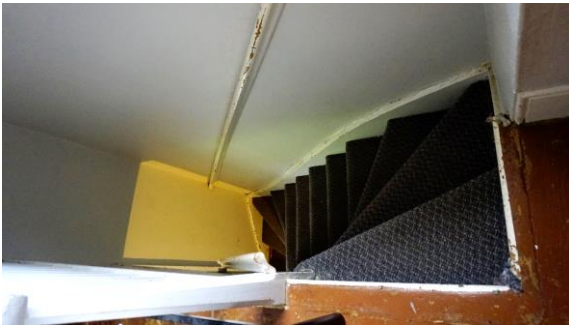
Photo 46: Winding staircase to second floor of rear tail

The second floor of the rear tail contains an open landing area, a storage room, and a bathroom. The rear tail is stepped down from the front portion of the residence. The rear tail is accessed by a winding staircase from the lower living room (Photo 46). It is carpeted with a simple wood banister. The open landing area has original wood flooring, lathe and plaster walls, wood trim, window, and door mouldings (Photo 47 and Photo 48). The storage room and bathroom have tiled flooring and interior wood doors (Photo 49 and Photo 50).

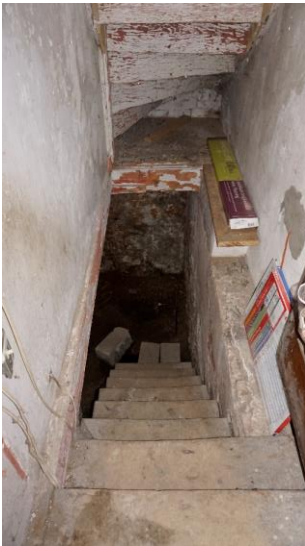
Photo 51: Basement staircase

The basement is accessed from the first-floor living room from straight wood stairs (Photo 51). The basement has exterior rubble stone walls with sections parged with concrete (Photo 52 to Photo 54). The interior walls are red brick. The basement has concrete flooring. The beams supporting the first floor were machine cut and span across the length of the structure (Photo 55).

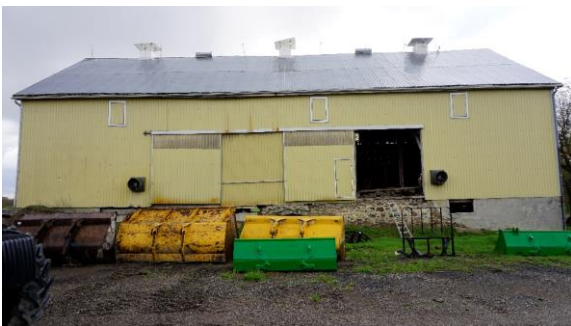
The two-level, five-bay barn is a late 19th century structure modified throughout the 20th century into a cattle barn. The exterior of the structure is clad with metal. The north gabled roof portion of the barn is a timber frame structure (Photo 56). It has a metal-clad roof with contemporary metal ventilators and lightning rods. The south elevation of the barn contains an addition with machine-cut wood beams and steel braces. The north elevation of the barn has a stone foundation and metal cladding. The elevation formerly had a bank as the access doors are set higher up from the current grade (Photo 57). The elevation has two large sliding doors, one with a man door opening. Adjacent to the doors are metal ventilator fans. On the upper storey of the barn are three hinged windows with metal cladding. The lower storey has a wood frame window.

Photo 56: North elevation looking south

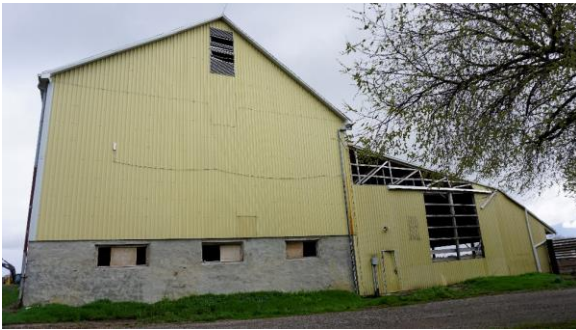
The west elevation includes a gabled end with a metal louvred window (Photo 58). The elevation has a concrete parged stone foundation with three wood frame windows with no glass. Its exterior is clad with metal. The west elevation of the addition also has metal cladding, with some areas missing cladding (Photo 59). This section has an entry door clad with metal.

Photo 58: West elevation looking southeast

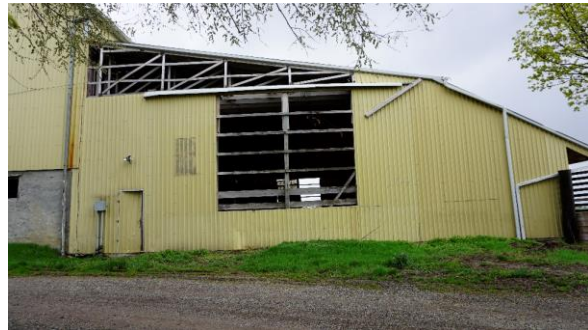
Photo 59: West elevation looking east

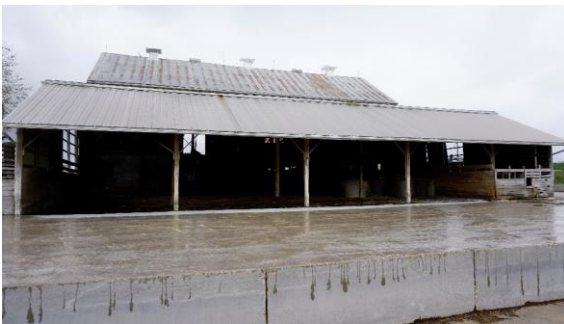
Photo 60: South elevation looking northeast

The south elevation includes the open addition that provides access to the outdoor cattle eating area with a poured concrete pad and concrete trough (Photo 60 to Photo 62). The east elevation includes a gabled end with a metal louvred window (Photo 63). The elevation has a concrete parged stone foundation with sections of concrete blocks. The foundation has a wood frame window and an open-door frame. The east elevation of the addition is clad with metal, with some areas missing cladding.

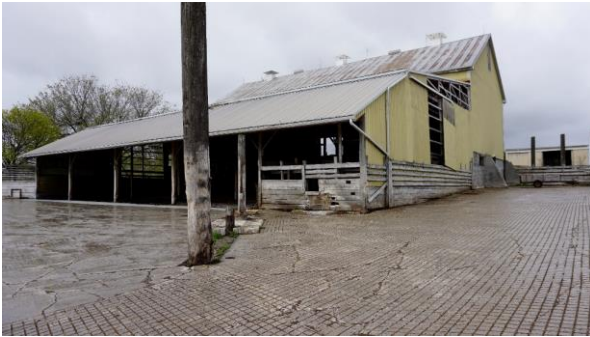
Photo 62: South and east elevations looking north

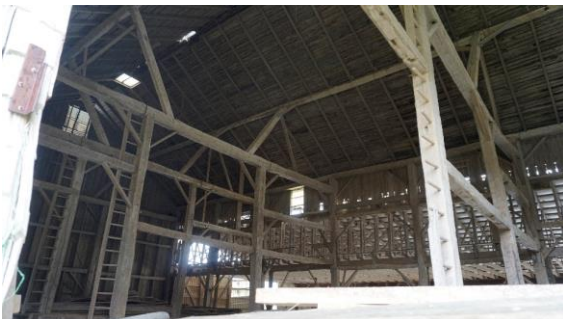
The upper storey of the barn includes the former threshing floor and hay storage area (Photo 64 to Photo 66). The role of these spaces was replaced on the property with new outbuildings. The upper storey floor was in poor condition with missing boards and was inaccessible during the site visit. The interior of the upper storey is supported by a simple two-posts-per-bent frame structure with five bays. The wood posts and beams are secured in place by mortise and pins. Posts and beams are supported by wood braces. Each bay has a wood ladder on one of its posts. The interior ceiling is clad with wood.

Photo 64: Upper storey looking southeast

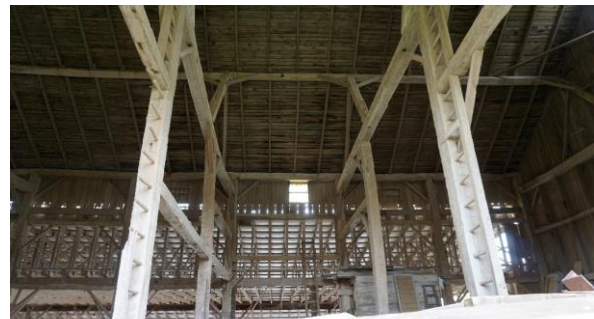
Photo 65: Upper storey looking south

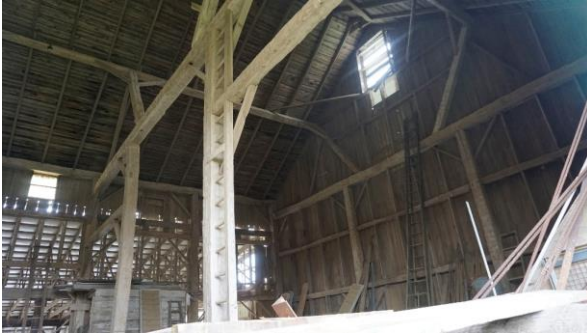
Photo 66: Upper storey looking southwest

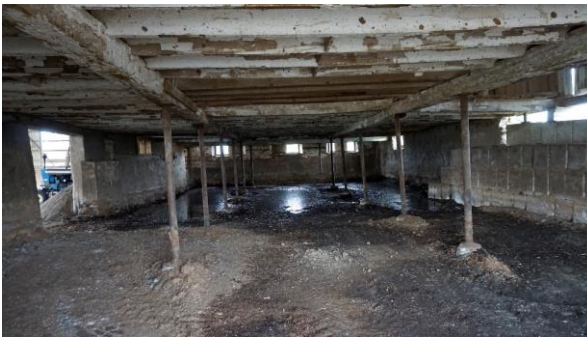
The lower storey of the barn was modified in the 20th century for cattle. The lower storey in the gabled portion housed cattle, while the addition provided a centre eating area and sick pen. The gabled portion of the barn includes a mixture of timber and machine-cut wood beams, with steel posts on concrete bases (Photo 67 to Photo 70). The lower storey has a dirt floor, and the addition has a concrete floor. The addition is an open wood frame structure with steel braces (Photo 71 to Photo 73).

Photo 67: Lower storey looking northwest

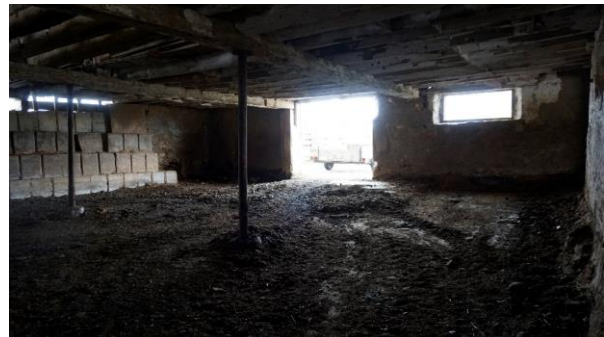
Photo 68: Lower storey looking northeast

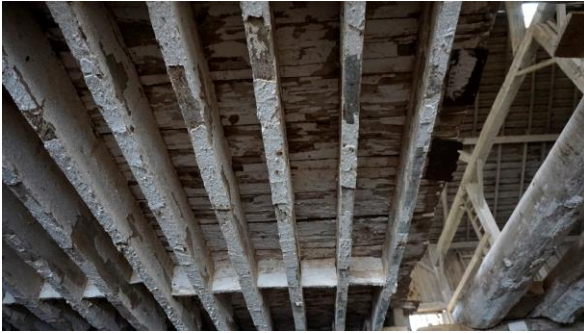
Photo 69: Machine cut wood beams

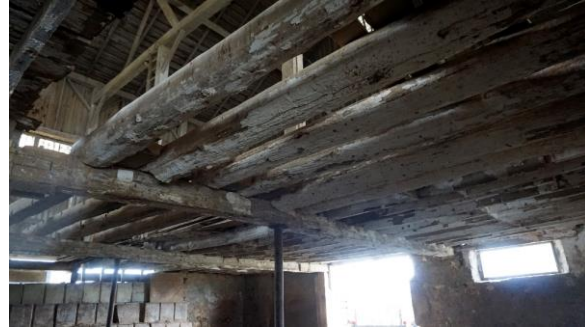
Photo 70: Timber beams

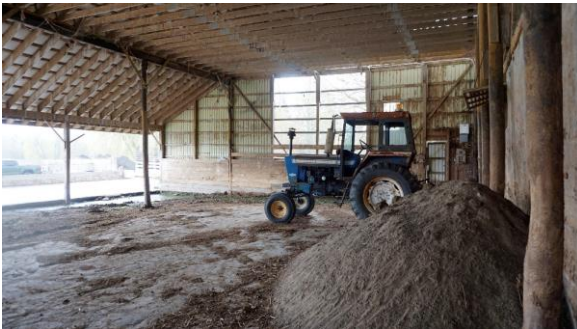
Photo 71: Addition looking southwest

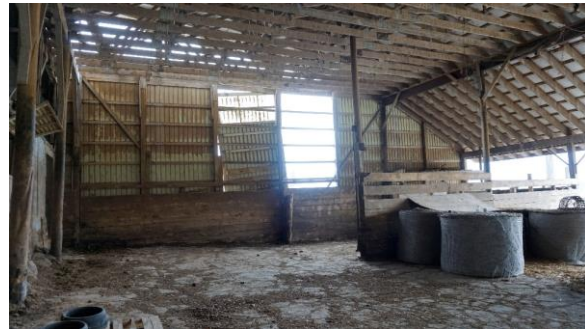
Photo 72: Addition looking southeast

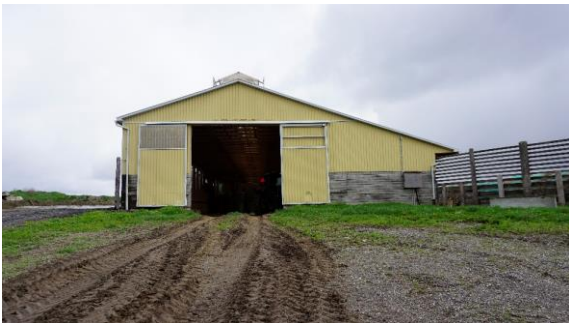
Photo 74: Cattle outbuilding, west elevation looking east

The cattle outbuilding was once used to house cattle and is currently used for hay storage. The outbuilding is a one-storey structure with a gable roof and salt box extension on its south elevation (Photo 74). The roof has metal cladding and metal eaves. The exterior of the building is clad in metal with lower horizontal wood cladding. The west elevation and east elevations have a set of large sliding doors clad with metal (Photo 75). The south elevation is open, providing access to an outdoor cattle space with a concrete pad and feeding trough (Photo 76 to Photo 77). The north elevation has a set of centrally placed wood sliding doors flanked by open wood frame windows that extend to the west and east (Photo 78). The interior of the outbuilding is a wood frame structure with wood braces and timber supports (Photo 79). It has a dirt floor.

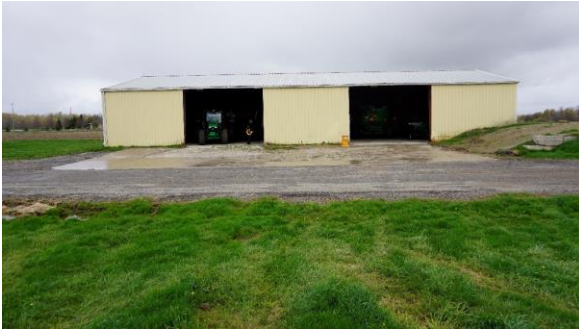
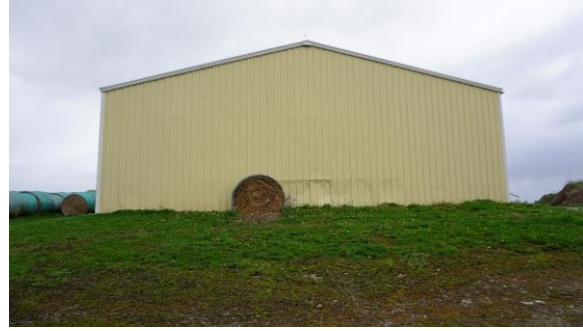
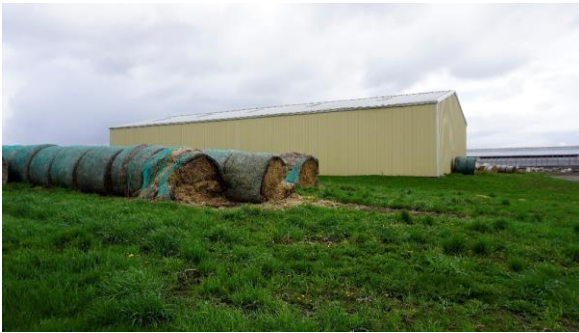
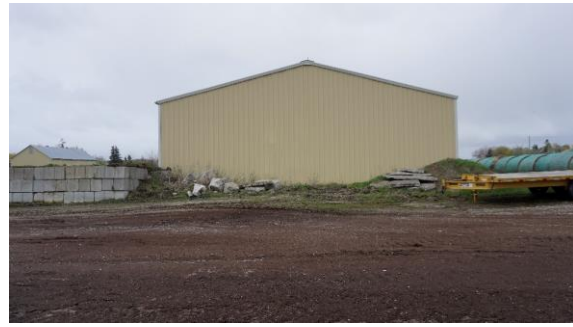
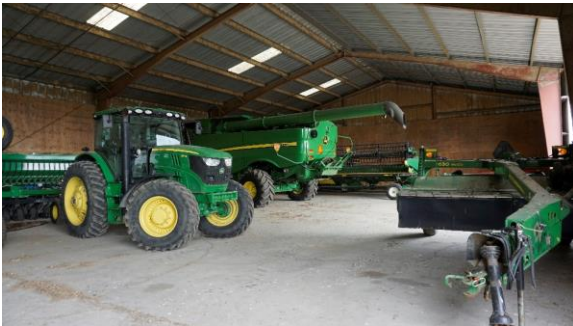
The two machinery and farm equipment storage outbuildings are similar, one-storey gabled roof structures with metal cladding and lightning rods (Photo 80 to Photo 89). They date to the late 20th century, determined through aerial photography. The exterior of the structure is corrugated metal cladding. The south elevation of each structure has two large door openings. The interior of the structures is steel framed with concrete flooring.

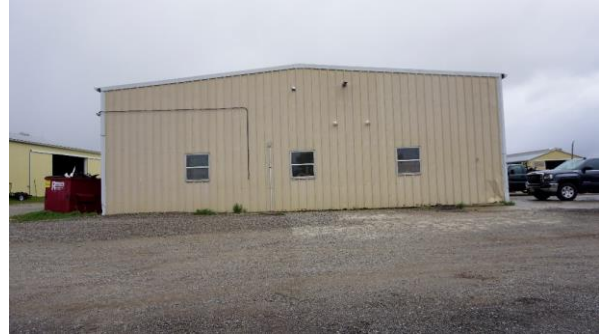
Photo 91: West elevation looking east

The farm office and workshop outbuilding is a one-storey structure with a low-pitched gable roof with metal cladding. It dates to the mid-20th century, determined through aerial photography. The exterior of the building is clad in corrugated metal. The south elevation has three large door openings for machinery and farm equipment and a metal entry door to the office (Photo 90). Adjacent to the office entry is a 1/1 metal window. The west elevation has three 1/1 metal windows (Photo 91). The north and east elevations have no windows or doors (Photo 92 and Photo 93).
