**Cultural Heritage Impact  
Statement - 12861 Dixie Road,  
Town of Caledon**

Final Report

December 6, 2024

Project Number: 160623115

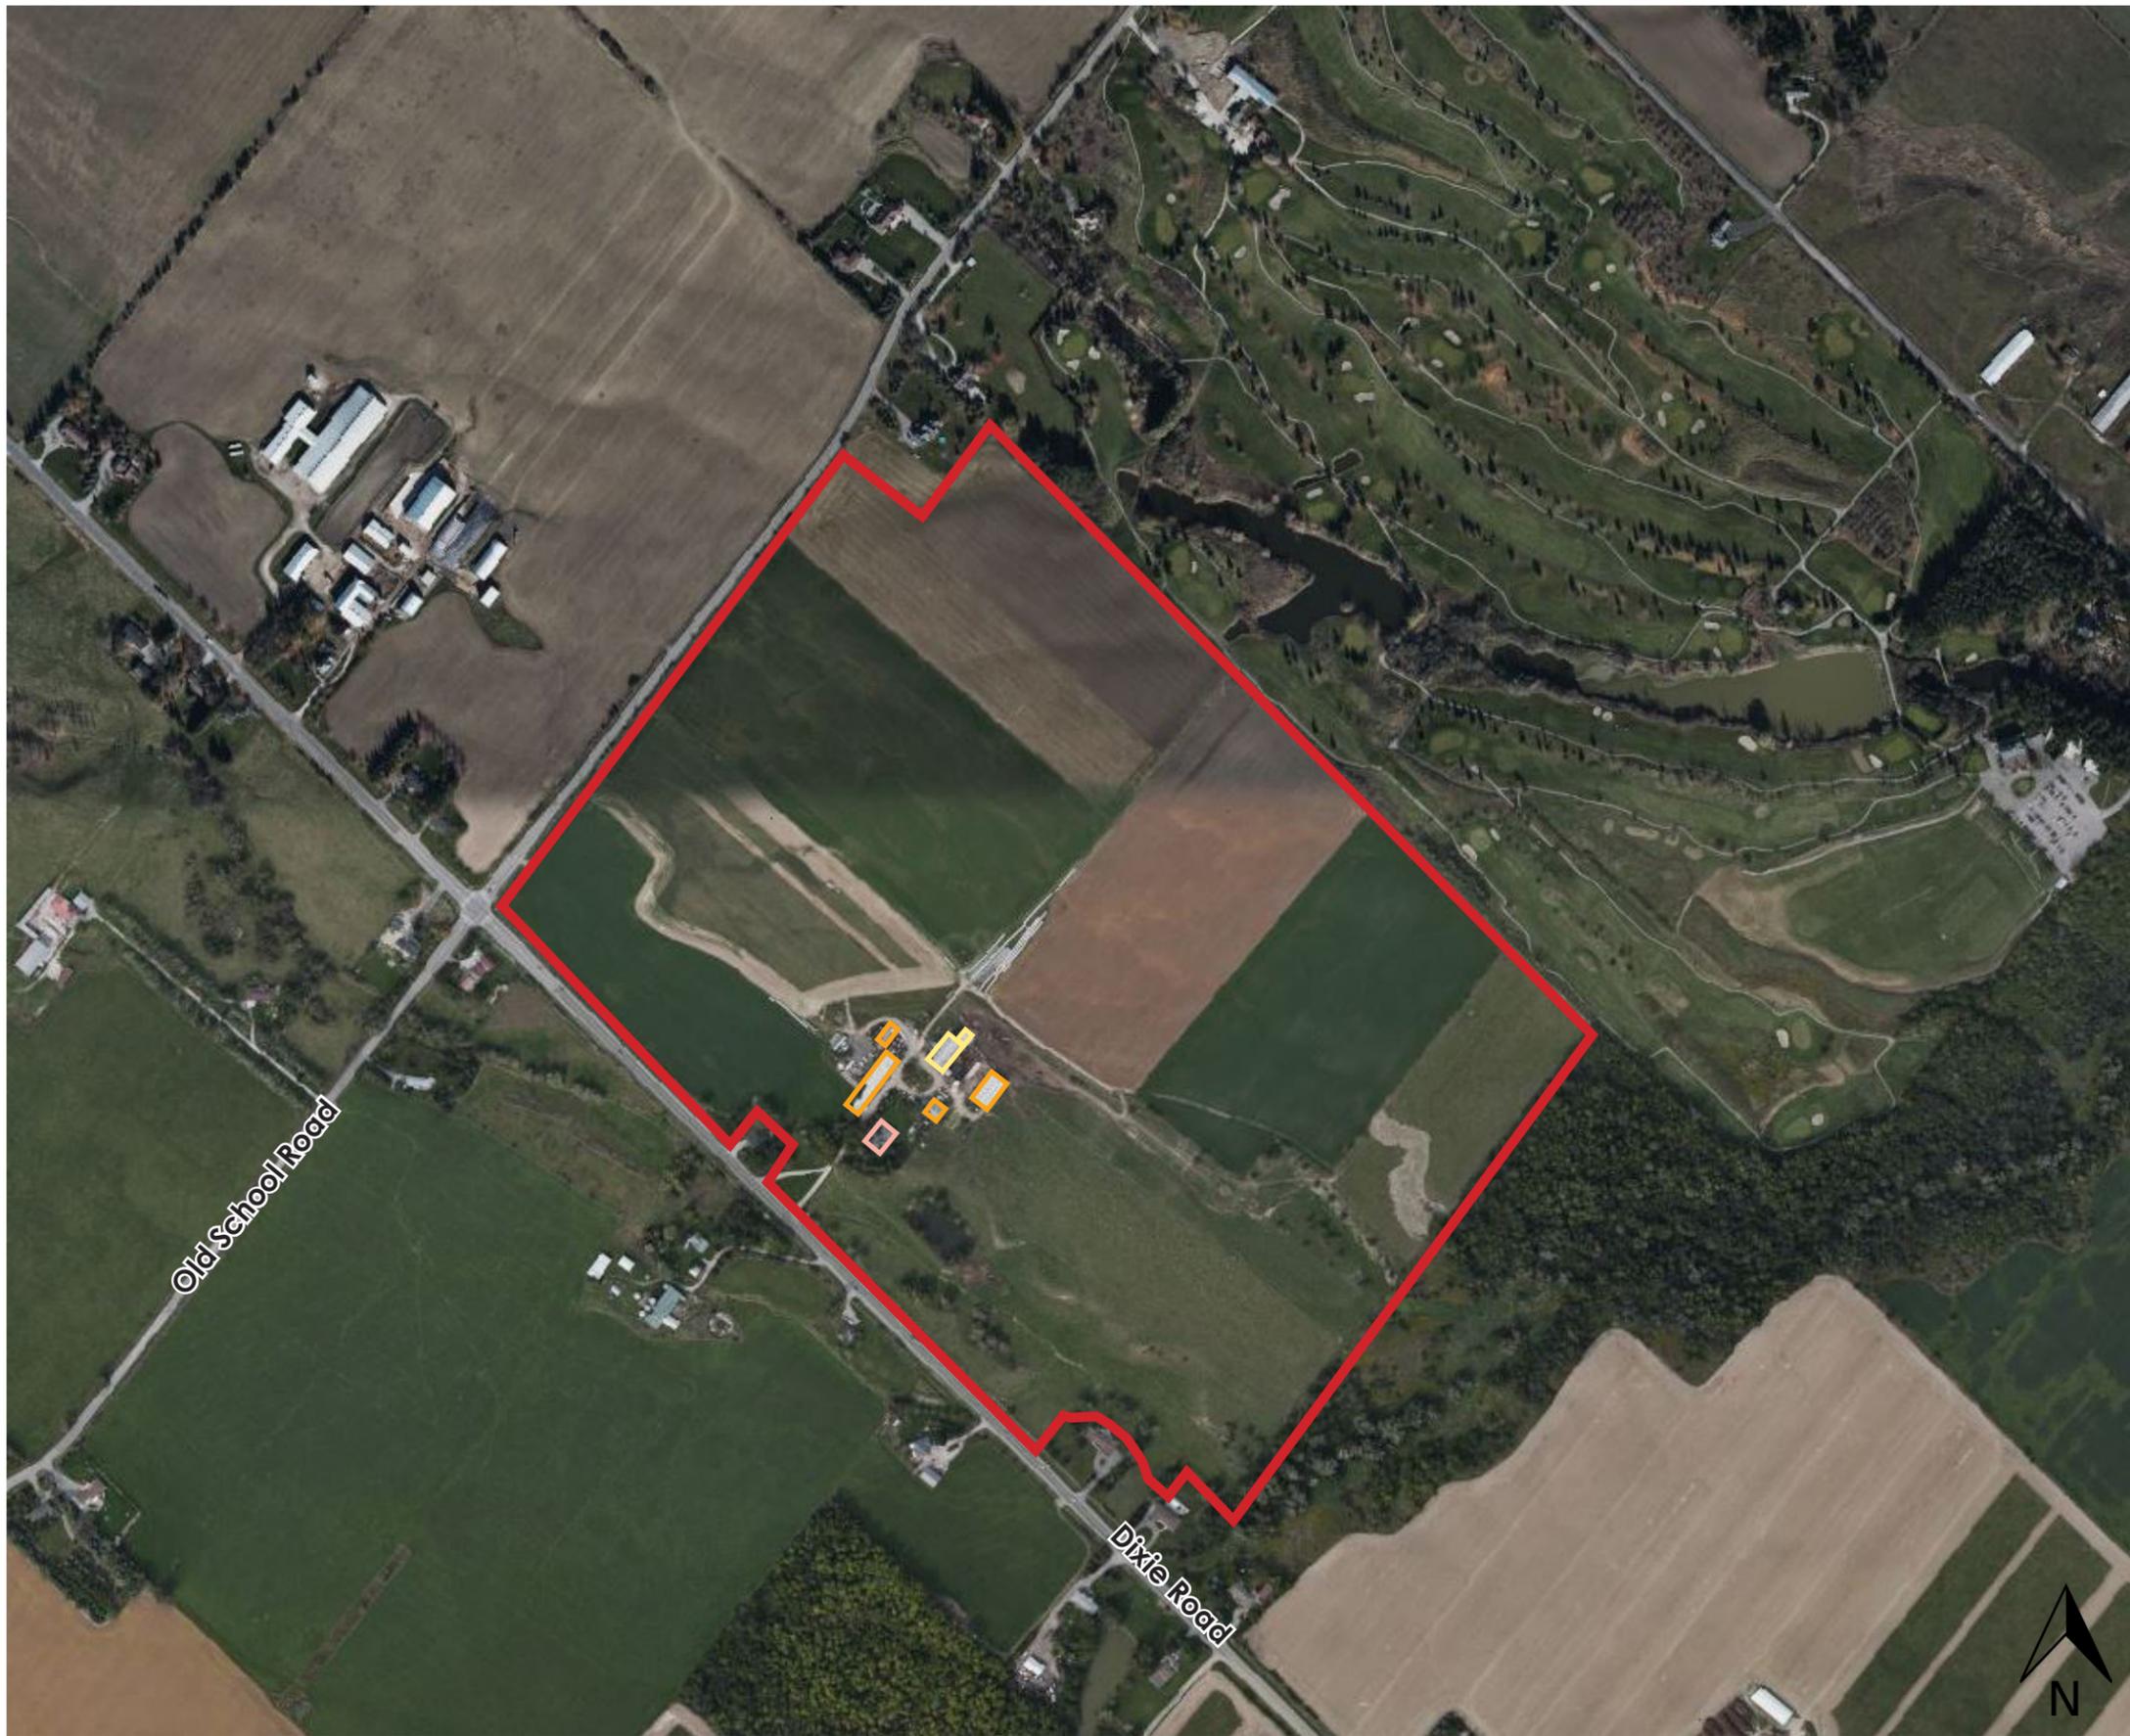
For the purpose of this CHIS, the Study Area is comprised of the municipal property boundary of 12861 Dixie Road (Figure 1). Directly adjacent to the Study Area is a listed property 12862 Dixie Road (formerly 12892 Dixie Road), a separate CHIS has been prepared for this property that is subject to a separate development.

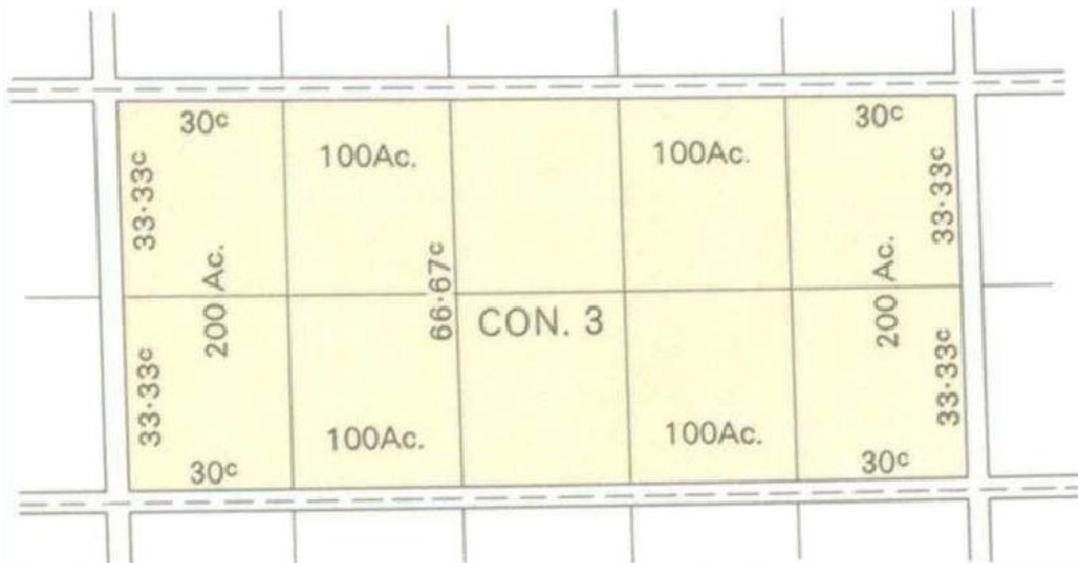
Plate 1: Double Front Survey System (Dean 1969)

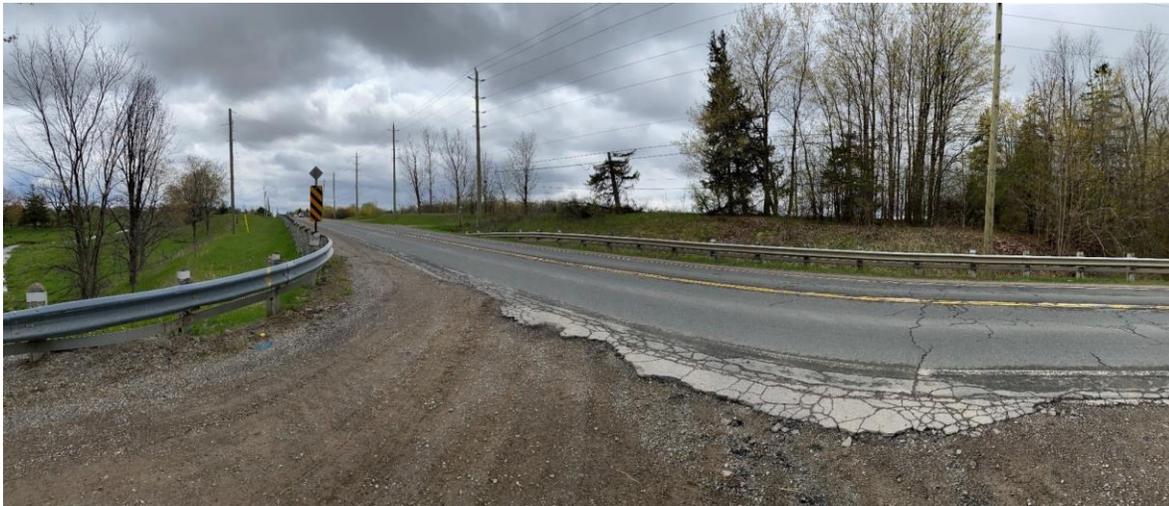
Photo 1: Dixie Road looking southwest from the Study Area

The property is on the east side of Dixie Road, between Old School Road and Mayfield Road (Photo 1 and Photo 2). The property is in a rural area of the Town just north of the City of Brampton. South of the property near the intersection of Mayfield Road and Dixie Road, the area is transitioning from rural and agricultural land use to a suburban setting containing new residential construction, office parks, and industrial buildings. This development is starting to extend north of the City of Brampton into the rural and agricultural lands of the Town.

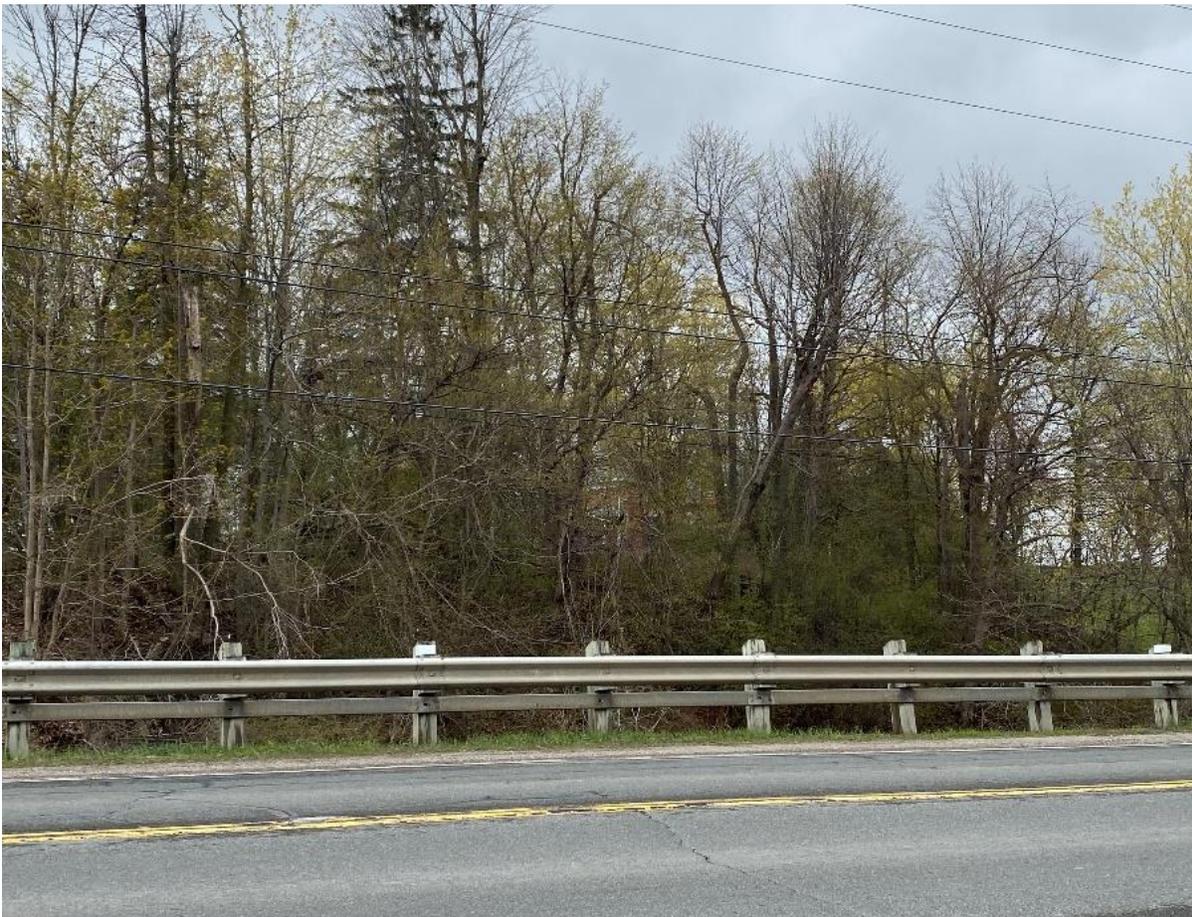
Photo 3: 12862 Dixie Road looking west from the Study Area

Dixie Road is a two-lane asphalt paved roadway with gravel shoulders. The west side of Dixie Road is lined with utility poles and bordered by a drainage ditch. Agricultural fields, other farmsteads, rural mid-20th century and contemporary estate-style residences, and a late 20th century golf course surround the property. Directly opposite the property is 12862 (formerly 12892) Dixie Road, a listed property on the Town's *Heritage Register* (Town of Caledon 2022). The residence at 12862 Dixie Road is set on a rise behind vegetation and is not visible from Dixie Road (Photo 3). The residence was built between 1862 and 1877 in a Classical Revival style.

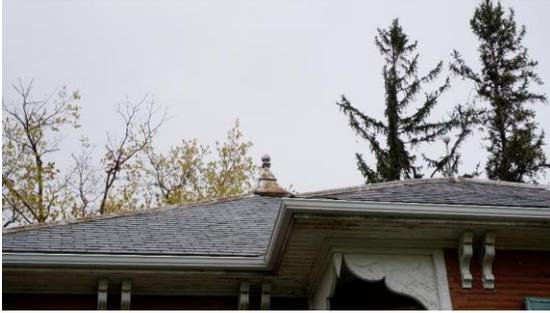
**Photo 4: Metal roof finial looking north**

The residence is a two and one half storey structure with a medium-pitched hipped roof with gabled bays. The roof is clad in asphalt shingles and has two brick chimneys a metal finial, and a lightning rod (Photo 4). The structure has wide wood eaves with decorative wood brackets. The structure stands on a stone foundation with a watertable formed with a splayed stretcher and three brick courses above the stone masonry (Photo 5). The exterior cladding is double-wythe red brick laid entirely in stretcher bond. The stone foundation is interspersed with basement windows set within wood segmental frames with brick voussoirs (Photo 5). The residence has a one-storey rear addition that was added in 1973, with a hip roof, asphalt shingles, a brick chimney, red brick cladding, and a concrete block foundation.

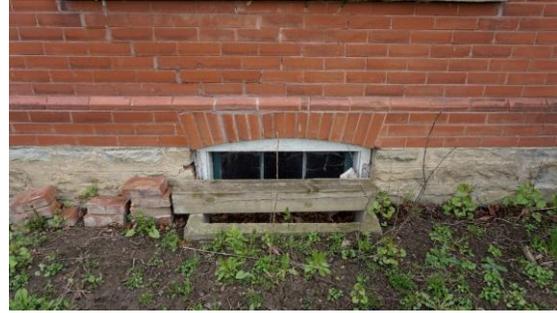
**Photo 5: Example of a basement window with a segmental frame and brick voussoir**

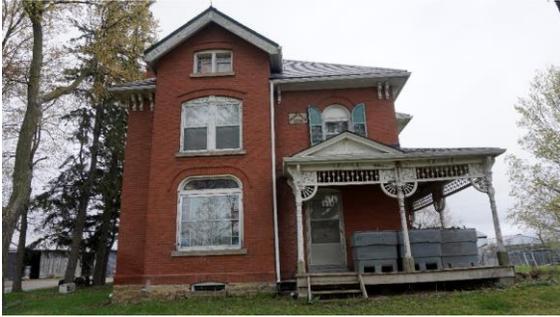
**Photo 6: Front façade looking west**

The front façade has a projecting gabled bay with decorative woodwork on its fascia (Photo 6). The first storey window on the bay is a large fixed wood window with leaded glass sidelights and a semi-elliptical leaded glass transom (Photo 7). The window has a semi-elliptical brick voussoir and a concrete sill. The second-storey window on the bay is two 1/1 windows within a wood segmental frame, with a brick voussoir and concrete sill (Photo 8). The half-storey on the bay has two 8/1 wood windows inset within a wood segmental frame with a brick voussoir and a concrete sill. The front and east elevations have a covered wraparound wood porch with decorative spindlework, decorative brackets, and turned wooden support columns (Photo 9). The porch has contemporary wood decking. The front entry has a wood half-glass door with decorative woodwork and panelling. The door has a metal storm door. They are set within a segmental frame with a brick voussoir (Photo 10). Above the porch is a date stone that reads, “Burn Brae 1896” (Photo 11). Burn Brae is a name of Scottish origin, with Burn meaning stream, and Brae a word for hills. Adjacent to the date stone is a 1/1 window within a wood semi-circular frame with a semi-circular brick voussoir, concrete sill, and wood louvred shutters.

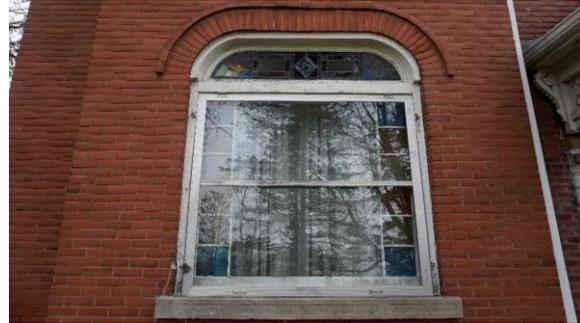
**Photo 7: First-storey bay window with leaded glass sidelights and semi-elliptical leaded glass transom**

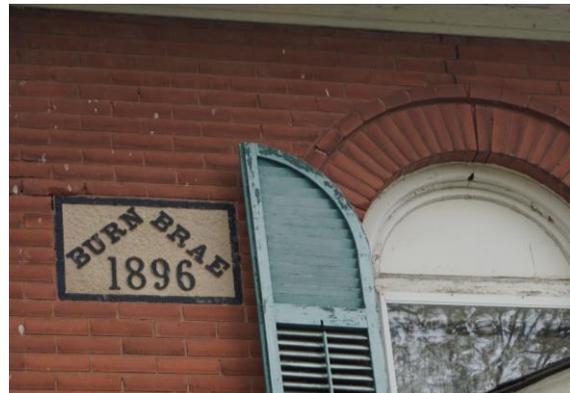
**Photo 11: "Burn Brae" date stone on front façade**

reference to the Scottish words burn, which refers to small watercourses, and brae, which referred to a hillside. A date stone on the front façade of the residence commemorates this association.

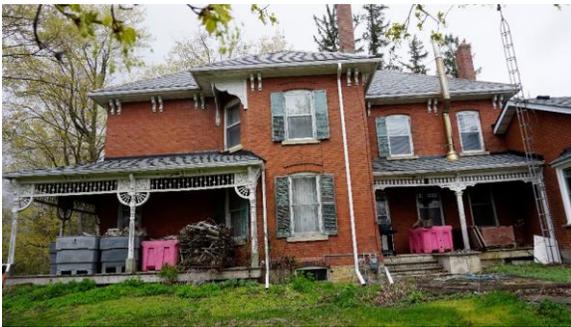
**Photo 12: South elevation looking north**

The south elevation has an angular projecting bay section, with 1/1 wood windows within wood segmental frames (Photo 12). The windows have brick voussoirs and concrete sills, and three have wood louvred shutters. The second-storey window that does not have shutters is covered with decorative brackets set on an angle. To the west of the bay is a 1/1 wood window with a leaded glass multi-pane transom. To the east of the bay, the first storey has a covered porch with a stone base, wood columns, and decorative woodwork (Photo 13). The side entry has a wood half-glass door with multi-pane lites within a segmental frame with a metal storm door. Adjacent to the entry and on the second storey are 1/1 windows within segmental frames. The windows each have a brick voussoir and concrete sill. A second-storey window has one wood louvred shutter remaining. A contemporary metal chimney pipe extends between the second-storey windows. The 1973 addition on its west elevation has a contemporary bay window, and on its south elevation, a contemporary sliding glass door (Photo 14 and Photo 15).

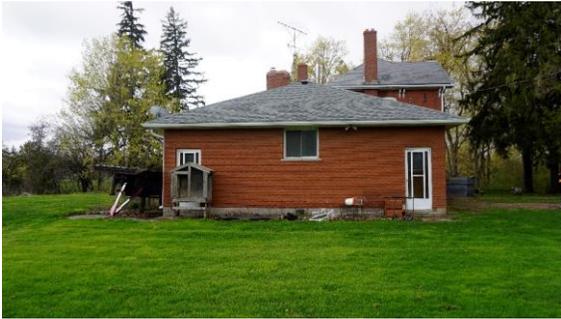
**Photo 16: East elevation of addition looking west**

The east elevation of the addition includes two contemporary entry doors with metal storm doors and a contemporary metal sliding window (Photo 16). The east elevation of the original residence has two 1/1 windows within wood segmental frames with brick voussoirs and concrete sills (Photo 17).

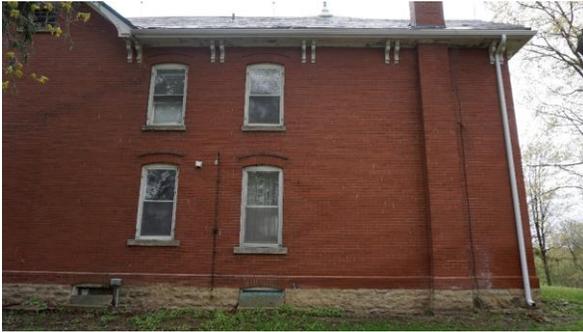
**Photo 18: North elevation looking south**

The north elevation has five 1/1 windows within wood segmental frames with brick voussoirs and concrete sills (Photo 18 and Photo 19). The gabled bay has a small segmental frame window with leaded glass (Photo 20). The north elevation of the addition has a metal garage door, a contemporary entry door with a storm door, a partial concrete porch with metal railings, and a contemporary window (Photo 21).

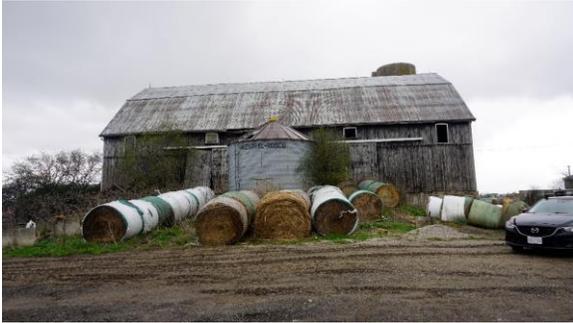
**Photo 22: North elevation of the barn looking south**

The barn is a timber framed structure with a gambrel roof clad with metal and lightning rods (Photo 22). The structure is clad with vertical planks. The barn has a fieldstone foundation with cut stone corners (Photo 23). The north elevation has an earth bank providing access to the second storey through large sliding wood doors. The upper storey of the north elevation has four rectangular wood frame openings. Only one opening has a wood multi-paned window. To the east of the earth bank is an attached wood one-storey outbuilding with a gabled roof with asphalt shingles (Photo 24). The structure is clad in horizontal wood and has wood frame windows.

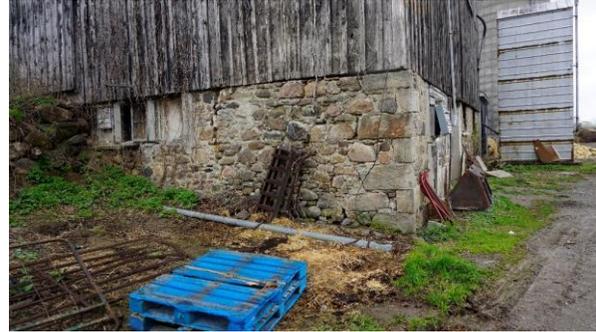
**Photo 23: Detail of fieldstone foundation with cut stone corners**

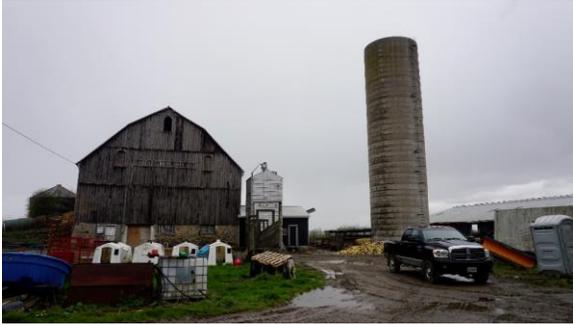
**Photo 25: West elevation looking east**

The west elevation contains a gambrel end with an arched window opening at its peak (Photo 25 and Photo 26). Directly below the peak are two boarded-up arched window openings and remnants of a name on the barn. Only an “R”, “I”, “S”, and “H” remain on the wood nameplate. The lower storey has been modified with a wood-panelled entry door, a louvred ventilator, and a boarded-up door within a concrete section. Adjacent to the concrete sections are two wood frame window openings with wood sills. Within the openings are wood multi-pane and metal 1/1 windows.

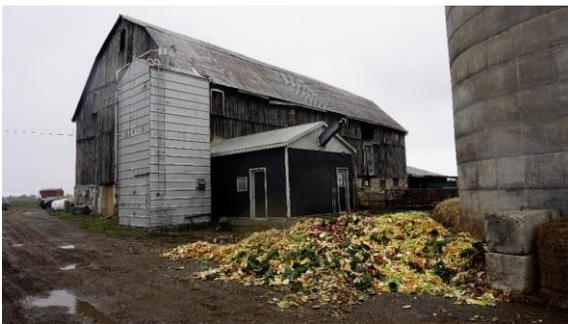
**Photo 27: South elevation looking northeast**

The south elevation of the barn has a 20<sup>th</sup> or 21<sup>st</sup> century addition in its southwest corner (Photo 27 and Photo 28). The addition is a one-storey structure with a metal-clad gable roof. The structure is clad in corrugated metal and has a concrete foundation. The structure has two wood doors clad with corrugated metal. The window has been boarded up. Attached to the west elevation of the addition is a 20th century metal silo.

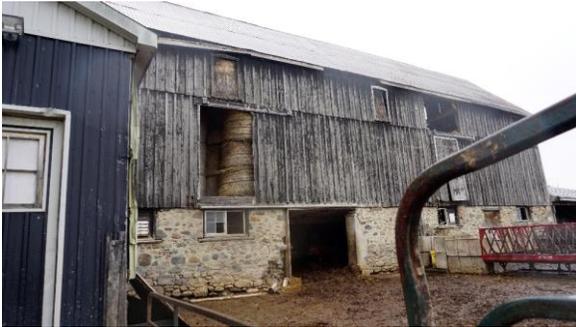
**Photo 29: South elevation looking northeast**

The south elevation of the original barn has two sliding doors and four rectangular wood frame openings that have been boarded up (Photo 29). The second storey of the barn, as visible from the south elevation, is being used to store hay. While the lower storey is being used to house cattle. The lower storey has a rectangular opening, four wood frame window openings with wood sills, and a wood door.

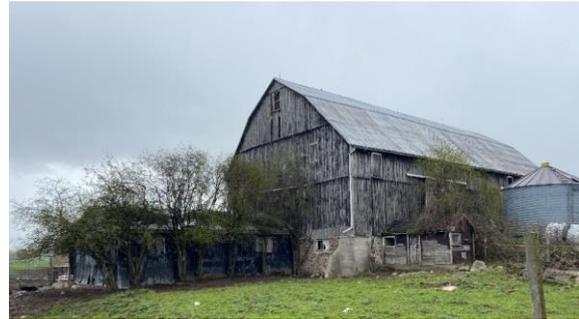
**Photo 30: East elevation looking southwest**

The east elevation contains a gambrel end with a rectangular wood frame window. The elevation has a one-storey addition with a gable roof clad with metal. The exterior of the structure is clad with metal and has wood frame windows (Photo 30).

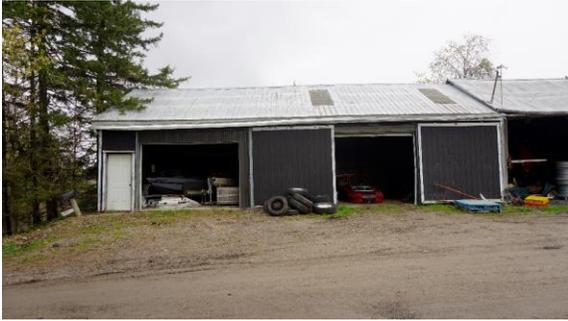
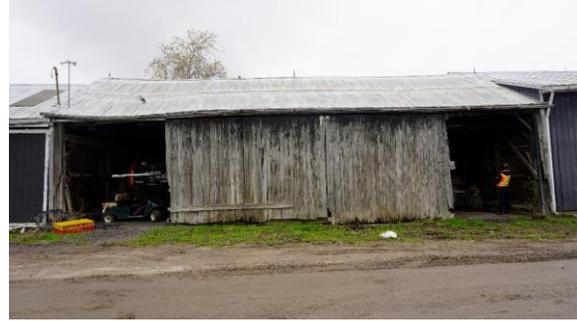
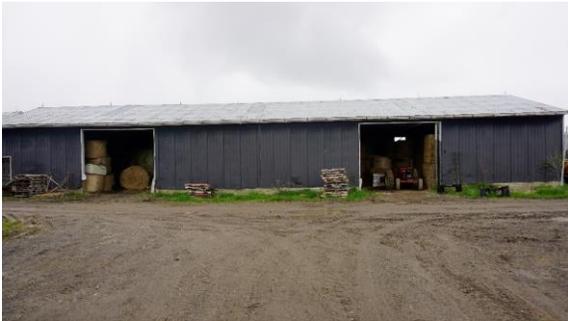
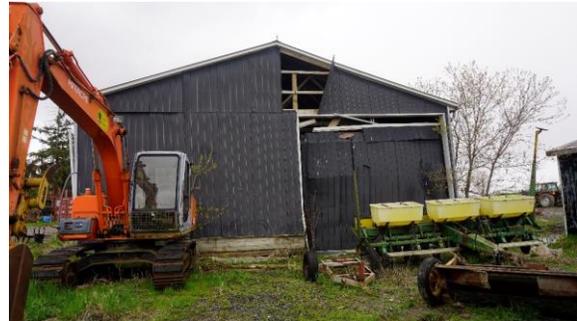
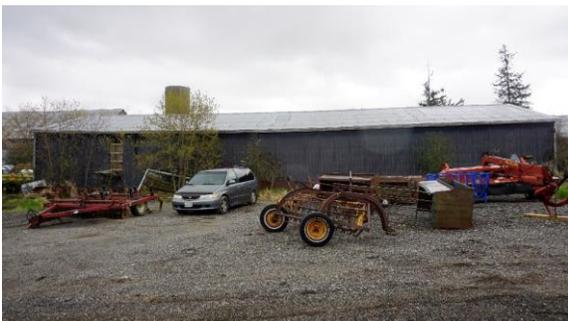
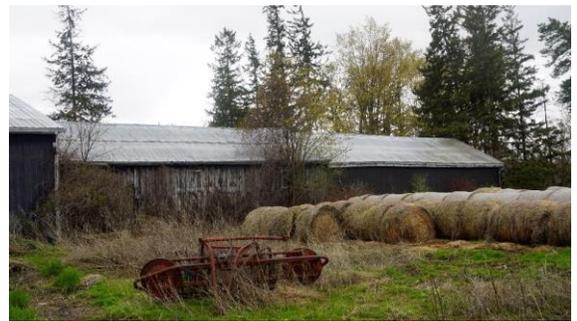
The driveshed is an evolved structure. The centre portion of the driveshed is the oldest section, dating to the late 19<sup>th</sup> to early 20<sup>th</sup> century, based on construction materials, with additions to the west and east. The west addition was added in the mid-20<sup>th</sup> century, and the east portion between 1974 and 1985, based on aerial photography. The centre portion is clad with vertical planks, while the west and east portions are clad in corrugated metal. The one-storey structure has a gable roof clad with metal and lightning rods. The south elevation includes all the access doors to the outbuilding (Photo 31). The south elevation of the west portion has two large sliding doors clad in corrugated metal and a steel entry door. The south elevation of the centre and east portions each have two large rectangular openings (Photo 32 and Photo 33). The east and north elevations do not have any openings (Photo 34 to Photo 36). The west elevation has two small wood frame windows (Photo 37). The interior of the west portion is a wood frame structure clad with wood panelling and has concrete flooring (Photo 38). The interior of the centre portion has hand-hewn beams and posts, with a wood frame ceiling clad with wide wood boards (Photo 39 and Photo 40). The interior of the east portion is a wood frame structure with steel braces (Photo 41).

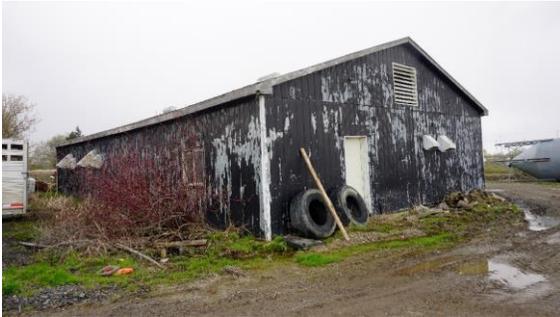
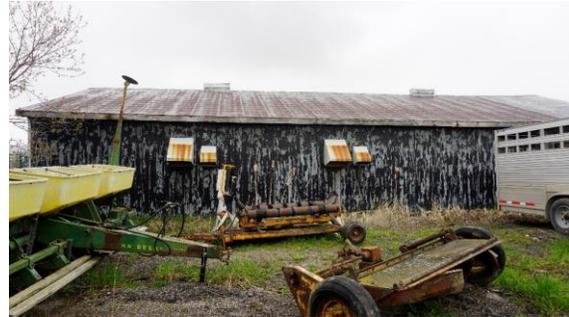
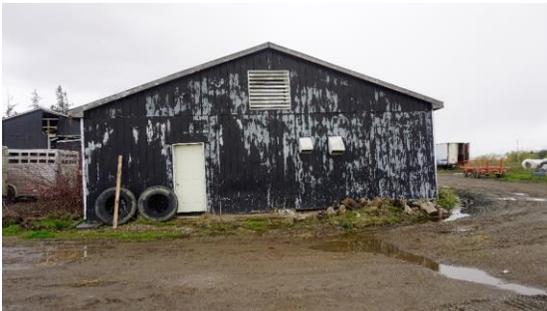
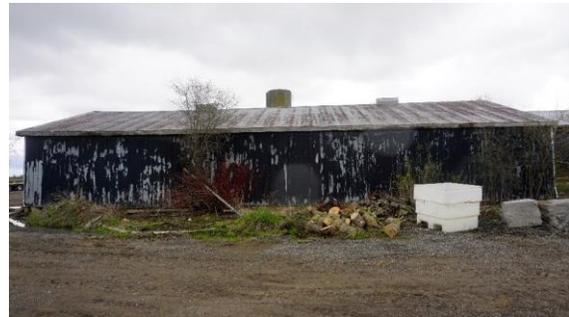
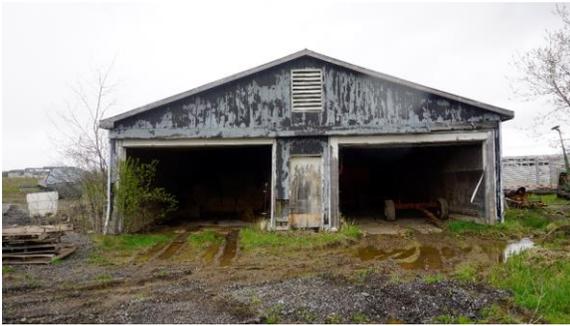
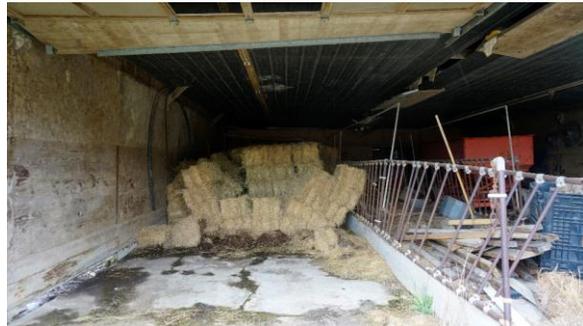
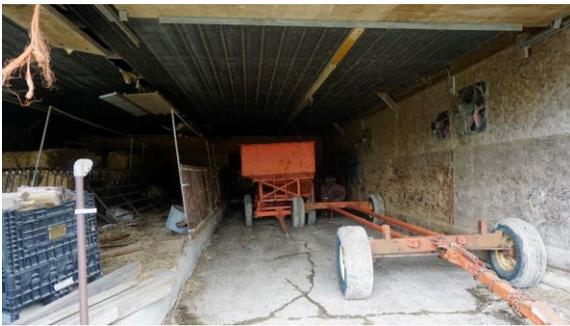
Northeast of the driveshed is a storage driveshed that was added to the property between 1985 and 1996, determined through aerial photography (Photo 42). The outbuilding is a one-storey structure with a gable roof clad in metal. Its exterior is clad in metal. The south elevation has a horizontal sliding window and metal ventilators (Photo 43). The east elevation has a steel entry door, a rectangular metal louvred opening, and ventilators (Photo 44). The north elevation has no openings (Photo 45). The west elevation has two large rectangular openings and a rectangular metal louvred opening (Photo 46). The outbuilding is a wood frame structure with wood panelling and concrete flooring (Photo 47 and Photo 48).

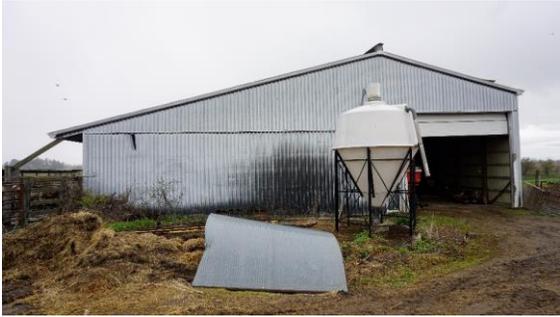
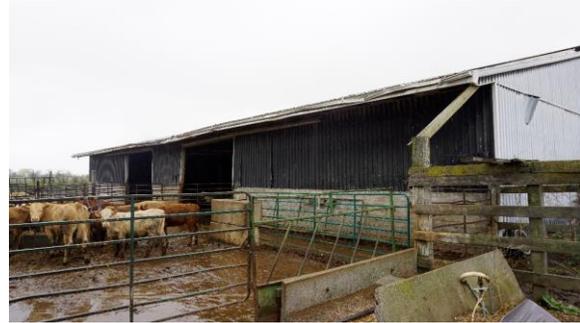
South of the barn is a cattle outbuilding added to the property between 1974 and 1986, determined through aerial photography. The outbuilding is a one-storey structure with a gable roof with a saltbox side on its north elevation (Photo 49). The roof is clad with metal. The exterior is clad in corrugated metal. The west elevation has a steel garage door. The north elevation has two large rectangular openings that provide access to the outdoor space for the cattle (Photo 50).

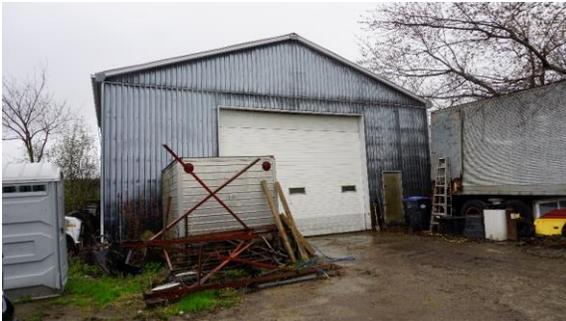
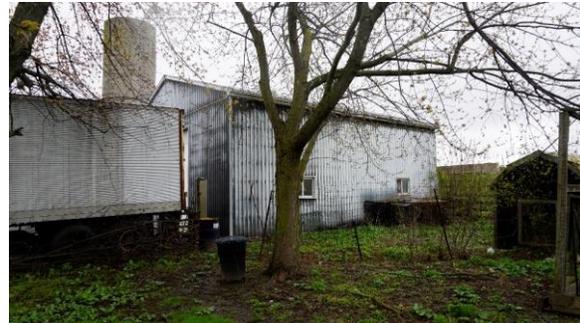
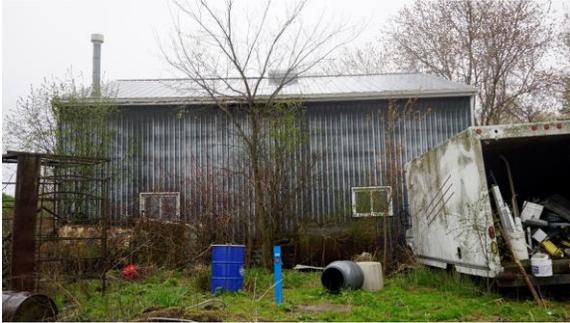
The storage outbuilding southeast of the barn was added to the property between 1974 and 1985. It is a one-storey structure with a gable roof clad with metal (Photo 51 to Photo 53). Its exterior is clad in corrugated metal. The north elevation has a steel garage door and a steel entry door. The west and east elevations each have two contemporary horizontal sliding windows.

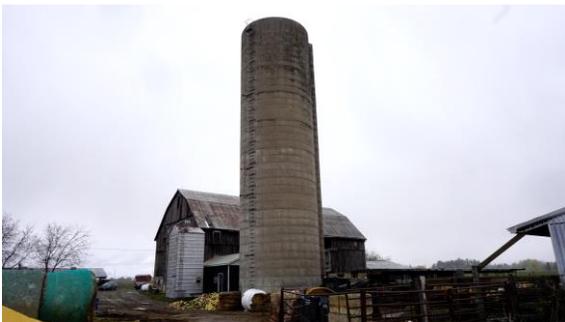
**Photo 54: Silo looking northeast**

The silo is a concrete stave tower structure that was added to the property between 1985 and 1996, determined through aerial photography (Photo 54).

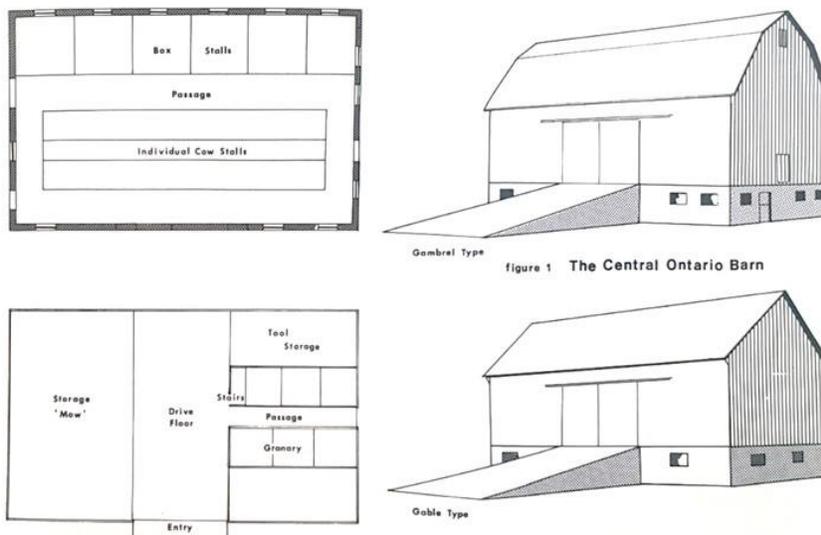
**Plate 2: Plan and Aspect of the Gambrel and Gable types of the Central Ontario Bank Barn. Source: Ennals 1968, 19.**

The property features a timber-framed bank barn with a gambrel roof, a design characteristic of Central Ontario Barns, as described by Ennals in 1972. These barns, which are typically 60 to 100 feet long and 40 to 50 feet wide, are based on the three-bay English barn design (Ennals 1972, 256). They either come with a ramp for accessing the second-level central bay or are built into a slope, earning them the name 'bank barn'. The central bay is used as a drive floor, threshing floor, or storage for work equipment, while the other two bays serve as storage or mows for hay, straw, or grain, and a granary. The first level is dedicated to housing livestock, with feed chutes leading from the second level (Plate 2) (Ennals 1972, 258).
