Proposed Warehouse Development

Preliminary Hydrogeological Assessment

12892 Dixie Road, Caledon, Ontario

February 23, 2021

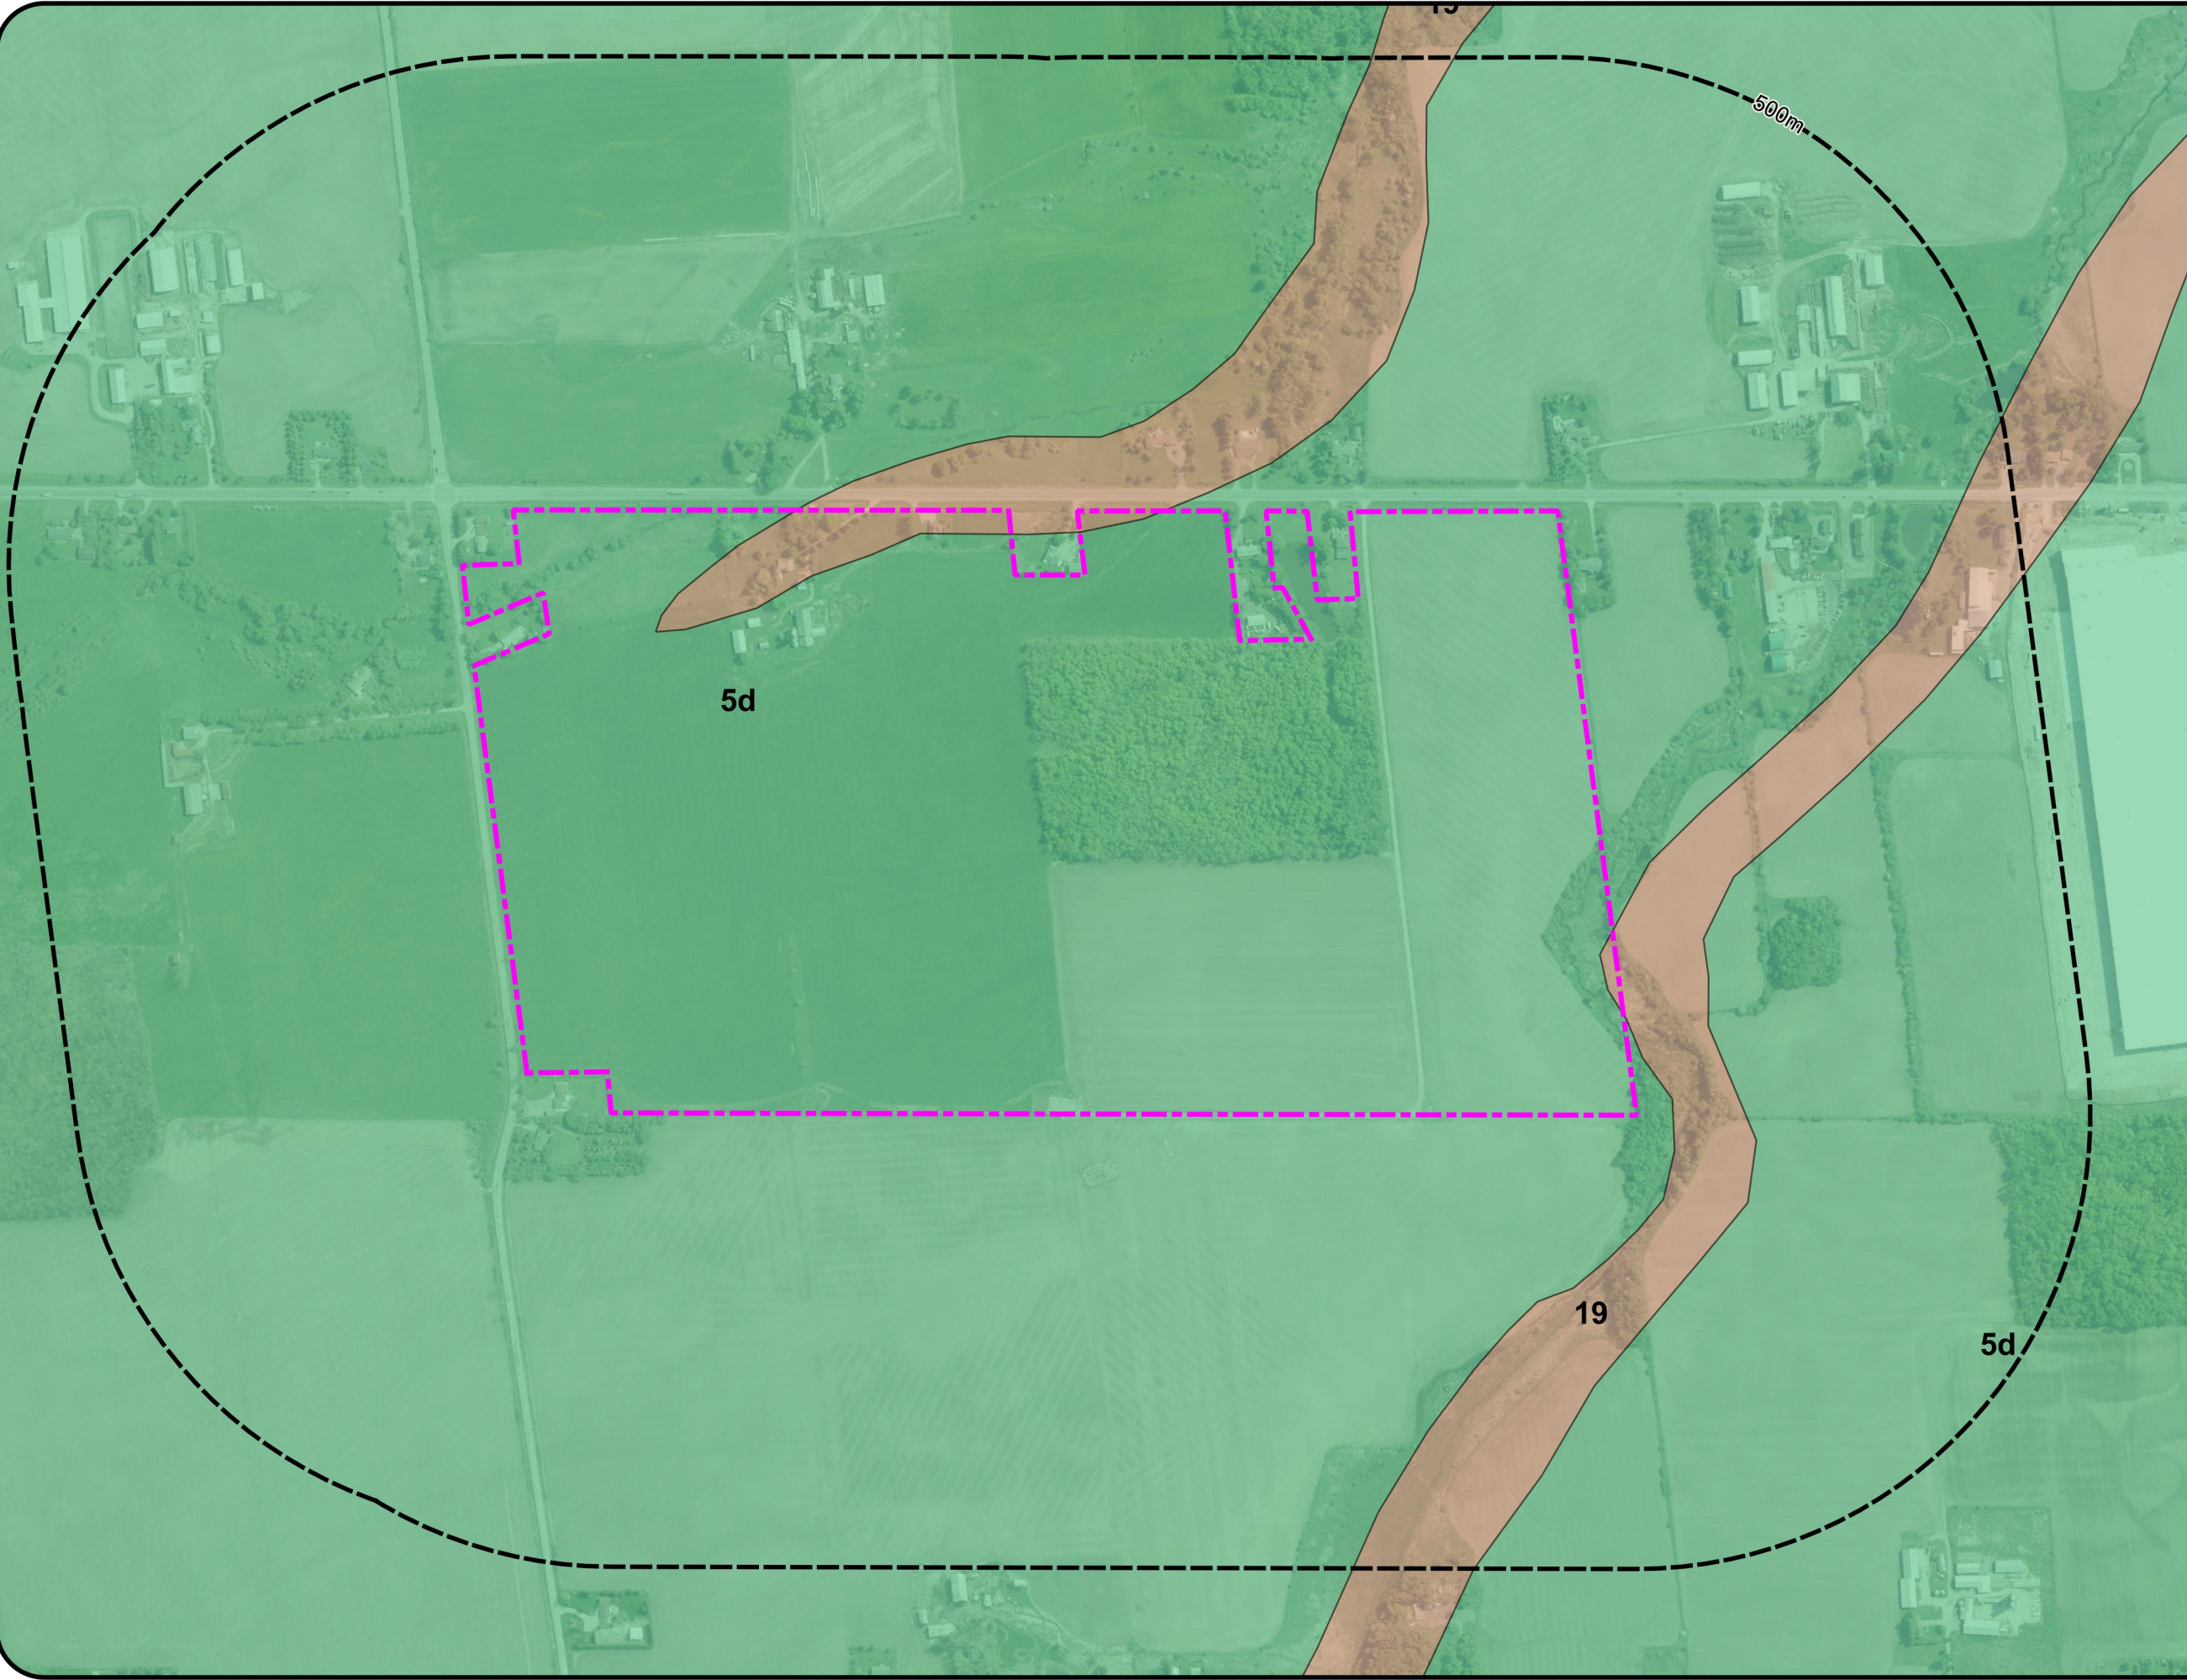
SITE	12892 Dixie Road Caledon, ON		Prepared By	MBC	
			Drawn By	SLG	
			Date	February 2021	
			Project No.	48043-300	
			Figure No.	1

MTE Consultants Inc. (MTE) was retained by Tribal Partners (Canada) Inc. (Tribal) to carry out a preliminary hydrogeological assessment to support the proposed development of 12892 Dixie Road in Caledon, Ontario (hereinafter referred to as the “Site”). The approximate location of the Site is shown on **Figure 1**.
