# 12824 and 12892 Dixie Road, Caledon

## Phase I Environmental Site Assessment

12824 and 12892 Dixie Road, Caledon, ON

September 30, 2020

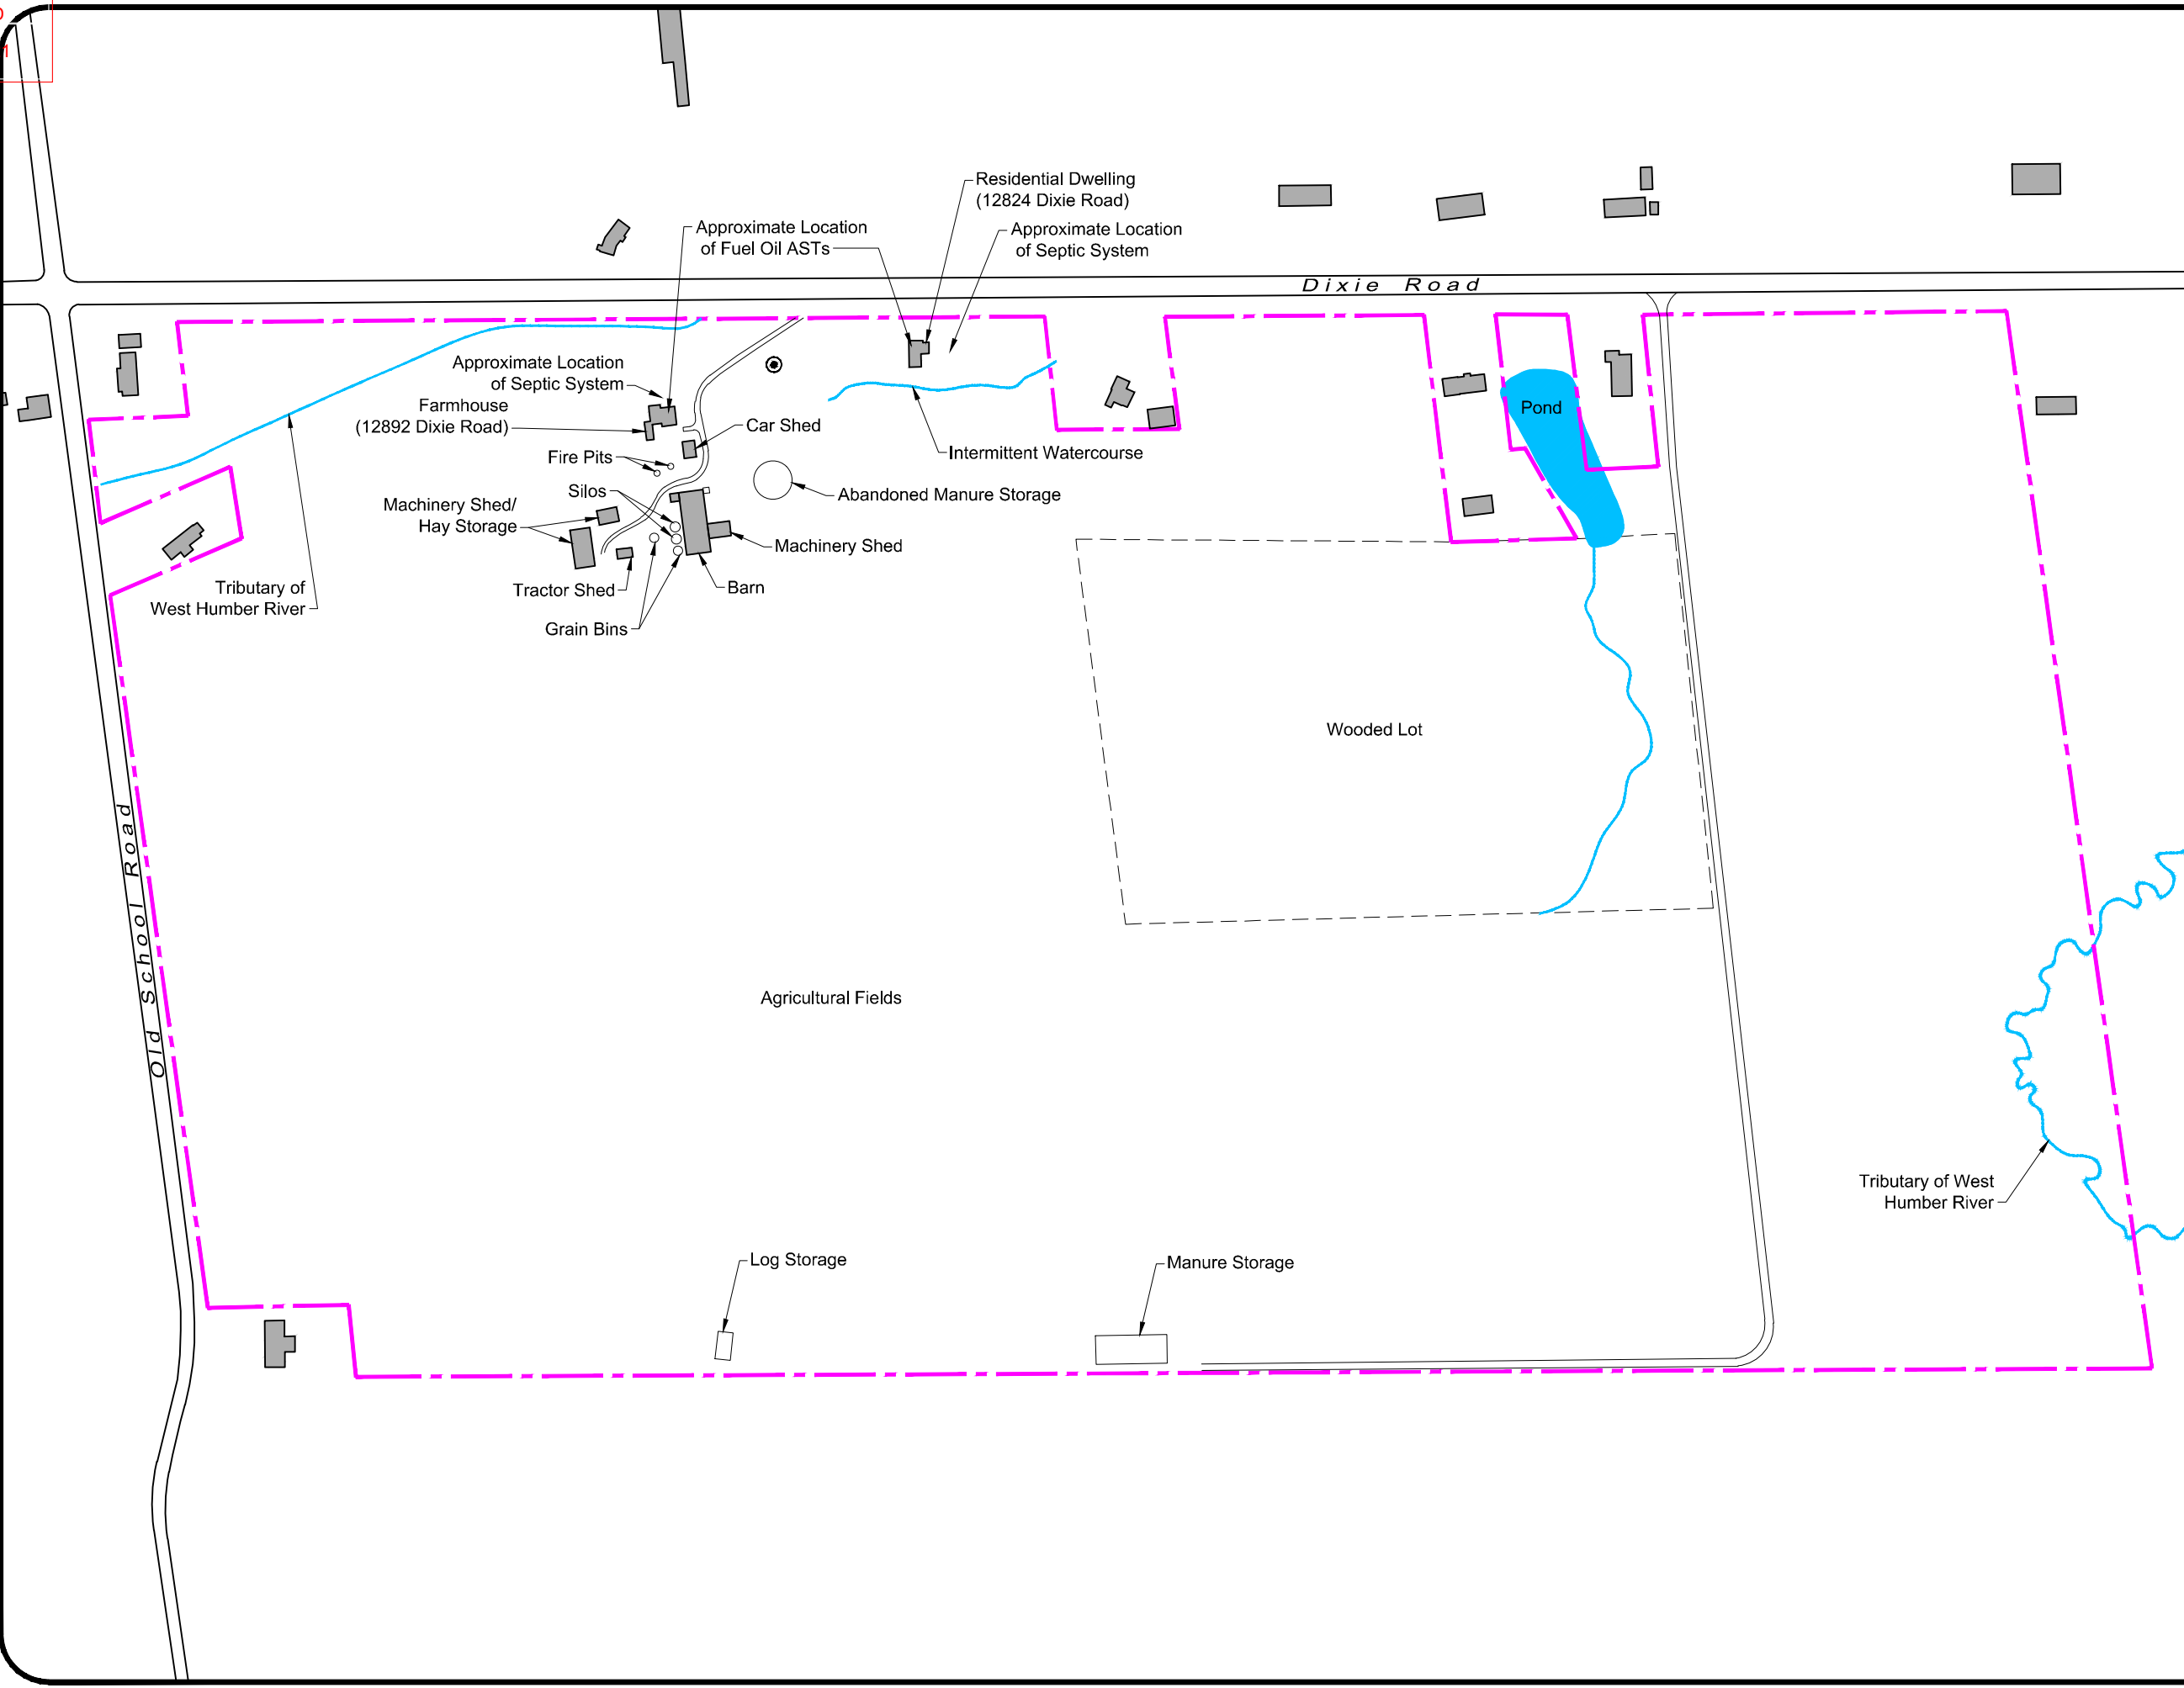
Project: 48043-100 CAD: P:\P\48043\100\48043-100-ESA1.DWG  
2 SITE LAYOUT AND FEATURES  
September 26, 2020 — 11:35 AM — Plotted By: TSchneider

Former above ground fuel oil ASTs were reported to have been removed from the basements of the farmhouse and residential buildings. During the Site visit evidence of these former ASTs (suspected former fill and vent pipes) was observed including:

- Two cut-off pipes near the eastern exterior wall of the farmhouse adjacent to the natural gas service; and
- Two patched holes in the concrete block foundation on the north exterior wall of the residential dwelling adjacent to the natural gas service.

The locations of the observed piping and reported locations of the former ASTs are depicted on **Figure 2**.

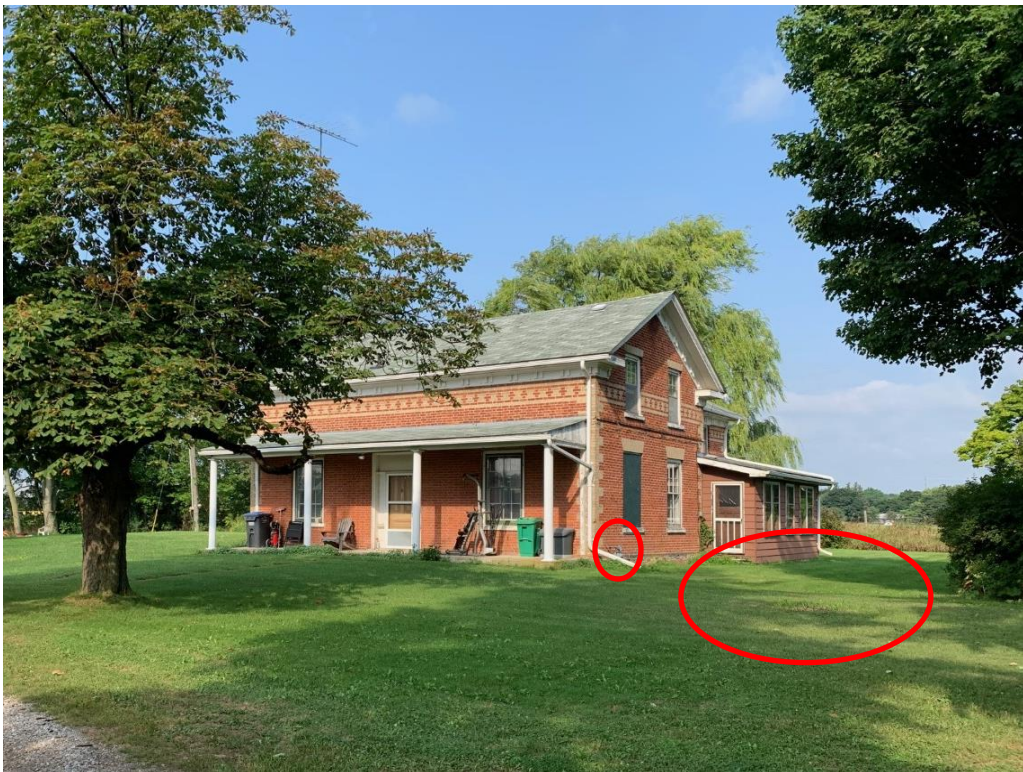
**Photograph No. 4** – View of septic system and former AST vent/fill pipes adjacent to the 12892 Dixie Road farmhouse facing southwest.

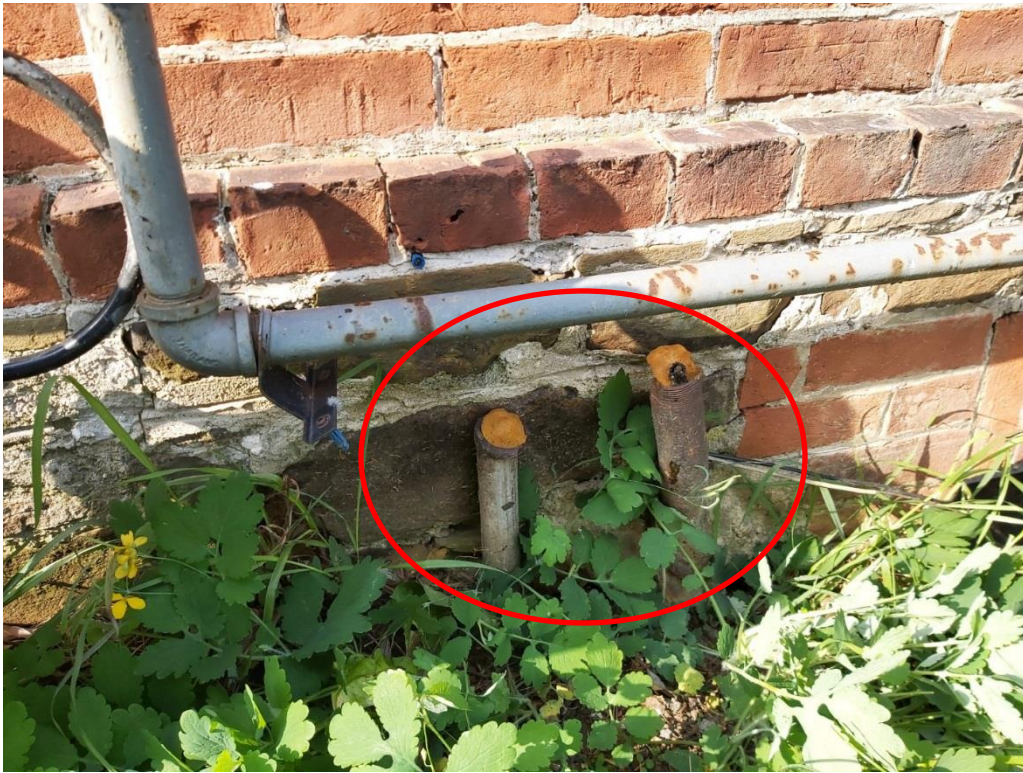
**Photograph No. 5** – View of the two cut-off pipes associated with the former fuel oil AST located along the east exterior wall of the 12892 Dixie Road farmhouse.

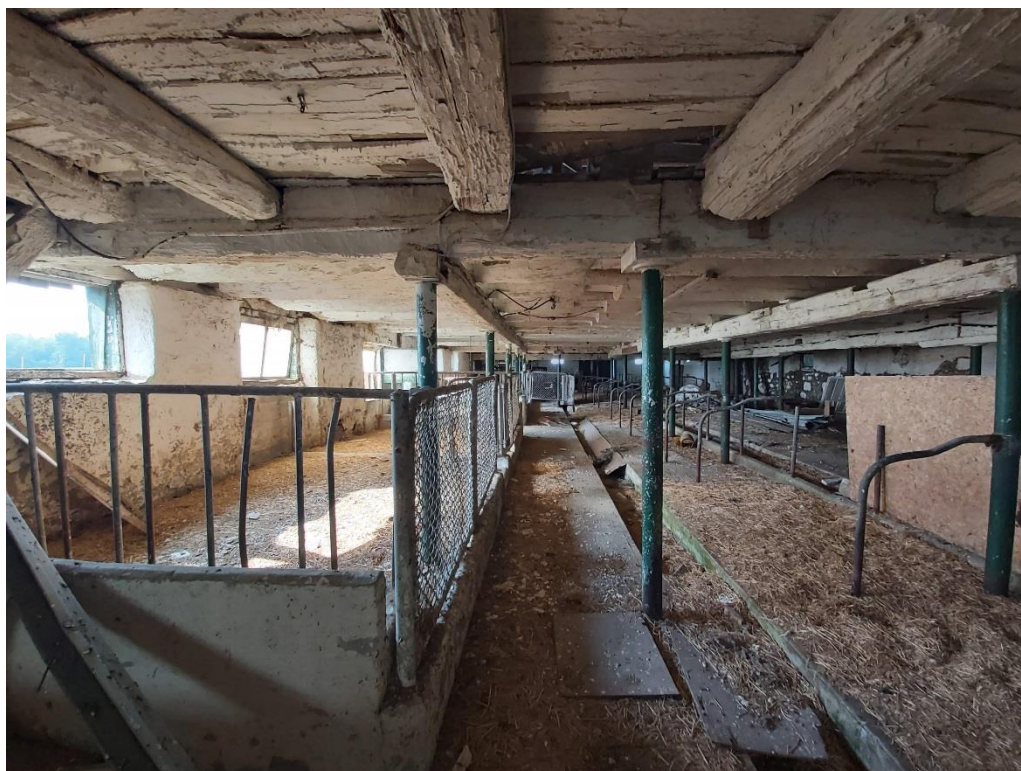
No hazardous wastes are currently generated on the Site. Household and agricultural waste was observed in the barn. Old metal items and pieces of concrete and wood were observed throughout the site. Some residual manure was observed in the manure storage area. No potentially hazardous wastes were observed during the Site visit.

**Photograph No. 8 – Interior view of the first storey of the barn.**

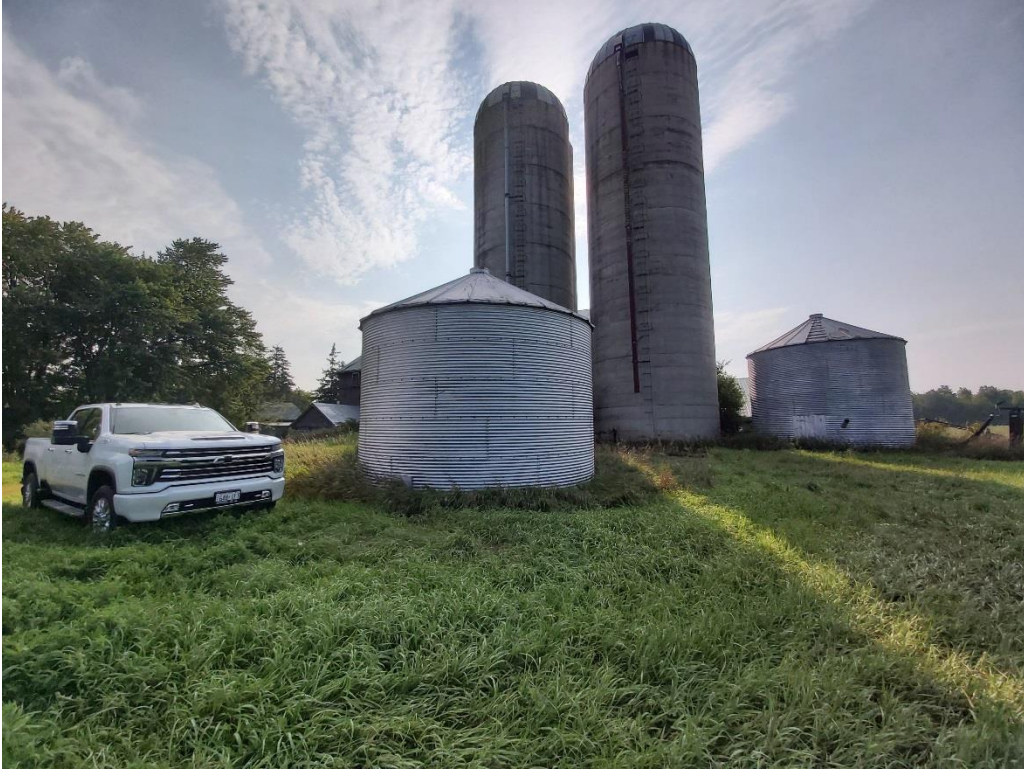
The Site is also occupied by two concrete silos and two metal grain bins. No environmental concerns were observed to be associated with these structures.

**Photograph No. 17** – View of the two silos and two grain bins.

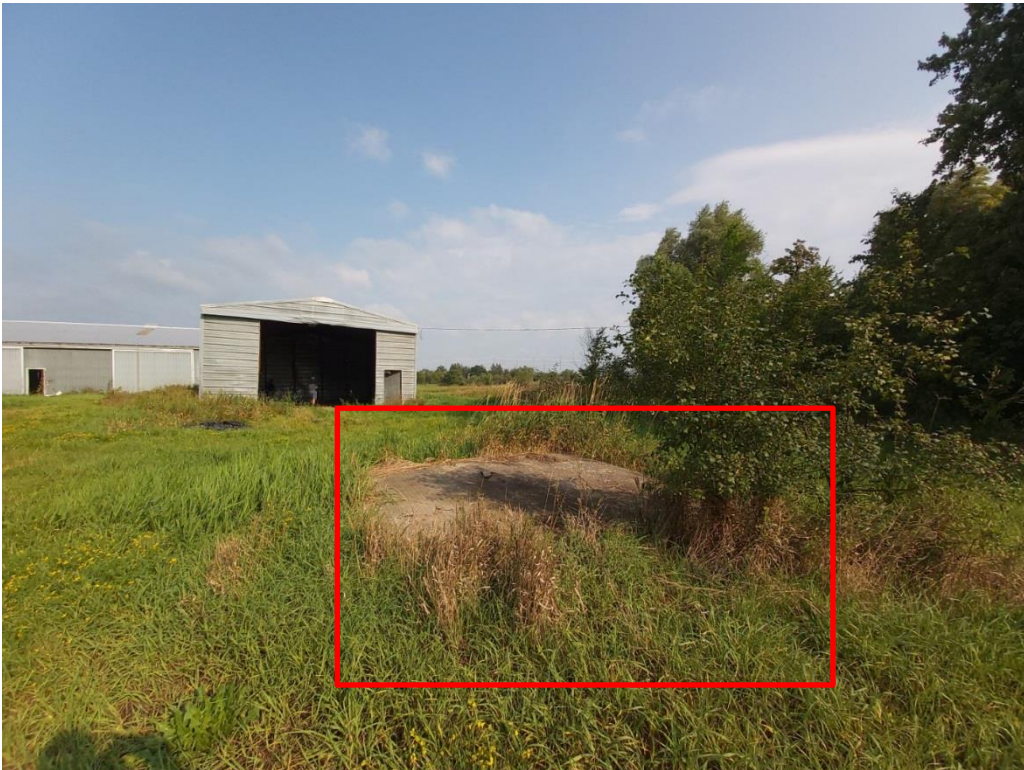
**Photograph No. 18** – View of the concrete slab facing north.

The use of the concrete slab with the two cut-off pipes is not known. It is recommended that a GPR survey be conducted concurrent with the Phase II ESA in the vicinity of the concrete slab to assess the potential that the pipes are associated with an underground storage tank (UST).

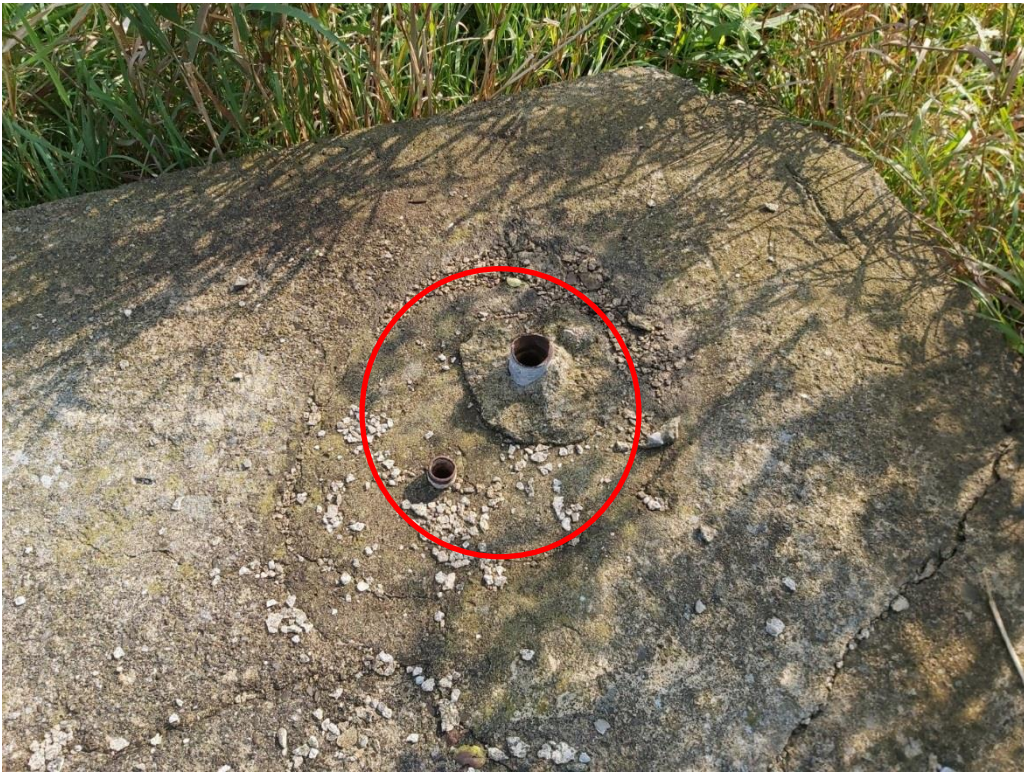
**Photograph No. 19** – View of the two cut-off pipes extending through the concrete slab.

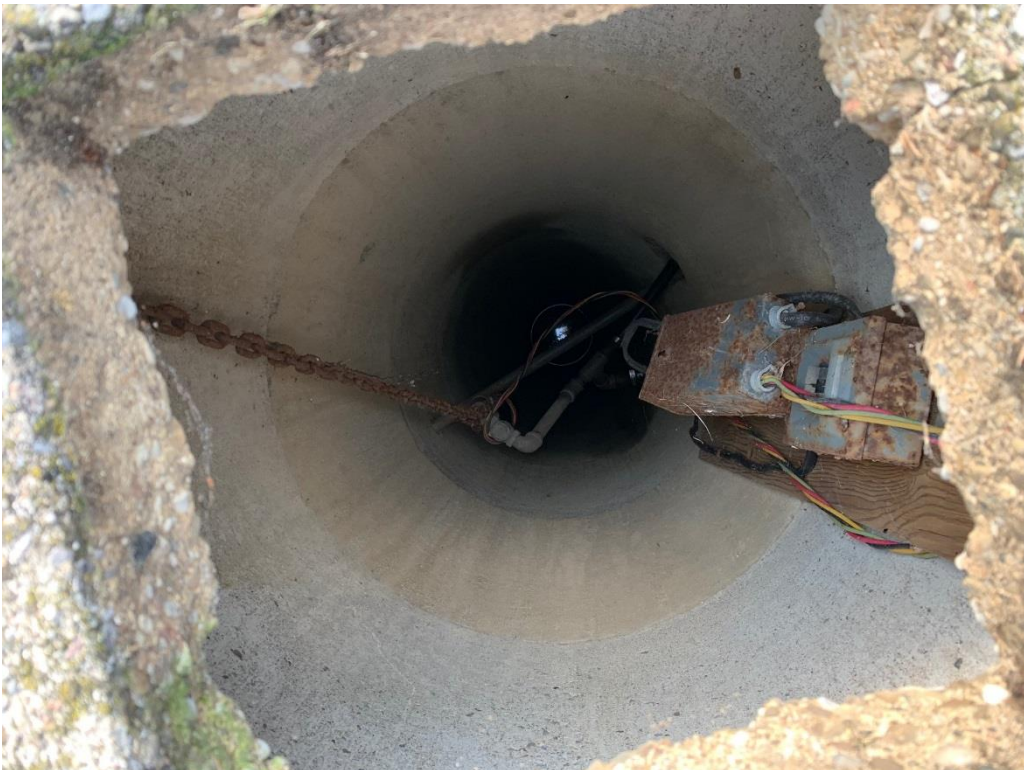
An abandoned private drinking water well was observed on Site during the Site visit. The water level in the well was measured to be approximately 10m below the top of the concrete casing (approximately 9.25m below ground surface).

**Photograph No. 20** – View of the abandoned well.

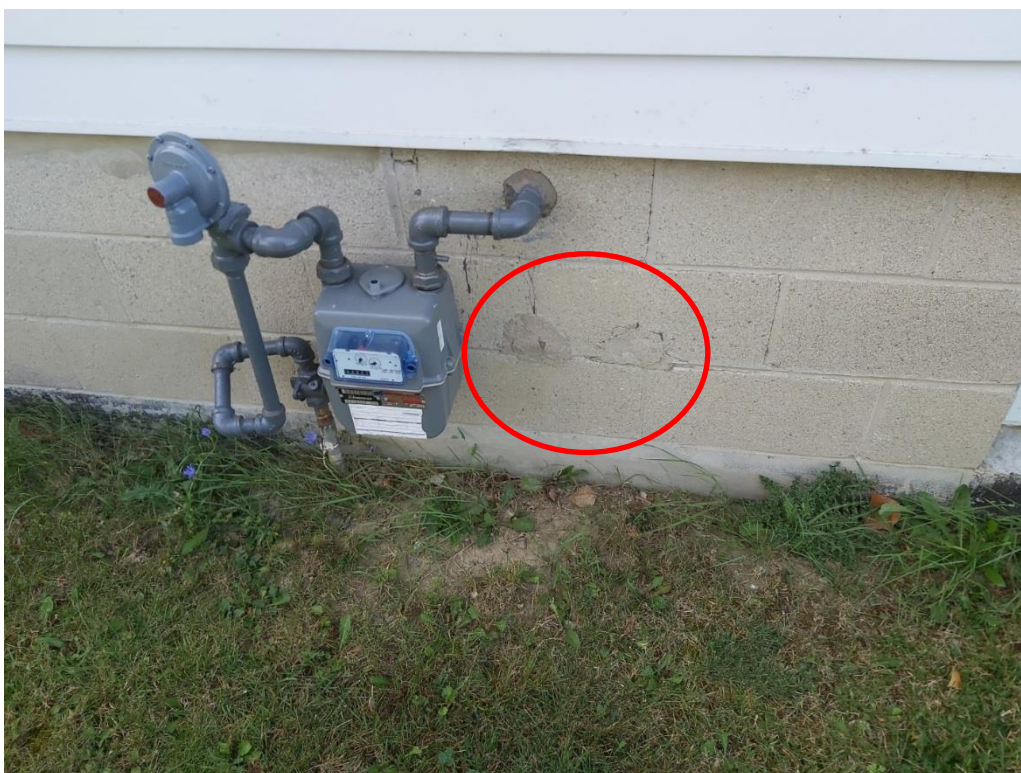
**Photograph No. 22** – View of evidence of two former pipes associated with the former fuel oil AST located along the north exterior wall of the 12824 Dixie Road residential dwelling.

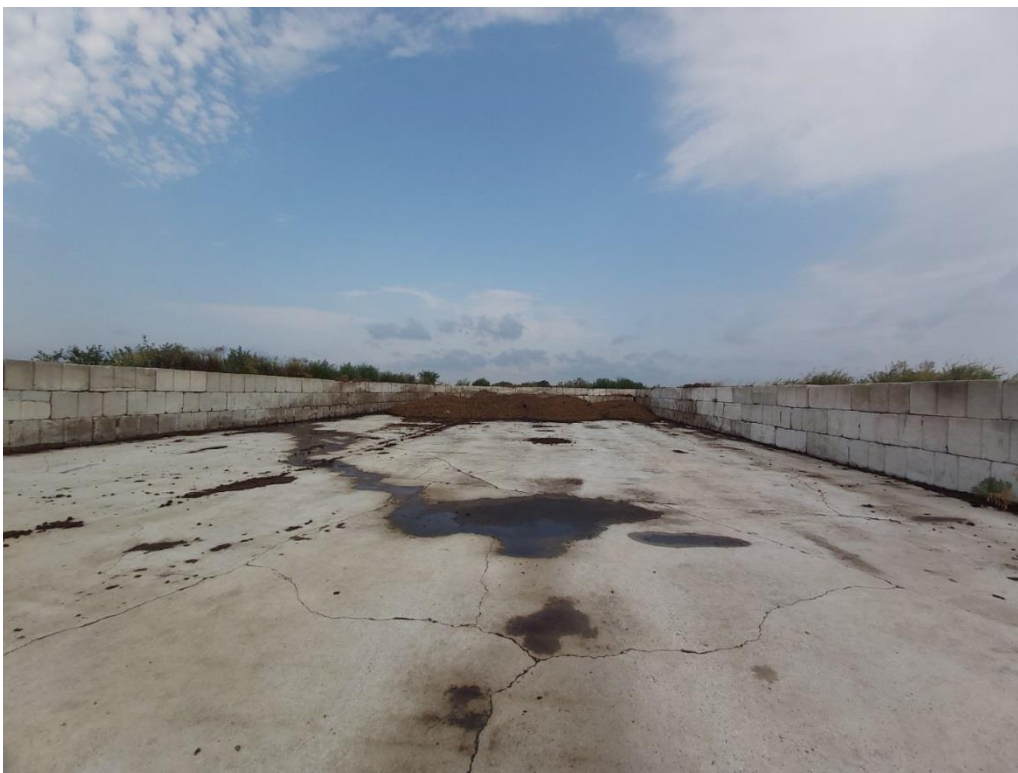
There were no pits or lagoons observed on-Site. Manure is currently, and was historically, stored in concrete structures on the Site.

**Photograph No. 23** – View of the current manure storage area facing north.
