REPORT, REV. 1

SLOPE STABILITY ASSESSMENT

**PROPOSED RESIDENTIAL SUBDIVISION
13286 NUNNVILLE ROAD
BOLTON, ONTARIO**

January 02, 2026
Ref. No. G7442, Rev. 1

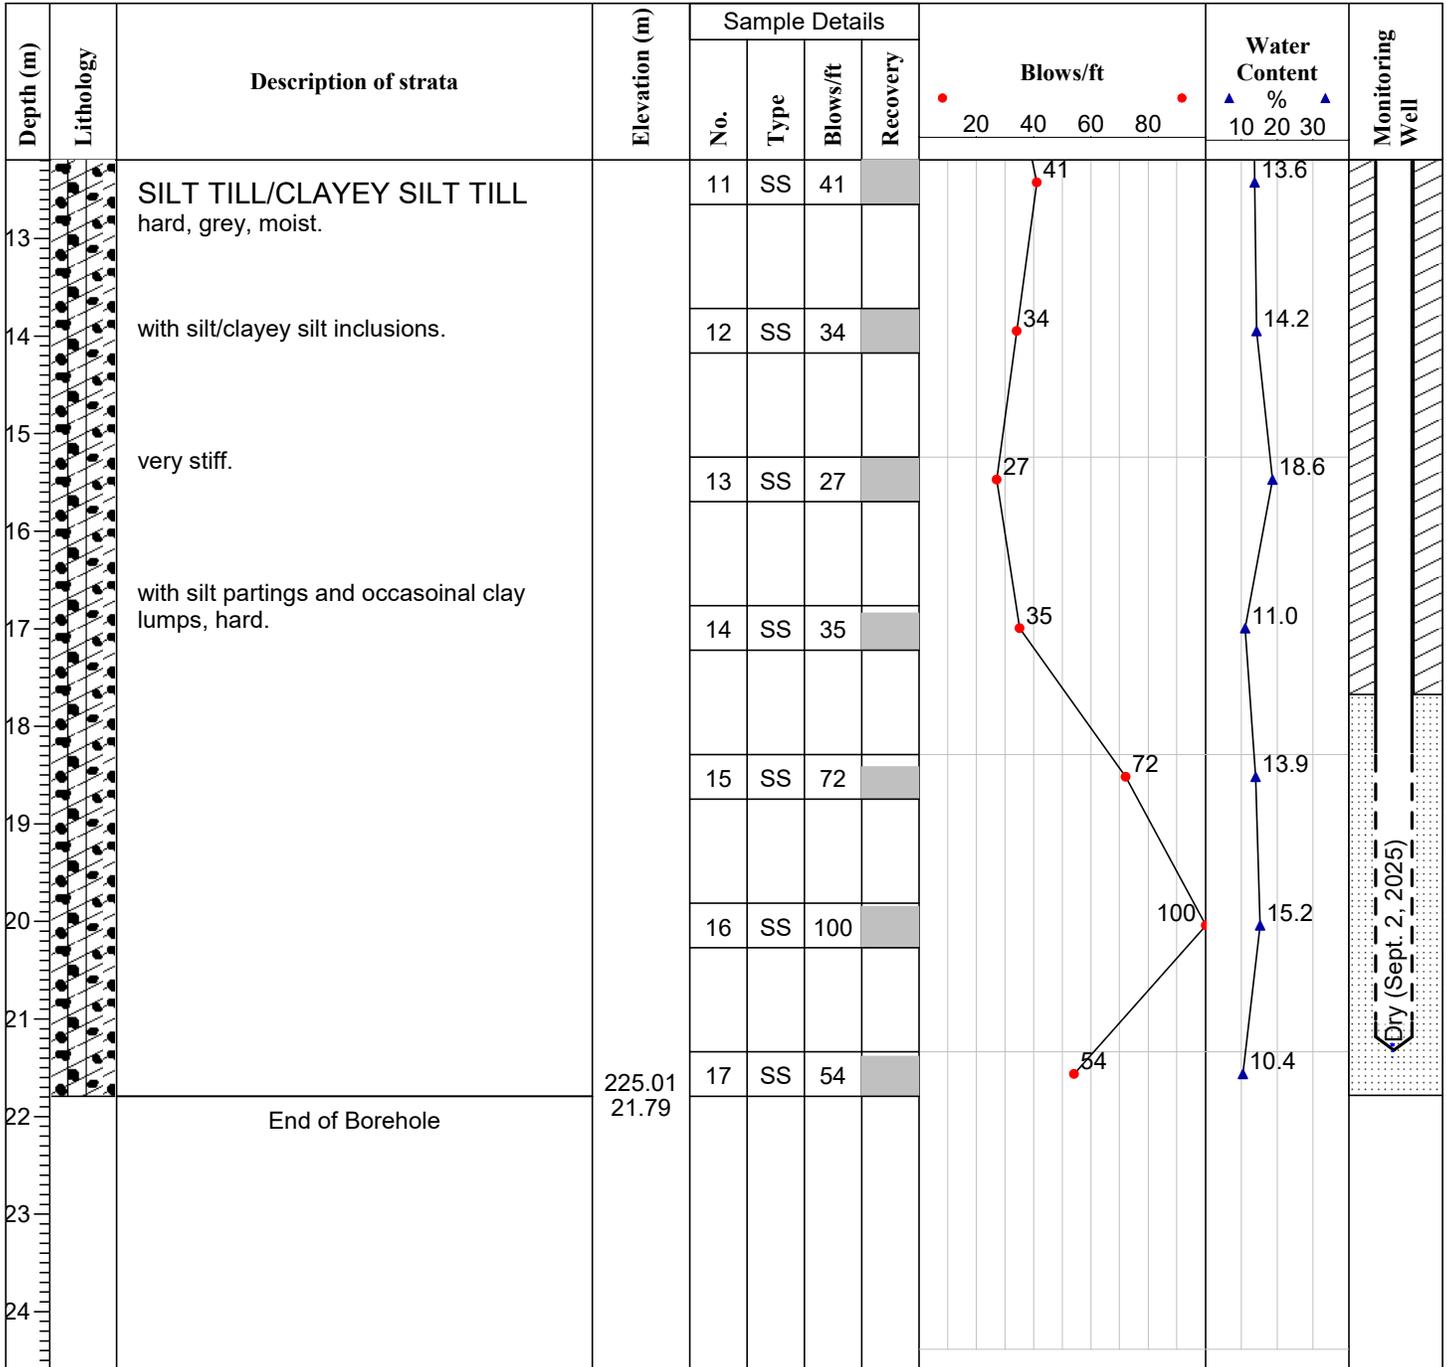
Remarks: -Upon completion of drilling, the borehole was open and dry.
 -On Sept. 2, 2025, the water level in the installed well was measured in the installed well and was dry.

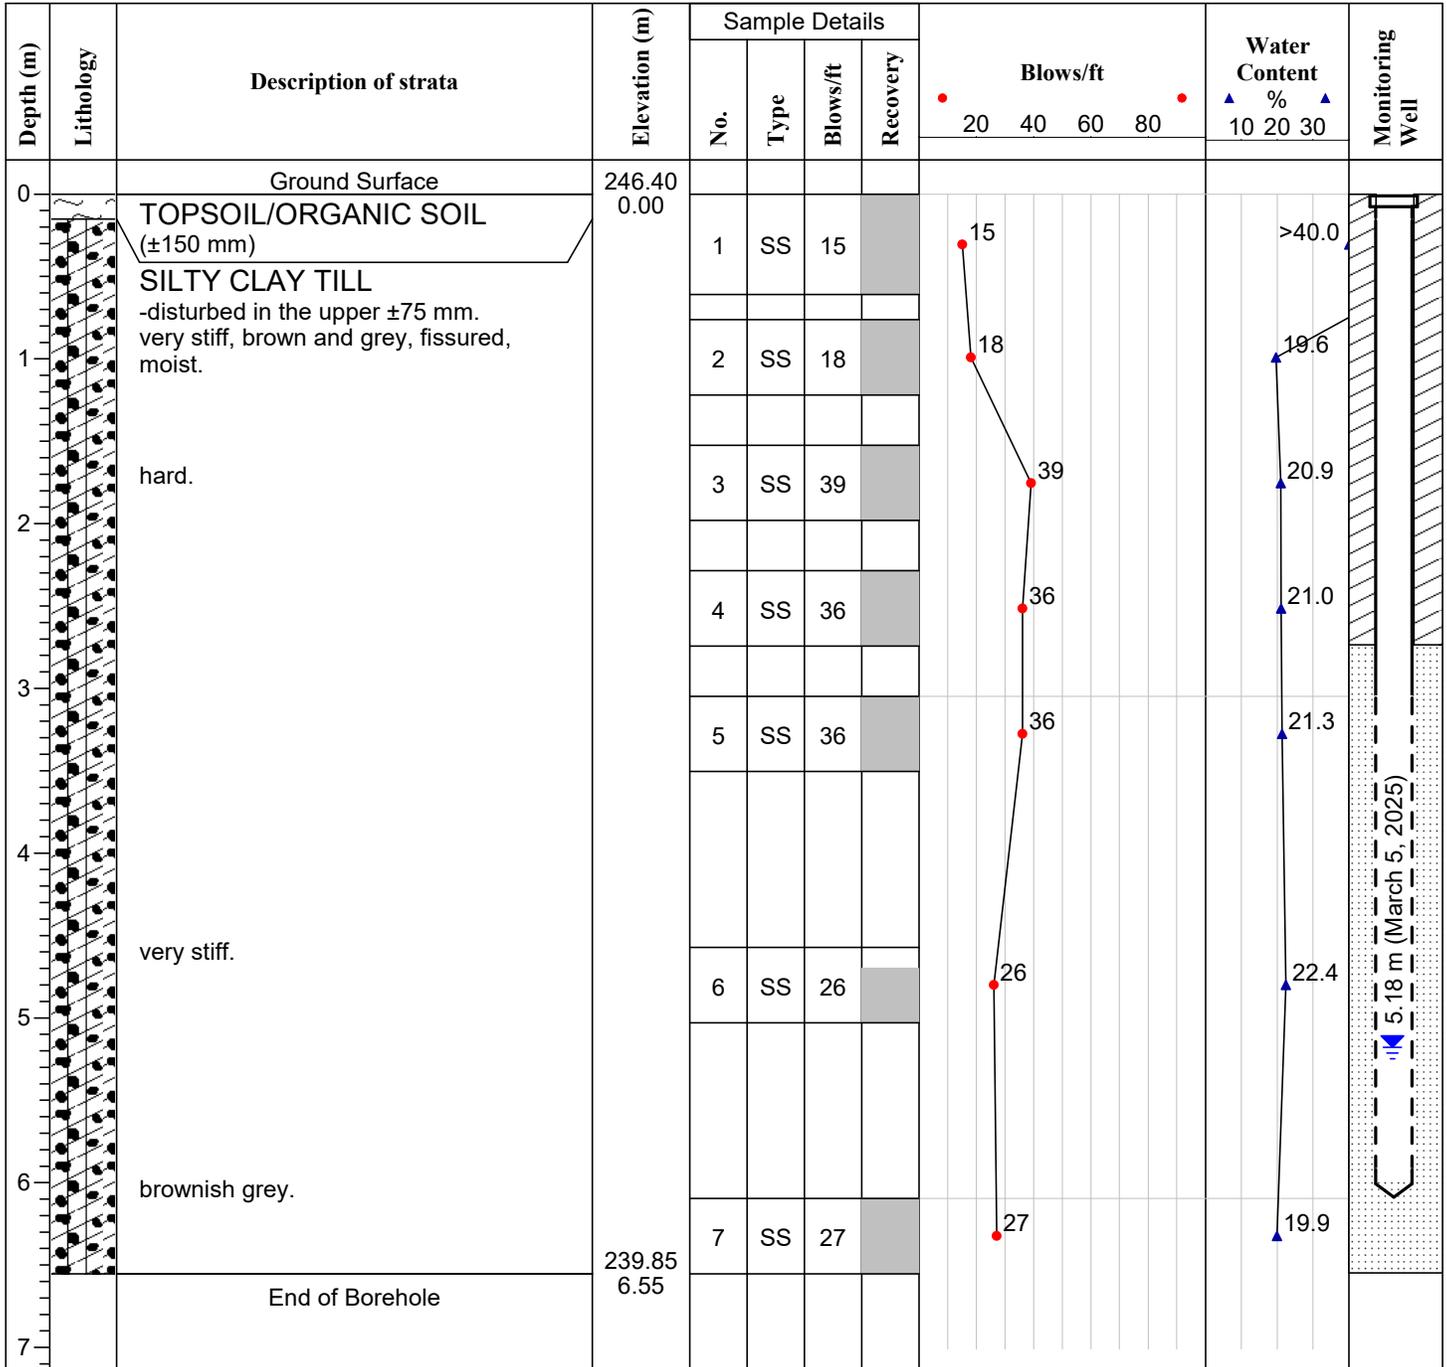
Remarks: -Upon completion of drilling, the borehole was open and dry.
 -On March 5, 2025, the water level in the installed well was measured at 5.18 m below EGSL.

| ID & Date of GWL Measurement | Groundwater Depth Below EGSL & (elevation) |
|---|---|
| BH/MW-102 <i>March 5, 2025</i> | 5.18 m (241.22 m) |

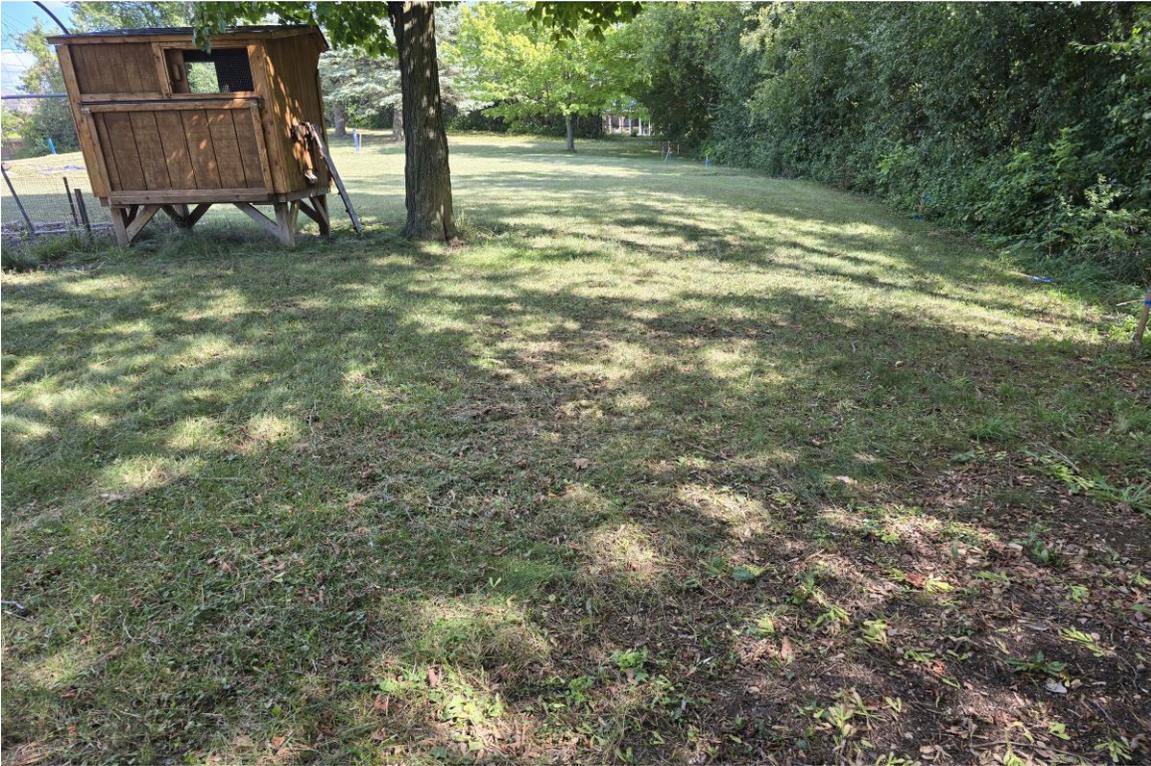
Photo 1: Relatively flat terrain along the top of the slope. No tension cracks were noted.

- The slope is covered with mature trees, bushes and vegetation.
- No tension cracks were observed at top of the slope.
- The trees are in a reasonable vertical position.
- In general, our field review of the slope condition suggests that the slope is in a stable condition with respect to global slope stability.

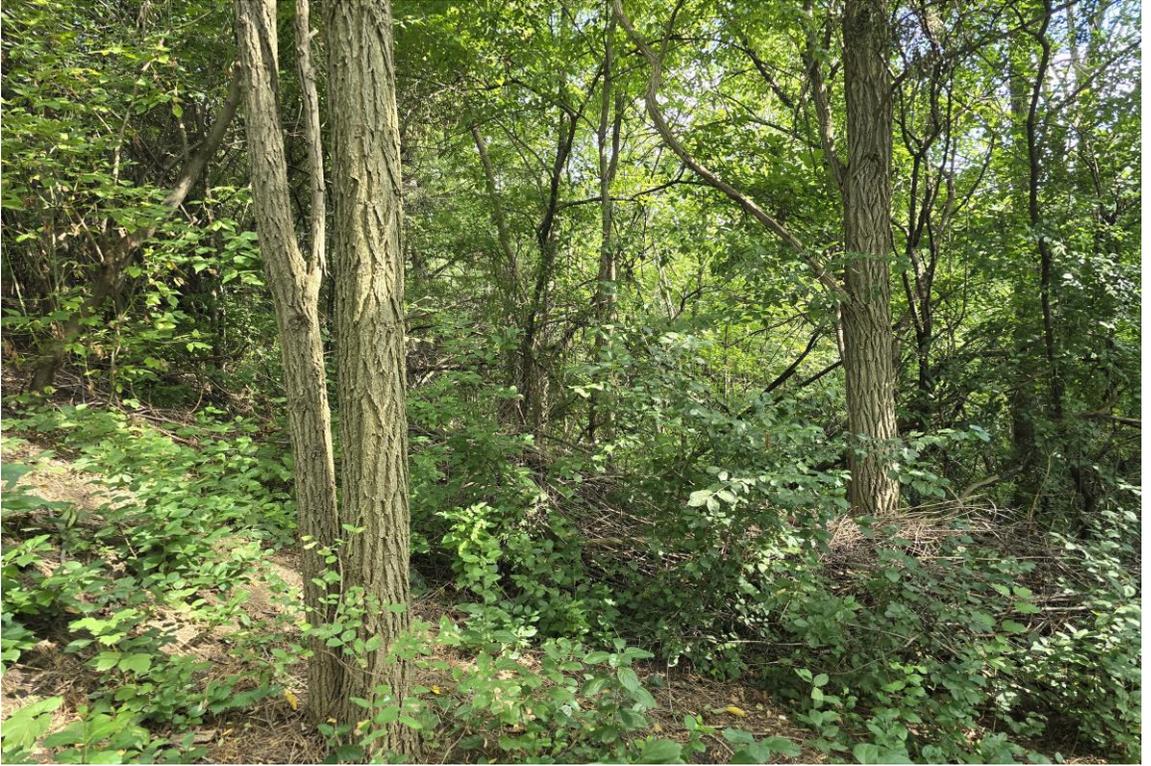
Photo 2: Trees within the slope are reasonably vertical.

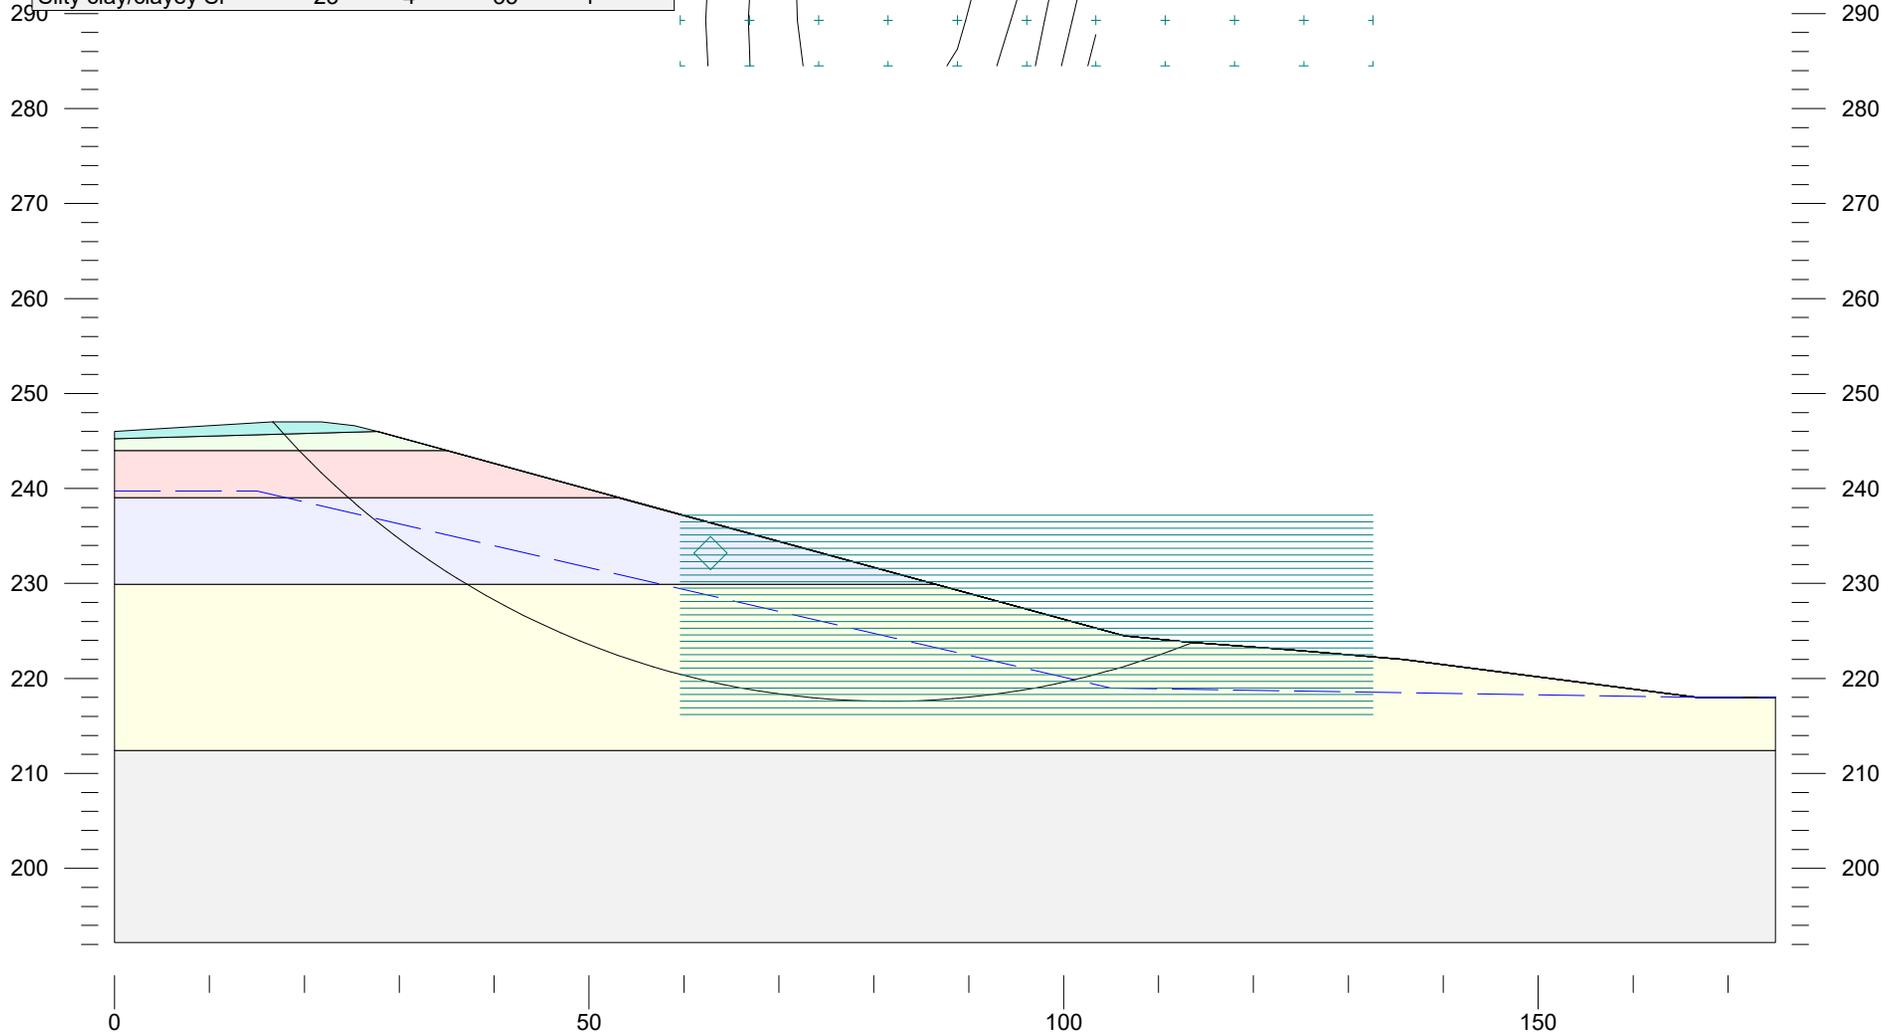
Forward Engineering & Associates Inc.
 JOB NO. 7442
 13286 Nunnville Rd.m Bolton, ON
 Aug. 2025
 SECTION AA
 Drawing No. 2

| Section | Slope Height | Inclination |
|---|---|---|
| AA | 23.50 m | 3.75 H to 1 V |

The slip surfaces with minimum safety factors greater than 1.5 are graphically shown on Drawings 2 to 5, enclosed in Appendix D.

No slip surface with minimum safety factor less than 1.5 was detected beyond the Physical Top of Bank (TOB) staked by TRCA on May 23, 2025. For location of the TOB, refer to Topography Survey, attached in Appendix D.

Based on the above, the TOB staked by TRCA on May 23, 2025 can be taken as the LTSTOS line, as presented on the Plan of Topography.

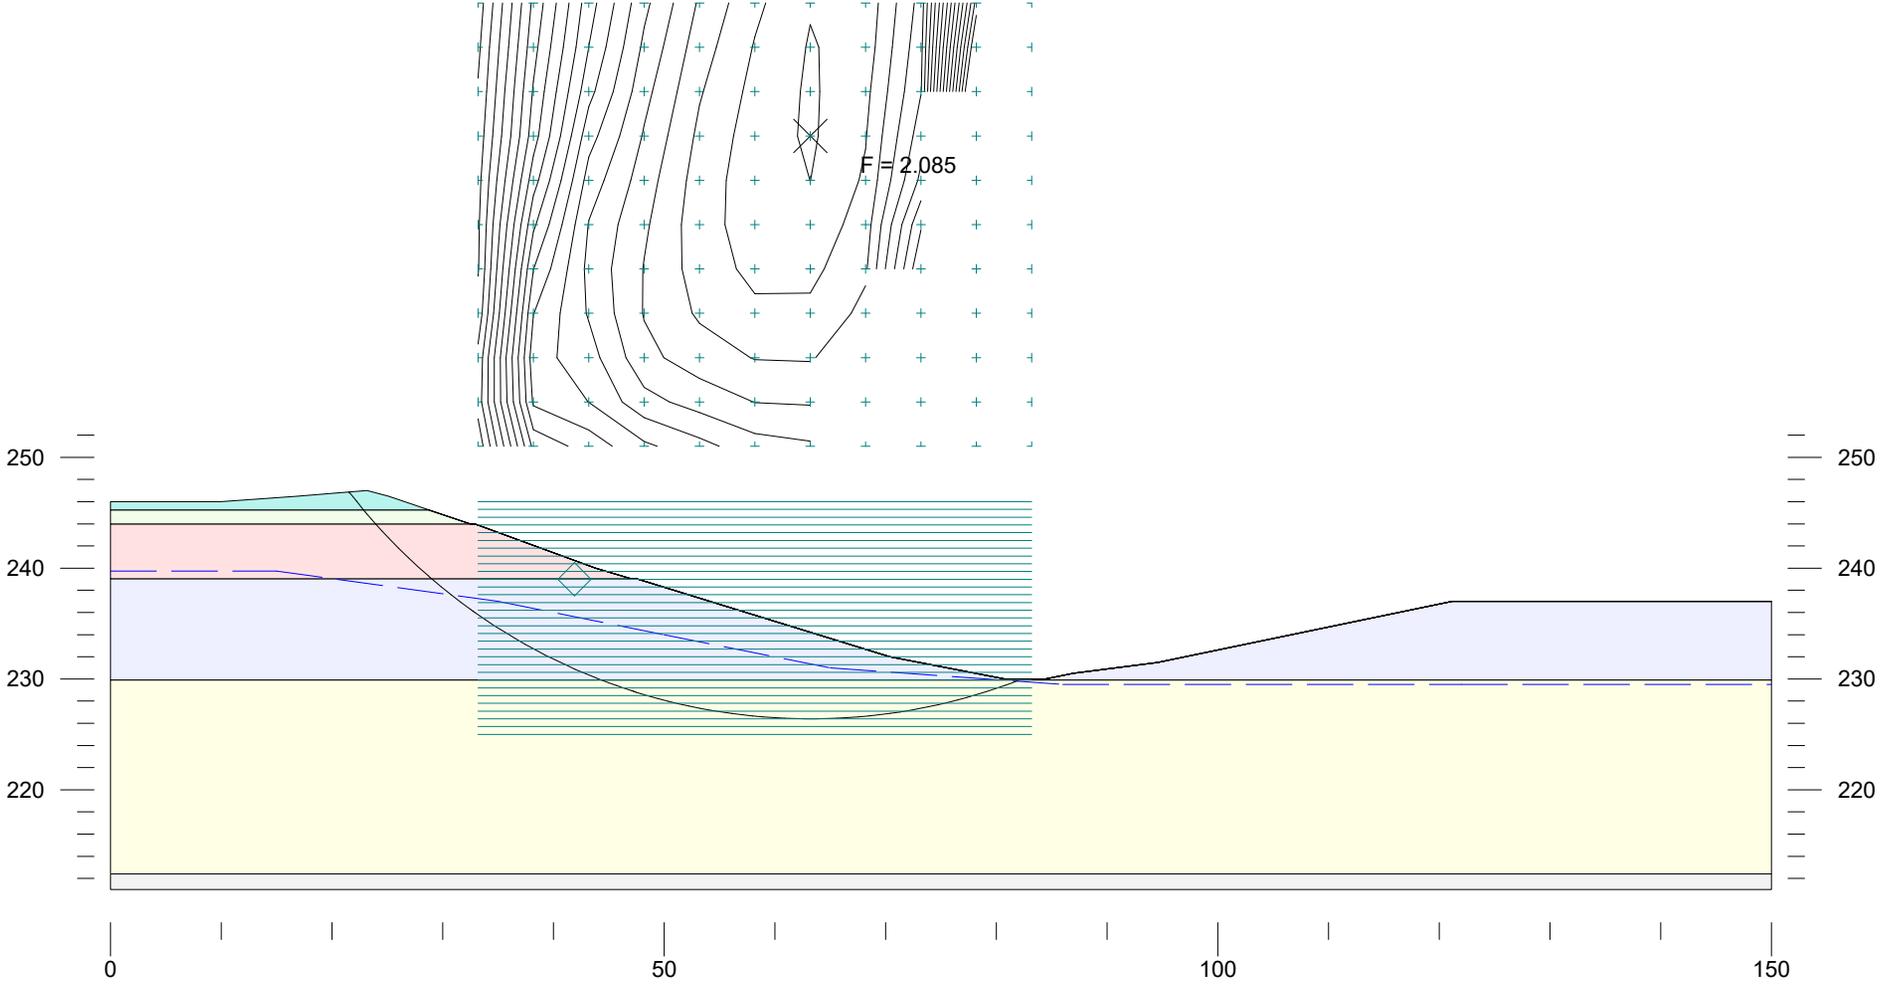
Forward Engineering & Associates Inc.
 JOB NO. 7442
 13286 Nunnville Rd.m Bolton, ON
 Aug. 2025
 SECTION BB
 Drawing No. 3

| Section | Slope Height | Inclination |
|---|---|---|
| BB | 16.50 m | 3.37 H to 1 V |

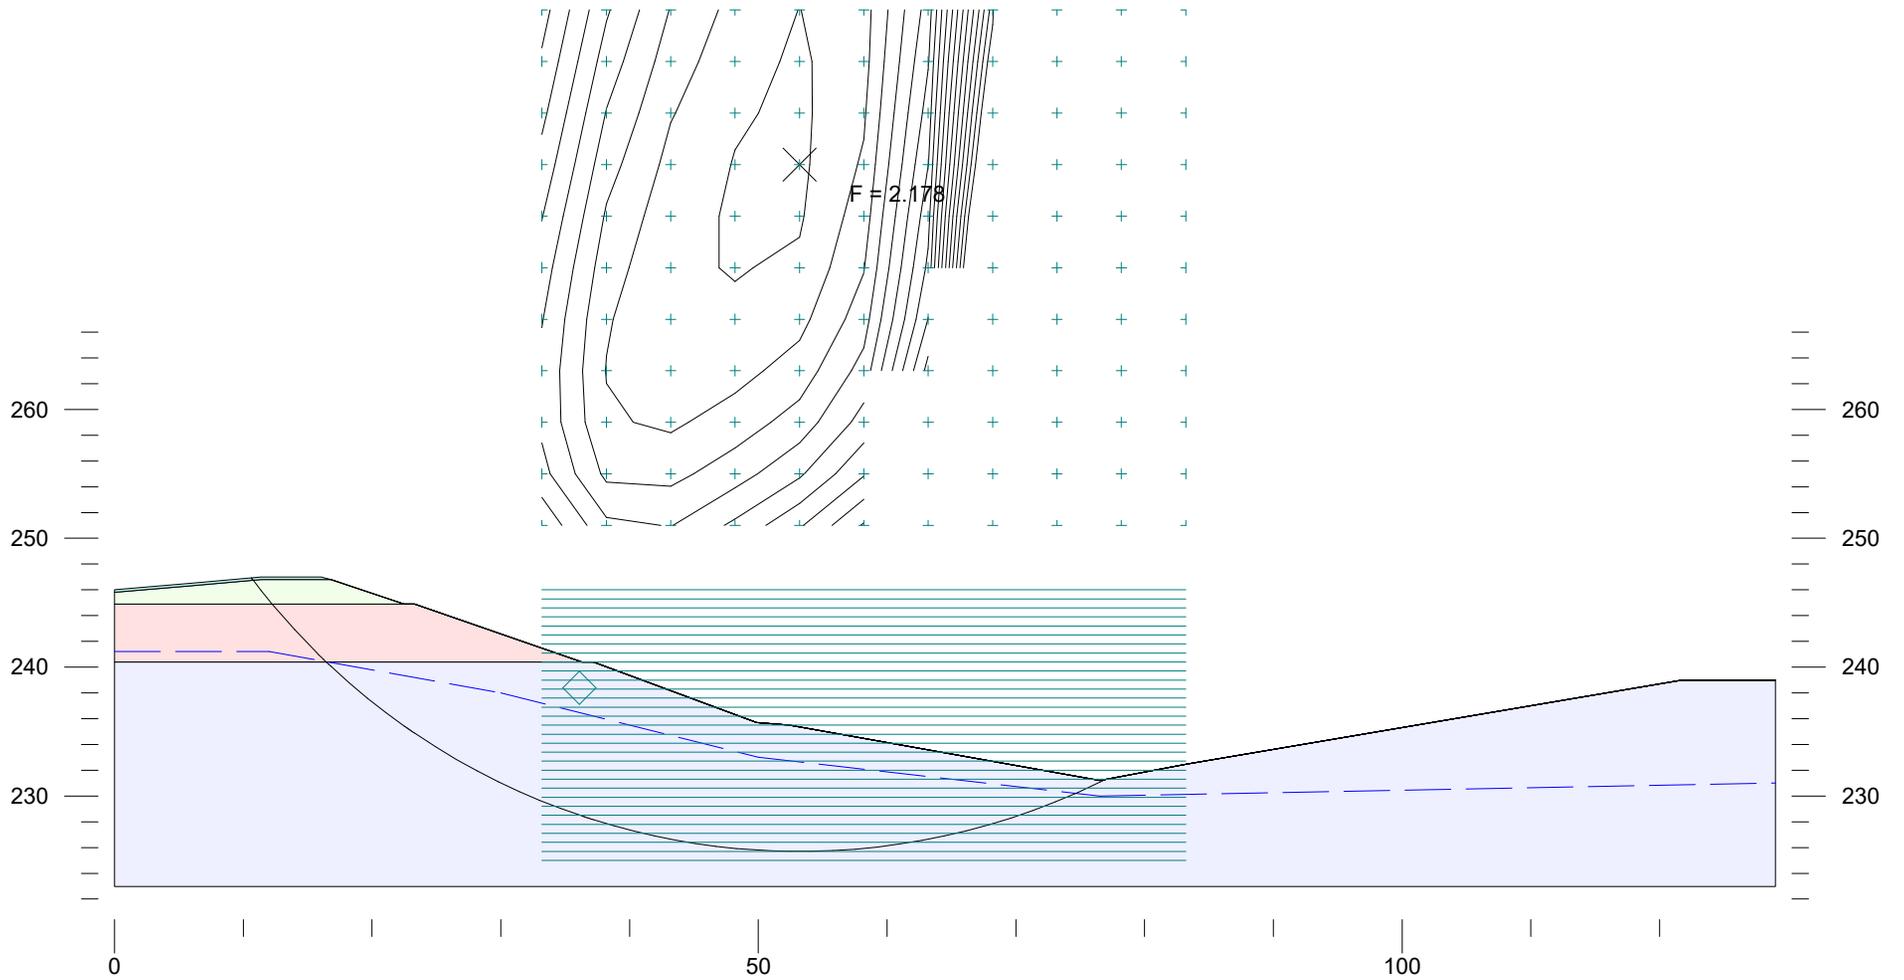
Forward Engineering & Associates Inc.
 JOB NO. 7442
 13286 Nunnville Rd.m Bolton, ON
 Aug. 2025
 SECTION CC
 Drawing No. 4

| Section | Slope Height | Inclination |
|---|---|---|
| CC | 15.30 m | 3.91 H to 1 V |

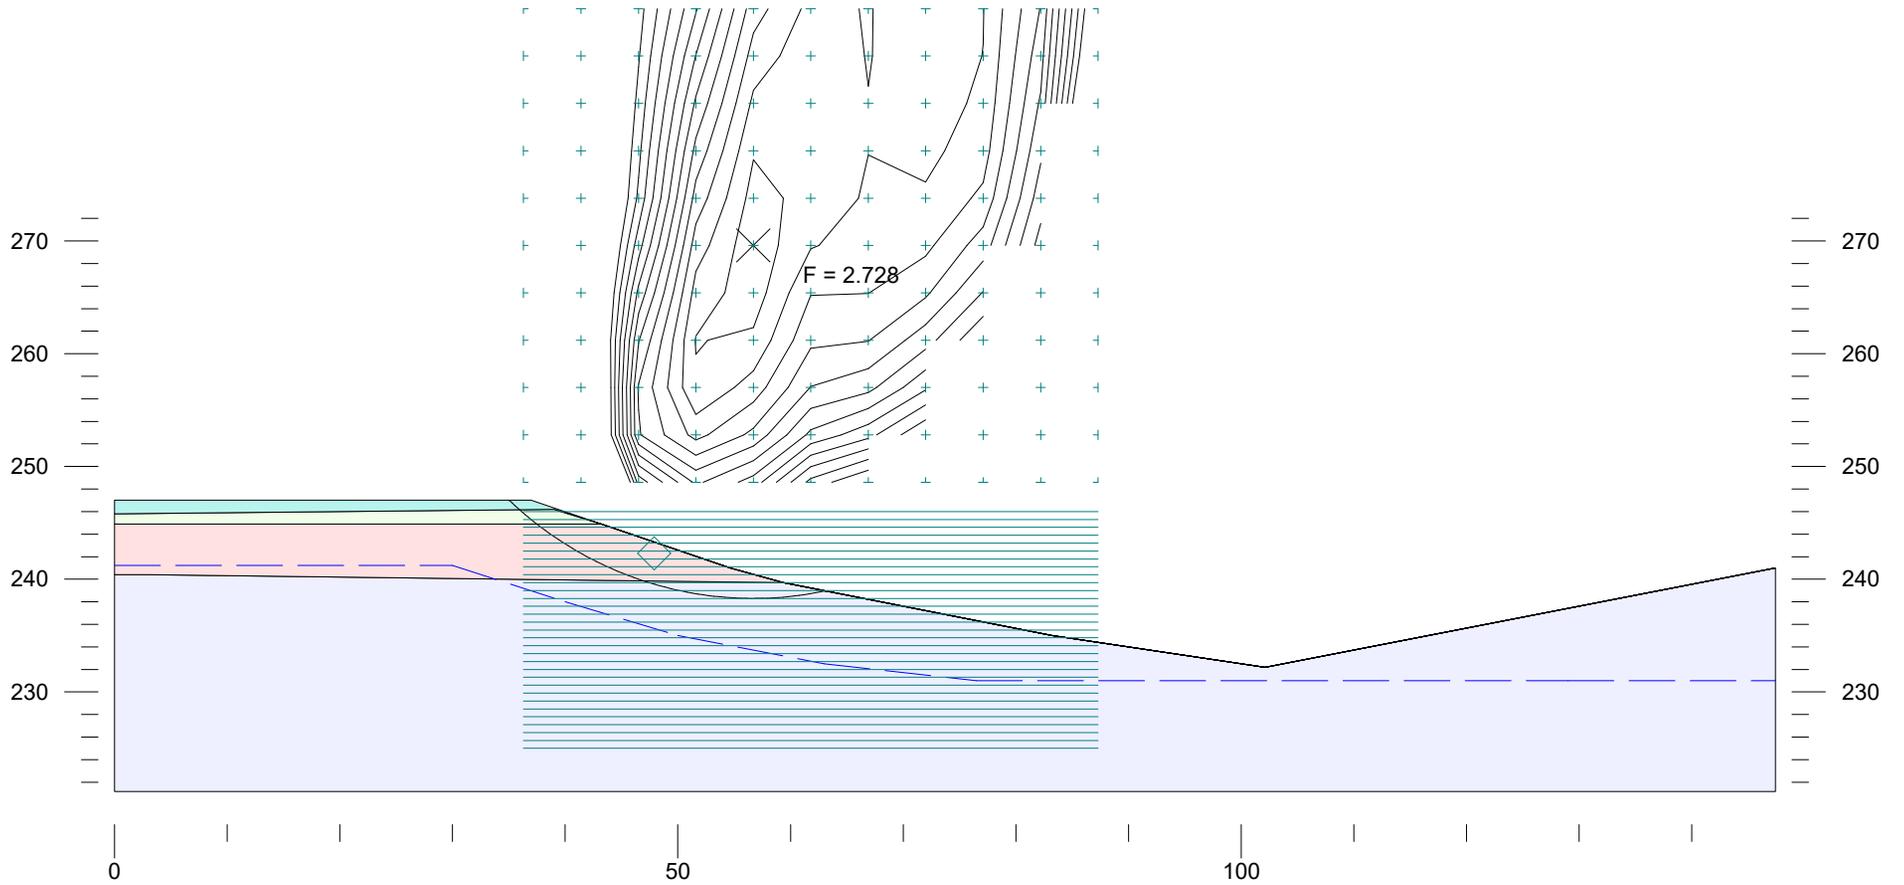
Forward Engineering & Associates Inc.
 JOB NO. 7442
 13286 Nunnville Rd.m Bolton, ON
 Aug. 2025
 SECTION DD
 Drawing No. 5

| Section | Slope Height | Inclination |
|---|---|---|
| DD | 14.80 m | 4.50 H to 1 V |
