REPORT ON
PHASE ONE ENVIRONMENTAL SITE ASSESSMENT
14245 HIGHWAY # 50
CALEDON, ONTARIO

DS Consultants Ltd.

Project No.: 526-20
Date: March 1, 2018

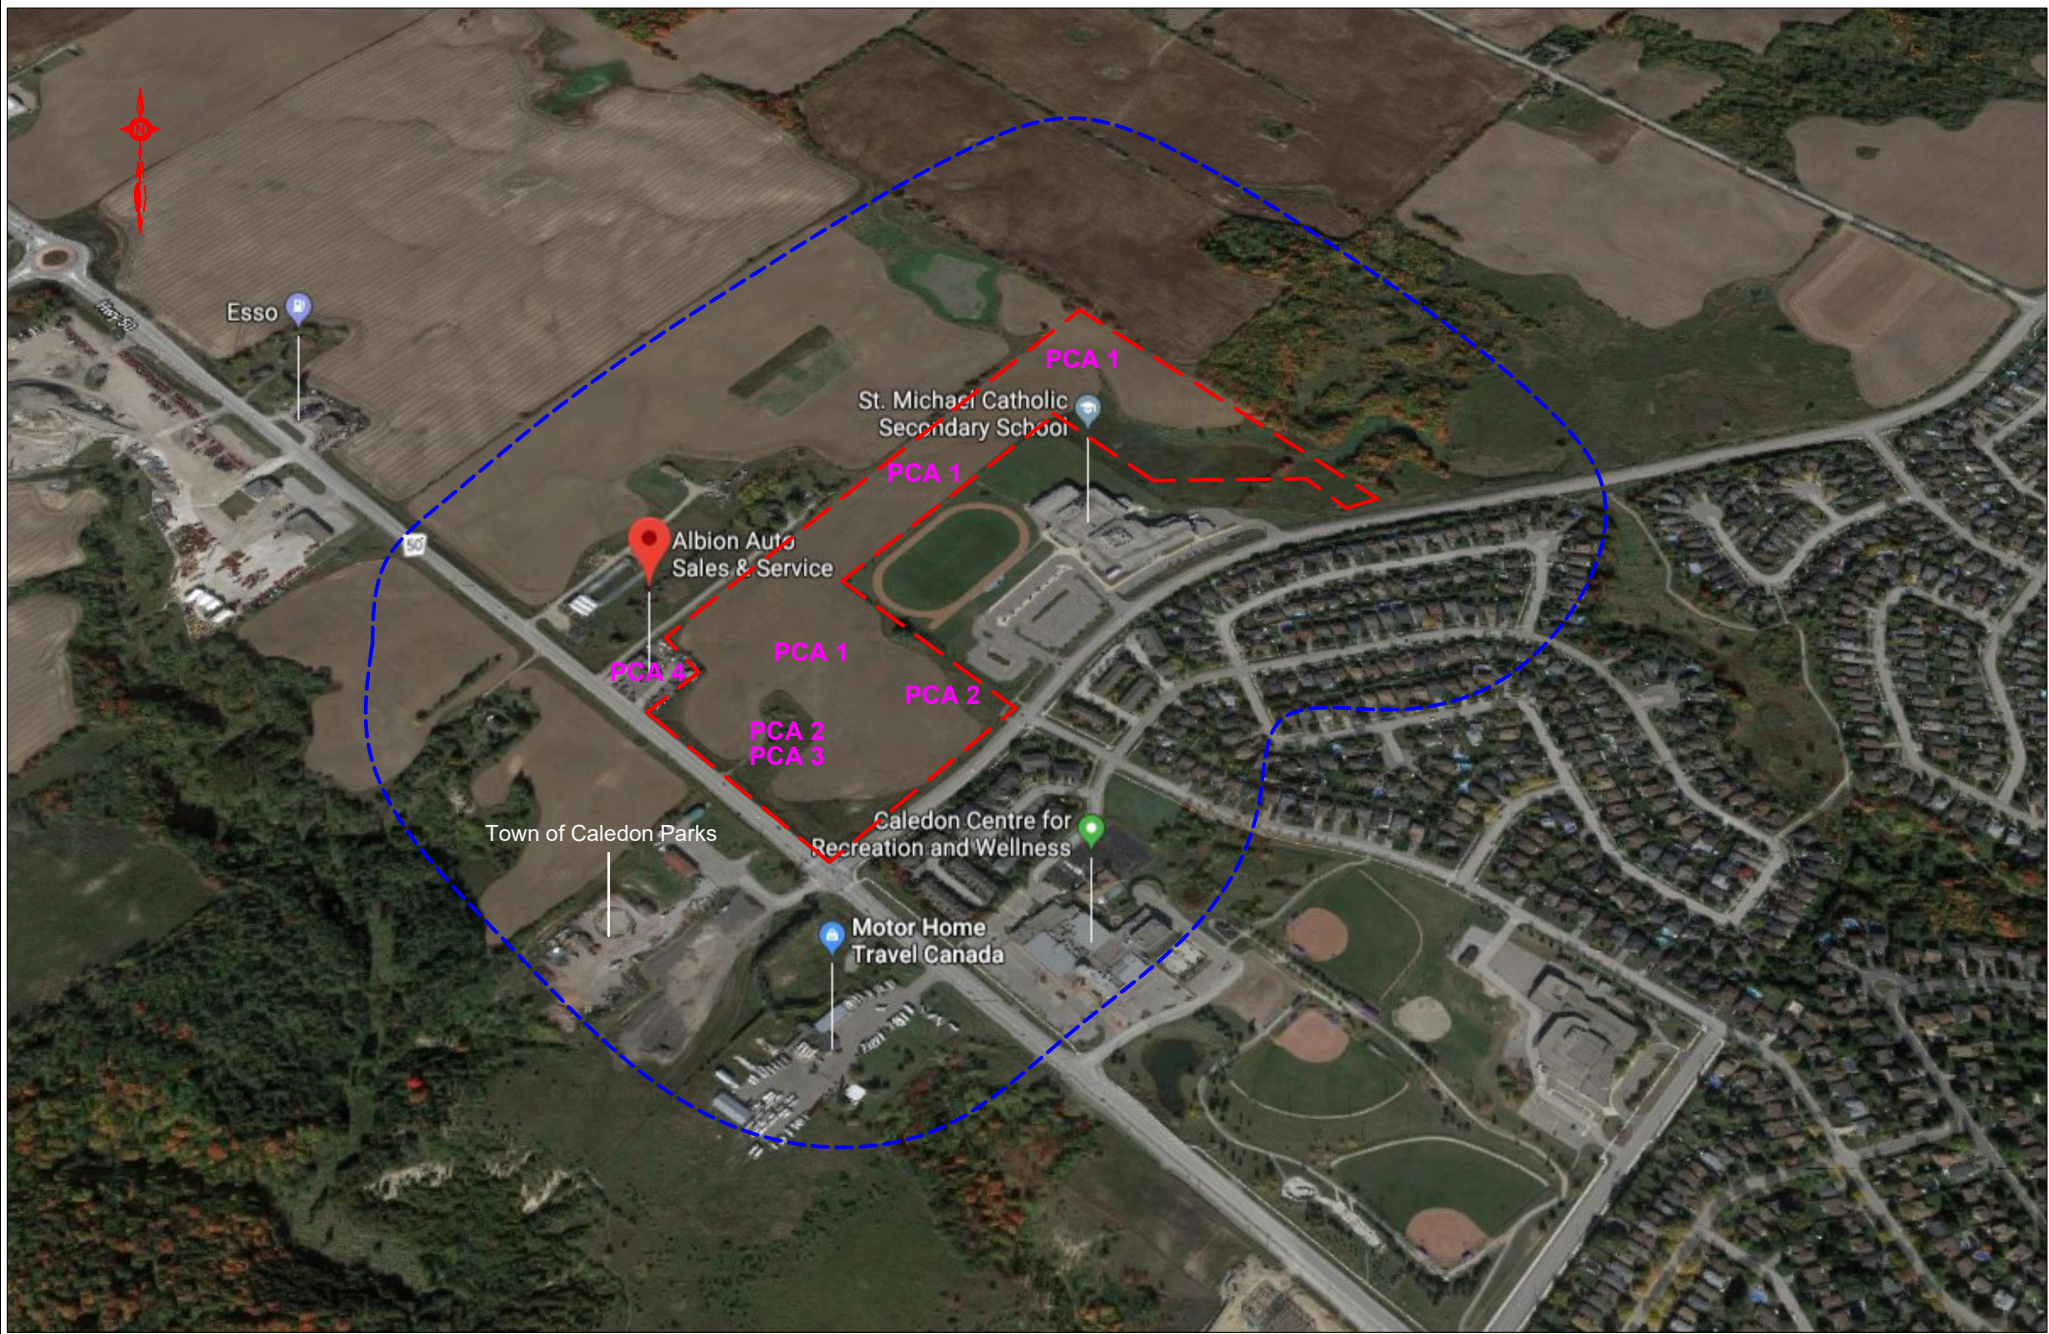
Reference	Phase One Property	Phase One Study Area
1976 Air Photo Figure 5	A structure was observed to the southwest of the Property. Access to the structure was from Hwy 50. No major changes to the Property.	A structure was observed at the northwest corner of the Property, at the location of current Albion auto repair shop. Development within the Study Area had begun, including the construction of residential shape properties further south of the Property, north of King Street West. No major changes to the neighbouring properties.
1982 Ontario Base Map	The Property included a structure.	The Study Area appeared to be used for agricultural purposes with low rise.
1995 Air Photo Figure 6	No major changes to the Property.	According to 1995 aerial, additional developments were observed to further south of the Property, north of King Street and west of Hwy 50.
2004 Satellite image	A structure was also observed on the southwest portion of the Property. Access to the structure was via a gravel surfaced way from Columbia Way.	Structure similar to the current configuration was observed at the northwest of the Property, at the location of auto repair shop. The property occupied by Secondary school appeared to be disturbed and included some structures. Structures similar to the current configurations were observed to the south of the Property, south of Columbia Way at the locations of residential subdivision and recreation centre.

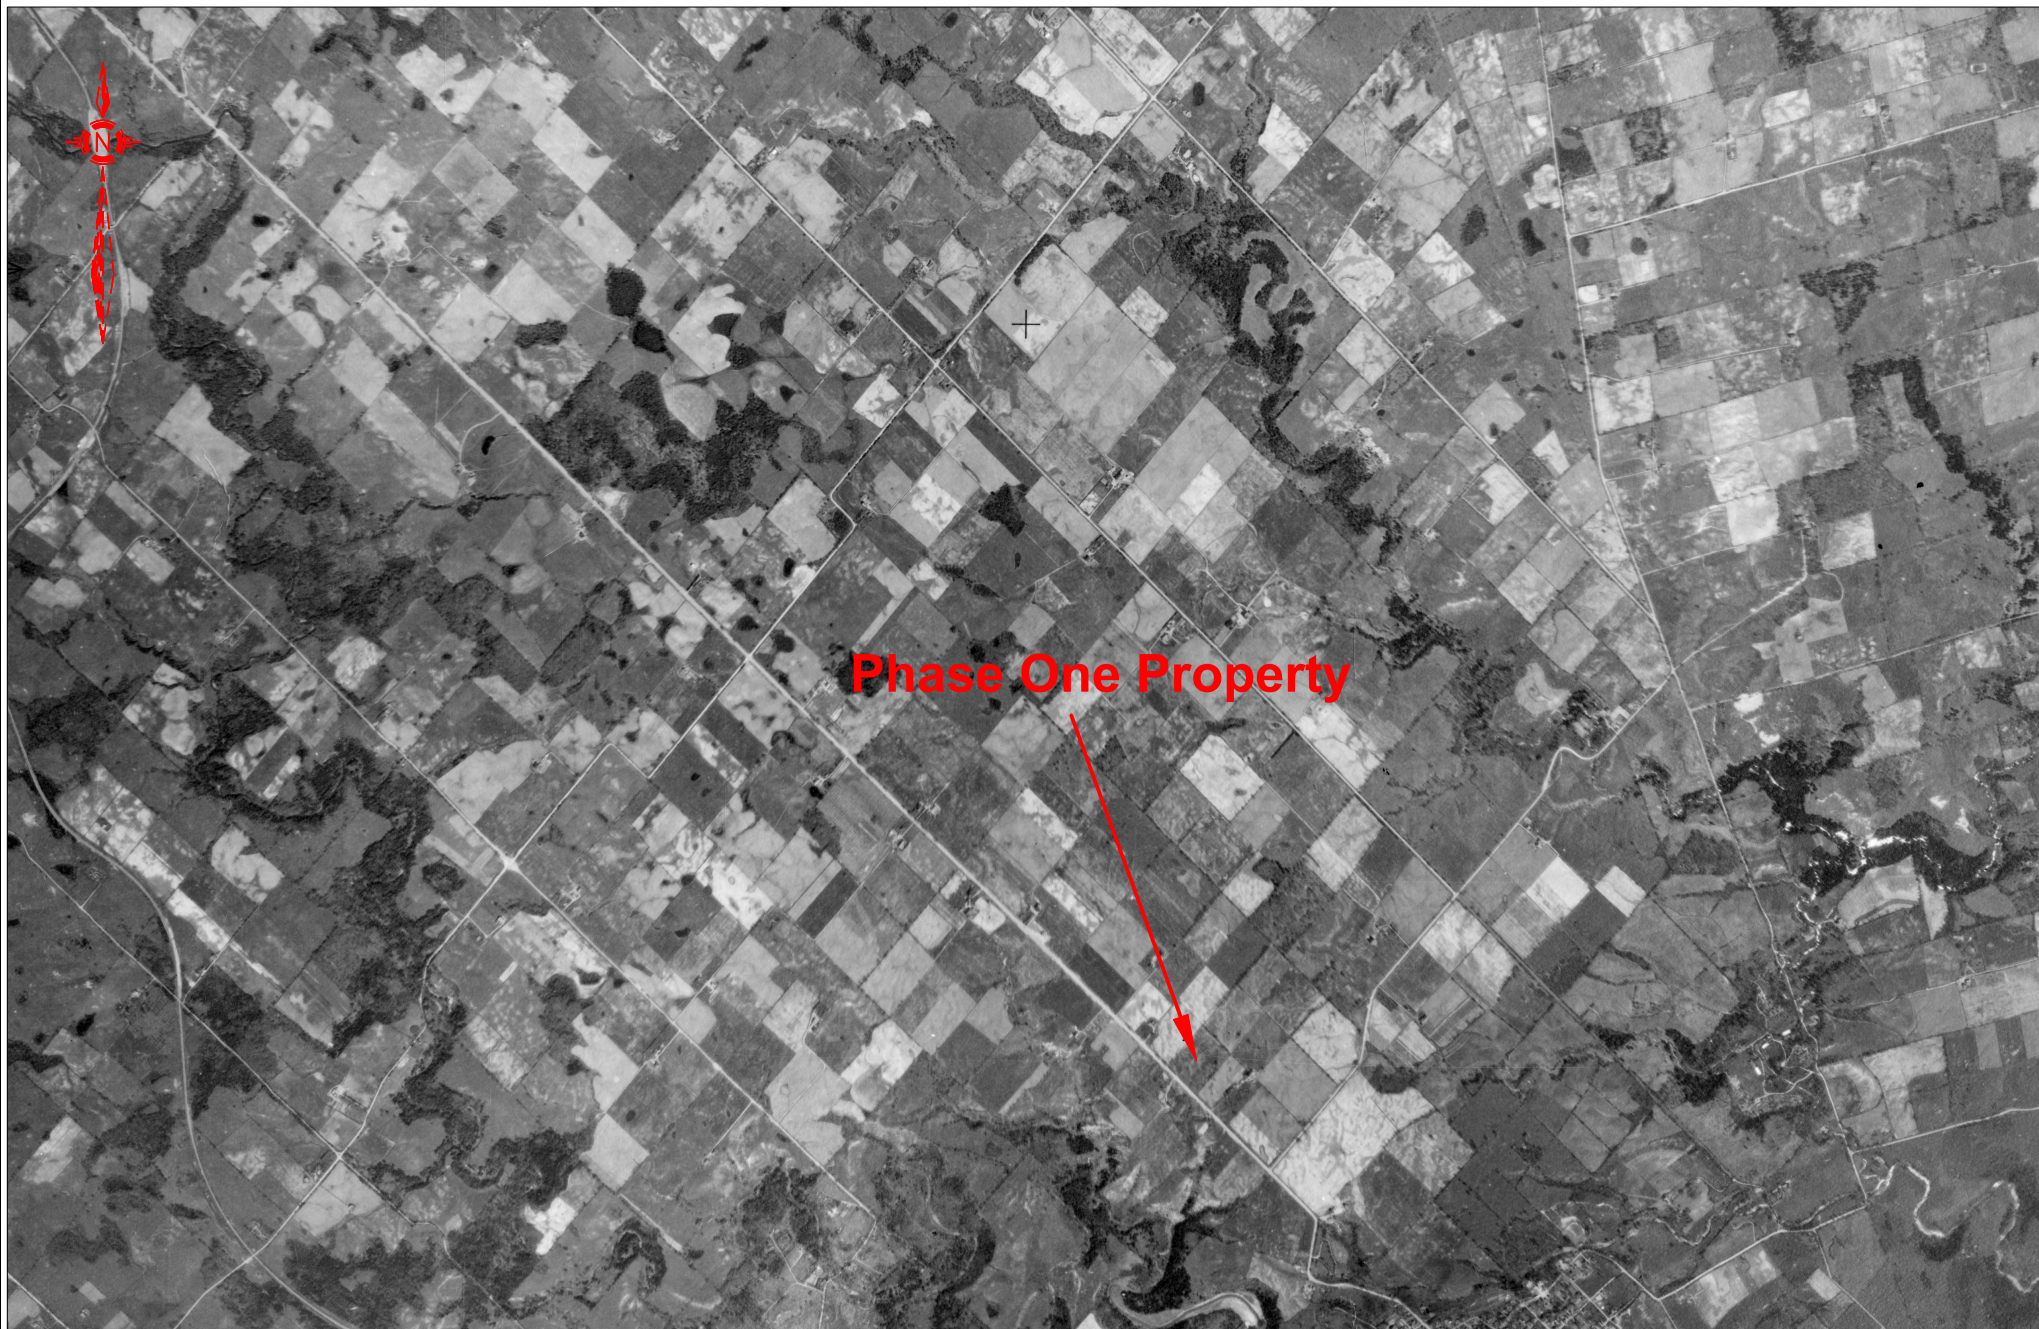
Date: 26/02/18 Figure No.: 3B

Reference	Phase One Property	Phase One Study Area
1951 Air Photo Figure 4	Based on the scale of the aerial photo, detailed description of the Property was not possible, however, the aerial photograph depicts the Phase One Property and surrounding lands that appeared to be undeveloped and used for agricultural purposes.	The surrounding area appeared to be undeveloped and used for agricultural purposes. A roadway in the current location of Hwy 50 was shown to the west of the Property. Low rise structures were observed along Hwy 50.

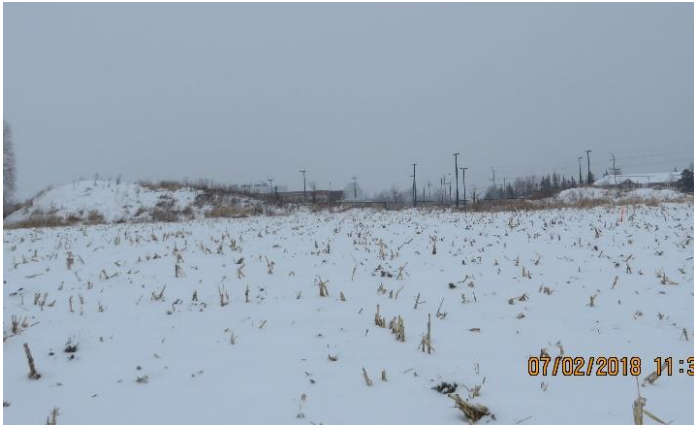
Photograph 1

Location: Phase One Property
Viewing: Northeast
Description: View of the two stockpiles of fill materials stored on the west portion of the Property

During the site visit two stockpiles fill materials were noted on the western portion of the school, on the Property. Fill materials of unknown quality could have been used historically for grading or agricultural purposes and at the location of former residential dwelling at the Property.

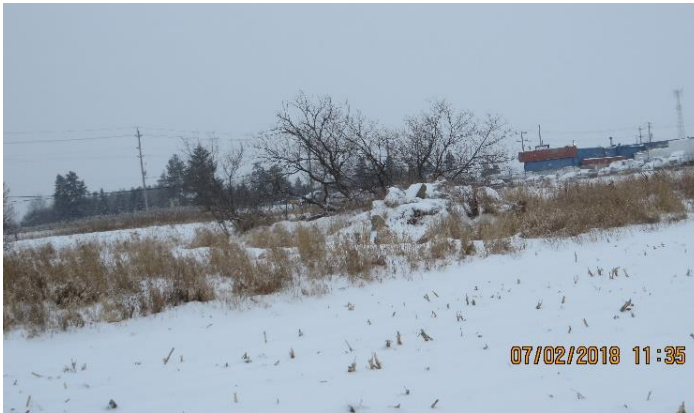
Photograph 2

Location: Phase One Property
Viewing: Northwest
Description: View of construction debris left after residential house demolition

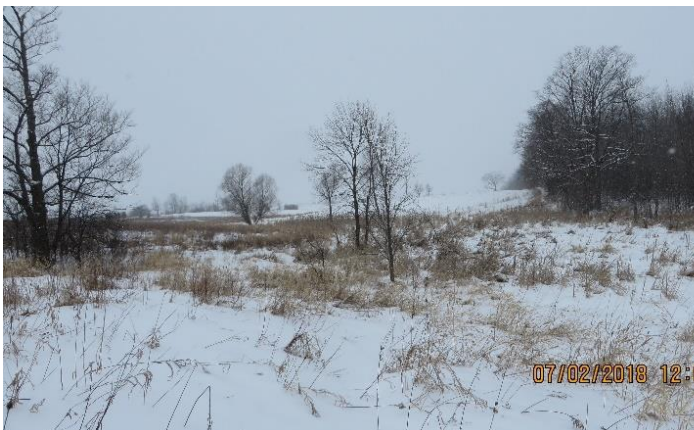
Photograph 3

Location: Phase One Property
Viewing: Northeast
Description: Unnamed creek crossing eastern portion of the site

During the site visit, a frozen creek was observed on eastern portion of the Property. A ditch was noted along eastern Property boundary, parallel to Hwy 50 and Columbia Street.

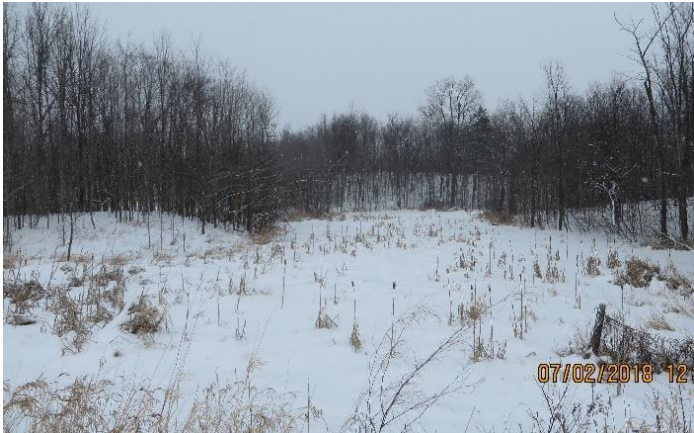
Photograph 5

Location: Adjacent Property
Viewing: East
Description: View of adjoining eastern property from the Phase One Property and a wooded area adjacent to the east of the Phase One Property boundary

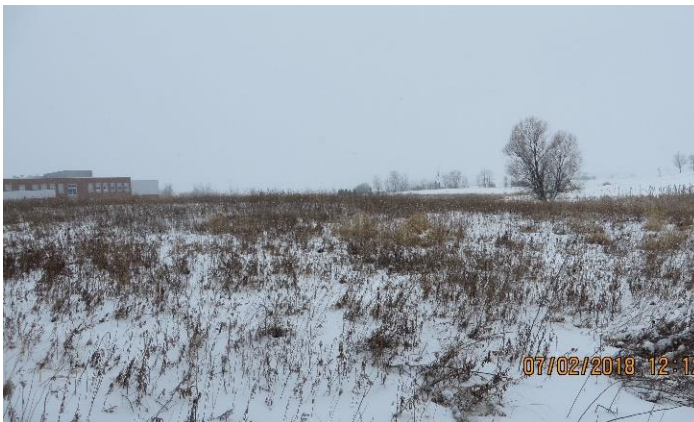
Photograph 6

Location: Phase One Property
Viewing: Northwest
Description: View of undeveloped eastern portion of Phase One Property

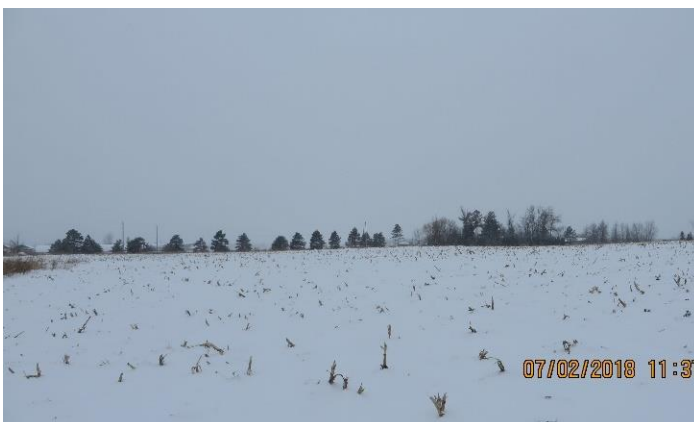
Photograph 7

Location: Phase One Property
Viewing: North
Description: View of the undeveloped northern portion of Phase One Property

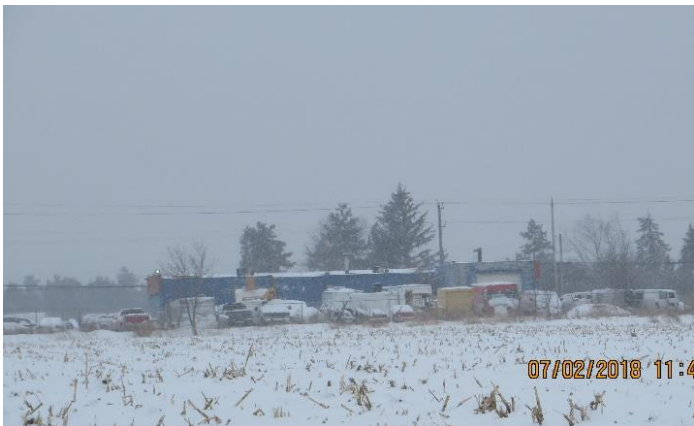
Photograph 12

Location: 14289 Hwy 50
Viewing: East
Description: View of adjoining
northwestern property
occupied by Albion Autocentre

Albion Auto Sales and Service (garage) is located in the northwest corner of the Property. PCA is also includes possible oil spills during auto repair activities.
