# Phase Two Environmental Site Assessment

Part Lot 12 Concession 4 Albion Part 1, 43R17061, Parcel 4  
Bolton, Ontario

**DS Project No :** 20-169-100

**Date:** 2023-05-16

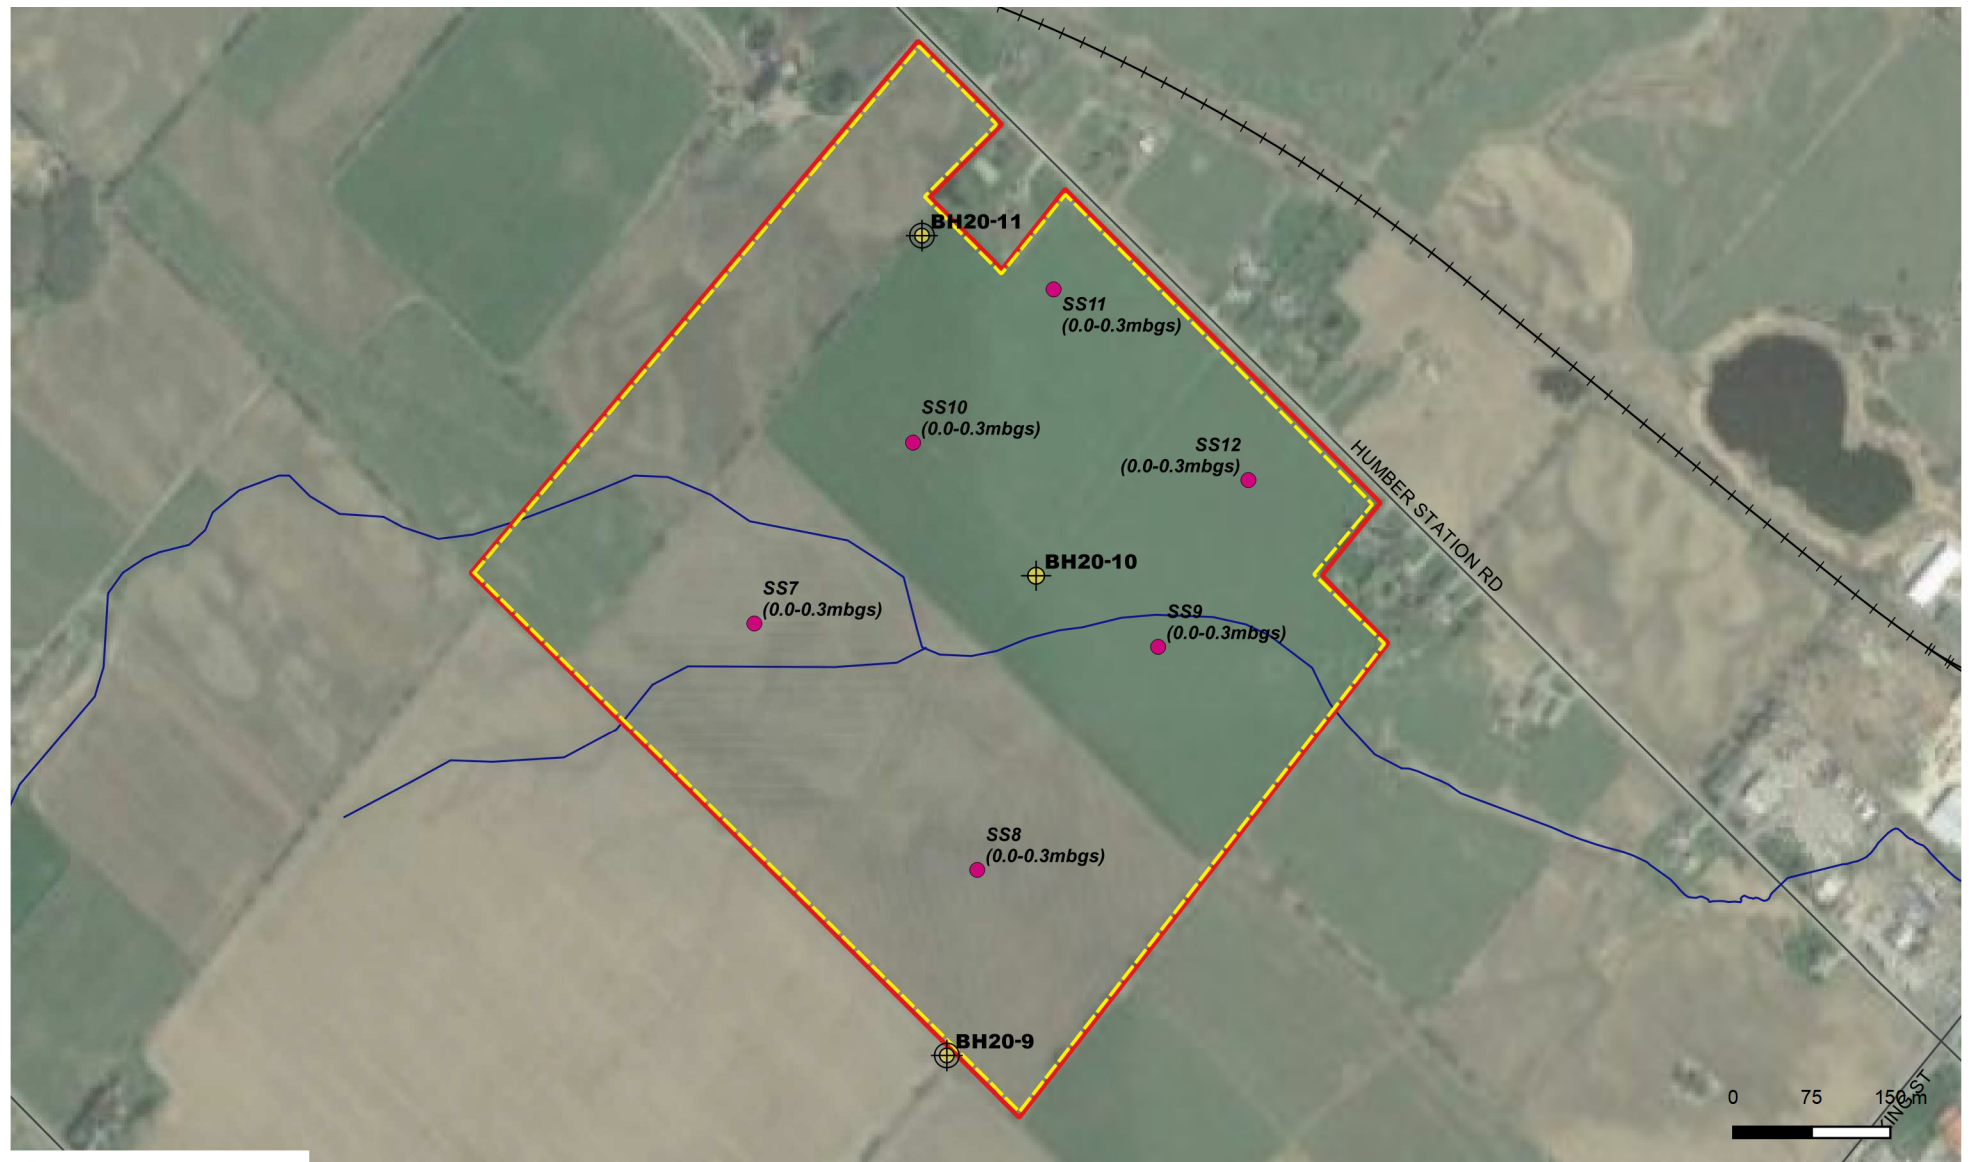
- Property Boundary
- Borehole
- Monitoring Well
- Soil Sample Location
- APEC-1

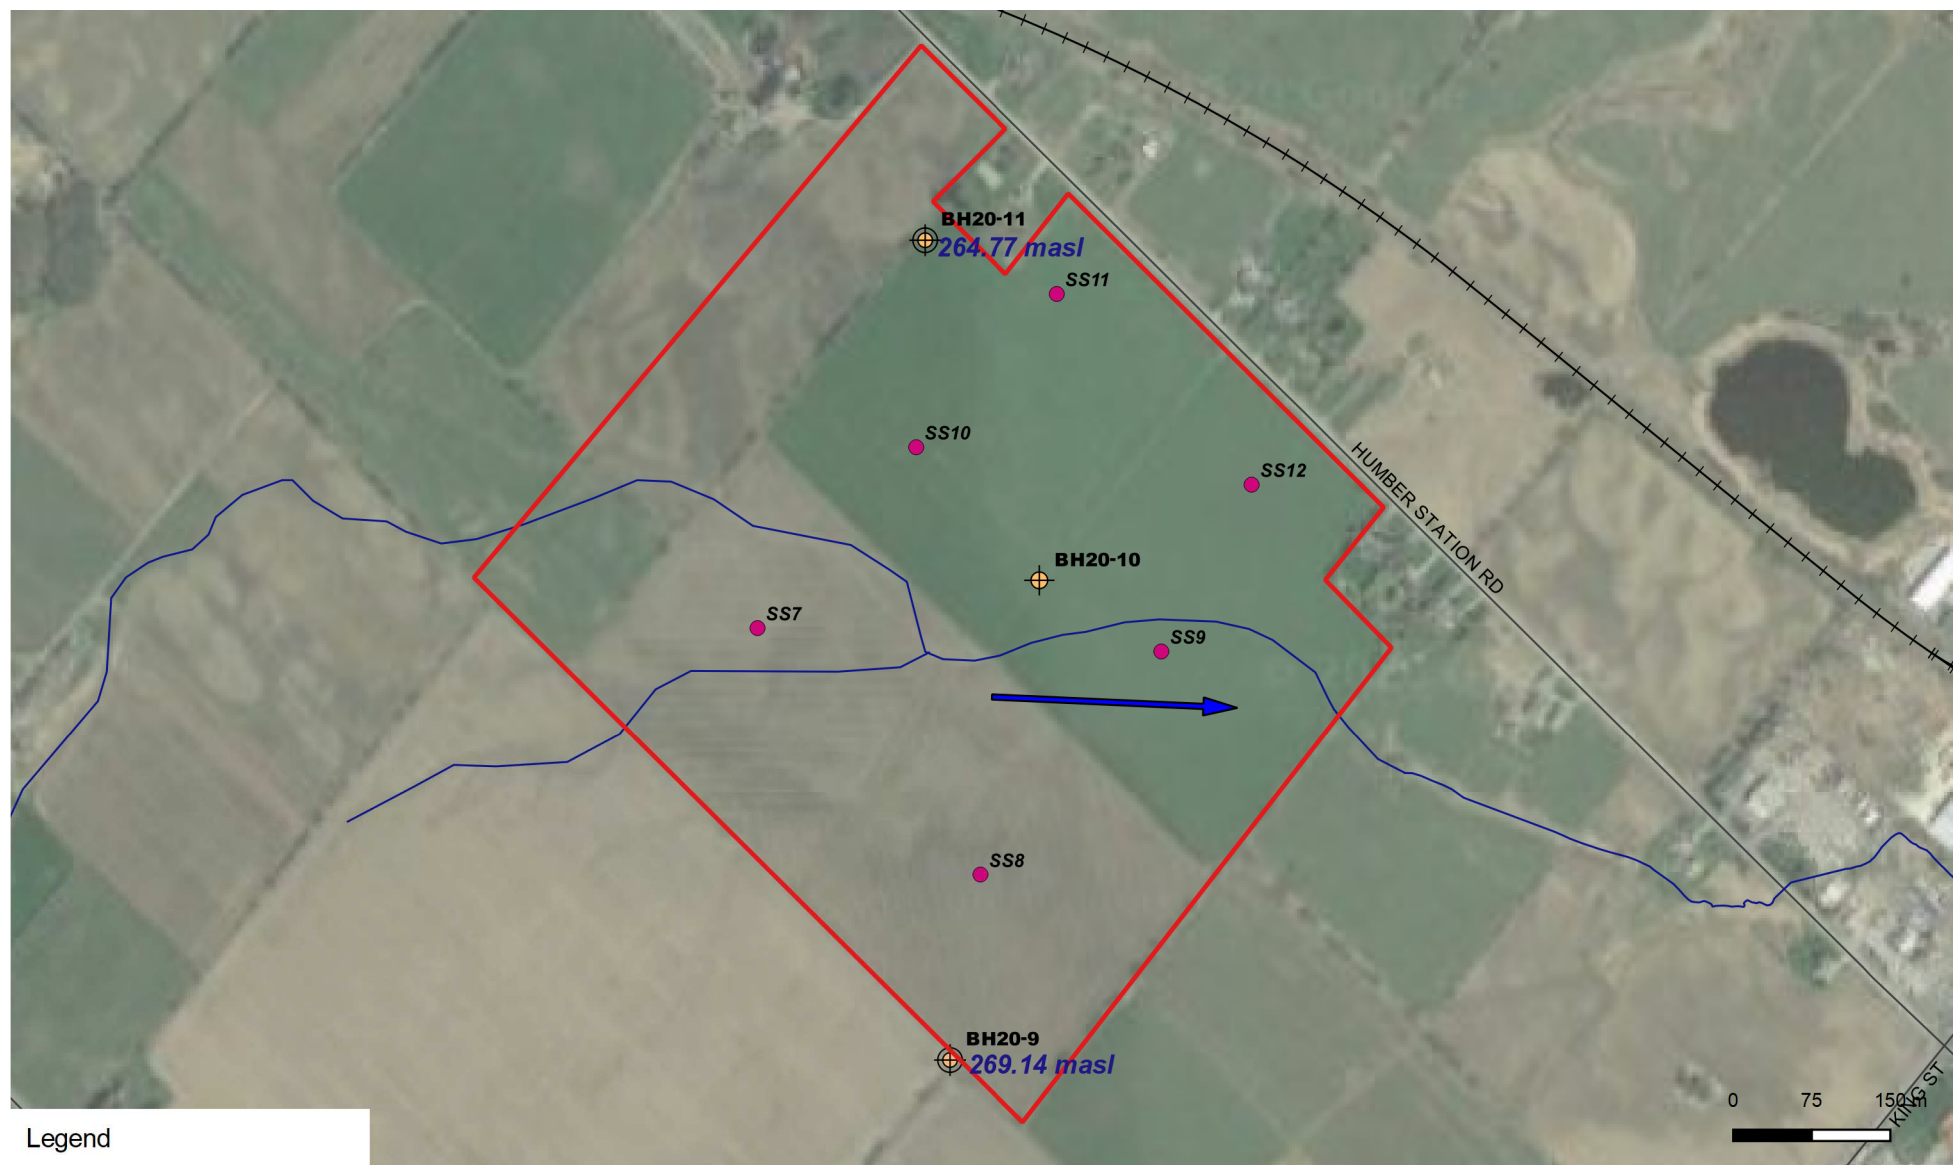
Size: 8.5 x 11	Approved By: E.K	Drawn By: S.Y / P.P	Date: May 2023
Rev: 0	Scale: As Shown	Project No.: 20-169-100	Figure No.: <b>6</b>
Image/Map Source: Google Satellite Image

- ▭ Property Boundary
- ⊗ Monitoring Well
- ⊗ Borehole
- ⊗ Monitoring Well
- Soil Sample Location
- ➔ Groundwater Flow Direction

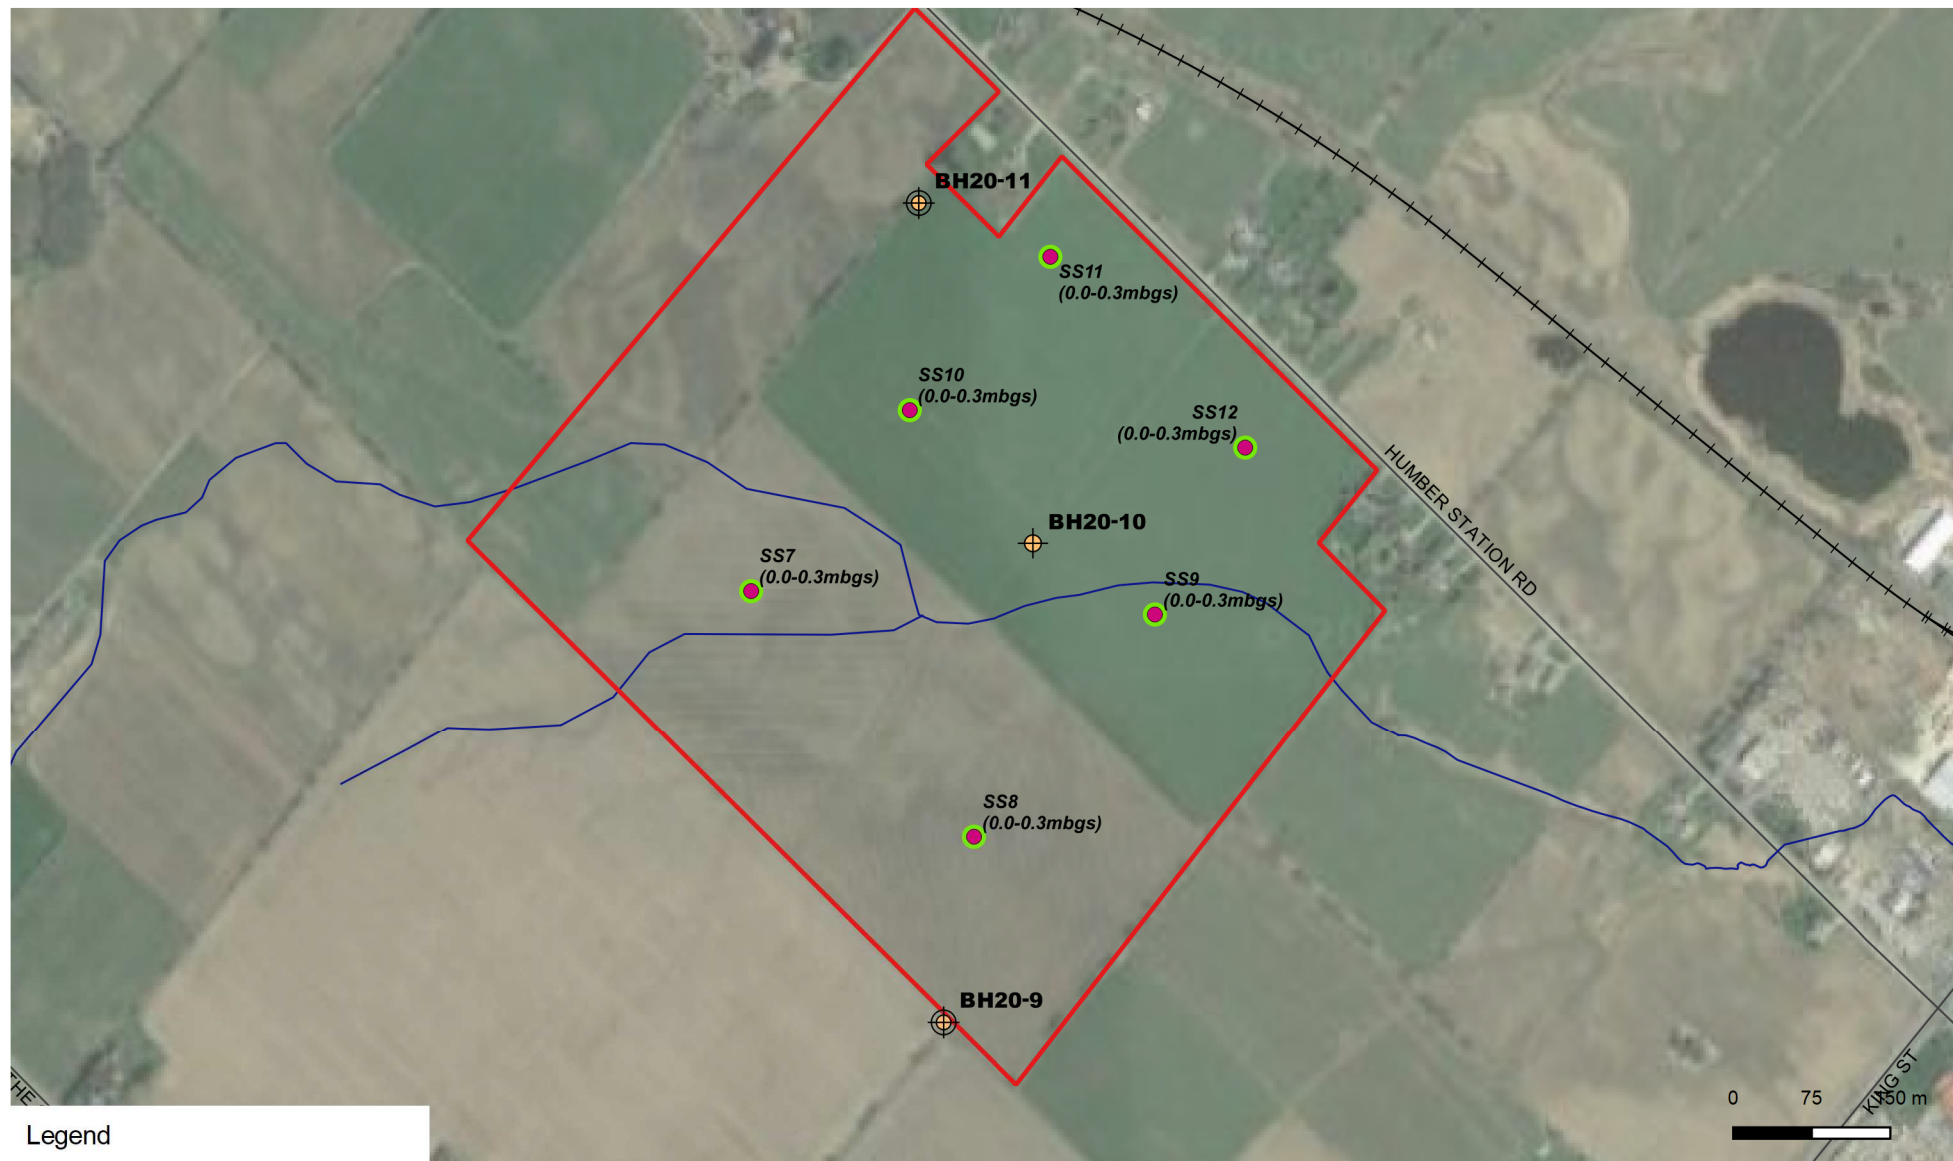
- Property Boundary
- Monitoring Well
- Borehole
- Monitoring Well
- Soil Sample Location
- Sample Met Applicable Standards

A total of six (6) samples were submitted for analysis of OC Pesticides. The results of the analyses are tabulated in Table 4 and presented on Figure 7. The results of the chemical analyses conducted indicated that all samples contained non-detectable concentrations of OC Pesticides and met the applicable Site Condition Standards.
