Phase I Environmental Site Assessment

14396 Humber Station Road Bolton, Ontario

DS Project No : 22-407-100

Date: 2022-11-10

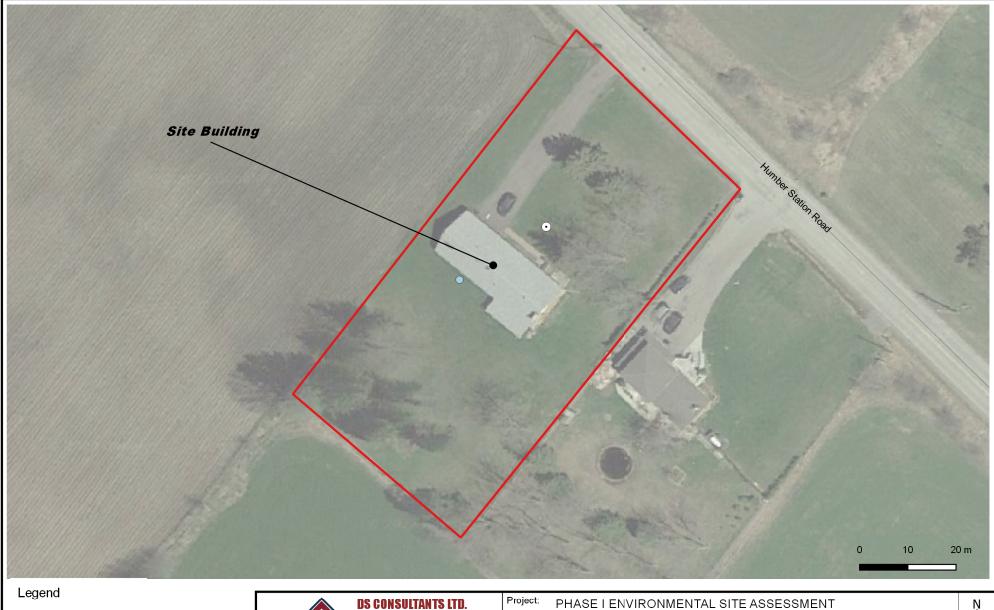
Figure 2- Phase I Property Site Plan

Septic Tank

Well

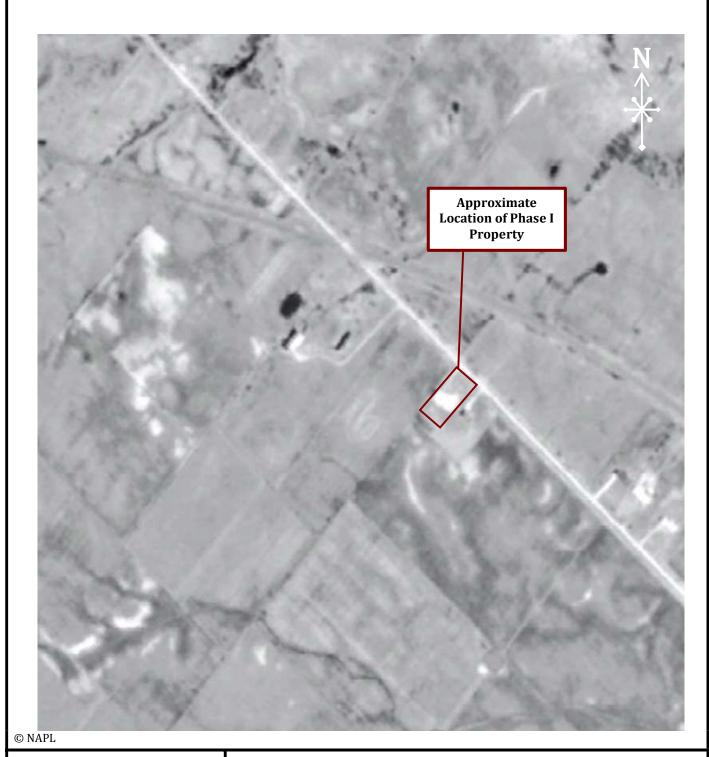
AERIAL PHOTOGRAPH: 1974

- The Phase I Property was historically used for agricultural purposes until 1973. The Phase I Property was subsequently used for residential purposes until present. No fuel oil tank or evidence of former fuel oil use on-Site was observed.
