**Mount Hope Road Lands**  
**Fluvial Geomorphic Characterization**  
**of Cold Creek**

Bolton, Caledon, Ontario

GEI Consultants Ltd.  
100 Ahrens Street West, Unit 201  
Kitchener, Ontario N1G 3G9

January 2025  
Project 2300880

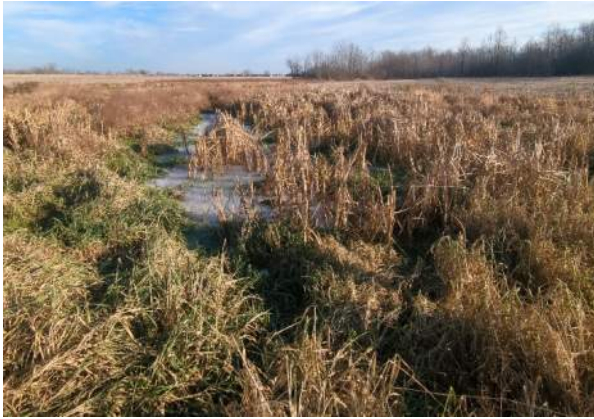
Photo 1 – Downstream view from TCC(1)-1's upstream extent. Draining into woodlot.

The upstream extent of TCC(1)-1 exists as a vegetated, swale-like feature that juts into an open field. The swale slowly transitions into an entrenched ditch until it reaches the woodlot, at which point it widens and dissipates into a pond. It is unclear whether the pond, approximately 20 m in width, exists as a permanent feature. The downstream end of the pond gradually transitions into a channel flanked by mature trees on both banks. Instream vegetation was not observed, although grassy debris was noted in the un-moving water. Woody debris, tree falls, and exposed roots were observed along the length of the reach. Riparian vegetation consisted mainly of trees, grasses, and herbaceous species. The riparian buffer extended >5 channel widths in dimension on either side. The reach continued through the forested area before terminating at the extent of the woodlot, at which point the bed of the channel rose to meet existing ground. No defined channel existed past this point.

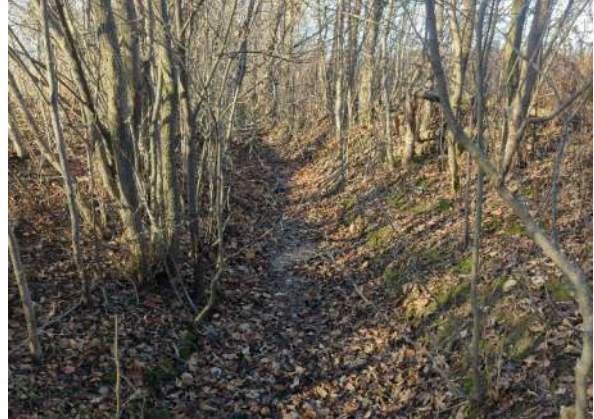
Photo 2 – Downstream view of treed ditch-like portion of TCC(1)-1, draining into pond.

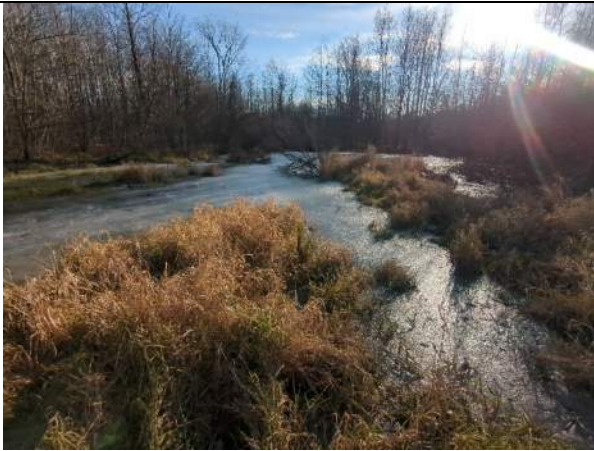
Photo 3 – Pond splitting TCC(1)-1 into two portions. Wetland-like vegetation is prevalent.

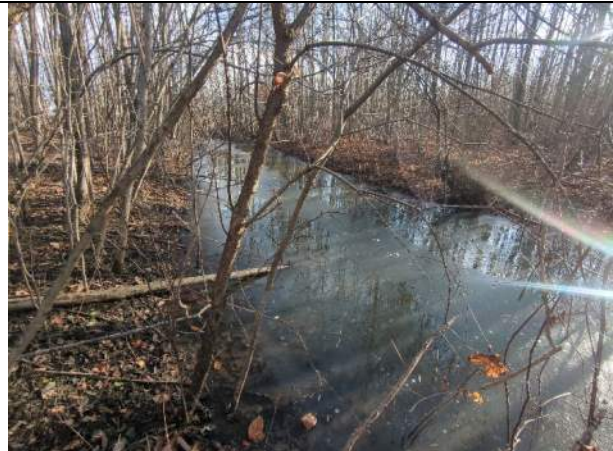
Photo 4 – Downstream view of TCC(1)-1. Watercourse drains water from pond towards TCC(1)-2.

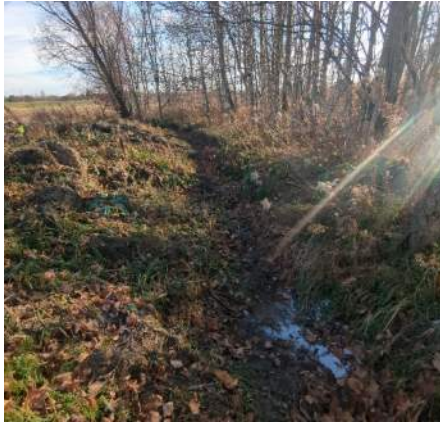
Photo 1 – Downstream view of TCC(1)-2's upstream extent. TCC(1)-1 rises to meet existing ground.

The reach delineation was subsequently verified during three separate field investigations (noted below). Results from the field investigations differed significantly from the desktop assessment due to the fact that TCC(1)-2 no longer existed, as the grassy field observed during the desktop assessment had been tilled over.

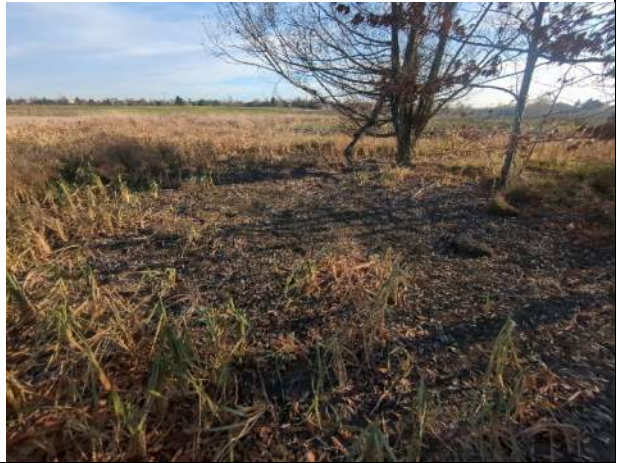
Photo 2 – Downstream view of where TCC(1)-2 exists in historical imagery. Previously drained into agricultural field

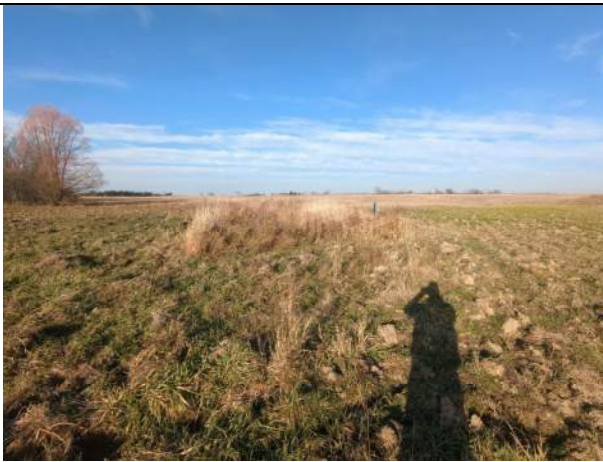
Photo 4 – Previous location of TCC(1)-2, likely removed during agricultural tilling operation. See arrows for locations.

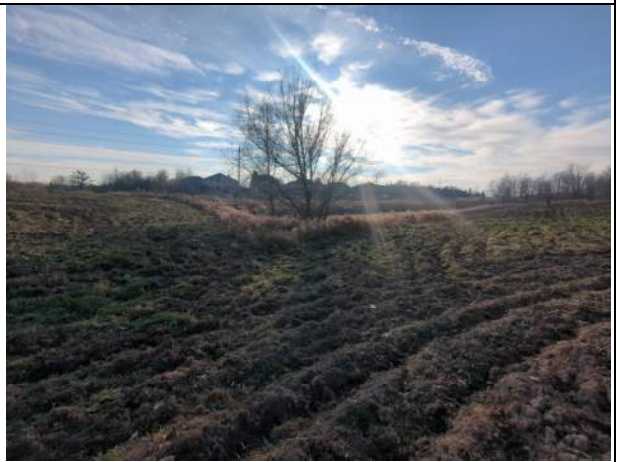
Photo 4 – Previous location of TCC(1)-2, leading to downstream culvert.

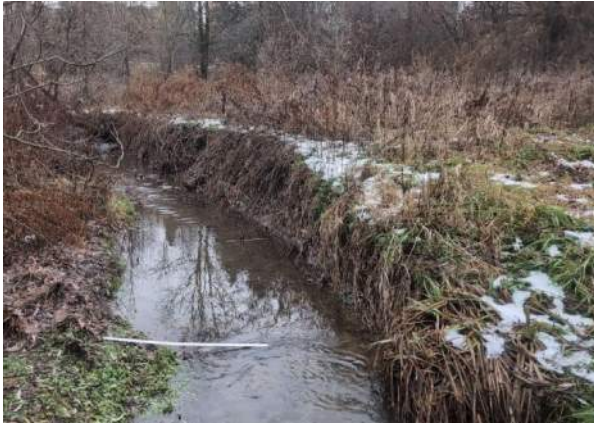
Photo 1 – Upstream view of TCC(0)-2's upstream extent. Undercutting along outside of meander bend was observed.

Distinct pools and riffles existed throughout the reach. The feature was relatively uniform in width and depth becoming more entrenched upon exiting the woodlot. Where defined, bankfull widths ranged between 1.5 – 2.6 m. Bankfull depths ranged between 0.4 – 0.6 m. Observed bank materials consisted of sandy loam, with some silt. Pool substrate was composed of silt, and sand. Bank angles were steep, ranging between 60 – 90° and erosion was noted on approximately 60 – 90% of banks.

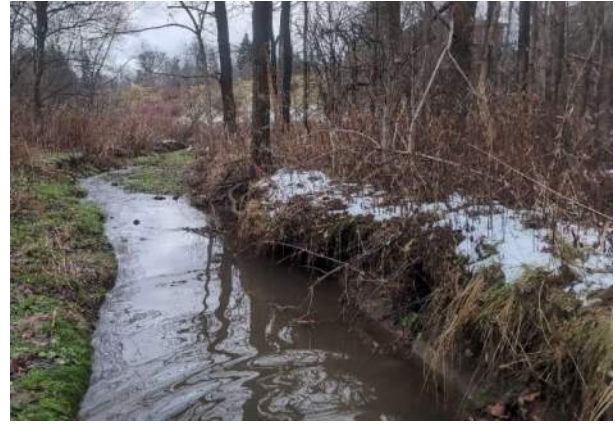
Photo 2 – Downstream view of TCC(0)-2's upstream extent, as it exits the woodlot.

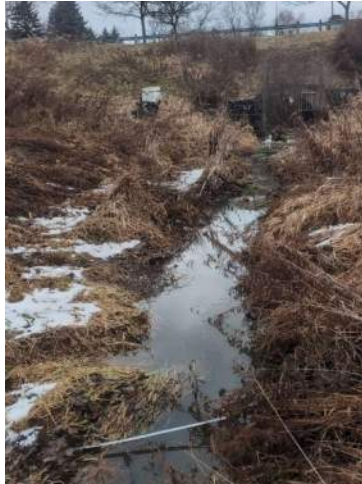
Photo 4 – Downstream view of TCC(0)-2's downstream portion, flowing into the culvert at Kingsview Drive.

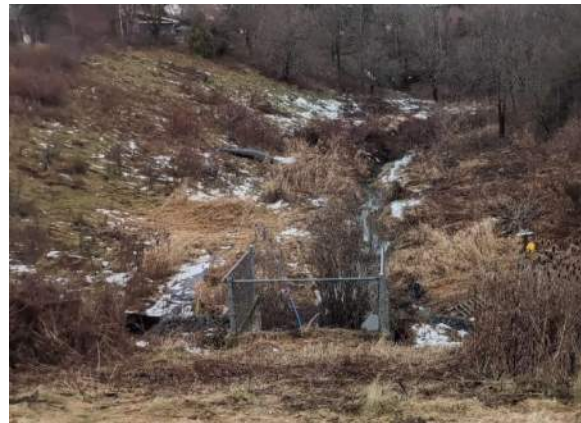
Photo 4 – Upstream view at TCC(0)-2's downstream extent, at Kingsview Drive.

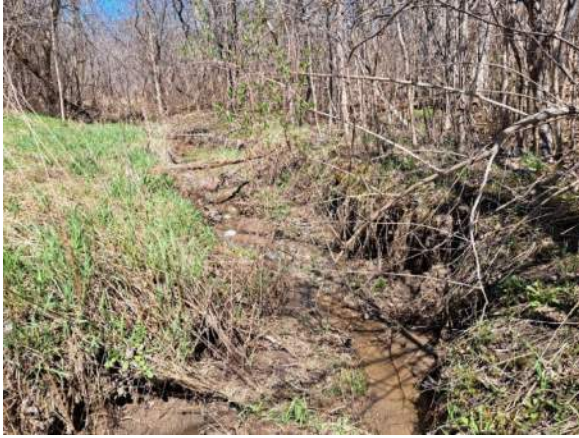
**Photo 1:** In the upstream portion of the reach bank erosion and undercutting were observed.

**Reach THR1** had an RGA score of 0.33, indicating that the reach is in transition/stress. The dominant mode of systematic adjustment was evidence of widening due to the presence of fallen trees, large organic debris, exposed tree roots and basal scour. Evidence of aggradation was also noted due to accretion on point bars, siltation in pools, and riffle embeddedness.

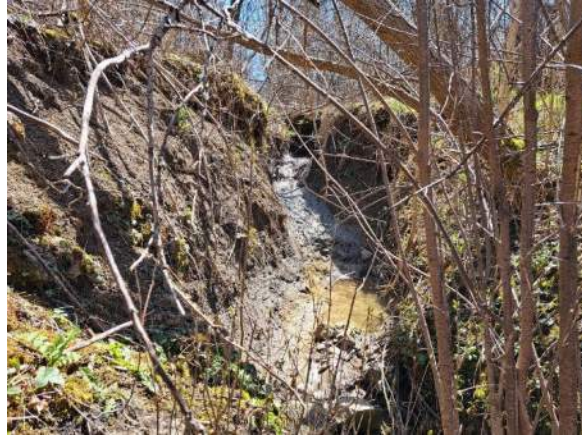
**Photo 2:** Two knickpoints were present, indicating channel adjustment.

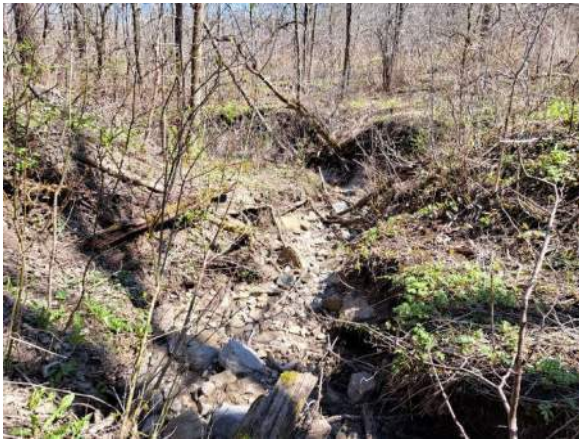
**Photo 3:** The channel was moderately entrenched and had a moderate channel gradient.

**Reach THR1** extends from Mount Hope Road to the downstream confluence and is approximately 455 m in length. The reach was characterized as a single channel flowing through a defined valley. It was moderately entrenched and had a moderate gradient. At the time of assessment, only intermittent pools of standing water were observed (i.e., no flow), ranging in depth from 0.09 m to 0.18 m. Riparian vegetation consisted of a wide, continuous buffer of mature trees and shrubs. Active bank erosion was documented along the reach, with fallen trees and bank slumping common. Undercuts measured between 0.3 m and 0.48 m. In addition, two knickpoints were observed. Riffle substrate consisted of largely gravel, while pool substrate consisted of clay/silt and sand. Bank materials were comprised of clay/silt and gravel. Average bankfull channel width and depth were 1.9 m and 0.64 m, respectively.

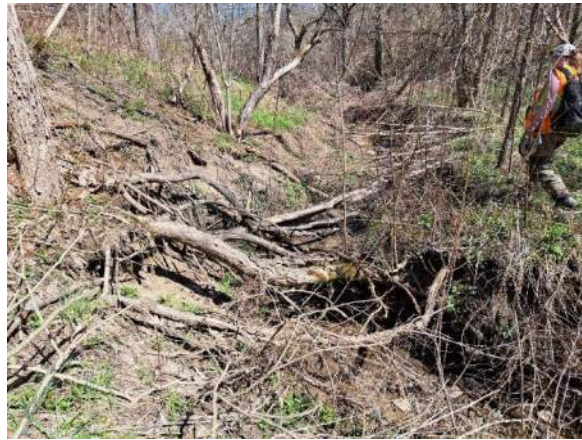
**Photo 4:** Woody debris, leaning and fallen trees and exposed tree roots were common.
