**REPORT ON  
HYDROGEOLOGICAL INVESTIGATION**

**Proposed Sub-Division Development**

**17791 Mount Hope Road**

Project: SP18-334-00  
November 22, 2019

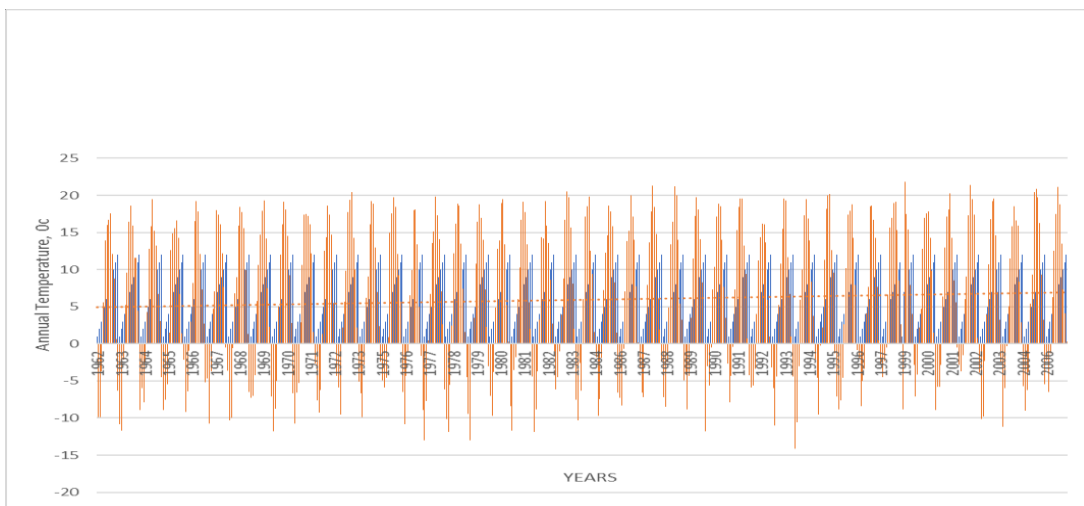
**Figure 11-3 Mean Annual Temperature at the Site**

The data was available for the years from 1962 to 2006. Temporal variations of annual temperature and precipitation are shown in Figures 11-3 and 11-4.

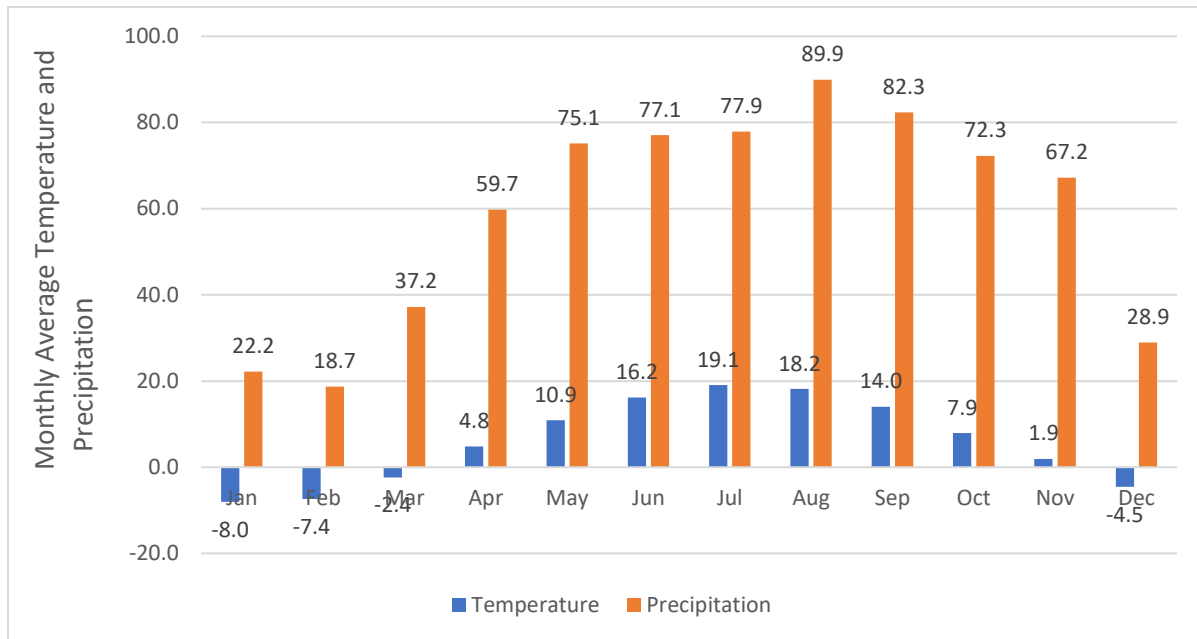
**Figure 11-5 Average Monthly Temperature at the Site**

Average monthly variations of both temperature and precipitation were calculated for the period from 1962 to 2006 and is presented below in Figure 11-5. The highest temperature was recorded in the month of July, while the highest rainfall was in the month of August.

Based on the data for the precipitation and temperature, actual evapotranspiration was estimated to be about 482 mm/annum using the USGS Thornthwaite Monthly Water Balance software (Appendix D), and the average annual precipitation was recorded to be 901 mm/annum.

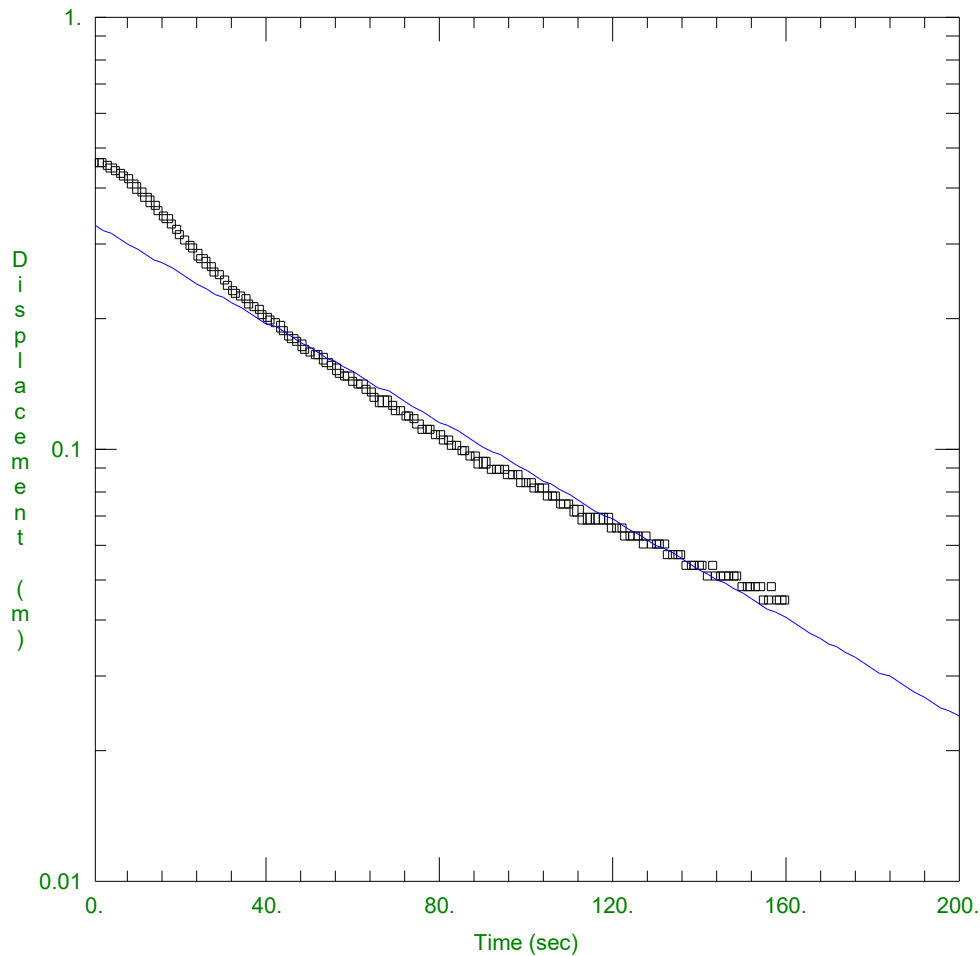
### FALLING HEAD TEST RESULTS

K = 3.833E-5 m/sec

y0 = 0.3313 m

- The hydraulic conductivity estimated for the screened soils ranged from  $1.23 \times 10^{-4}$  m/s to  $3.28 \times 10^{-7}$  m/s, with a geometric average value of  $1.15 \times 10^{-5}$  m/s, which is in the typical range of hydraulic conductivity for sand and gravelly sand, as observed in the boreholes.

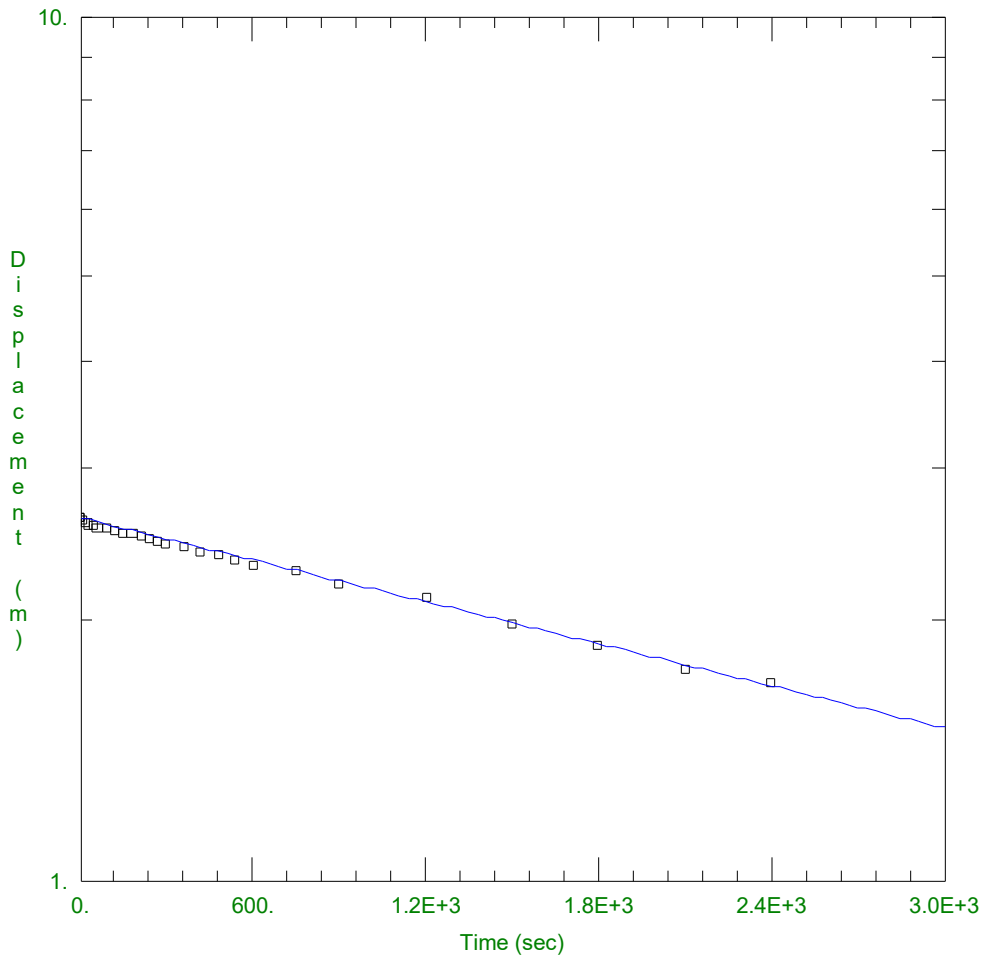
### RISING HEAD TEST RESULTS

K = 3.285E-7 m/sec

y0 = 2.633 m

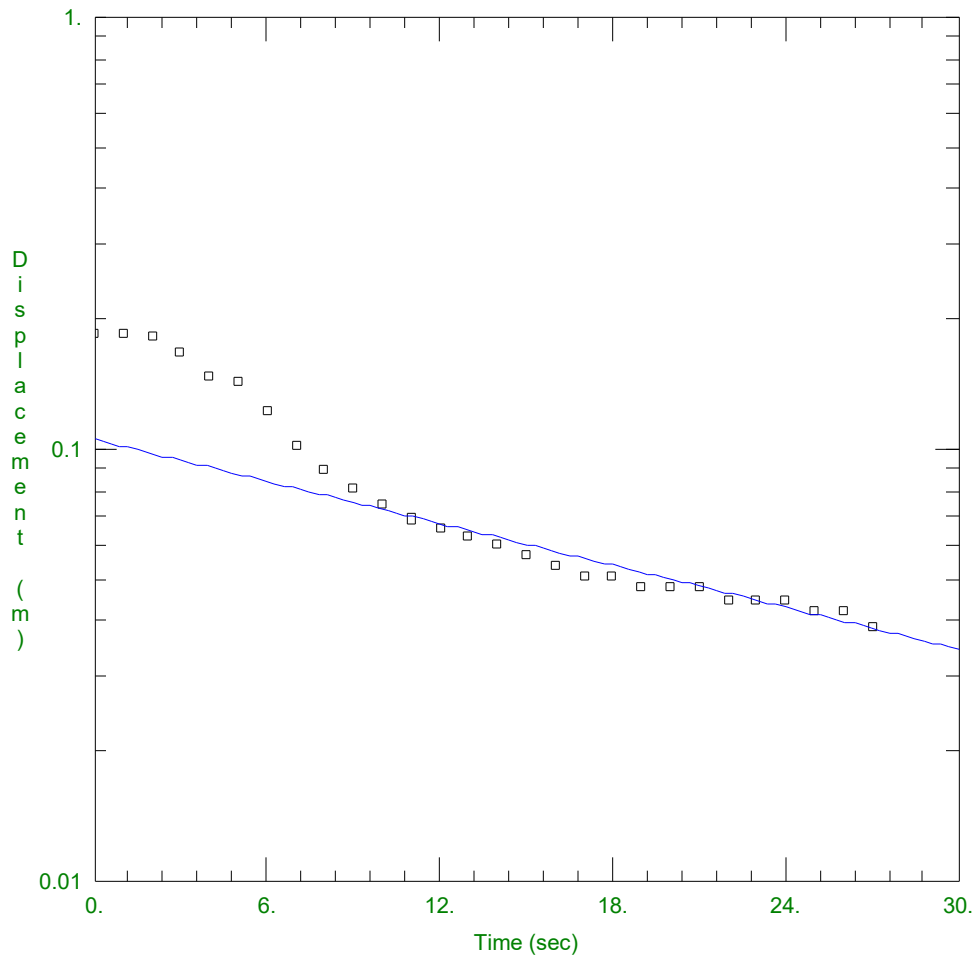
### FALLING HEAD TEST RESULTS

Data Set: S:\...\BH19-3A.aqt
