**PHASE ONE ENVIRONMENTAL SITE ASSESSMENT  
PROPOSED NEW DEVELOPMENT  
17791 MOUNT HOPE ROAD  
CALEDON, ONTARIO**

**SIRATI & PARTNERS CONSULTANTS LIMITED**

Project: SP18-334-20  
June 25, 2019

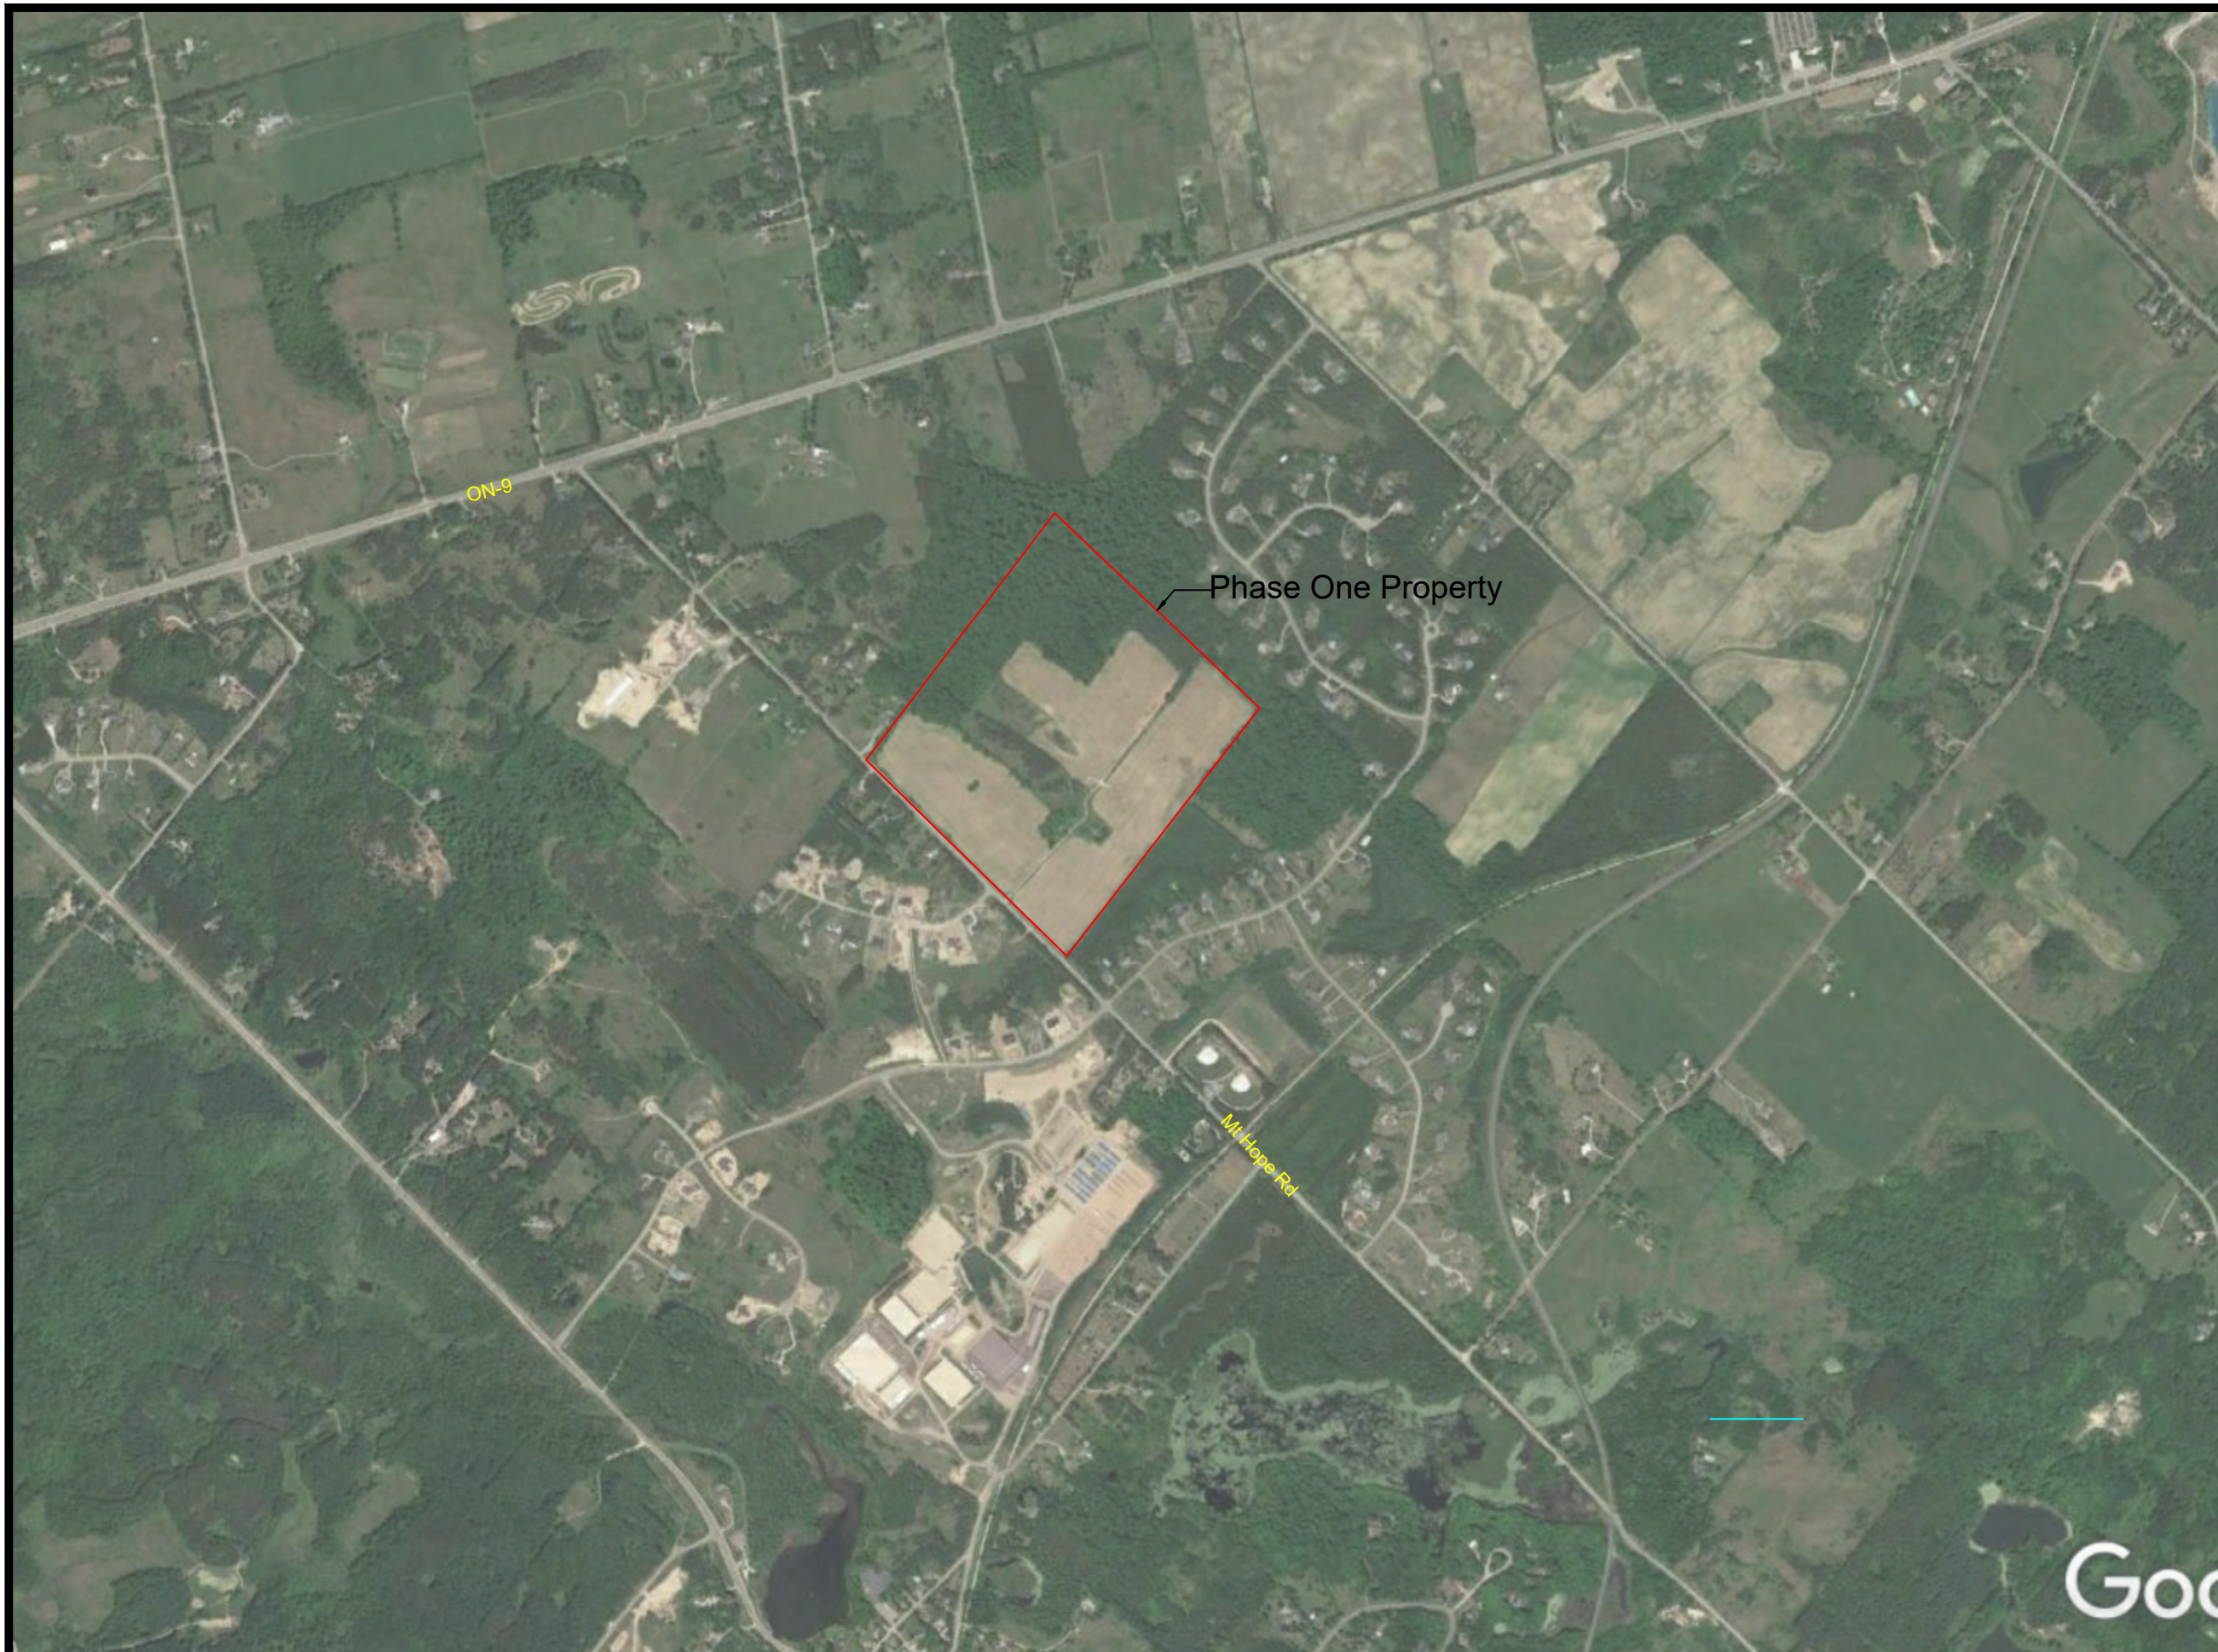
Sirati & Partners Consultants Ltd. (SIRATI) was retained by Palgrave Estate Homes (the Client) to conduct a Phase One Environmental Site Assessment (ESA) of the property located at 17791 Mount Hope Road, in the Town of Caledon, Ontario (the Phase One Property or the Site). The approximate site location is shown on Figure 1.

The Phase One Property is located on the east side of Mount Hope Road, in the Town of Caledon, Ontario. The approximate site location and property boundary are presented on Figures 1 and 2. A legal survey plan is provided in Appendix A.

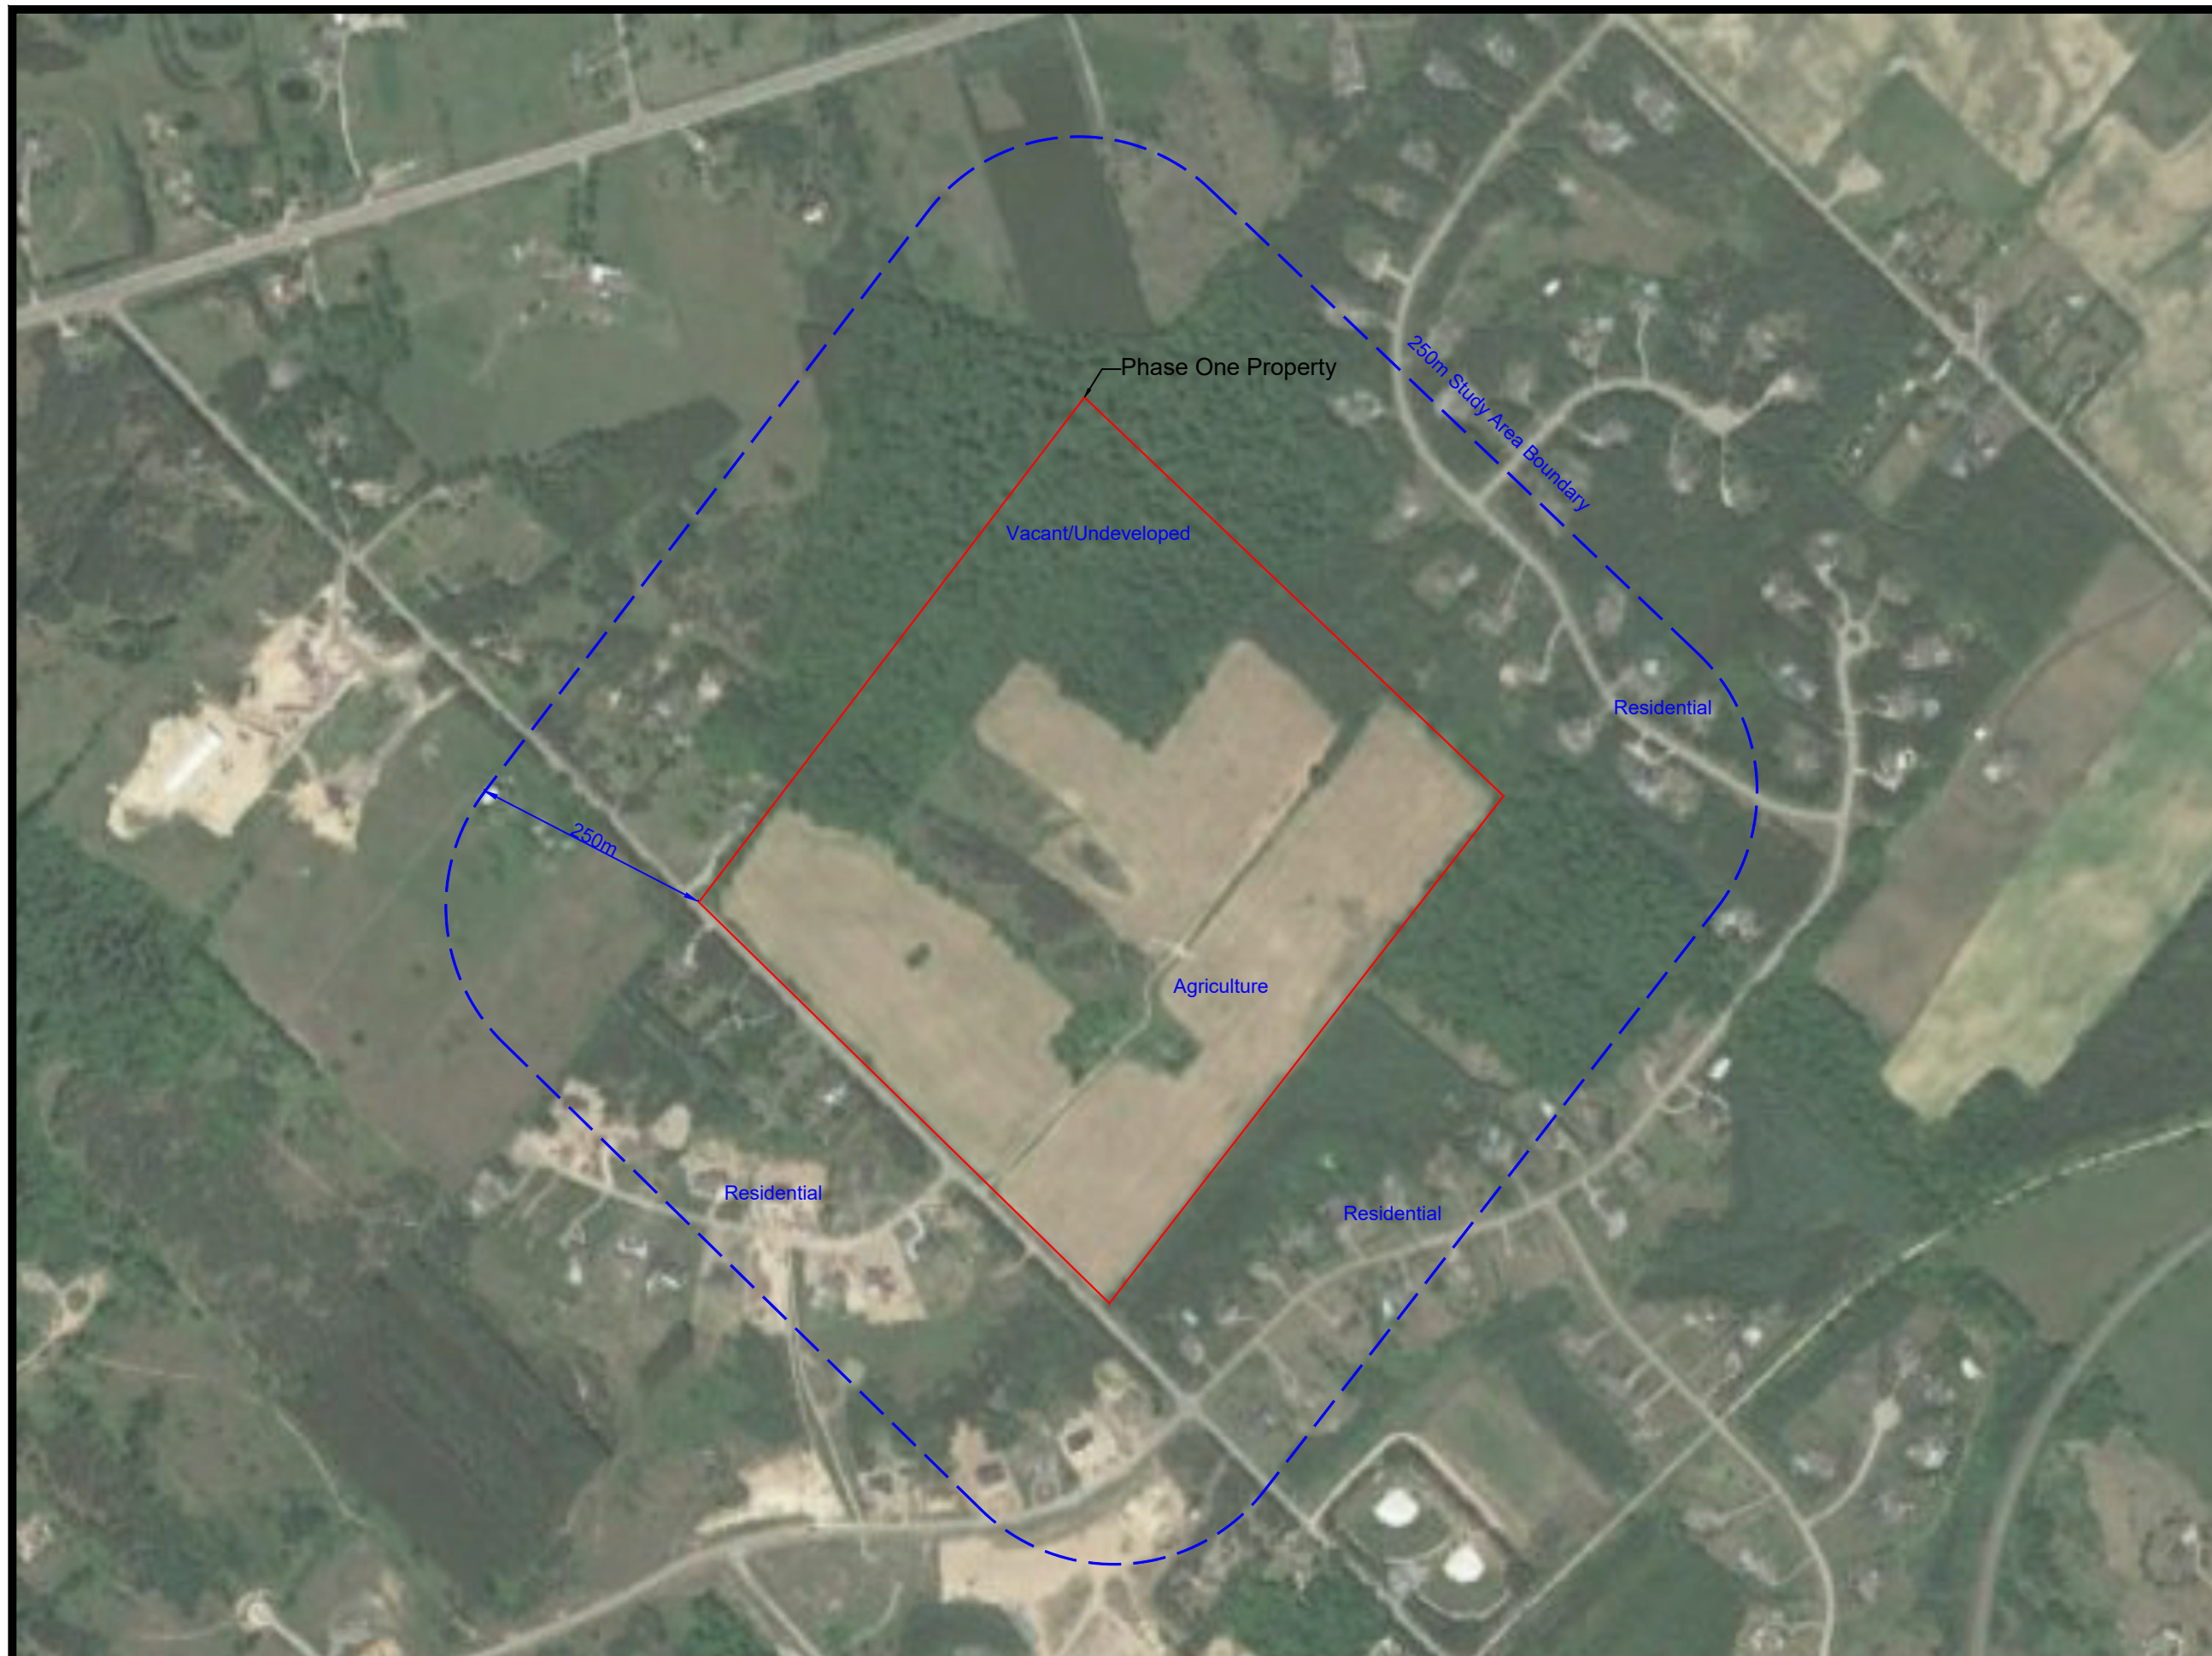
2

Based on review of the available historical information and on observations made during the site visit, the Phase One Property is surrounded by vacant/undeveloped land and residential properties. SIRATI did not note any significant potentially contaminating activities in properties beyond 250 m from the Site. Therefore, it is SIRATI's opinion that a 250 m radius study area around the Phase One Property is sufficient to identify issues of potential environmental concerns with respect to the Phase One Property. The properties or areas which are included in the Phase One Study Area are shown in Figure 2.

A visual site inspection was conducted and written and photographic records were made. The layout of the Phase One Property at the time of the site visit is presented on Figure 2. Photographs taken during the site reconnaissance and accompanying descriptions are presented in Appendix H.

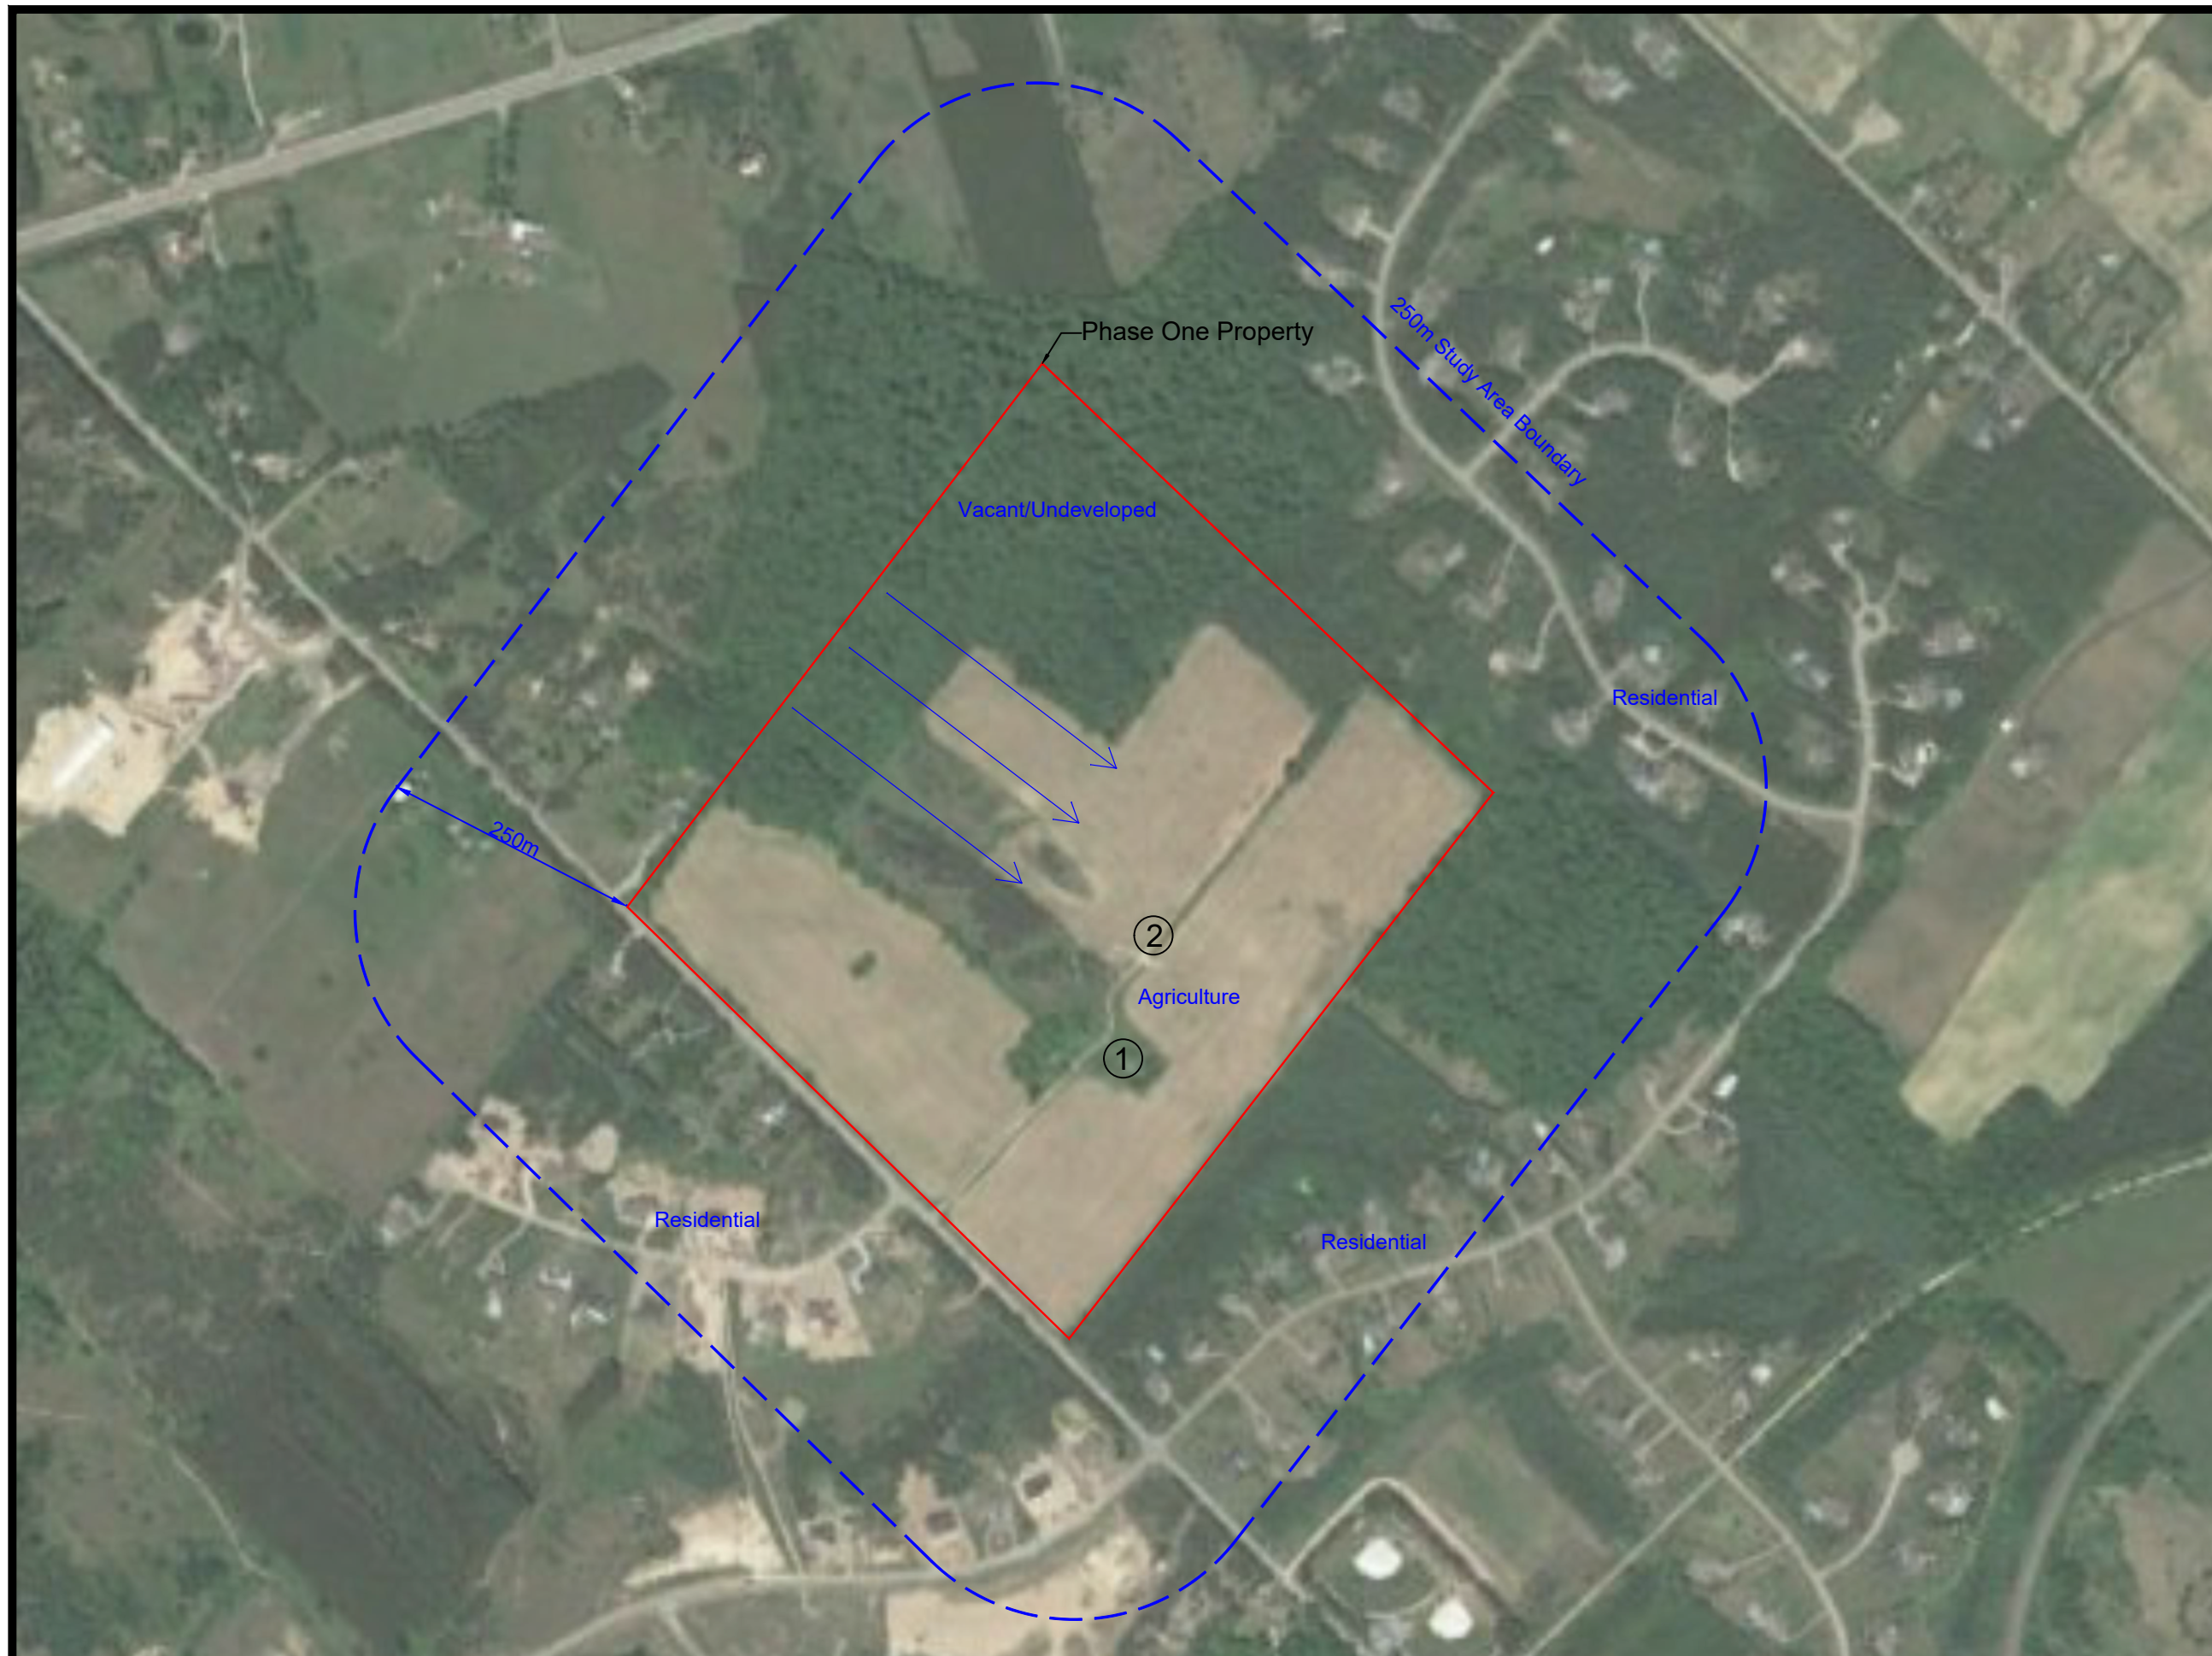
4

Based on the information obtained, no PCAs were identified on the properties located in the Phase One Study Area. However, PCAs were identified on the Phase One Property, which are summarized in the following table and shown on Figure 4.

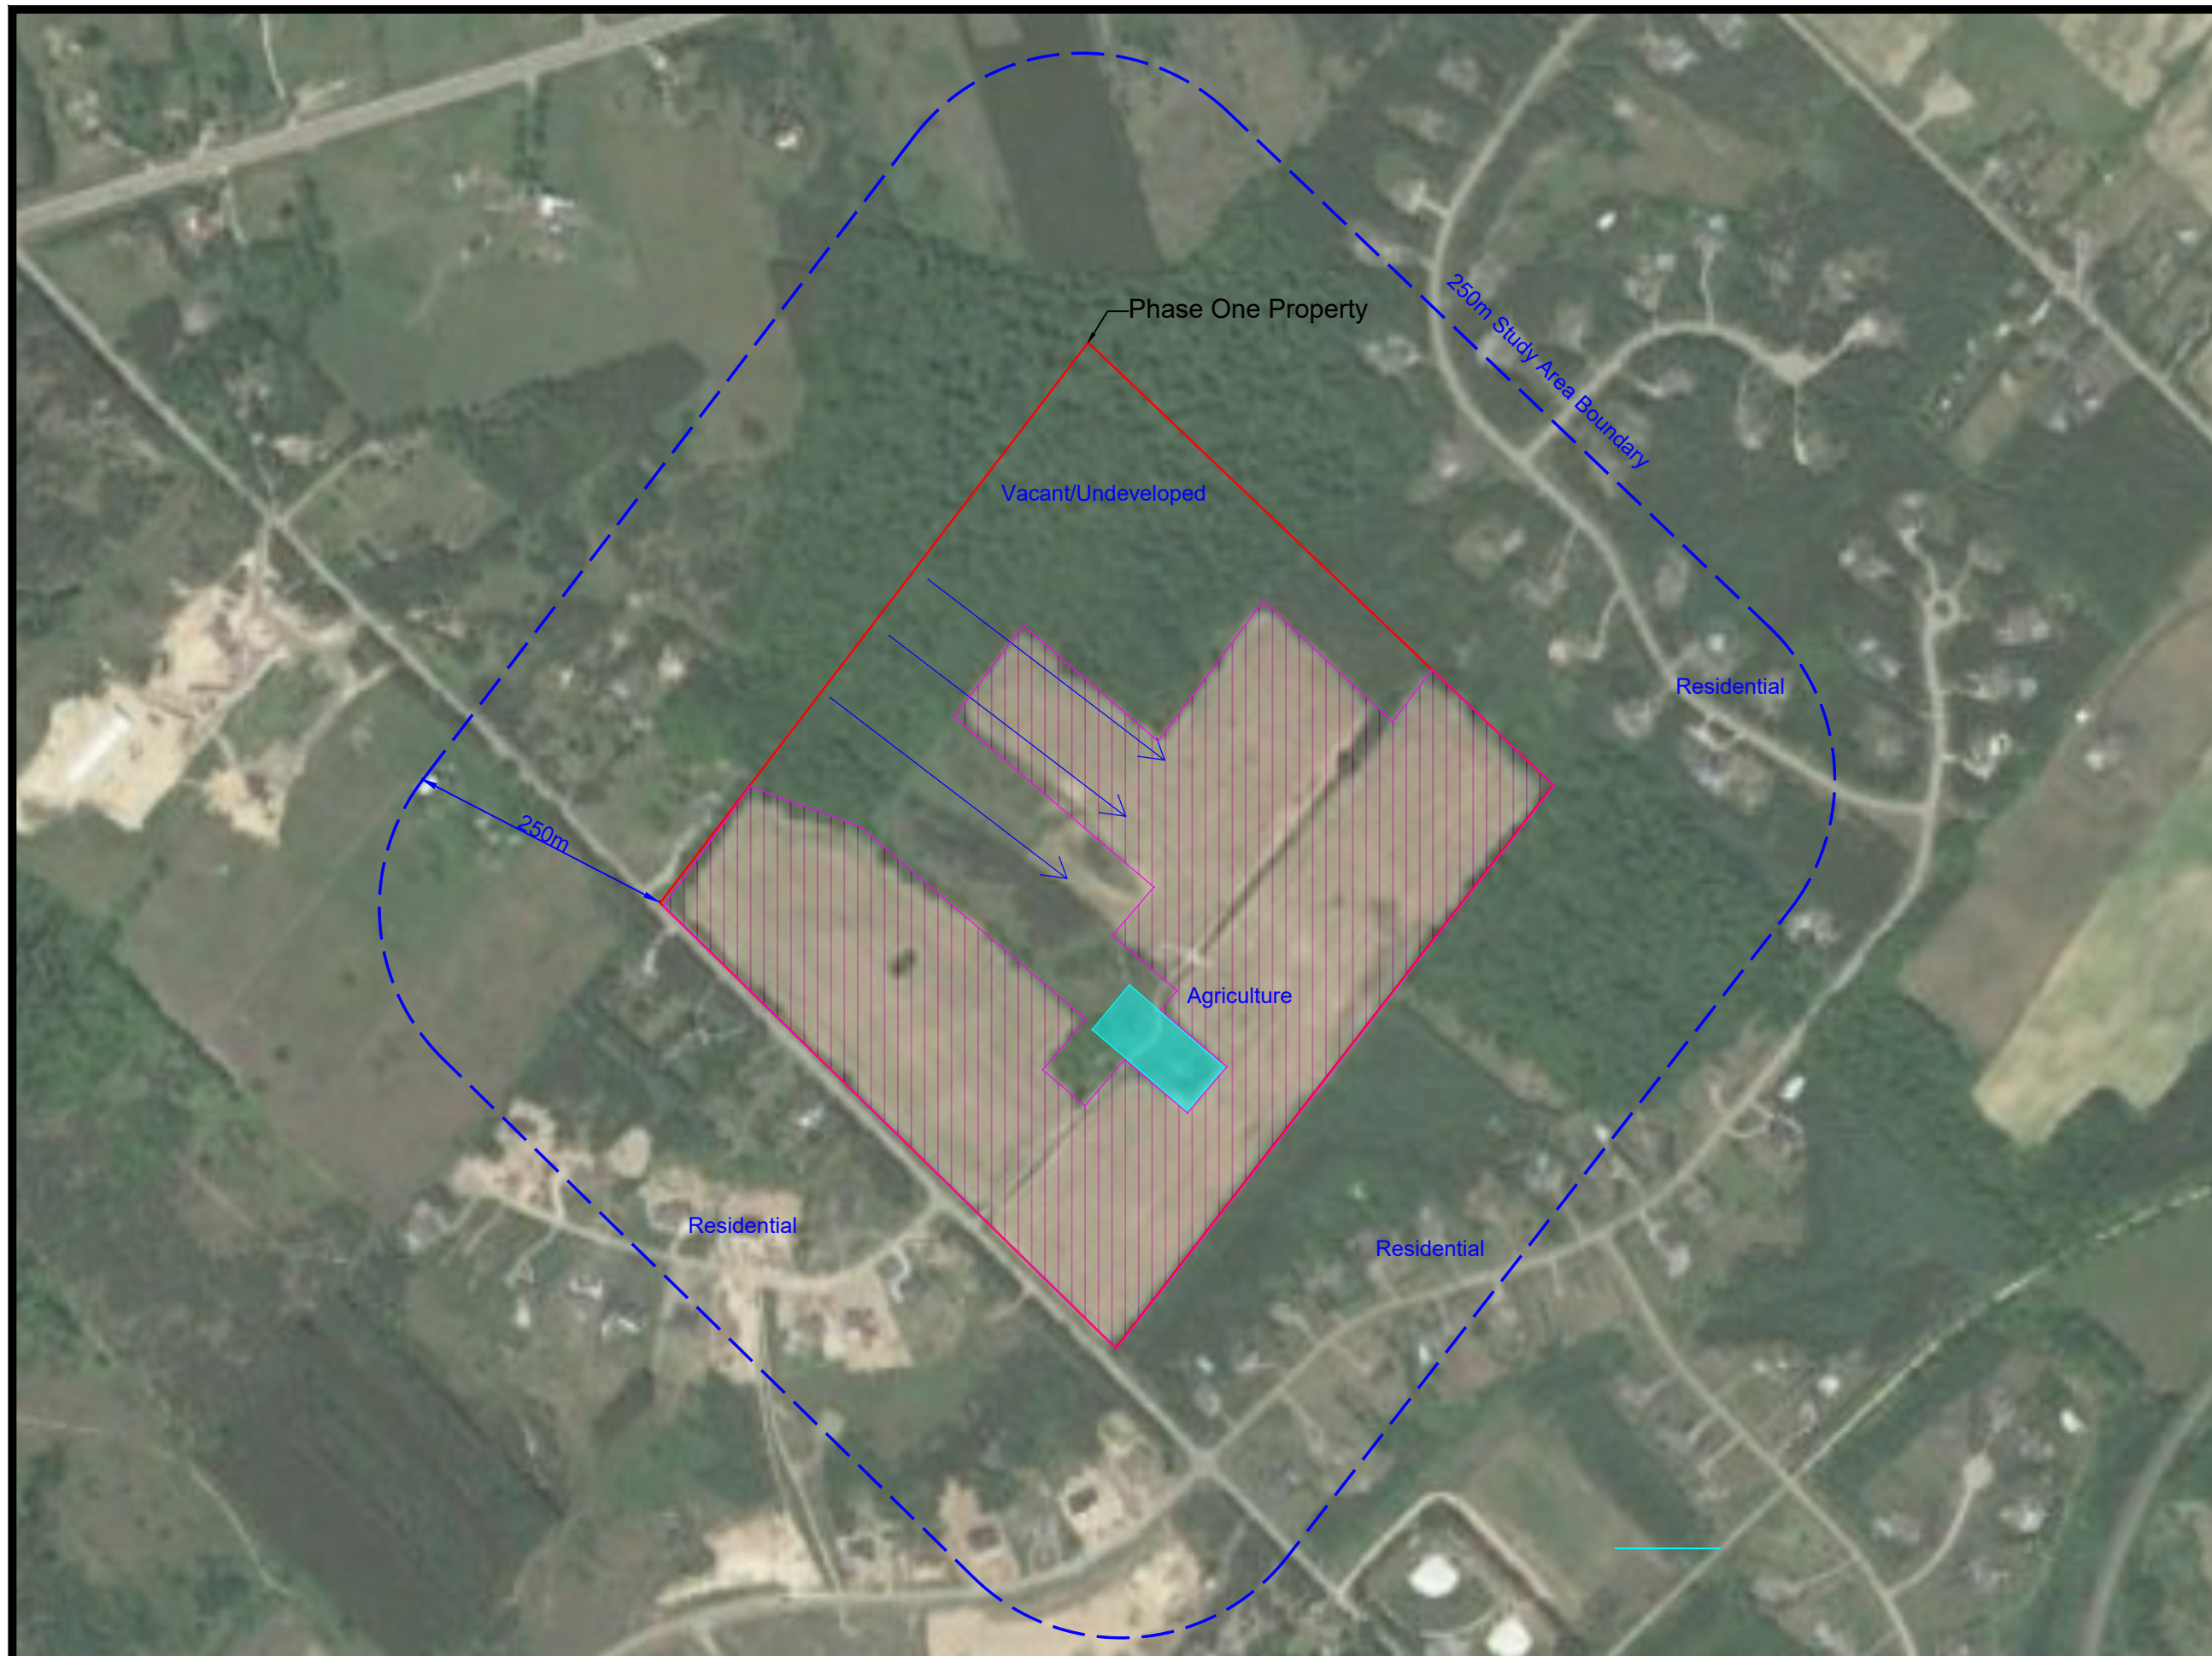
5

Based on the above analyses of the identified PCAs, two (2) areas of potential environmental concern could be identified on the Phase One Property. A summary of the APECs and associated contaminants of potential concern (COPCs) are summarized in the following table and shown on Figure 5.

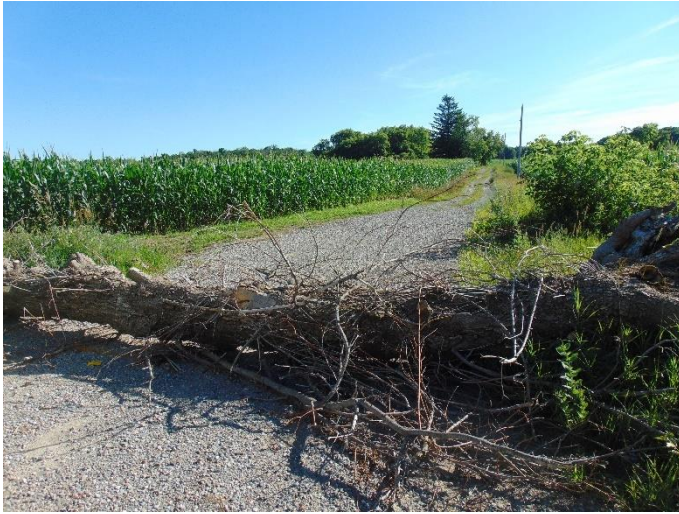
Photograph 1

Location: Phase One Property  
Viewing: Northeast  
Description: Entrance to the Phase One Property

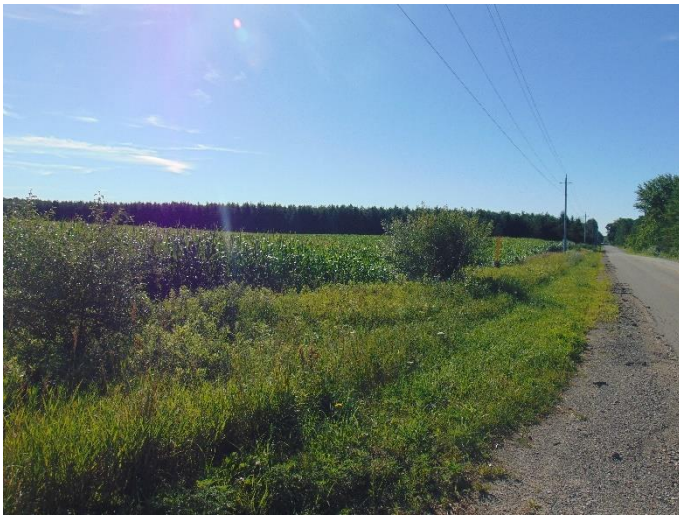
Photograph 2

Location: Phase One Property  
Viewing: Southeast  
Description: View of corn field near the entrance area and Mount Hope Road.

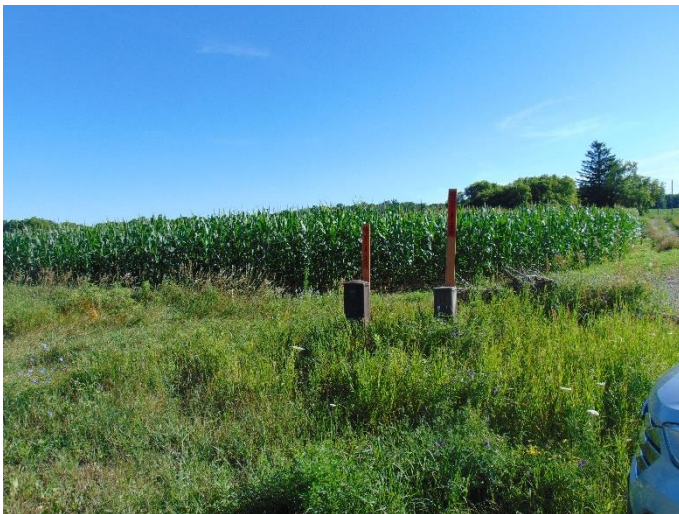
Photograph 3

Location: Phase One Property  
Viewing: North  
Description: View of corn field from the entrance of the Phase One Property

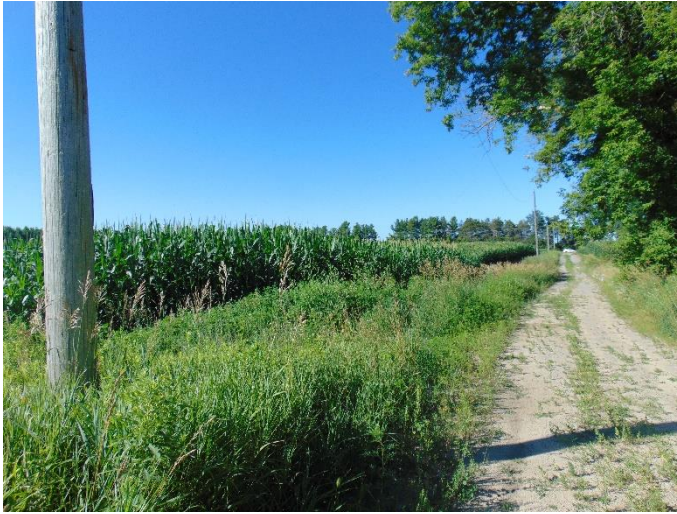
Photograph 4

A dirt road was observed in the southeast portion of the Site, which connects Mount Hope Road to the former building structure area and extends further northeast.

Location: Phase One Property  
Viewing: Southwest  
Description: View of the dirt road and corn field on the Phase One Property (looking to entrance area)

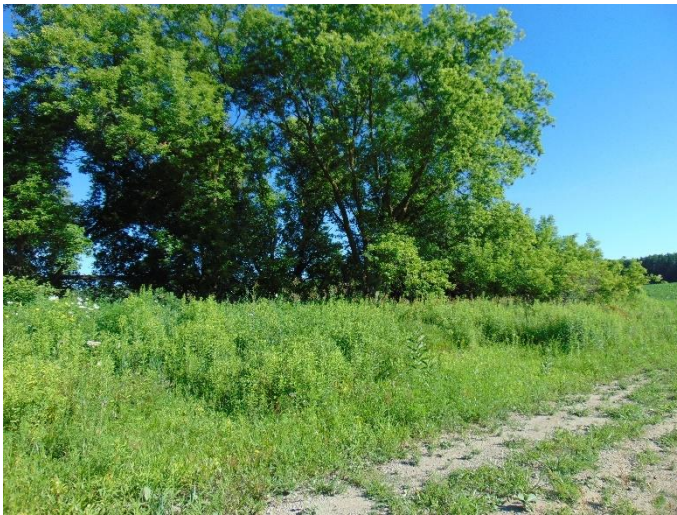
Photograph 5

Location: Phase One Property  
Viewing: North  
Description: View of the area where former shed was located (looking from dirt road)

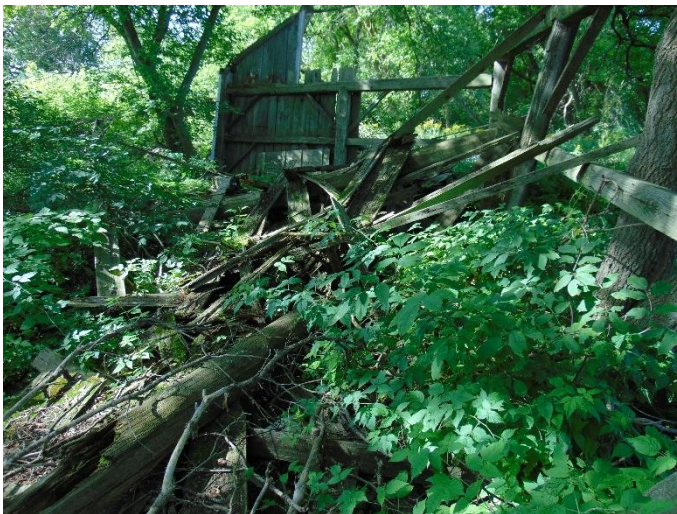
Photograph 6

During the site visit, no fill materials were observed at the Phase One Property. However, concrete slabs and construction debris and wooden debris of previous structures were observed in the former building structure area. Fill materials may be present in this area.

Location: Phase One Property  
Viewing: -  
Description: View of the former shed

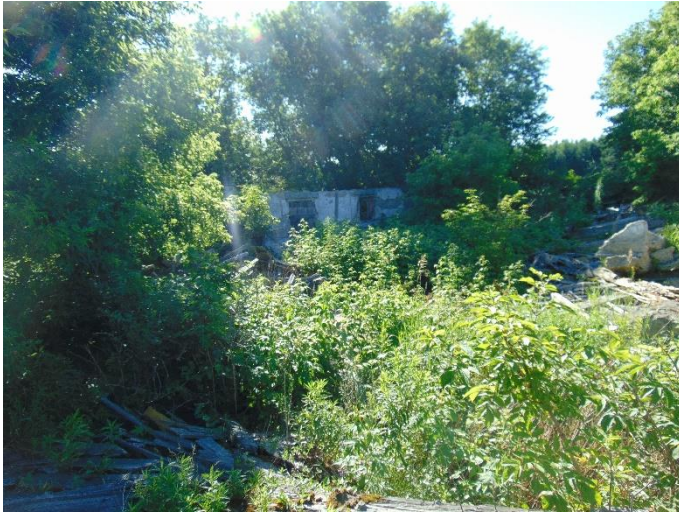
Photograph 7

Based on the site visit, it was found that the Site was used as a farmland for planting corn crops. No current building structures were present on Site. However, building foundation, concrete slabs, wooden and/or construction debris were noted in the former building structure area.

Location: Phase One Property  
Viewing: West  
Description: View of the former house area

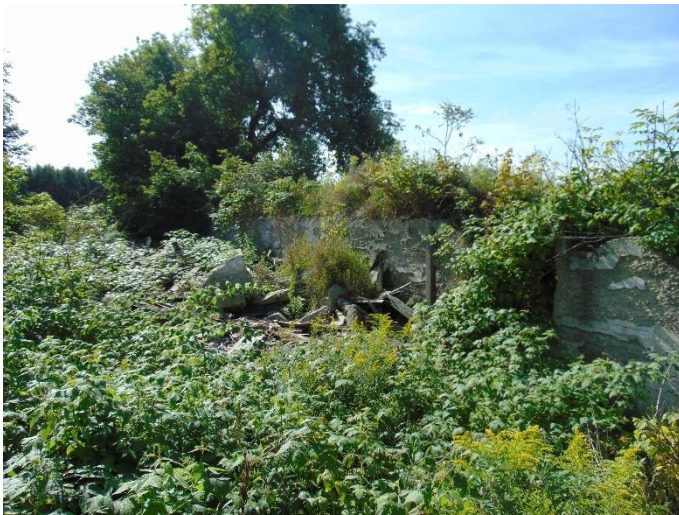
Photograph 8

Location: Phase One Property  
Viewing: -  
Description: View of the former house area

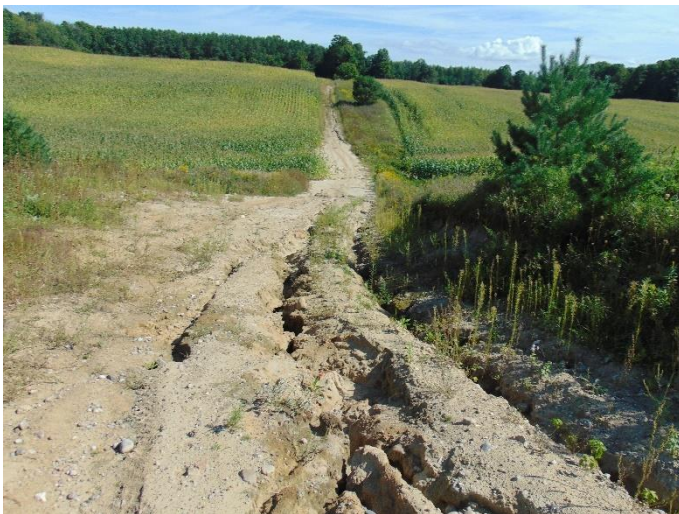
Photograph 9

Location: Phase One Property  
Viewing: Northeast  
Description: View of the dirt road and corn field, northeast of the former building area

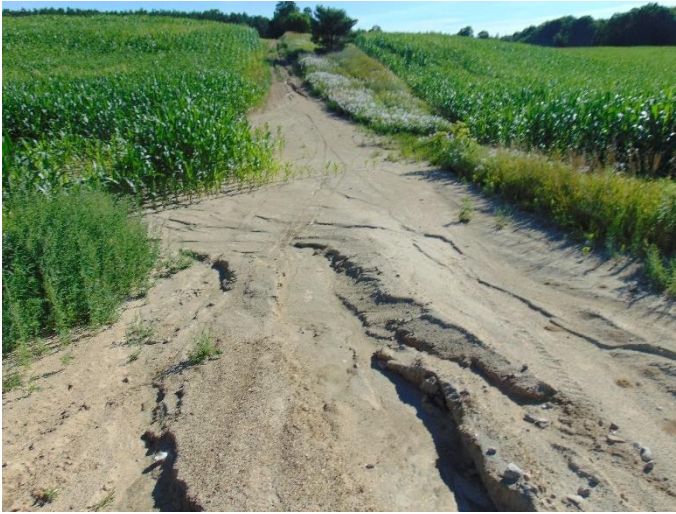
Photograph 10

The unnamed tributary was found to be dry, indicating the nature of such tributary as an ephemeral creek.

Location: Phase One Property  
Viewing: Northeast  
Description: View of the approximate location of a dry creek

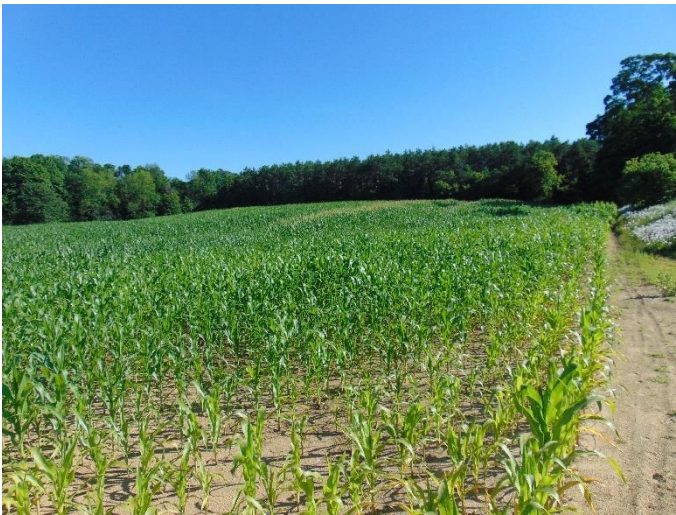
Photograph 11

Location: Phase One Property  
Viewing: Northeast  
Description: View of corn field in the northeast property boundary area

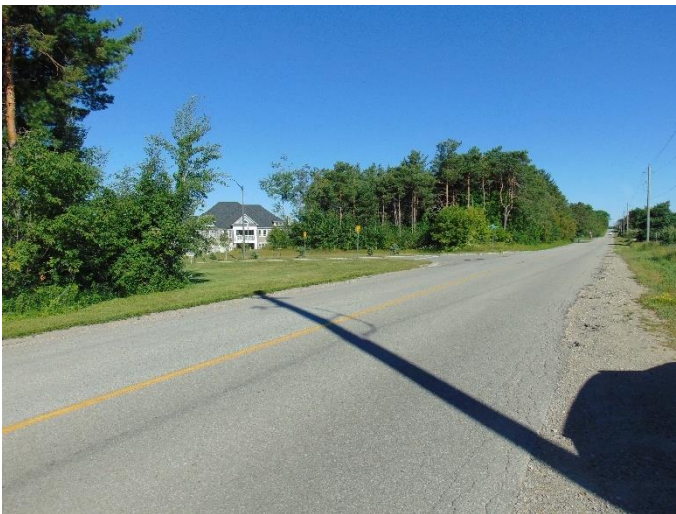
Photograph 12

Location: Phase One Property  
Viewing: Northwest  
Description: View of intersection of Mount Hope Road and Doctor Reynar Road, and residential building

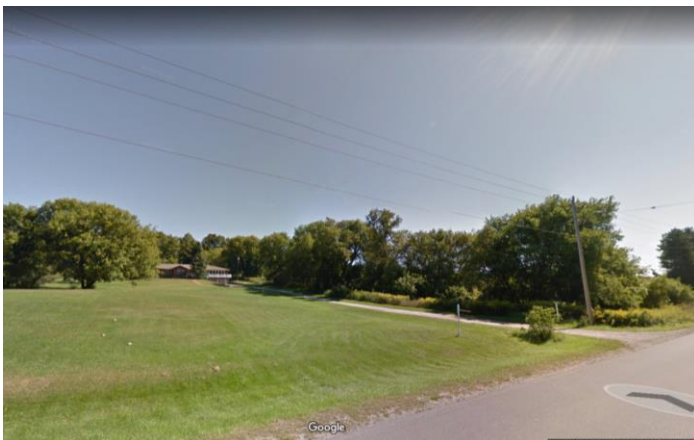
Photograph 15

Location: Phase One Study Area  
Viewing: East  
Description: View of the adjacent property located at the northwest corner of the Phase One Property (Google Earth Image dated Sept 2011)
