# **HYDROGEOLOGICAL IMPACT STUDY**

**Proposed New Sub-Division**

**0 Mount Pleasant Road**

Project: SP17-212-00

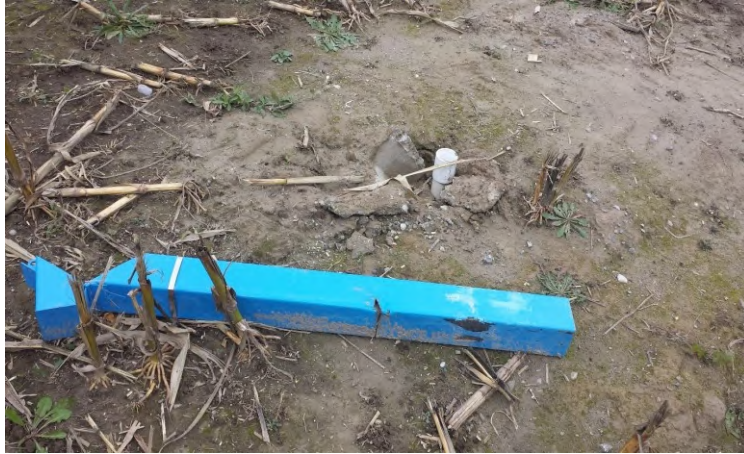
Photograph 1: View of the damaged monitoring well (MW8). The PVC pipe was broken and the protective casing was uprooted. A cut was noted in the protective steel casing.

It should be noted that monitoring well MW8 was found to be damaged when October 2017 groundwater monitoring was conducted, which was repaired in the next monitoring event in December 2017. Records of observations are presented in photographs below.

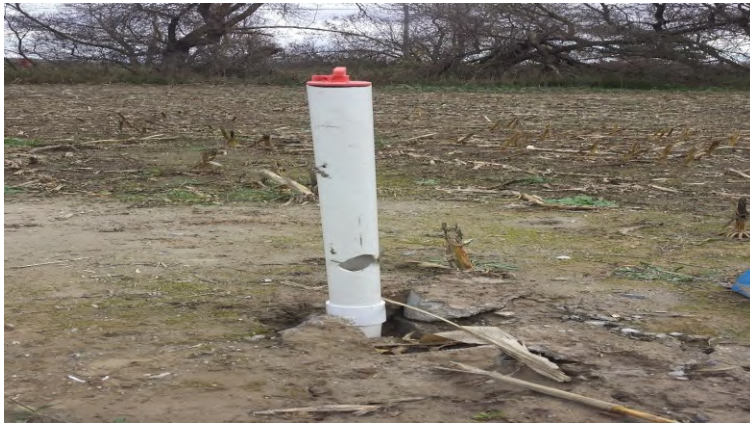
Photograph 2: View of the broken PVC pipe. A cut could be seen.

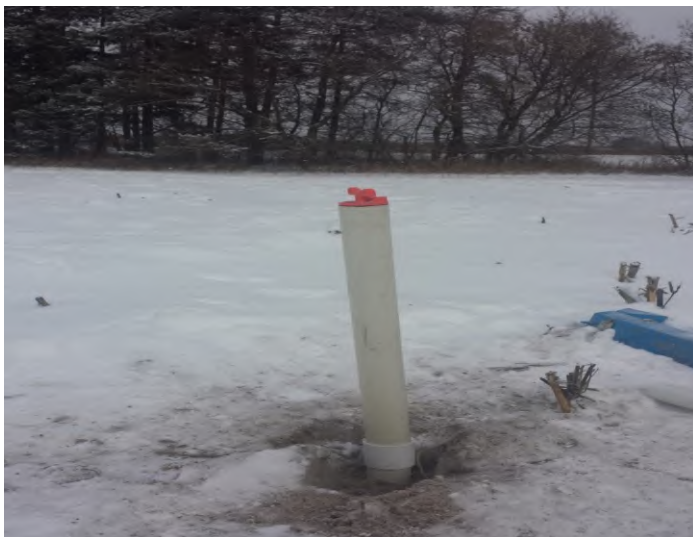
Photograph 3: View of the restored PVC pipe. Due to the hard ground surface, the protective casing could not be set in place.

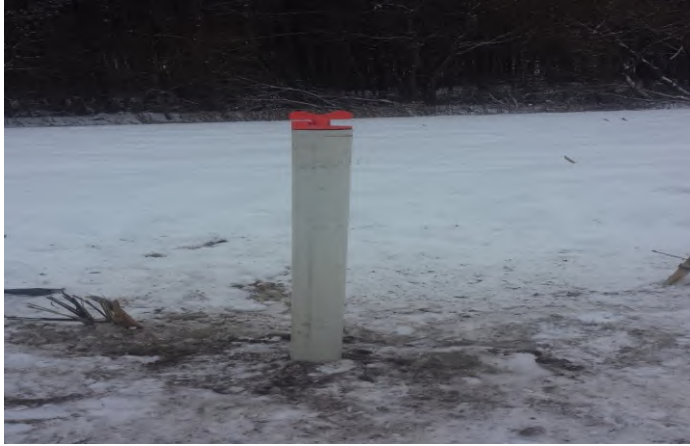
Photograph 4: View of the restored PVC pipe
