Headwater Drainage Feature Assessment
Tullamore Secondary Plan Area
Town of Caledon

Prepared for:
Riepma Consultants, Inc.

Prepared by:
Azimuth Environmental
Consulting, Inc.

March 2024

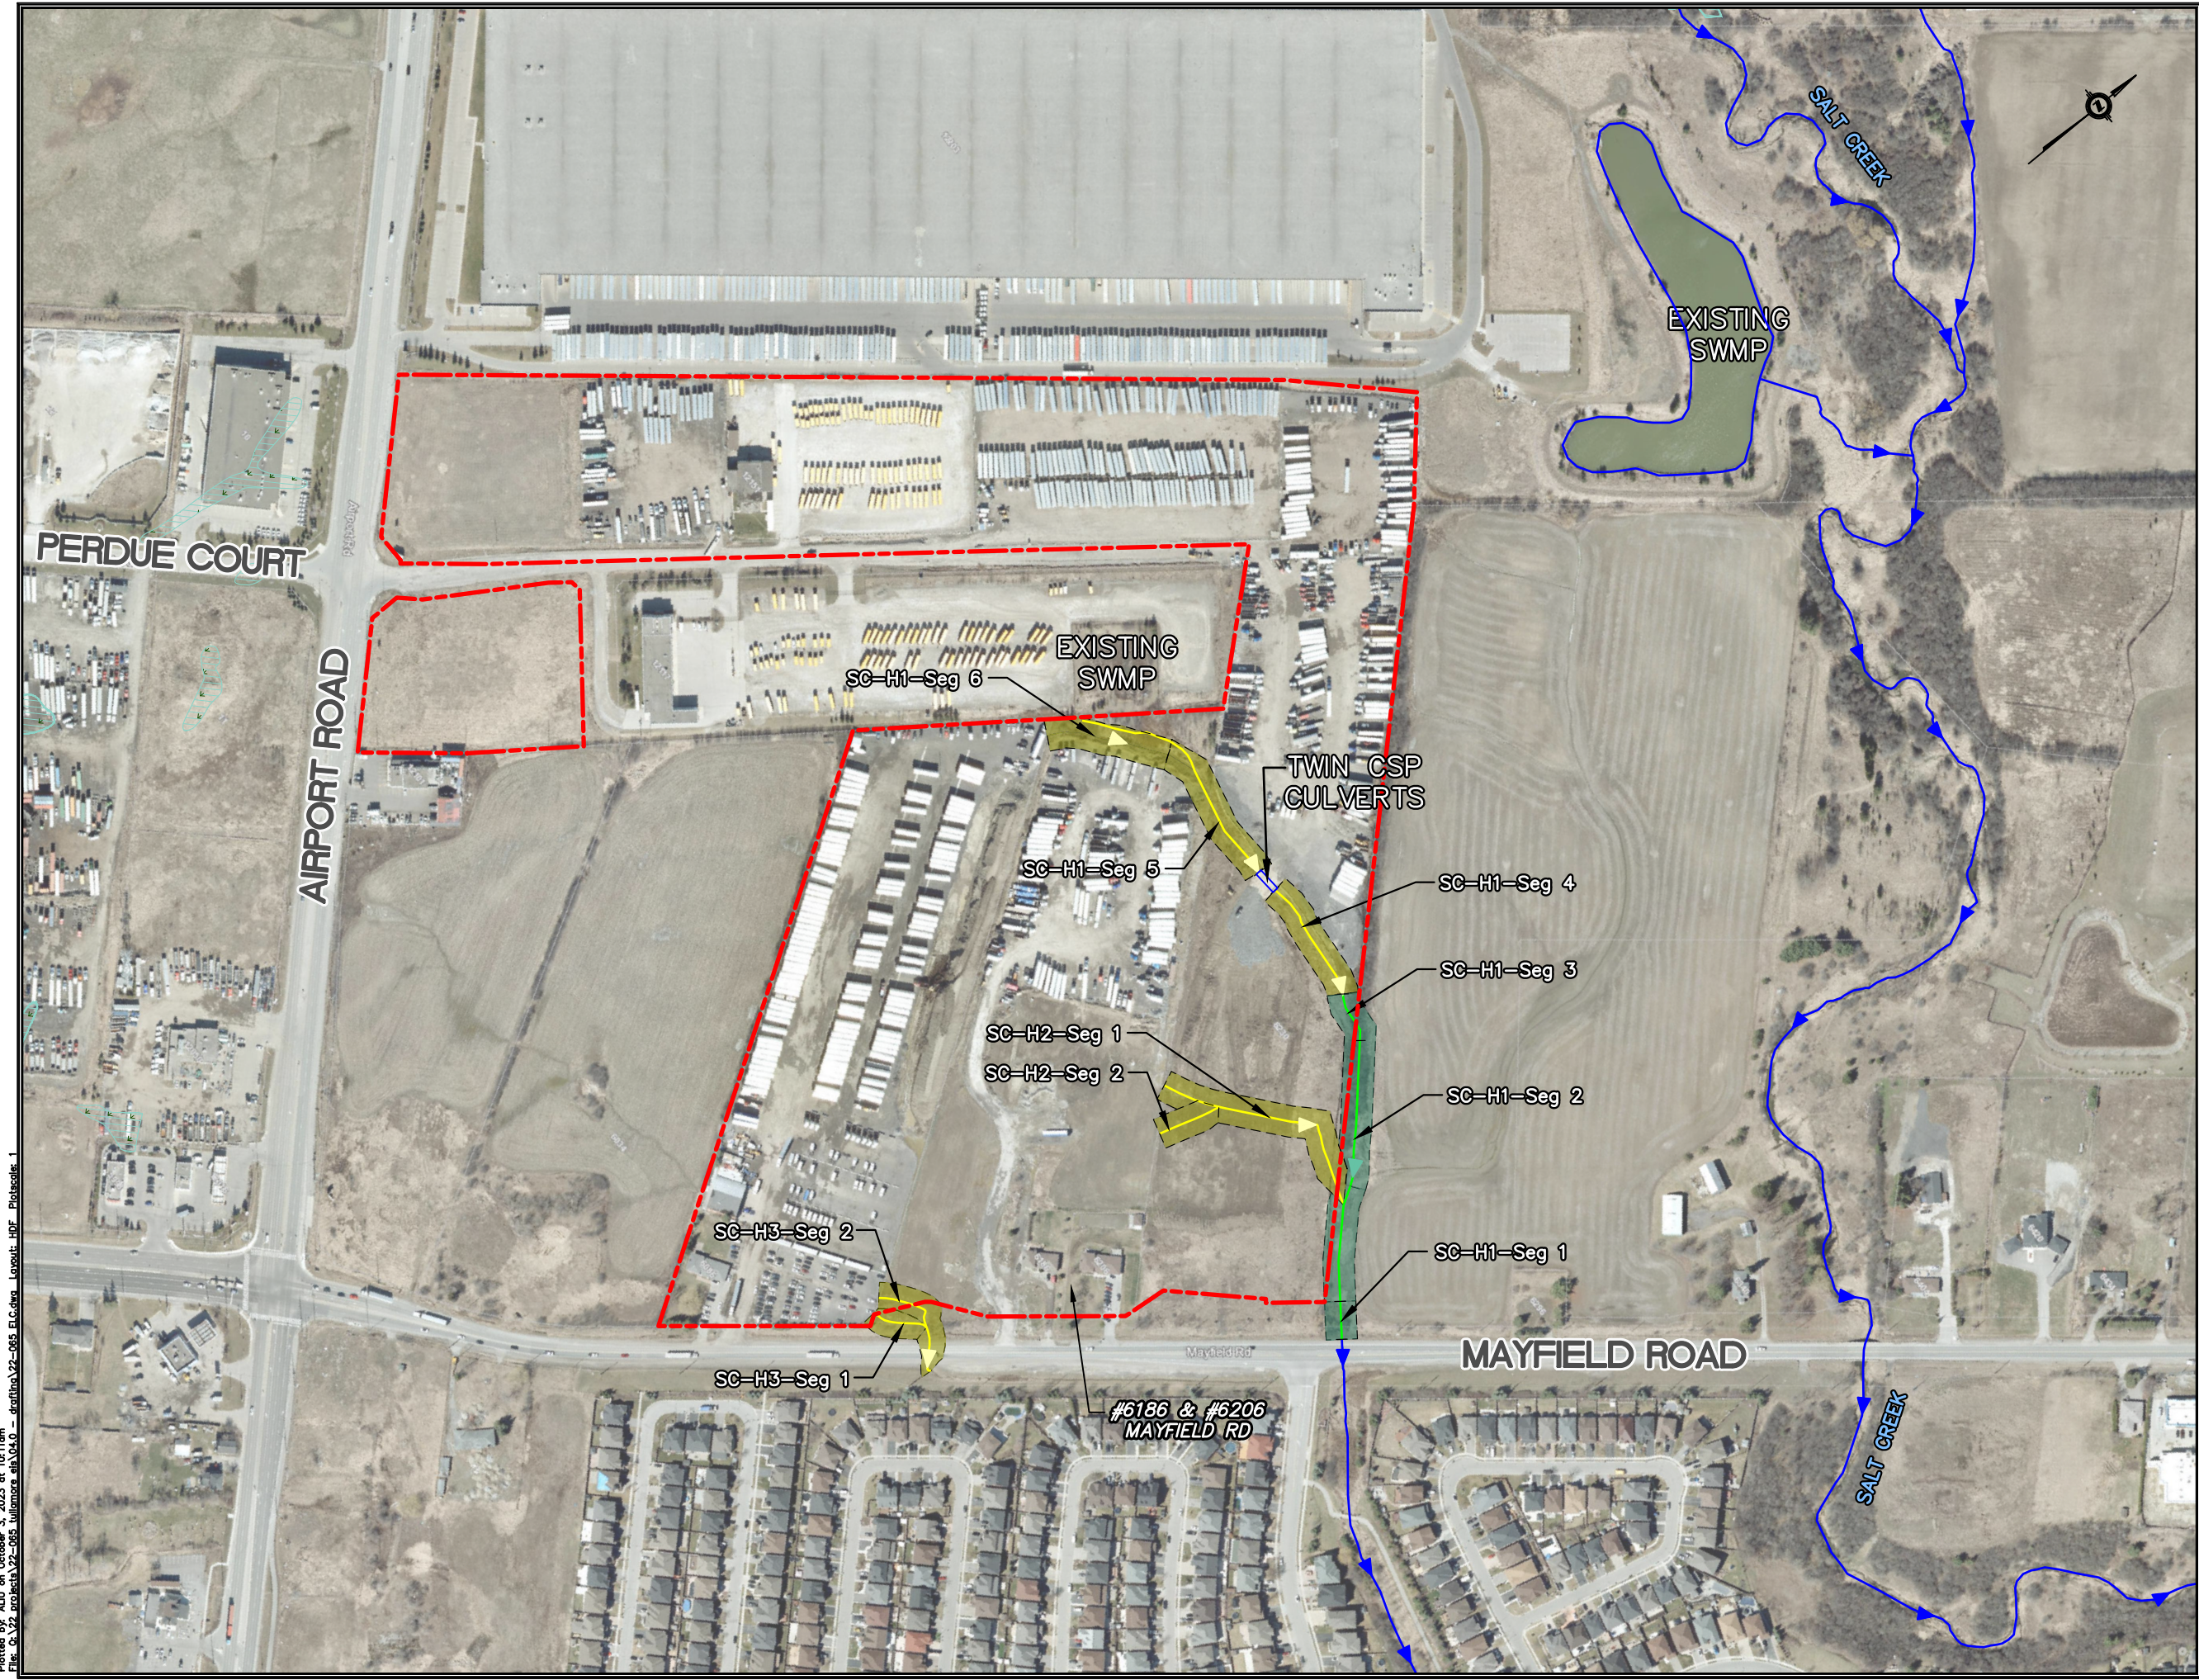
HEADWATER DRAINAGE FEATURE ASSESSMENT

DRAINAGE FEATURE SEGMENT CODE	MANAGEMENT RECOMMENDATION
SC-H1-Seg 1	PROTECTION
SC-H1-Seg 2	CONSERVATION
SC-H1-Seg 3	CONSERVATION
SC-H1-Seg 4	MITIGATION
SC-H1-Seg 5	MITIGATION
SC-H1-Seg 6	MITIGATION
SC-H2-Seg 1	MITIGATION
SC-H2-Seg 2	MITIGATION
SC-H3-Seg 1	PROTECTION
SC-H3-Seg 2	PROTECTION

HDF management recommendations are summarized in **Table 1** below based on the field surveys completed. All drainage features in the study area are shown on **Figure 2** with their management recommendations. The HDF management recommendations are based on the CVC/TRCA HDF Guidelines (2014) and the CVC/TRCA flow chart which provides direction on management options (flow chart provided in **Figure 3** below).

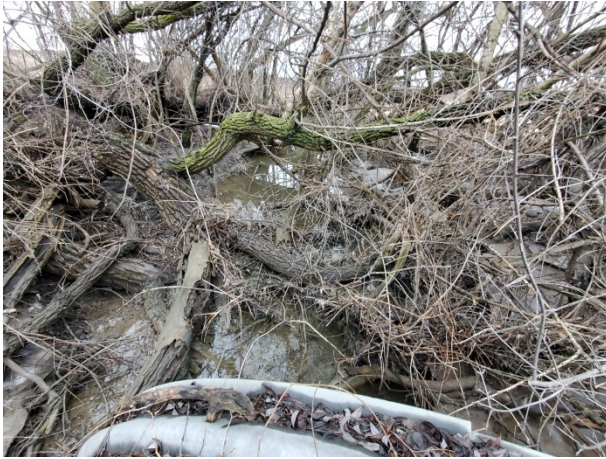
SC-H1-Seg 1 (March 20, 2022)

Segment ID: SC-H1-Seg 1

Hydrology: Important

Riparian: Important

Fish Habitat: Valued

Terrestrial Habitat: Contributing

Notes: Short (20m) segment immediately north of Mayfield Road within treed area.

Mgmt Rec.: Protection

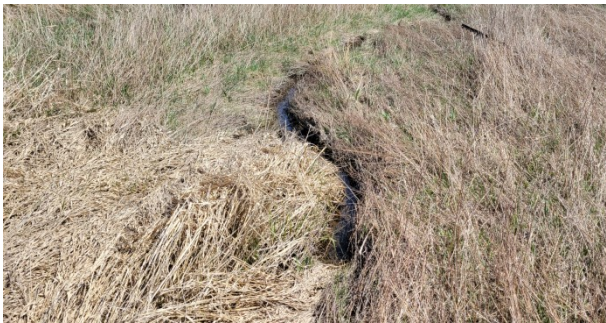
SC-H1-Seg 2 (April 29, 2022)

Segment ID: SC-H1-Seg 2

Hydrology: Valued

Modifier: Agriculture

Riparian: Important

Fish Habitat: Contributing

Terrestrial Habitat: Contributing

Notes: Small channel through grassed meadow segment. Originally assigned 'Conservation' management recommendation, but was changed to 'Protection' due to SC-H1-Seg 3 upstream.

segment. Therefore, the management recommendation for SC-H1-Seg 2 was changed to 'Protection' as well, similar to SC-H1-Seg 3.

Mgmt Rec.: Protection

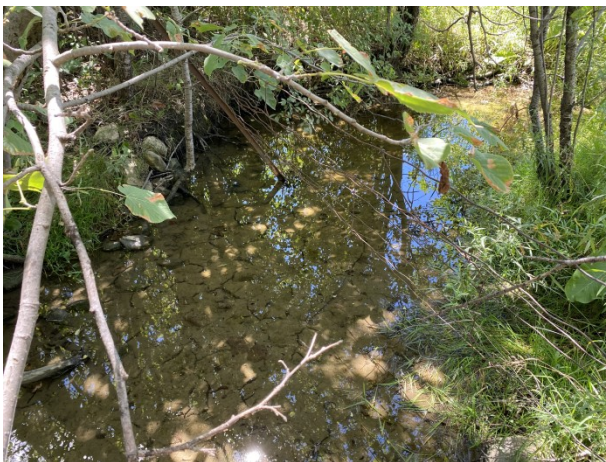
SC-H1-Seg 3 (August 11, 2022)

Segment ID: SC-H1-Seg 3

Hydrology: Important

Modifier: Agriculture

Riparian: Important

Fish Habitat: Contributing

Terrestrial Habitat: Contributing

Notes: Short (20m) segment in treed hedgerow with standing water present during late summer site visit.

Similarly, SC-H1-Seg 3 also had water present during all three field investigations, and is therefore considered to have ‘Important’ hydrological functions and a management recommendation of ‘Protection’. Downstream of SC-H1-Seg 3, SC-H1-Seg 2 was dry during the late summer site visit and was originally given a management recommendation of ‘Conservation’. However, based on the CVC/TRCA HDF Guidelines (2014), in the event that a lower level of protection is identified for a segment downstream of a segment with a higher level of protection, the more conservative approach shall be adopted for both segments and the downstream segment should be reclassified to match the upstream

Mgmt Rec.: Protection

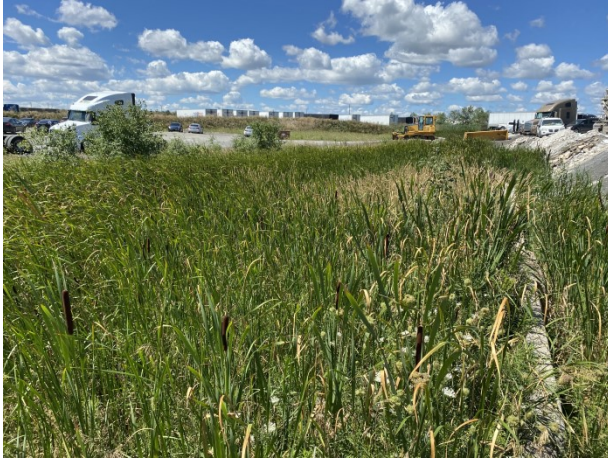
SC-H1-Seg 4 (August 11, 2022)

Segment ID: SC-H1-Seg 4

Hydrology: Valued

Modifier: Development

Riparian: Limited

Fish Habitat: Contributing

Terrestrial Habitat: Limited

Notes: Dense cattail swale with no natural riparian/terrestrial vegetation. Development on both sides of feature.

Mgmt Rec.: Mitigation

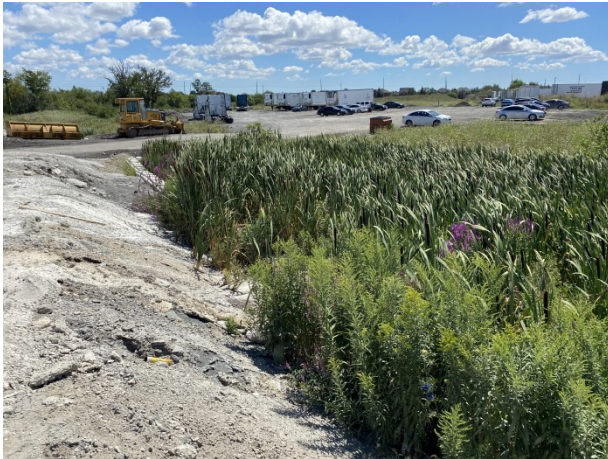
SC-H1-Seg 5 (August 11, 2022)

Segment ID: SC-H1-Seg 5

Hydrology: Valued

Modifier: Development

Riparian: Limited

Fish Habitat: Contributing

Terrestrial Habitat: Limited

Notes: Dense cattail swale with no natural riparian/terrestrial vegetation. Development on both sides of feature. Separated from SC-H1-Seg 4 by twin CSP culverts.

Mgmt Rec.: Mitigation

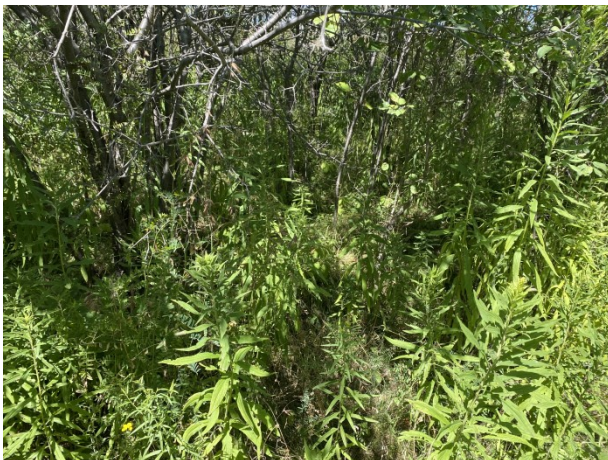
SC-H1-Seg 6 (August 11, 2022)

Segment ID: SC-H1-Seg 6

Hydrology: Contributing

Riparian: Limited

Fish Habitat: Contributing

Terrestrial Habitat: Contributing

Notes: Poorly defined swale in scrubland area. No substrate sorting or aquatic vegetation observed.

Mgmt Rec.: Mitigation

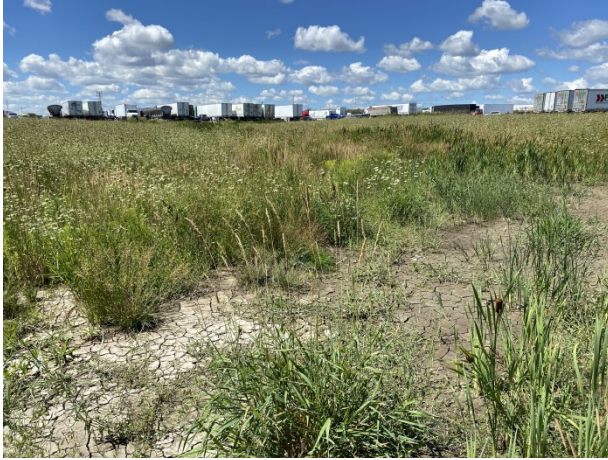
SC-H2-Seg 1 (August 11, 2022)

Segment ID: SC-H2-Seg 1

Hydrology: Contributing

Modifier: Development

Riparian: Limited

Terrestrial Habitat: Limited

Notes: Poorly defined swale in meadow area. Upstream segment altered by development in feature (truck parking lot).

Mgmt Rec.: Mitigation

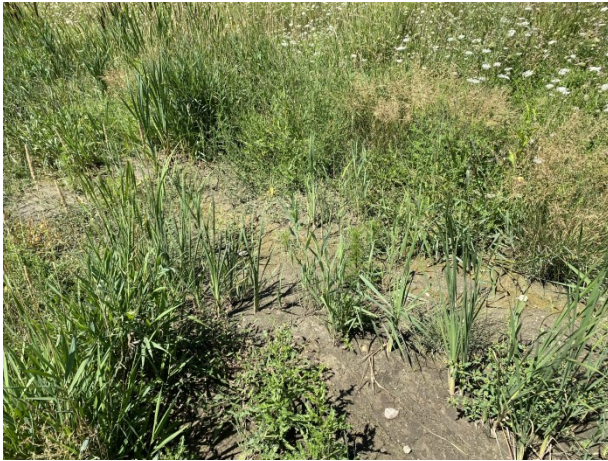
SC-H2-Seg 2 (August 11, 2022)

Segment ID: SC-H2-Seg 2

Hydrology: Contributing

Modifier: Development

Riparian: Limited

Terrestrial Habitat: Limited

Notes: Poorly defined swale in meadow area. Upstream segment altered by development in feature (truck parking lot).

Mgmt Rec.: Mitigation

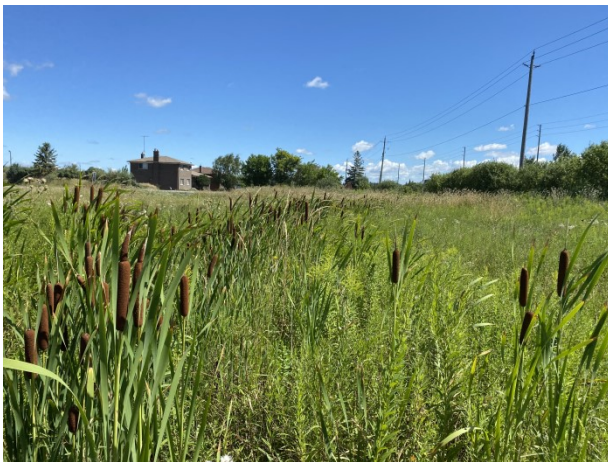
SC-H3-Seg 1 (August 11, 2022)

Segment ID: SC-H3-Seg 1

Hydrology: Valued

Modifier: Development

Riparian: Valued

Fish Habitat: Contributing

Terrestrial Habitat: Limited

Notes: Narrow swale feature with cattails present. Standing water present in feature during late summer site visit. Upstream segment altered by development in feature (parking lot).

SC-H3-Seg 1	0.3		NA											indirect		Poorly defined drainage channel that collects overland flow from parking lot to the west. Standing water with no flow observed.	
		SC-H3-Seg 2	0.1		NA											indirect		Poorly defined drainage channel that collects overland flow from parking lot to the west. Standing water with no flow observed.

Mgmt Rec.: Mitigation

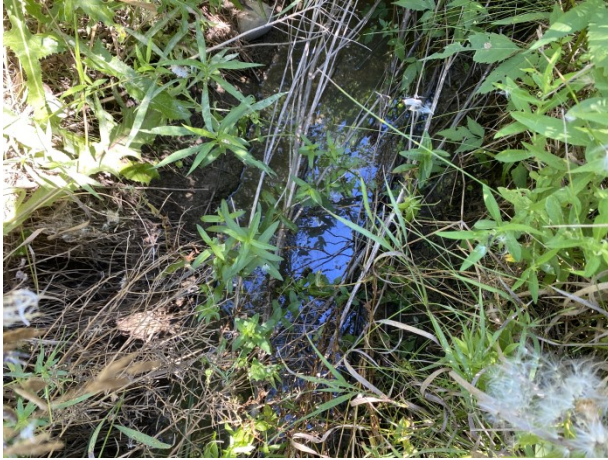
SC-H3-Seg 2 (August 11, 2022)

Segment ID: SC-H3-Seg 2

Hydrology: Valued

Modifier: Development

Riparian: Valued

Fish Habitat: Contributing

Terrestrial Habitat: Limited

Notes: Narrow channel feature with cattails present. Standing water present in feature during late summer site visit.

Upstream segment altered by development in feature (parking lot).

Mgmt Rec.: Mitigation
