6939 King Street, Caledon

Meander Belt Study

DRAFT REPORT

Re: 6939 King Street, Caledon - Meander Belt Study

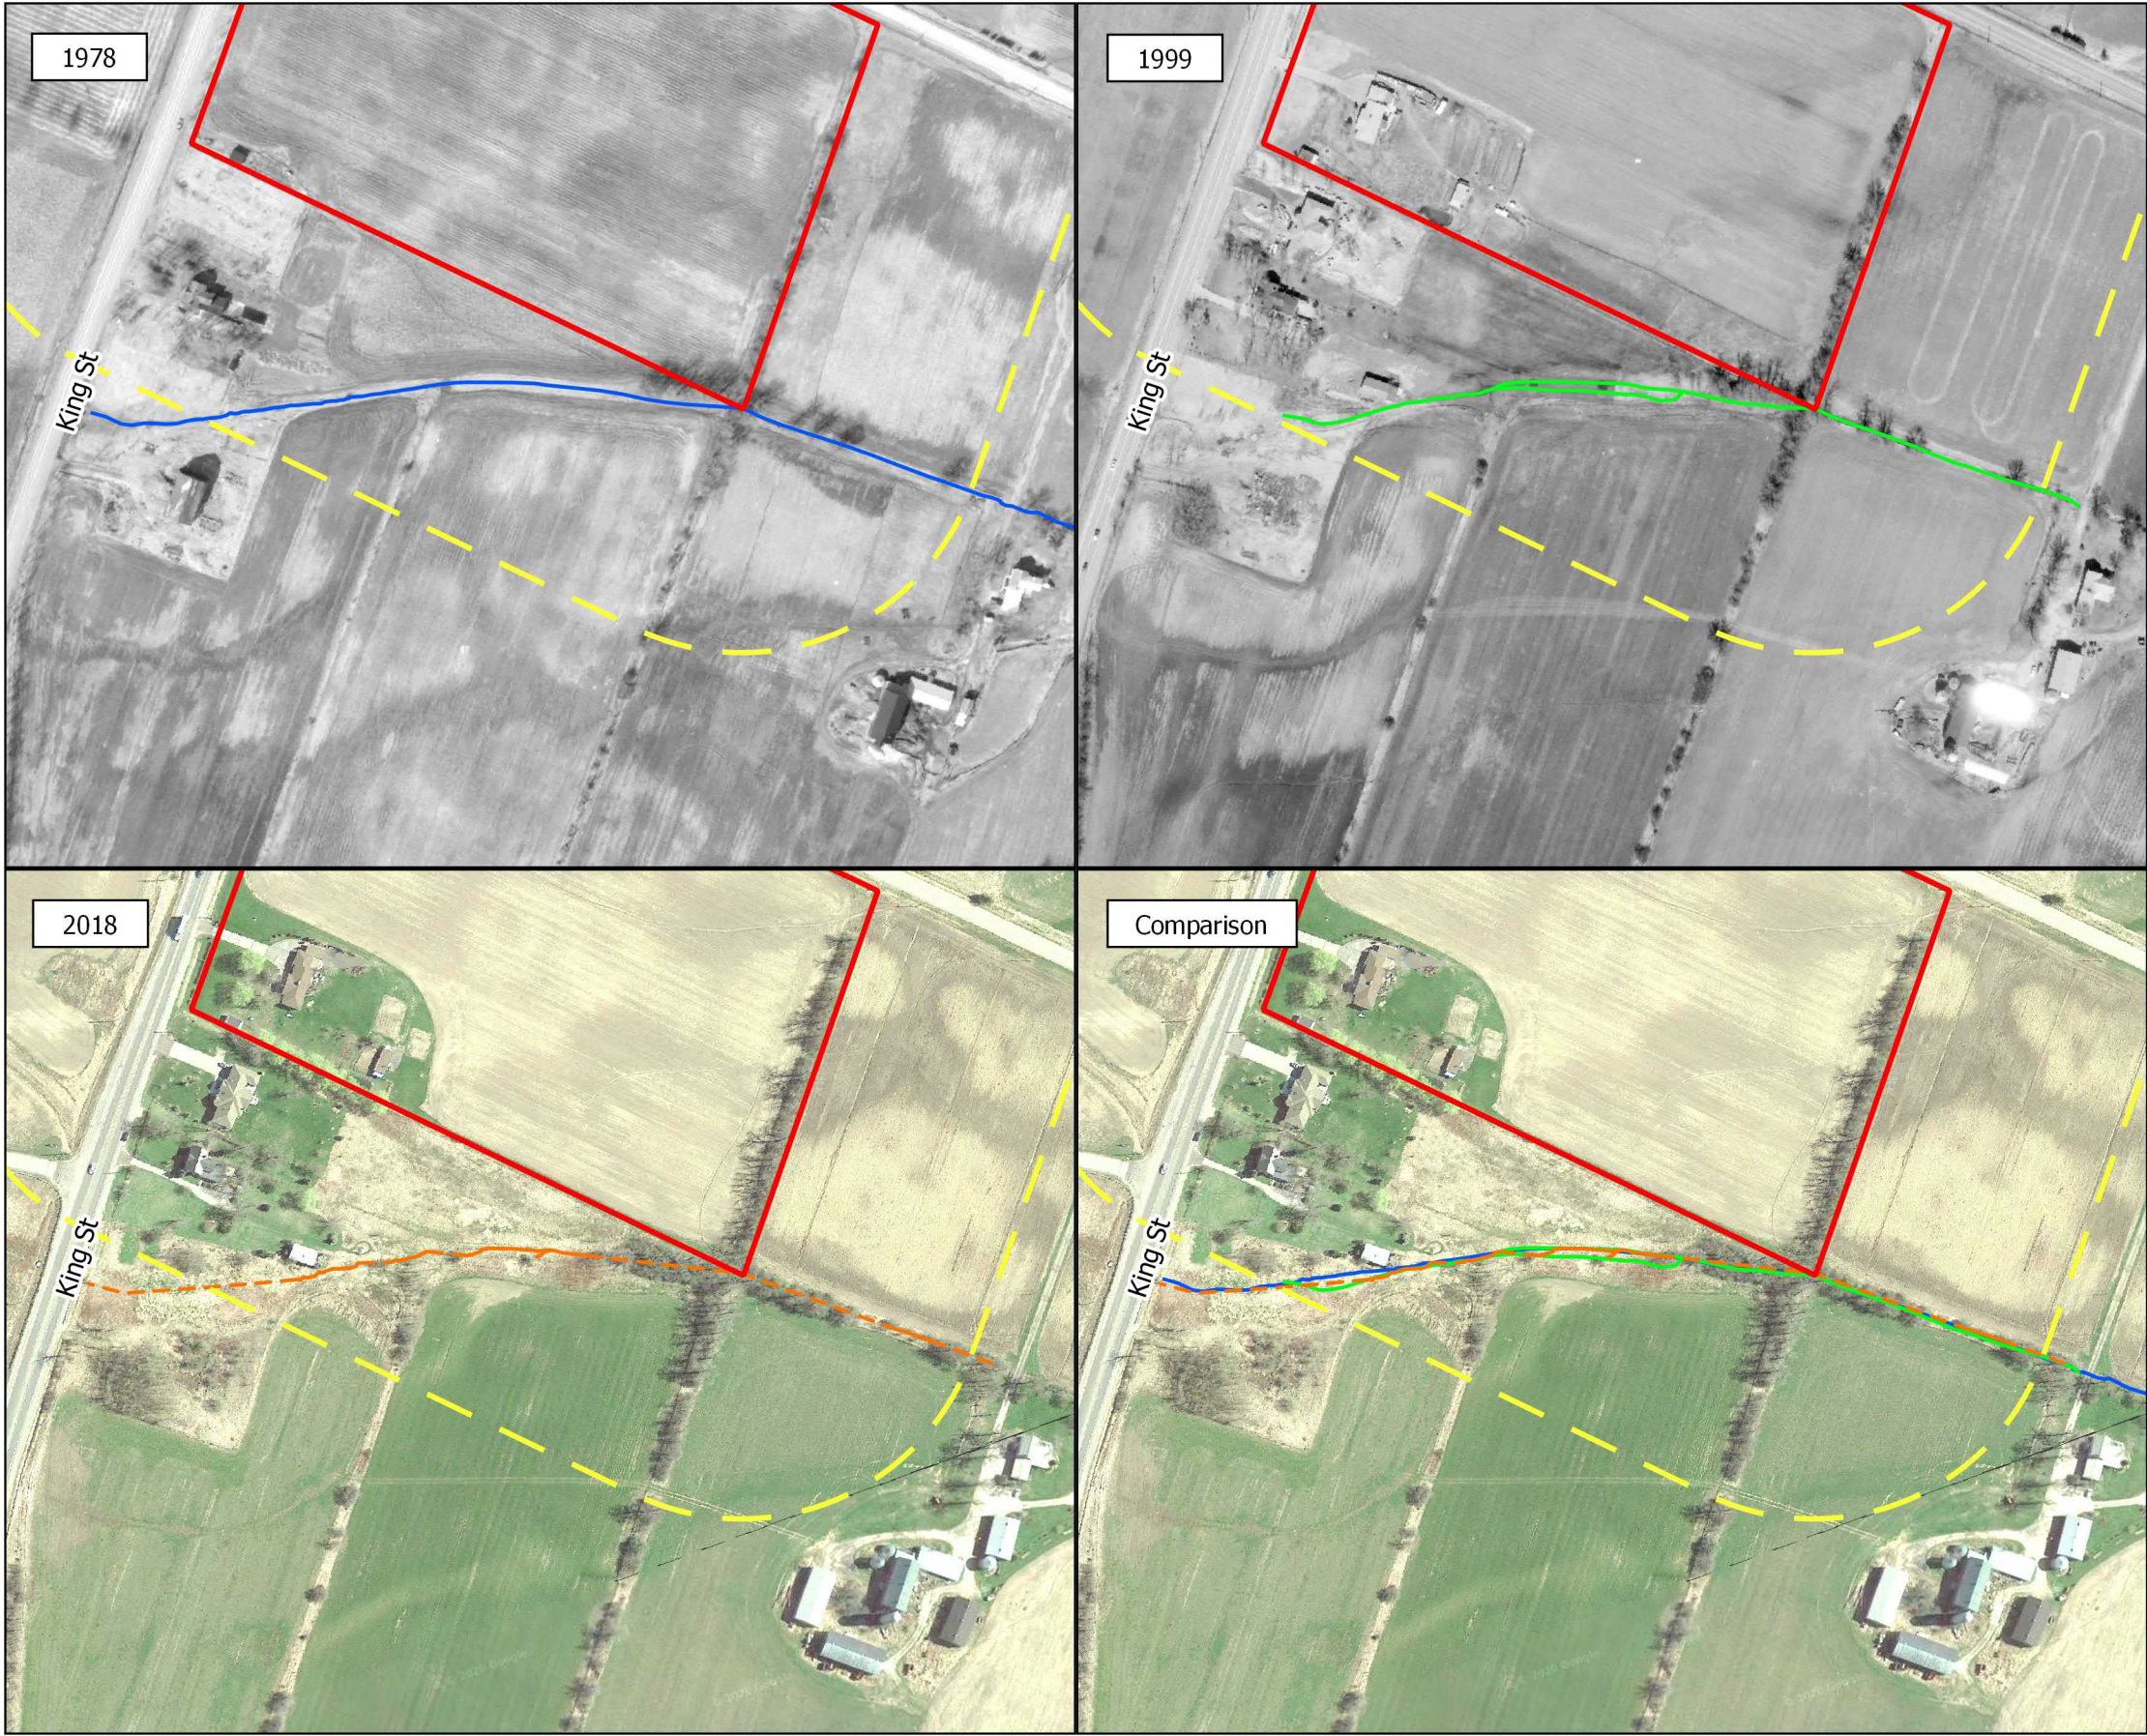
Historical Creek Delineation
6939 King Street, Caledon, Ontario

To gain an understanding of the valley system and evolution of the channel within the study area, historic aerial imagery was reviewed. It was necessary to use imagery that was clear of vegetative cover to provide an unobstructed view of the channel. Imagery was obtained for 1978, 1999, and 2018, providing a period of record of approximately 40 years and covering three time periods, per the recommendations of the meander belt delineation protocol (TRCA, 2001). A summary of the data sources used and their corresponding interpretation is provided in Table 1. The aerial imagery and centreline delineations for different years are illustrated in Appendix A.

Year	Summary
1978	King Street and Centreville Creek Road were both paved roads. The surrounding land-use was predominantly agricultural, with intermittent farm structures and residences. A few minor exceptions were pockets of forested areas towards the north, northwest and east as well as some small pond features. The channel corridor does not appear to have any riparian vegetation except for some trees intermittently along the channel and possibly some grassy vegetation. The entire study reach appears to be a straightened agricultural ditch, possessing little-to-no lateral planform variability. Upstream of King Street, the channel becomes very poorly defined, appearing to be depressions that would convey overland flow through the agricultural field. Downstream of the study area, the channel appears to exhibit some planform variability until it crosses under Centreville Creek Road and joins with another tributary where it proceeds to run parallel to the road in a straight ditch for approximately 240 m.

1999	The surrounding land-use remains relatively unchanged from 1978, with only minor changes to the landscape. The only noticeable change was the removal and addition of several buildings adjacent to previously built residential and agricultural developments. The channel corridor remains in a similar alignment, with minor planform changes including the divergence of flow paths for approximately 80 m. The riparian vegetation consists of the same trees, with similar grassy vegetation. There is evidence of tracks from agricultural machinery crossing the channel corridor near the upstream end of the study area.
2018	Again, the surrounding land-use remains relatively unchanged from 1999 and 1978. The most notable change to the surrounding area is a new sports field complex upstream of the study area, north of King Street. The new facility is approximately 6 hectares and includes 5 sports fields, 2 parking areas and a SWM pond. It appears that the channel now originates from the SWM pond outlet. Previously, the channel originated from overland flow paths through the agricultural fields now occupied by the new complex. The riparian corridor of the channel through the study area contains the same trees as previous years, with some new tree and shrub growth within the corridor. The grassy vegetation persists adjacent to the channel. The channel exhibits some minor lateral migration, although due to the growth of the grassy vegetation, the alignment was difficult to delineate in some sections.
