# Queensgate Blvd. and Pembrooke Street, Caledon, Ontario

Phase I Environmental Site Assessment

BRM-00603811-C0

October 8, 2020

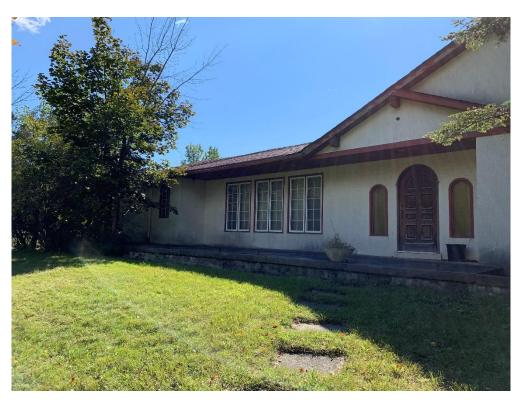
Photo 1: View of the Residential Dwelling located within middle-eastern portion of the Site (looking south)

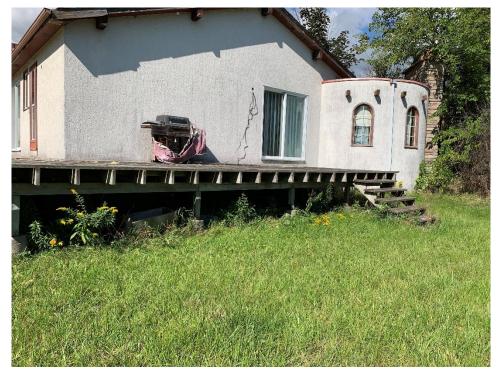
Photo 2: View of the eastern face of the Residential Dwelling (looking west)

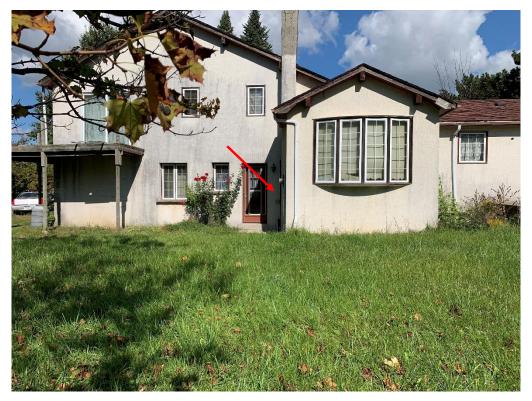
A set of fill/vent pipes was noted along the south building wall of the house. EXP was informed that these pipes are associated with an aboveground fuel storage tank (AST) located inside the basement of the residential dwelling.

Photo 3: View of the southwest corner of the Residential Dwelling- Arrow pointing to the location of fill-vent pipes of the AST located inside the basement (looking north)

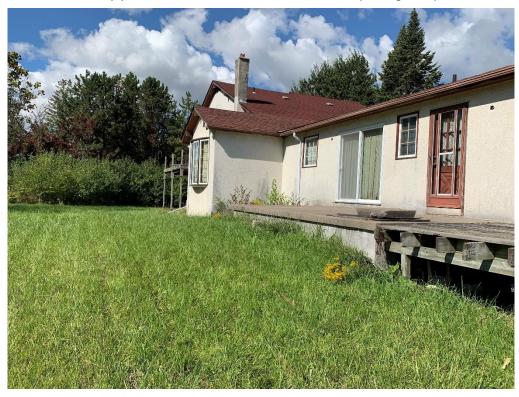
Photo 4: View along southern face of the Residential Dwelling (looking west)

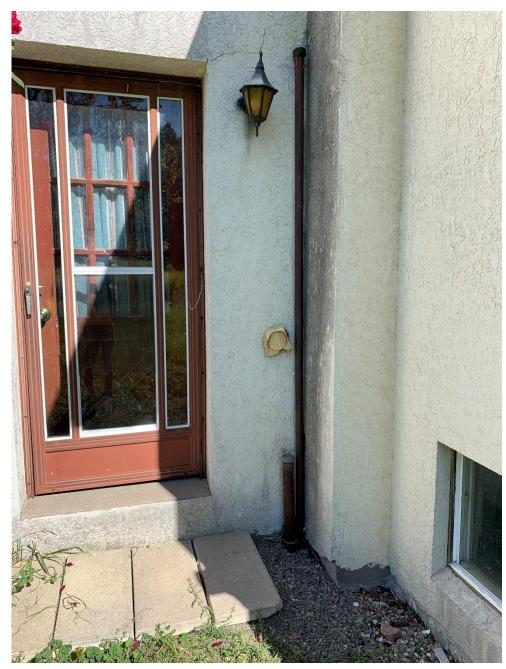
Photo 5: Closer View of the fill-vent pipes of the AST located inside the basement (also shown in Photo 3)

Issues Identified	Recommendations	Rationale
Presence of AST in the basement of the residential dwelling	The subject AST is currently in use. In the near future at the time of site redevelopment, prior to demolition, the subject AST should be removed by a licensed contractor and disposed of at a licensed waste disposal facility.  If Record of Site Condition (RSC) is to be filed in future, confirmation of the soil and groundwater quality at the location of this AST would be required.	As per Ontario Regulation 153/04 (as amended), onsite potential containing activity (PCA) needs confirmation of the subsurface quality prior to file RSC.
Potential for presence Regulated Building Materials  (ACMs, Lead, Mercury and PCBs)	If renovations or demolition of the building are planned, it is recommended that these materials be managed in accordance with the applicable regulations and guidelines.  Conduct a Designated Substances Survey (DSS) prior to any demolition or renovation activities.	Once disturbed, these materials may be released into the environment and pose environmental and/or health concerns.

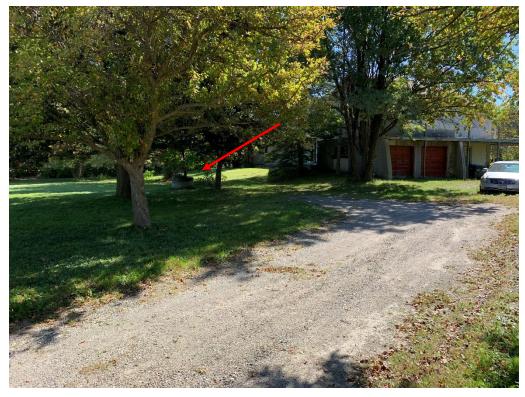
The residential dwelling at the Site is serviced by a private water supply well (dug well) located about 10 m northwest of the house. No abandoned or other existing wells were noted on the subject property at the time of the Site visit.

Photo 7: View of the driveway providing access to the house on site; arrow pointed to the dug well

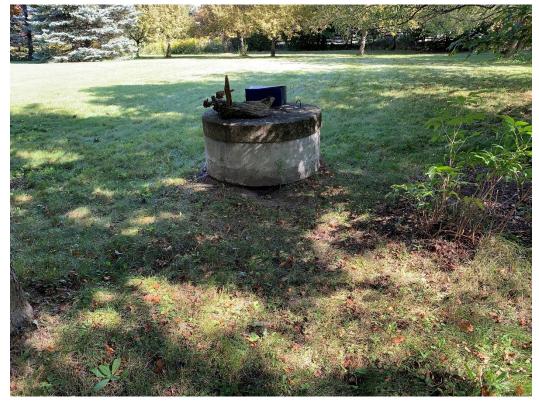
Photo 8: Closer View of the dug well- private water supply well located on the north side of the residential dwelling

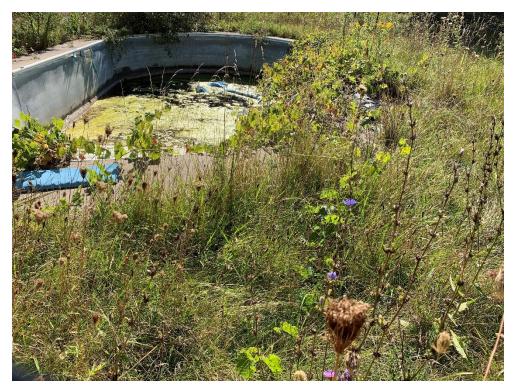
The middle eastern portion of the Site is currently developed with a residential dwelling. The residential dwelling is a 1.5 storey building structure with one basement level. An in-ground swimming pool was noted on the east side of the residential dwelling. The swimming pool was noted in a state of disrepair.

Photo 9: View of the in-ground swimming pool located on east side of the residential dwelling
