Phase Two Environmental Site Assessment

Part Lot 12 Concession 4 Albion Part 1, 43R17061, Parcel 4
Bolton, Ontario

DS Project No : 20-169-100

Date: 2021-01-08

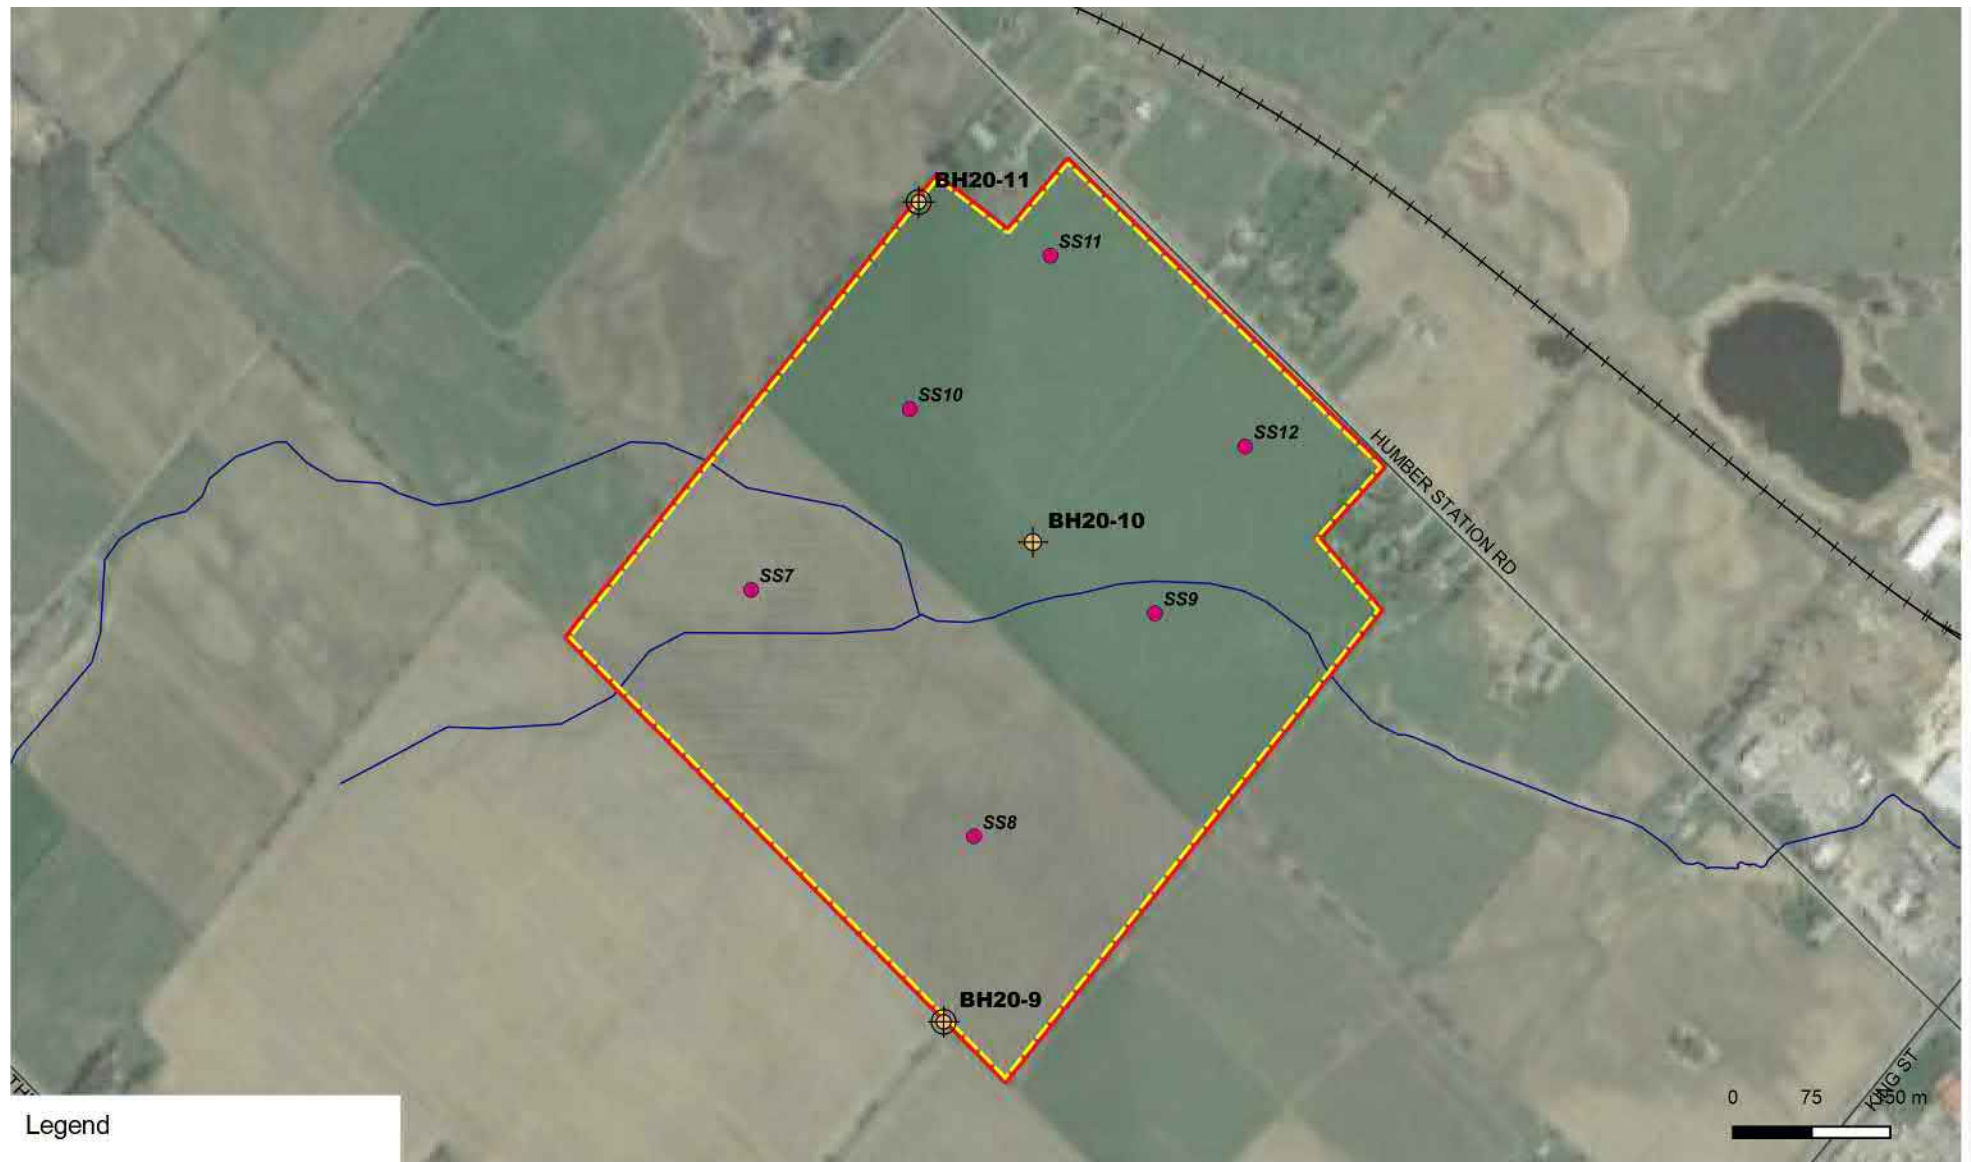
- Approx Development Boundary
- Approx Property Boundary
- + Monitoring Well
- + Borehole
- Soil Sample Location
- APEC-1

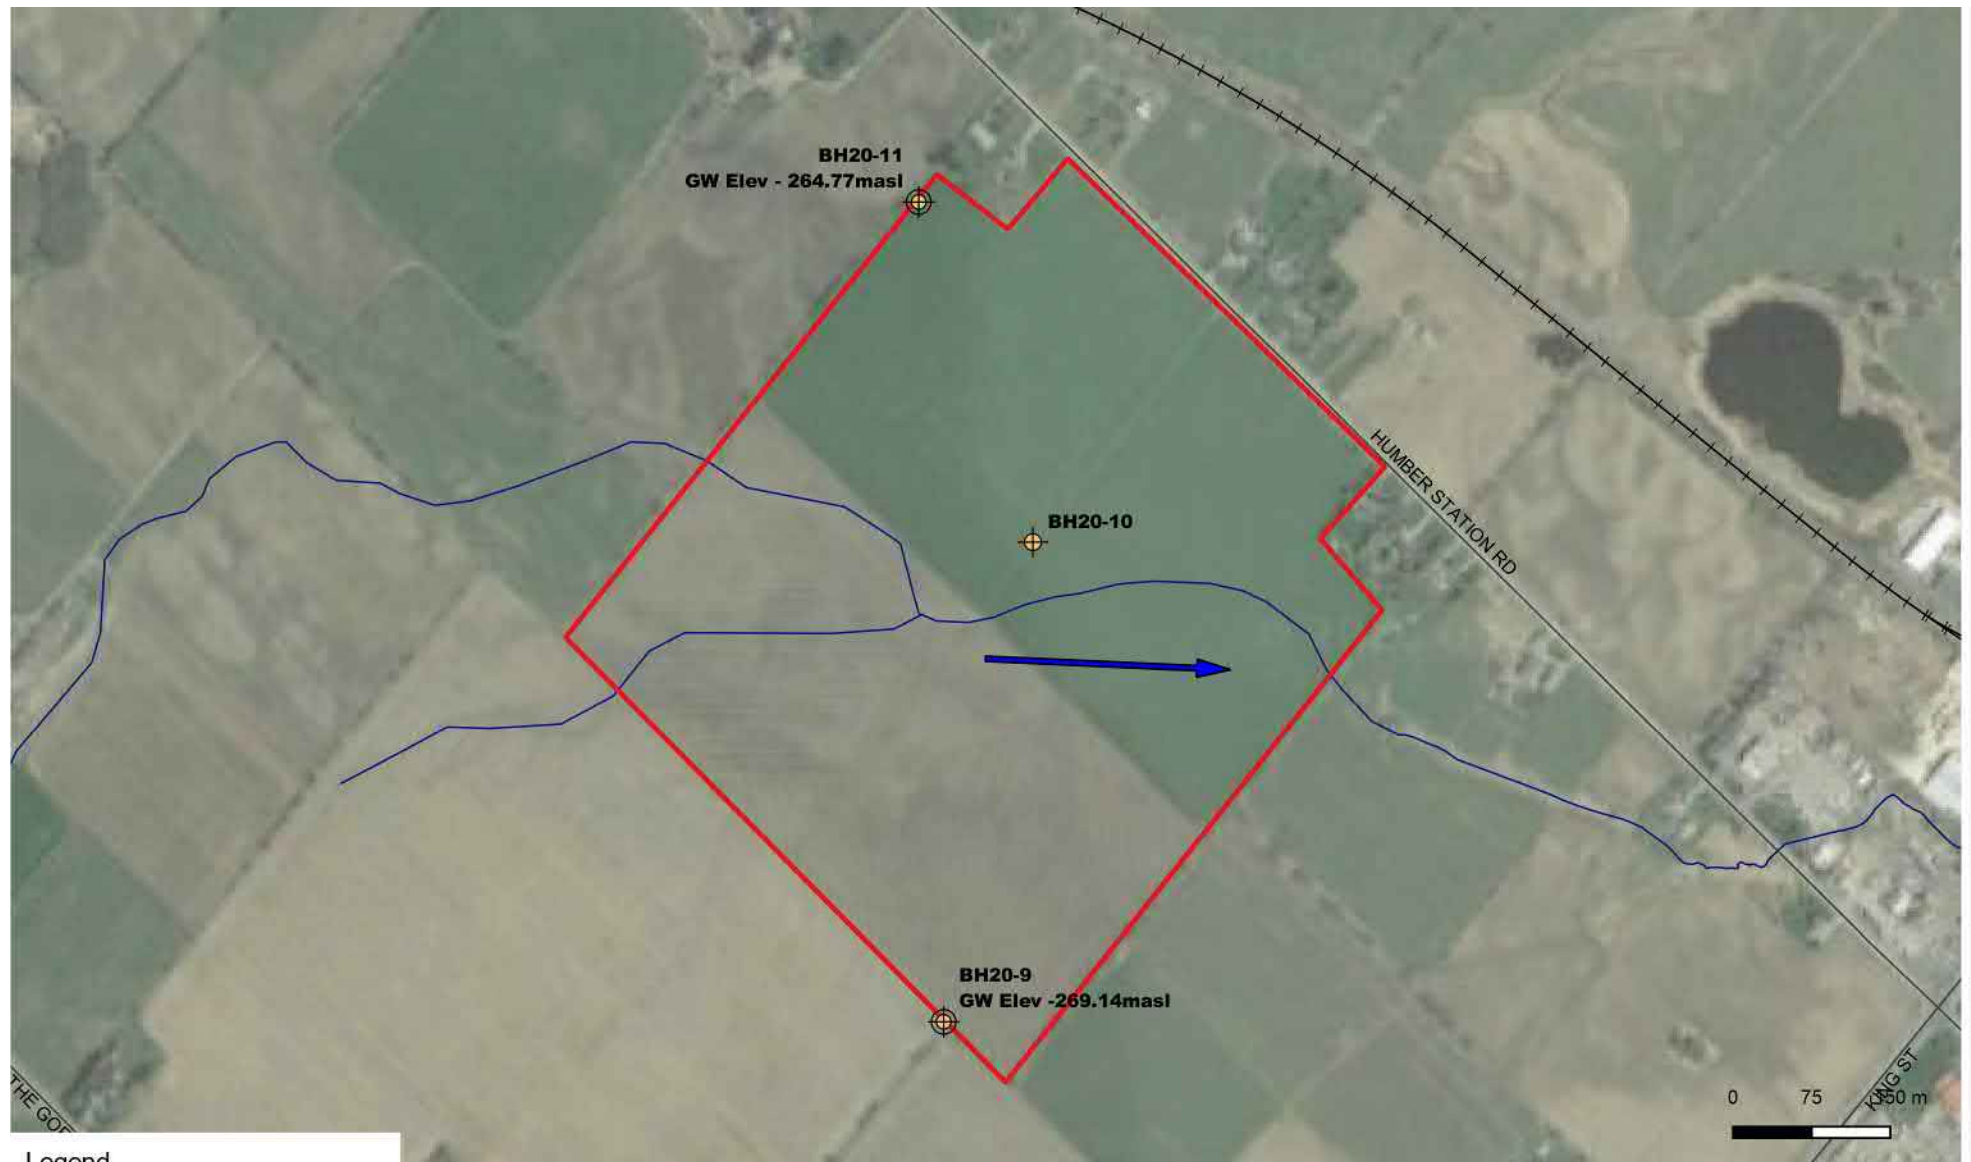
Rev: 0	Scale: As Shown	Project No.: 20-169-100	Figure No.: 6
-----------	-----------------	-------------------------	----------------------

- ◆ The depth to groundwater was measured in two (2) monitoring wells installed during the course of this investigation. The groundwater levels were found to range between 4.97 to 5.33 mbgs, with corresponding elevations of 269.14 to 264.77 metres above sea level (masl) on October 22, 2020. The groundwater flow direction on-Site could not be confirmed as there were only two (2) monitoring wells present. However, based on the local topography the groundwater flow direction is inferred to be southeasterly.

- Approx Development Boundary
- Approx Property Boundary
- Monitoring Well
- Borehole
- Groundwater Flow Direction
