Cultural Heritage Report: Existing Conditions and Preliminary Impact Assessment

Caledon Pit / Quarry

19129150-5700-R01-RevB

13 December 2022 (Revised 21 July 2023)

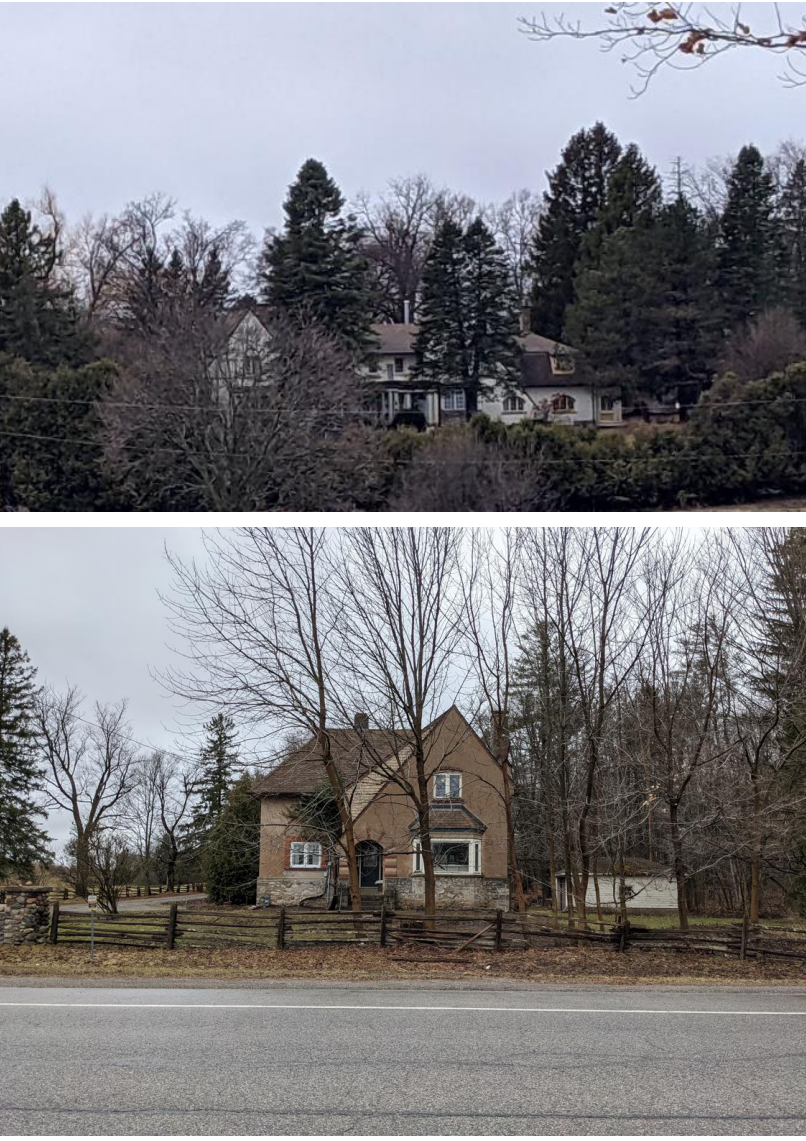
Address or Location	Cultural Heritage Status	Photograph	Description	Potential CHVI	Potential Heritage Attributes
18906 Main Street	Listed (not designated) on the Town of Caledon's <i>Heritage Register</i>

<p>Described on the Town of Caledon's <i>Heritage Register</i> as an arts and crafts style farmhouse with a plaster exterior commenced between 1850-1875 and 1900-1924.</p> <p>Historical research conducted for this Cultural Heritage Report determined that a farmhouse was located on the property as early as 1859 and appears to be situated in the same location as the present-day house with a large set-back at 18906 Main Street (top image). At that time the property was listed under James Dodds of Lot 18, Concession 4 WCR. By 1877, a second structure was constructed on the property fronting the concession road and appears to be situated in the same location as the present-day plaster façade house fronting Main Street (bottom image).</p> <p>The first house is a single-detached, two-storey structure with a T-shaped main block (with extensions to the northwest) and medium pitch gable and hip roof. The house is set back approximately 285 m from Main Street and is accessed by a partially paved, partially gravelled driveway to the northwest of the house.</p> <p>The second house is a single-detached, storey-and-a-half structure with a rectangular shaped main block, stone foundation and high pitch gable and hip roof. The house is set back approximately 10 m from Main Street and is accessed by the same driveway to the first house which runs south of this second house.</p> <p>To the south of the first house is a large barn with a metal gambrel roof as well as a smaller outbuilding with a metal gable roof (construction materials for both are indiscernible from ROW; details observed from satellite imagery). The barn and outbuilding are set-back approximately 335 m from Main Street and are accessed via a second partially paved/ gravelled driveway located to the south of the first driveway.</p> <p>The large property parcel extends to the northwest and southwest and consists of large, ploughed fields delineated by hedgerows/ treelines, interspersed with woodlots and traversed by a branch of the Credit River.</p>	<p>Design or physical value:</p> <ul style="list-style-type: none"> ■ Arts and crafts style farmhouse <p>Historical or associative value:</p> <ul style="list-style-type: none"> ■ N/A <p>Contextual value:</p> <ul style="list-style-type: none"> ■ Physical connection between the farmhouses and outbuildings ■ Maintenance and support of the rural and natural landscape of area (large fields lined by hedge rows/ trees; Credit Valley River) 	<ul style="list-style-type: none"> ■ First house main block with: <ul style="list-style-type: none"> ■ Gable roof ■ T-shaped plan ■ Second house main block with <ul style="list-style-type: none"> ■ Gable roof ■ Rectangular plan ■ Stone foundation ■ Large agricultural fields delineated by hedgerows/ treelines

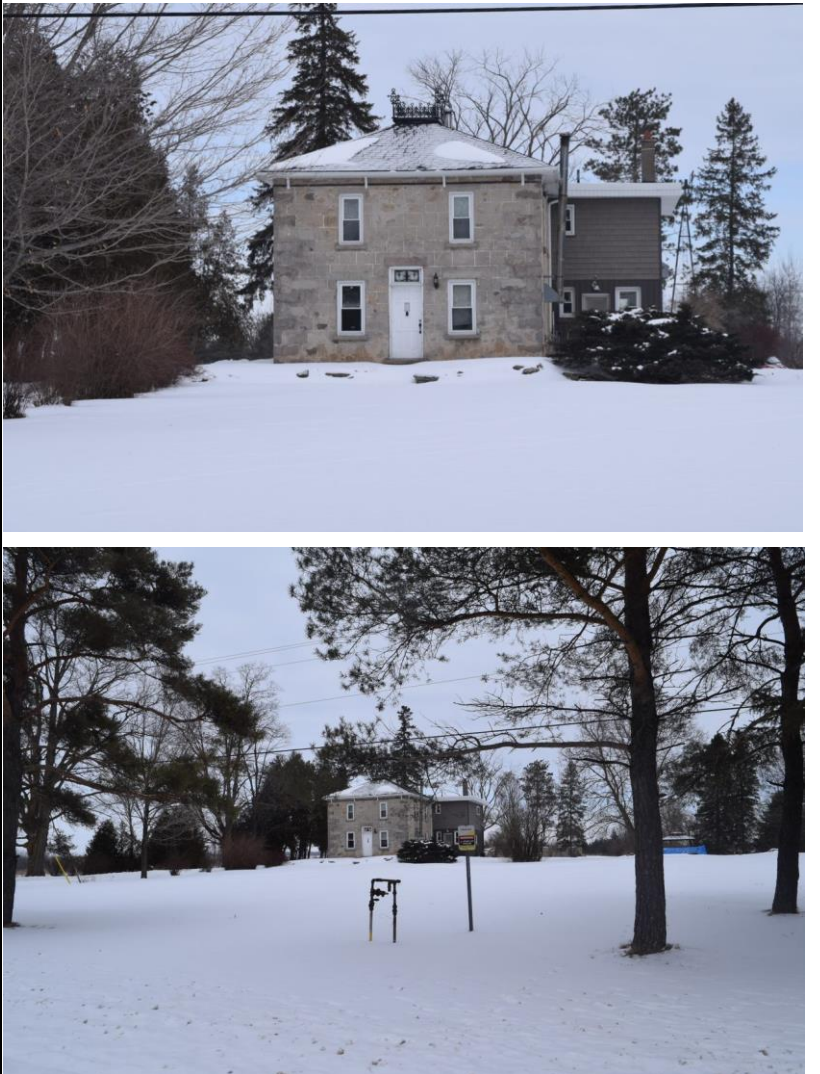
Address or Location	Cultural Heritage Status	Photograph	Description	Potential CHVI	Potential Heritage Attributes
18719 Main Street	Listed (not designated) on the Town of Caledon's <i>Heritage Register</i>

<p>Described on the Town of Caledon's <i>Heritage Register</i> as an Italianate style farmhouse with a cut stone exterior dating 1875-1899.</p> <p>Historical research conducted for this Cultural Heritage Report determined that a farmhouse was located on the property as early as 1859 and appears to be situated near the location of the present-day house at 18719 Main Street. At that time, the property was listed under Samuel Wallace of the northwest half of Lot 17, Concession 3 WCR.</p> <p>The house is a single-detached, two-storey structure with a rectangular shaped main block (with an extension to the southeast) and low pitch hip roof. The house is set back approximately 50 m from Main Street and is accessed by a gravelled driveway to the northwest of the house.</p> <p>To the northeast of the house is a barn with a metal gable roof (construction material indiscernible from ROW) set-back approximately 93 m from Main Street and accessed via the same driveway to the house. To the northeast of the barn are the remnants of a foundation for an earlier outbuilding.</p> <p>The property parcel consists of ploughed fields delineated by hedgerows/ treelines and a woodlot to the northeast which backs on to the Brampton-Orangeville Railway corridor identified on the Town of Caledon's <i>Cultural Heritage Landscapes Inventory</i> as the Former CVR CHL.</p>	<p>Design or physical value:</p> <ul style="list-style-type: none"> ■ Italianate style farmhouse <p>Historical or associative value:</p> <ul style="list-style-type: none"> ■ N/A <p>Contextual value:</p> <ul style="list-style-type: none"> ■ Physical connection between the farmhouse and outbuilding(s) ■ Maintenance and support of the rural landscape of area (fields lined by hedge rows/ trees) ■ Maintenance and support of the Former CVR CHL 	<ul style="list-style-type: none"> ■ House main block with: <ul style="list-style-type: none"> ■ Hip roof ■ Rectangular shaped plan ■ Stone construction ■ Agricultural field delineated by hedgerows/ treelines ■ Views of the Former CVR CHL

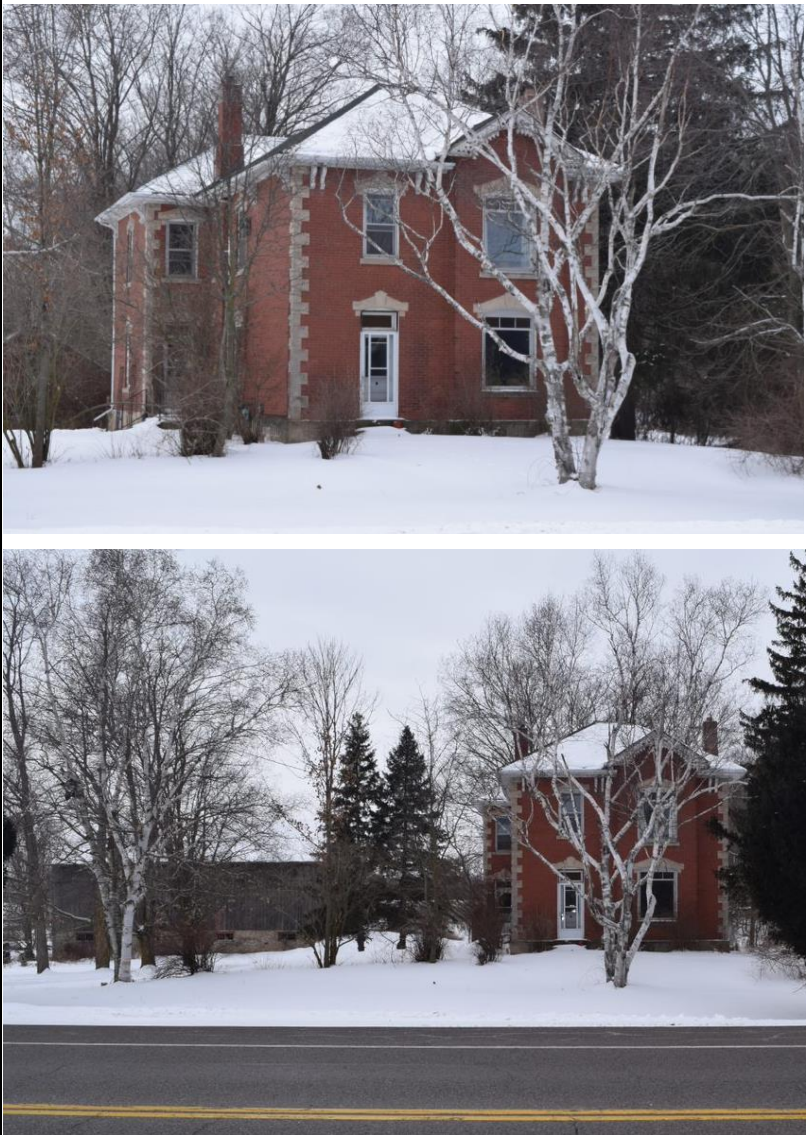
Address or Location	Cultural Heritage Status	Photograph	Description	Potential CHVI	Potential Heritage Attributes
18722 Main Street	Listed (not designated) on the Town of Caledon's <i>Heritage Register</i>

<p>Described on the Town of Caledon's <i>Heritage Register</i> as an Italianate style farmhouse with a red brick exterior dating 1875-1899.</p> <p>Historical research conducted for this Cultural Heritage Report determined that a farmhouse and barn were located on the property as early as 1937 and appear to be situated in the same location as the present-day house and barn at 18722 Main Street.</p> <p>The house is a single-detached, two-storey structure with a slight L-shaped main block and medium pitch hip roof. The house is set back approximately 20 m from Main Street and is accessed by a gravelled driveway to the southeast of the house.</p> <p>To the southwest of the house is a timber framed barn with a metal gable roof and stone foundation set-back approximately 75 m from Main Street and accessed via the same driveway to the house. The barn appears to be of the Central Ontario Barn style popular during the latter half of the 19th century.</p> <p>The large property parcel extends to the northwest and consists of large, ploughed fields delineated by hedgerows/ treelines, interspersed with woodlots and traversed by a branch of the Credit River.</p> <p>NOTE: A preliminary heritage evaluation for this property is presented in APPENDIX C.</p>	<p>Design or physical value:</p> <ul style="list-style-type: none"> ■ Italianate style farmhouse ■ Central or Southern Ontario Barn style ■ Board and Batten outbuilding <p>Historical or associative value:</p> <ul style="list-style-type: none"> ■ N/A <p>Contextual value:</p> <ul style="list-style-type: none"> ■ Spatial organization and range of forms in building complex maintains and supports local character ■ Historical connection to 18667 Mississauga Road 	<ul style="list-style-type: none"> ■ Italianate style farmhouse: <ul style="list-style-type: none"> ■ Two storey residence with L shaped floorplan. ■ Projecting bay feature on northeast elevation with decorative bargeboard on gable. ■ Medium pitch hip roof featuring a wide overhang, decorative paired brackets. ■ Red brick construction with dichromatic stone accents. <ul style="list-style-type: none"> – Stone quoins carved in a Drafted Margins pattern, decorative stone window heads, stone lug sills also carved in Drafted Margins pattern. ■ Segmental arched windows with original wooden frames. ■ Parged stone foundation. ■ Central or Southern Ontario Style Barn. <ul style="list-style-type: none"> ■ Timber framed barn. ■ Gable roof. ■ Field stone foundation. ■ Ramp on the northwest elevation. ■ Board and batten outbuilding. ■ Mature vegetation. <ul style="list-style-type: none"> ■ Group of four deciduous trees lining the southeast side of the driveway. ■ Cluster of coniferous trees on the northwest side of the house.

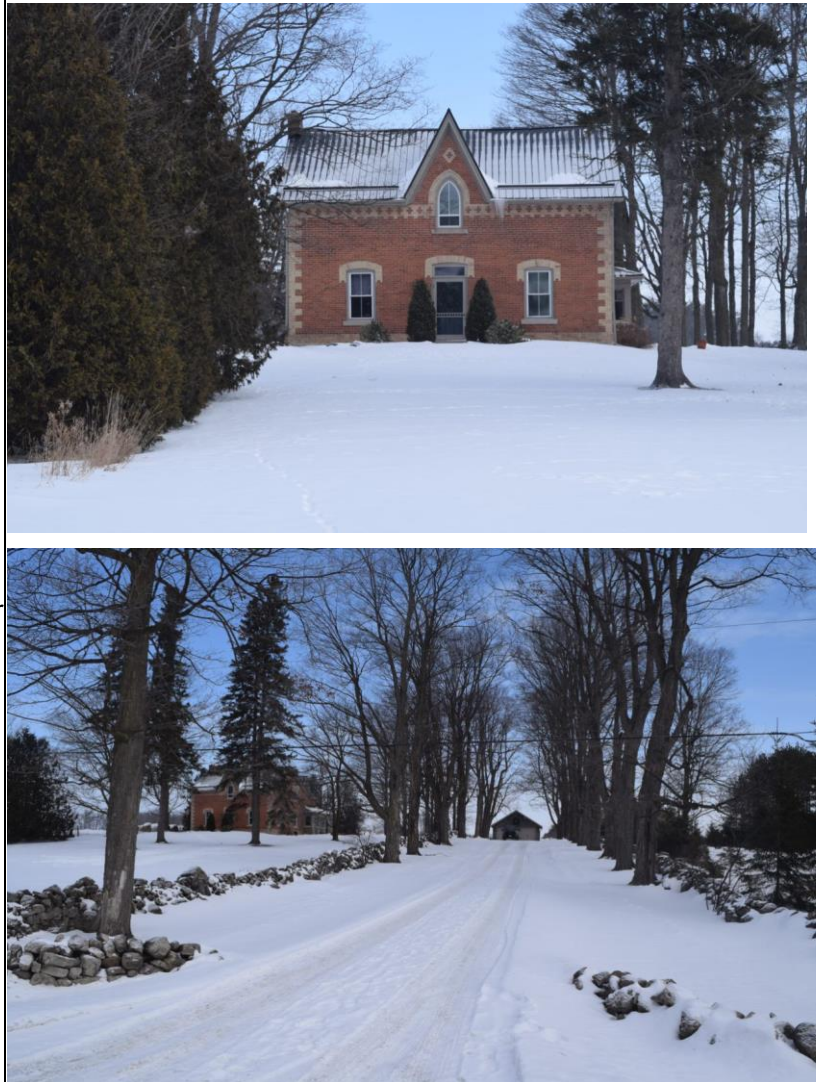
Address or Location	Cultural Heritage Status	Photograph	Description	Potential CHVI	Potential Heritage Attributes
18473 Main Street	Listed (not designated) on the Town of Caledon's <i>Heritage Register</i>

<p>Described on the Town of Caledon's <i>Heritage Register</i> as a Gothic Revival style farmhouse with a red brick exterior dating 1875-1899.</p> <p>Historical research conducted for this Cultural Heritage Report determined that a farmhouse and barn were located on the property as early as 1937 and the former appears to be situated in the same location as the present-day house at 18473 Main Street. The barn is no longer extant.</p> <p>The house is a single-detached, storey-and-a-half structure with a T-shaped main block (with an extension to the east) and medium pitch gable roof. The house is set back approximately 57 m from Main Street and is accessed by a treelined gravelled driveway with stone boundary walls to the southeast of the house which lead to a two-door wooden driveshed.</p> <p>Though now a small parcel, the property was originally part of the larger Coulter Estate depicted on historical mapping as early as 1859.</p>	<p>Design or physical value:</p> <ul style="list-style-type: none"> ■ Gothic Revival style farmhouse/ cottage <p>Historical or associative value:</p> <ul style="list-style-type: none"> ■ Association with former Coulter Estate for which Coulterville is named <p>Contextual value:</p> <ul style="list-style-type: none"> ■ Maintenance and support of the rural landscape of area 	<ul style="list-style-type: none"> ■ House main block with: <ul style="list-style-type: none"> ■ Gable roof ■ T-shaped plan ■ Treelined laneway ■ Stone boundary walls

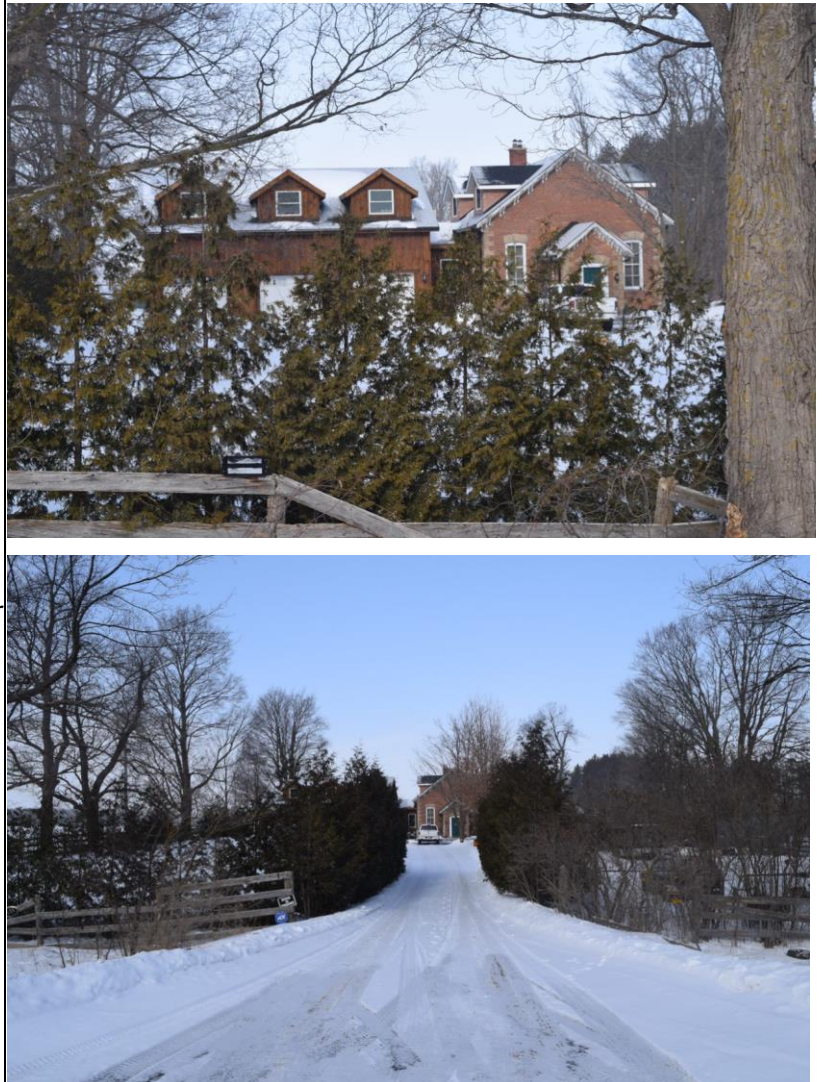
Address or Location	Cultural Heritage Status	Photograph	Description	Potential CHVI	Potential Heritage Attributes
1626 Charleston Sideroad	Listed (not designated) on the Town of Caledon's <i>Heritage Register</i>

<p>Described on the Town of Caledon's <i>Heritage Register</i> as a 19th century schoolhouse dating to 1879.</p> <p>Historical research conducted for this Cultural Heritage Report determined that a school was located on the property as early as 1877 and appears to be situated in the same location as the present-day house conversion at 1626 Charleston Sideroad.</p> <p>The house is a single-detached, storey-and-a-half, red brick structure with a rectangular shaped main block (with a large garage extension to the southwest) and medium pitch gable roof. The house is set back approximately 60 m from Charleston Sideroad and is accessed by a gravelled driveway to the southeast of the house.</p> <p>Though now a small parcel, the property was originally part of the larger Coulter Estate visible on historical mapping as early as 1859.</p>	<p>Potential CHVI</p> <p>Design or physical value:</p> <ul style="list-style-type: none"> 19th century schoolhouse design <p>Historical or associative value:</p> <ul style="list-style-type: none"> Association with former Coulter Estate for which Coulterville is named <p>Contextual value:</p> <ul style="list-style-type: none"> Maintenance and support of the rural landscape of area within the context of public institutions in a rural setting 	<p>Potential Heritage Attributes</p> <ul style="list-style-type: none"> House (converted) main block with: <ul style="list-style-type: none"> Gable roof Rectangular plan

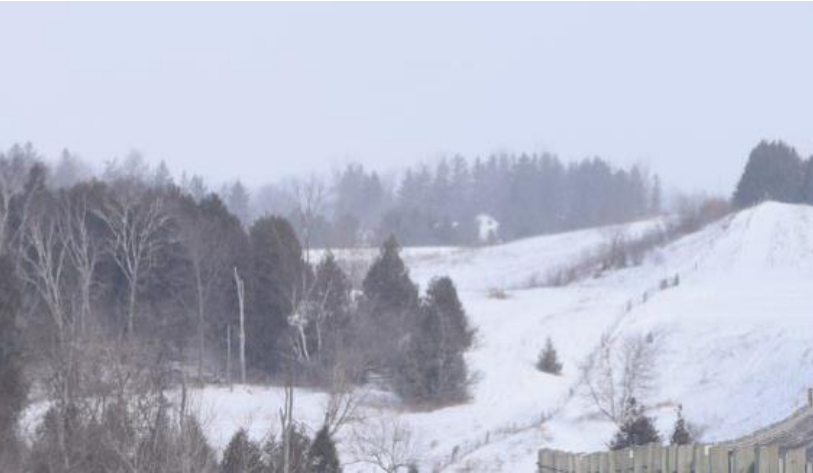
Address or Location	Cultural Heritage Status	Photograph	Description	Potential CHVI	Potential Heritage Attributes
0 Charleston Sideroad	Identified on the Town of Caledon's <i>BHRI of Pre-1946 Structures</i>

<p>The property is identified on the Town of Caledon's <i>BHRI of Pre-1946 Structures</i> as a former farmstead east of 1626 Charleston Sideroad.</p> <p>Historical research conducted for this Cultural Heritage Report determined that two structures, likely a farmhouse and outbuilding, were located on the property as early as 1937 and appear to be situated near the same location as the present-day silo (only visible remnant of the former farm) at 0 Charleston Sideroad.</p> <p>Characteristics of the silo include that it appears to be a dilapidated, unroofed, concrete structure. It is set back approximately 117 m from Charleston Sideroad and is accessed by an overgrown dirt and grass driveway to the north of the silo.</p> <p>The large property parcel consists of large unploughed fields now dominated by woodlots, shrubs and tall grasses which back on to the Brampton-Orangeville Railway corridor identified on the Town of Caledon's <i>Cultural Heritage Landscapes Inventory</i> as the Former CVR CHL.</p>	<p>Design or physical value:</p> <ul style="list-style-type: none"> ■ Remnants of silo structure <p>Historical or associative value:</p> <ul style="list-style-type: none"> ■ N/A <p>Contextual value:</p> <ul style="list-style-type: none"> ■ Physical connection between the silo remnants and former surrounding farm. ■ Maintenance and support of the Former CVR CHL 	<ul style="list-style-type: none"> ■ Silo remnants with: <ul style="list-style-type: none"> ■ Concrete construction ■ Views of the Former CVR CHL

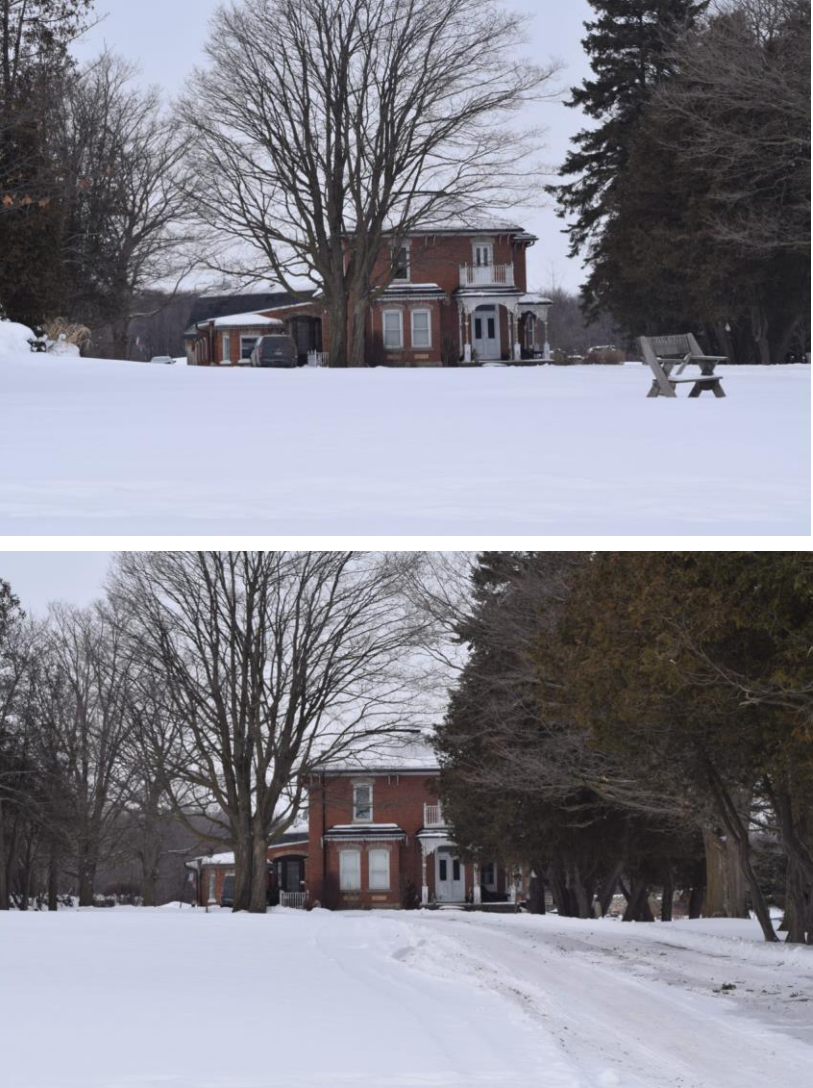
<p>1420 Charleston Sideroad</p>	<p>Listed (not designated) on the Town of Caledon's <i>Heritage Register</i></p>

<p>Described on the Town of Caledon's <i>Heritage Register</i> as an Italianate style farmhouse with a red brick exterior and paired windows dating 1875-1899.</p> <p>Historical research conducted for this Cultural Heritage Report determined that a farmhouse was constructed on the property between 1877 and 1937. In 1877, the property was listed under James Cameron of the southeast half of Lot 16, Concession 4 WCR and was the third structure constructed on Cameron's property (first was built by 1859, the second was located at the eastmost corner of the property by 1877).</p> <p>The house is a single-detached, two-storey structure with a T-shaped main block (with a large extension to the northwest and southwest) and medium pitch hip roof. The house is set back approximately 95 m from Charleston Sideroad and is accessed by a paved driveway to the southeast of the house.</p> <p>To the northwest of the house is a small outbuilding with a metal gambrel roof (construction material indiscernible from ROW) set-back approximately 120 m from Charleston Sideroad and accessed via the same driveway to the house (which wraps around the southwest side of the house). To the north of the barn are the remnants of a foundation from an earlier outbuilding.</p> <p>NOTE: A preliminary heritage evaluation for this property is presented in APPENDIX C.</p>	<p>Design or physical value:</p> <ul style="list-style-type: none"> ■ Main block of the Italianate style farmhouse ■ Barn foundation ruins <p>Historical or associative value:</p> <ul style="list-style-type: none"> ■ N/A <p>Contextual value:</p> <ul style="list-style-type: none"> ■ Physical connection between the farmhouse and outbuilding. ■ Maintenance and support of the rural landscape of area. 	<ul style="list-style-type: none"> ■ Residence main block: <ul style="list-style-type: none"> ■ Two storey Italianate style farmhouse with red brick exterior. ■ Cut stone foundations with carved top course. ■ Hip roof with wide eaves and paired brackets. ■ Decorative elements of the main block: <ul style="list-style-type: none"> – Decorative stone and brick accents (keystone eyebrow arches and drafted margin carved lug sills). – Accents carved into the wooden window frame heads. ■ Porches along the southeast and northeast elevations, creating a wrap around effect for the east corner of the house: <ul style="list-style-type: none"> – Wooden arcades and square posts with decorative scrollwork and filigree accents. – Mansard roof and second storey access of the southeast elevation, hipped roof with curved underside of the northeast elevation. – Stone foundation. ■ Bay window: <ul style="list-style-type: none"> – mansard roof with decorative brackets in groups of three, same stone window heads and sills as the rest of the main block windows, and buff brick decorative panels below the windows. ■ Barn foundation ruins. ■ Mature vegetation: <ul style="list-style-type: none"> ■ Deciduous and coniferous trees lining the driveway.

<p>1420 Charleston Sideroad Listed (not designated) on the Town of Caledon's <i>Heritage Register</i></p>	<p>The proposed extraction area will encompass the majority of the property parcel, and is anticipated to directly impact the property, potentially adversely affecting the property's potential CHVI and heritage attributes which are linked to its BHR (i.e., the Italianate style farmhouse, barn foundation ruins, mature vegetation, and fieldstone wall).</p> <p>The proposed extraction area encompasses the entire property, on which the proposed construction activities will include extraction (blasting) as well as the possible use of temporary workspaces/ laydown areas, vegetation removal, and heavy machinery/ traffic.</p> <p>The location of the proposed construction activities suggests the possible demolition/ destruction of the farmhouse, barn foundation ruins, mature vegetation, and fieldstone wall, which will result in a change in land use and permanent removal of all potential CHVI and heritage attributes identified for the property (major direct impact).</p> <p>Given the possible demolition/ destruction of the property's heritage attributes, indirect impacts from vibration, fugitive dust emissions and shadows have not been assessed.</p> <p>While the isolation of the property's potential heritage attributes from the surrounding neighbourhood is not expected (as no known connection between the property and nearby structures or features were identified), the isolation of the potential heritage attributes within the property is expected as the possible demolition/ destruction will remove the connection between the BHRs and landscape features identified as heritage attributes.</p> <p>Direct or indirect obstruction of significant views or vistas is not expected as no significant views or vista were identified.</p>	<ul style="list-style-type: none"> ■ A major direct impact is anticipated for this property. To inform the impact assessment and offer focused mitigation recommendations, a preliminary heritage evaluation was completed to identify the property's potential CHVI and heritage attributes (see APPENDIX C). 	<ul style="list-style-type: none"> ■ Based on the results of the preliminary heritage evaluation the portion of the property mapped on Figure 10 contains cultural heritage value. As a result: <ul style="list-style-type: none"> ■ Prior to any site alteration or extraction within these areas, a Heritage Impact Assessment (HIA) shall be required. The HIA should include a full evaluation of the property using the criteria prescribed in O. Reg. 9/06, provide a Statement of CHVI with list of heritage attributes, identify all direct and indirect impacts, and recommend site-specific mitigation measures to ensure the CHVI and heritage attributes of the property are conserved in accordance with provincial requirements; ■ Until the site-specific mitigation measures of the HIA are implemented a construction buffer shall be established to reduce the risk of accidental damage from vehicles, heavy equipment operation, or other activities of the mineral aggregate operation. The area of cultural heritage potential includes a 50 m construction buffer. This construction buffer shall be demarcated with temporary fencing and clearly marked as a "no-go-zone"; ■ Until the site-specific mitigation measures of the HIA are implemented the licensee shall implement the recommendations of the blast impact

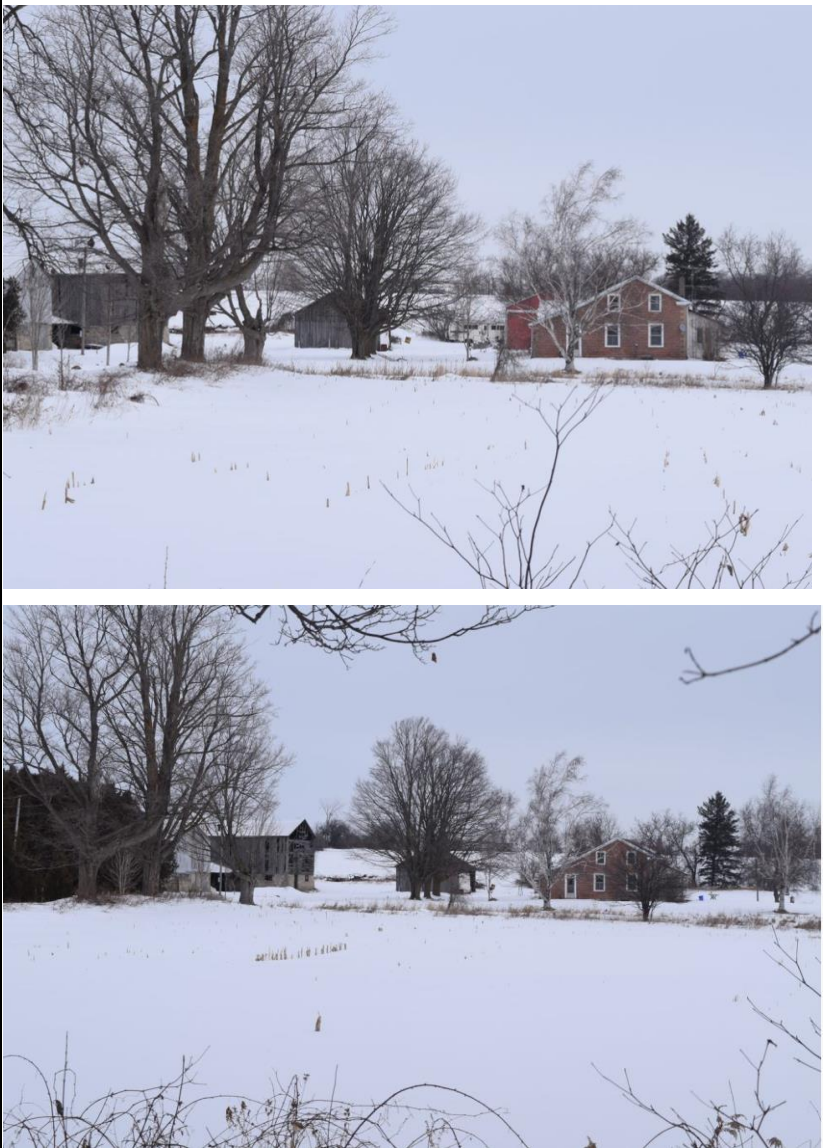
Address or Location	Cultural Heritage Status	Photograph	Description	Potential CHVI	Potential Heritage Attributes
18667 Mississauga Road	Listed (not designated) on the Town of Caledon's <i>Heritage Register</i>

<p>Described on the Town of Caledon's <i>Heritage Register</i> as a mid-19th century farmstead dating c. 1850-1874.</p> <p>Historical research conducted for this Cultural Heritage Report determined that a farmhouse was located on the property as early as 1859 and appears to be situated in the same location as the present-day house at 18667 Main Street. At that time, the property was listed under Duncan Cameron of Lot 17, Concession 4 WCR.</p> <p>The house is a single-detached, storey-and-a-half, red brick structure with a rectangular shaped main block and saltbox roof. The house appears to be of the gable front, side hall type, is set back approximately 182 m from Mississauga Road and is accessed by a treelined gravelled driveway to the northwest of the house.</p> <p>To the north of the house are two outbuildings (one wooden and one metal) and a large T-shaped timber framed barn (with a southwest extension) with a metal gable roof and stone foundation set-back approximately 190 m from Mississauga Road and accessed via the same driveway to the house. The barn appears to be of the Central Ontario Barn style popular during the latter half of the 19th century.</p> <p>The large property parcel consists of large, ploughed fields delineated by hedgerows/ treelines, interspersed with woodlots and traversed by a branch of the Credit River.</p> <p>NOTE: A preliminary heritage evaluation for this property is presented in APPENDIX C.</p>	<p>Design or physical value:</p> <ul style="list-style-type: none"> ■ Gable front, side hall type main block of the residence ■ Central or Southern Ontario Barn style of the barn complex ■ Outbuilding No. 1 <p>Historical or associative value:</p> <ul style="list-style-type: none"> ■ N/A <p>Contextual value:</p> <ul style="list-style-type: none"> ■ Spatial organization and range of forms in building complex maintains and supports local character ■ Physical connection between the farmhouse and outbuildings ■ Historical connection to 18722 Main Street 	<ul style="list-style-type: none"> ■ Fieldstone wall. ■ Residence main block: <ul style="list-style-type: none"> ■ Rectangular footprint with side hall floorplan ■ Parged stone foundations. ■ Gable roof. ■ Red brick (stretcher bond) with contrasting buff coloured brick detailing including: <ul style="list-style-type: none"> – Quoins. – Decorative diamond pattern on gable of southeast elevation. – Stretcher and solder brick flat arches above openings. ■ Original interior and storm windows on the northeast elevation. ■ Decorative wooden trim around original entrance on southeast elevation. ■ Barn complex (Central or Southern Ontario style) <ul style="list-style-type: none"> ■ Fieldstone foundations with cut stone cornerstones. ■ Timber frame construction. ■ Outbuilding No. 1 (driveshed) <ul style="list-style-type: none"> ■ Timber frame construction ■ Diamond shaped gable window on southwest elevation ■ Maltese/diamond cross shaped cut out on gable of northeast elevation ■ Mature tree lines <ul style="list-style-type: none"> ■ Along driveway and ROW ■ Fieldstone walls at the foot of the driveway

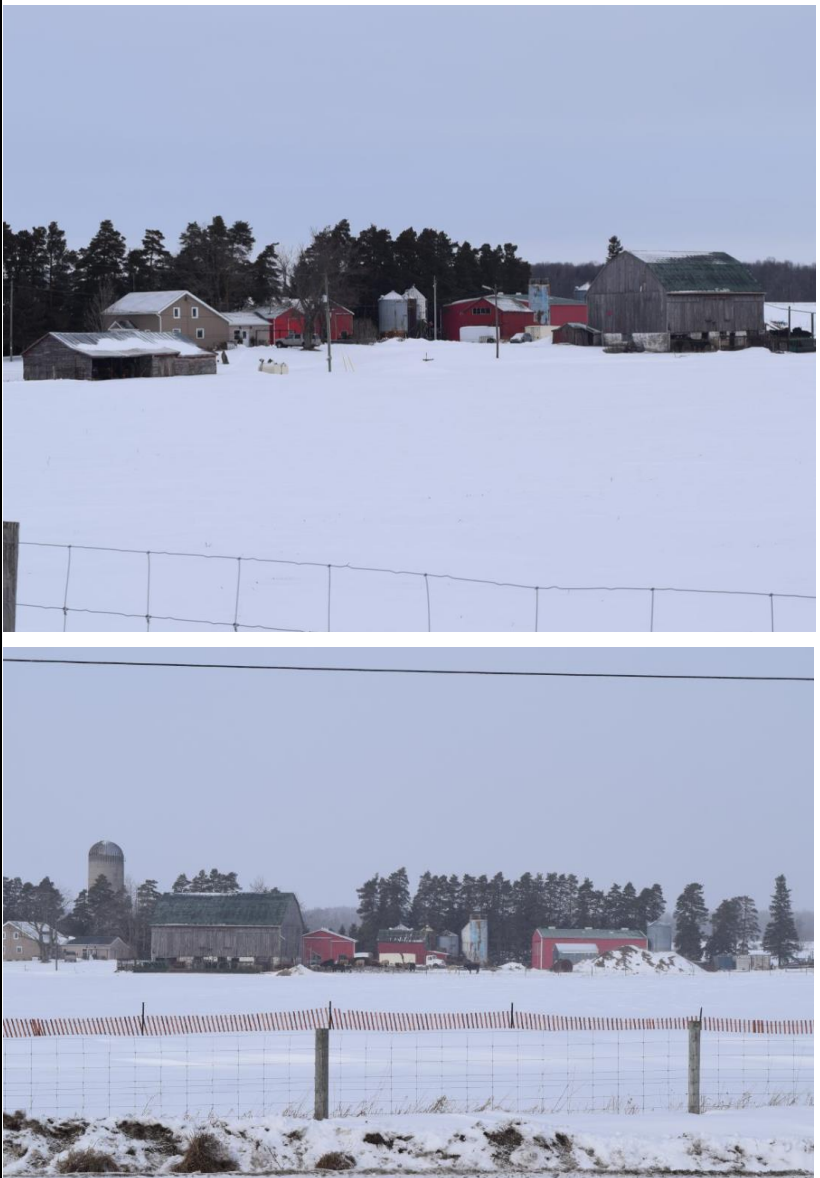
Address or Location	Cultural Heritage Status	Photograph	Description	Potential CHVI	Potential Heritage Attributes
18501 Mississauga Road	Listed (not designated) on the Town of Caledon's <i>Heritage Register</i>

<p>Described on the Town of Caledon's <i>Heritage Register</i> as a Neoclassical style farmhouse with vertical board exterior and an addition at the rear, dating c. 1850-1874.</p> <p>Historical research conducted for this Cultural Heritage Report determined that a farmhouse was located on the property as early as 1859 and appears to be situated in the same location as the present-day house at 18501 Mississauga Road. At that time, the property was listed under James Cameron of Lot 16, Concession 4 WCR.</p> <p>The house is a single-detached, storey-and-a-half, buff brick structure with a rectangular shaped main block (with a large one-storey extension to the northeast) and saltbox roof. The house is set back approximately 181 m from Mississauga Road and is accessed by a gravelled driveway to the southeast of the house.</p> <p>To the east of the house is a large timber framed barn with a metal gambrel roof and possible concrete faced stone foundation set-back approximately 219 m from Mississauga Road and accessed via the same driveway to the house. The barn appears to be of the Central Ontario Barn style popular during the latter half of the 19th century. Additional outbuildings on the property include a wooden shed with metal gable roof to the south of the house, two large concrete silos with an indeterminate outbuilding to the northwest of the house and a complex of four metal outbuildings and three metal silos to the northeast of the house.</p> <p>The property parcel consists of ploughed fields delineated by hedgerows/ treelines.</p> <p>NOTE: A preliminary heritage evaluation for this property is presented in APPENDIX C.</p>	<p>Design or physical value:</p> <ul style="list-style-type: none"> ■ One-and-a-half storey main block of the farmhouse ■ Barn No. 1 ■ Barn No. 1 <p>Historical or associative value:</p> <ul style="list-style-type: none"> ■ N/A <p>Contextual value:</p> <ul style="list-style-type: none"> ■ Spatial organization and range of forms in building complex maintains and supports local character ■ Physical connection between the farmhouse and outbuildings 	<ul style="list-style-type: none"> ■ Main residence <ul style="list-style-type: none"> ■ Original one-and-a-half storey main block with rectangular floor plan and gable roof ■ Barn No. 1 <ul style="list-style-type: none"> ■ Timber frame construction ■ Fieldstone foundation ■ Gable roof ■ Barn No. 2 <ul style="list-style-type: none"> ■ Concrete block foundations ■ Timber frame construction ■ Metal gambrel roof. ■ Mature vegetation <ul style="list-style-type: none"> ■ Coniferous windbreaks around the house <ul style="list-style-type: none"> – Perpendicular to Mississauga Road, in a northeast to southwest orientation, to the northwest of the main building complex.

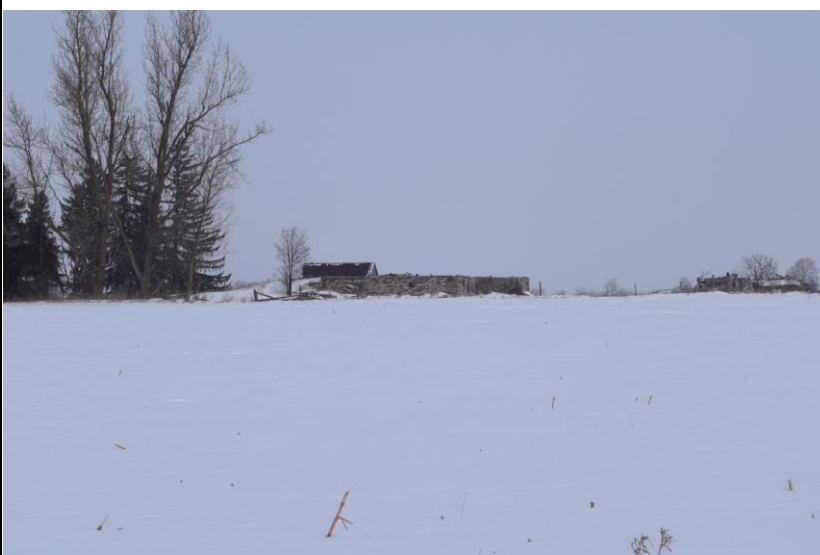
Address or Location	Cultural Heritage Status	Photograph	Description	Potential CHVI	Potential Heritage Attributes
1055 Charleston Sideroad	Identified on the Town of Caledon's <i>BHRI of Pre-1946 Structures</i>

<p>The property is identified on the Town of Caledon's <i>BHRI of Pre-1946 Structures</i> as the "property across the road at the southeast corner of Mississauga Road and Charleston Road".</p> <p>Historical research conducted for this Cultural Heritage Report determined that a farmhouse was located on the property as early as 1877 and appears to be situated in the same location as the present-day foundation remnants at 1055 Charleston Sideroad. At that time, the property was listed as part of the Morris Estate in the southwest half of Lot 15, Concession 4 WCR. The present-day outbuilding on the property appears to be of later construction.</p> <p>The foundation remnants appear to be rubble fieldstone. The foundation is set back approximately 73 m from Charleston Sideroad and is accessed by an overgrown dirt and grass driveway to the northeast of the foundation.</p> <p>To the southeast of the foundation are the remnants of a smaller structure's foundation and to the north of the foundation is a one-storey board and batten shed with metal roof set-back approximately 62 m from Charleston Sideroad and accessed via the same driveway to the foundation.</p> <p>The property parcel consists of ploughed fields delineated by hedgerows/ treelines.</p> <p>NOTE: A preliminary heritage evaluation for this property is presented in APPENDIX C.</p>	<p>Design or physical value:</p> <ul style="list-style-type: none"> ■ N/A <p>Historical or associative value:</p> <ul style="list-style-type: none"> ■ N/A <p>Contextual value:</p> <ul style="list-style-type: none"> ■ Spatial organization and range of forms in building complex maintains and supports local character ■ Physical connection between the remnant outbuilding(s) and former surrounding farm 	<ul style="list-style-type: none"> ■ Rubble fieldstone foundations for both barn ruins. ■ Treelines delineating the edge of the farm building complex.

<p>1055 Charleston Sideroad Identified on the Town of Caledon's <i>BHRI of Pre-1946 Structures</i></p>	<p>The proposed extraction area will encompass the majority of the property parcel, and is anticipated to directly impact the property's potential CHVI and heritage attributes which are linked to its BHR (i.e., the foundation remnants) and mature treelines.</p> <p>The proposed extraction area encompasses the area of the foundation remnants and mature treelines, Proposed construction activities include extraction (blasting) as well as the possible use of temporary workspaces/ laydown areas, vegetation removal, and heavy machinery/ traffic.</p> <p>The location of the proposed construction activities suggests the possible demolition/ destruction of the foundation remnants and mature treelines which will result in a change in land use and permanent removal of all potential CHVI and heritage attributes identified for the property (major direct impact).</p> <p>Given the possible demolition/ destruction of the BHR on the property, indirect impacts from vibration, fugitive dust emissions and shadows have not been assessed.</p>	<ul style="list-style-type: none"> ■ A major direct impact is anticipated for this property. To inform the impact assessment and offer focused mitigation recommendations, a preliminary heritage evaluation was completed to identify the property's potential CHVI and heritage attributes (see APPENDIX C). 	<ul style="list-style-type: none"> ■ Based on the results of the preliminary heritage evaluation the portion of the property mapped on Figure 10 contains cultural heritage value. As a result: <ul style="list-style-type: none"> ■ Prior to any site alteration or extraction within these areas, a Heritage Impact Assessment (HIA) shall be required. The HIA should include a full evaluation of the property using the criteria prescribed in O. Reg. 9/06, provide a Statement of CHVI with list of heritage attributes, identify all direct and indirect impacts, and recommend site-specific

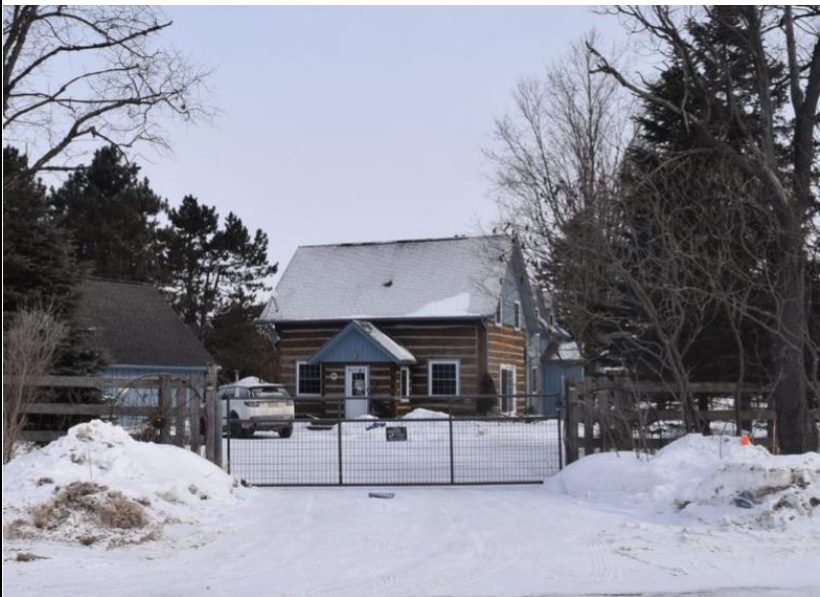
Address or Location	Cultural Heritage Status	Photograph	Description	Potential CHVI	Potential Heritage Attributes
18309 Mississauga Road	Property of potential CHVI

<p>While historical research conducted for this Cultural Heritage Report did not identify the presence of a farmhouse on the property before 1973, the hewn log construction suggests the structure may have been relocated or reassembled from repurposed materials (like 18205 Mississauga Road).</p> <p>Characteristics of the house include that it is a single-detached, storey-and-a-half structure with a rectangular shaped main block (with an extension to the northeast) and medium pitch gable roof. The house is set back approximately 30 m from Mississauga Road and is accessed by a paved asphalt driveway. To the west of the house is a detached garage of recent construction.</p>	<p>Design or physical value:</p> <ul style="list-style-type: none"> ■ Hewn log constructed house <p>Historical or associative value:</p> <ul style="list-style-type: none"> ■ N/A <p>Contextual value:</p> <ul style="list-style-type: none"> ■ N/A 	<ul style="list-style-type: none"> ■ House main block with: <ul style="list-style-type: none"> ■ Hewn log construction ■ Rectangular shaped plan

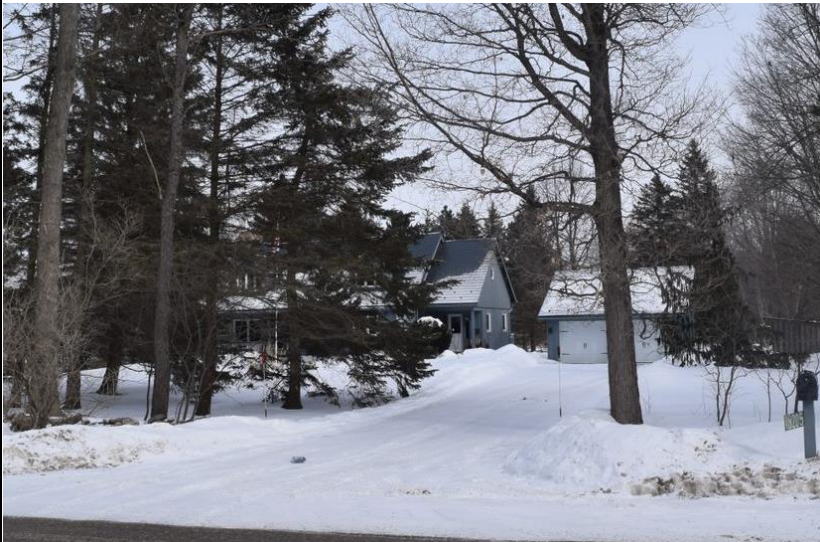
18205 Mississauga Road	Identified on the Town of Caledon's <i>BHRI of Pre-1946 Structures</i>

<p>The property is identified on the Town of Caledon's <i>BHRI of Pre-1946 Structures</i> as built with logs/ wood from the Ottawa Valley, however, historical research conducted for this Cultural Heritage Report could not identify the structure on pre-1973 mapping.</p> <p>The house is a single-detached, storey-and-a-half structure with a rectangular shaped main block (and small extension to the southeast), medium pitch gable roof, and two dormer windows on the front/ southwest façade. The house is set back approximately 32 m from Mississauga Road and is accessed by a paved asphalt driveway leading to a detached garage of recent construction (appears to be vertical siding) southeast of the house.</p>	<p>Design or physical value:</p> <ul style="list-style-type: none"> ■ Ottawa Valley wood/ log construction <p>Historical or associative value:</p> <ul style="list-style-type: none"> ■ N/A <p>Contextual value:</p> <ul style="list-style-type: none"> ■ N/A 	<ul style="list-style-type: none"> ■ House main block with: <ul style="list-style-type: none"> ■ Log façade ■ Rectangular plan

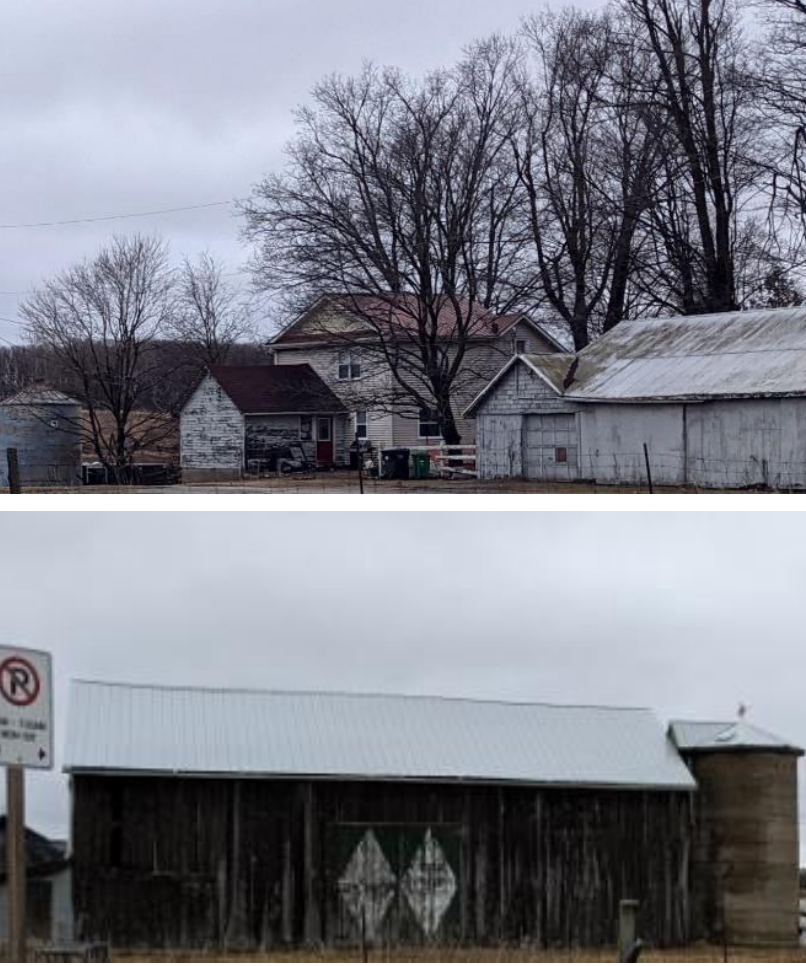
Address or Location	Cultural Heritage Status	Photograph	Description	Potential CHVI	Potential Heritage Attributes
833 Charleston Sideroad	Listed (not designated) on the Town of Caledon's <i>Heritage Register</i>

<p>Described on the Town of Caledon's <i>Heritage Register</i> as a late Neoclassical style farmhouse dating c. 1875-1899.</p> <p>Historical research determined that a farmhouse was located on the property as early as 1877 and appears to be situated in the same location as the present-day house at 833 Charleston Sideroad. At that time, the property was listed under William Richardson of the northeast half of Lot 15, Concession 4 WCR.</p> <p>The house is a single-detached, two-storey wood frame structure with a rectangular shaped main block (with a small one-storey wood frame extension to the northeast) and low-pitch gable roof. The house is set back approximately 50 m from Charleston Sideroad and is accessed by a gravelled driveway to the northeast of the house.</p> <p>To the north of the house is a large timber framed barn (including a large extension to the east) with a relatively new metal gable roof but indeterminate foundation. It is set-back approximately 35 m from Charleston Sideroad and accessed via the same driveway to the house. The barn appears to be of the Central Ontario Barn style popular during the latter half of the 19th century. Additional outbuildings on the property include a silo to the southwest of the barn, two wooden sheds to the southeast of the barn and one metal shed to the northwest of the house.</p> <p>The large property parcel consists of large, ploughed fields delineated by hedgerows/ treelines.</p>	<p>Design or physical value:</p> <ul style="list-style-type: none"> ■ Late Neoclassical style farmhouse ■ Central Ontario Barn style <p>Historical or associative value:</p> <ul style="list-style-type: none"> ■ N/A <p>Contextual value:</p> <ul style="list-style-type: none"> ■ Physical connection between the farmhouse and outbuildings ■ Spatial organization and range of forms in building complex maintains and supports local character ■ Maintenance and support of the rural landscape of area (large fields lined by hedge rows/ trees) 	<ul style="list-style-type: none"> ■ House main block with: <ul style="list-style-type: none"> ■ Wood frame ■ Rectangular shaped plan ■ Barn with: <ul style="list-style-type: none"> ■ Timber frame ■ Large agricultural fields delineated by hedgerows/ treelines

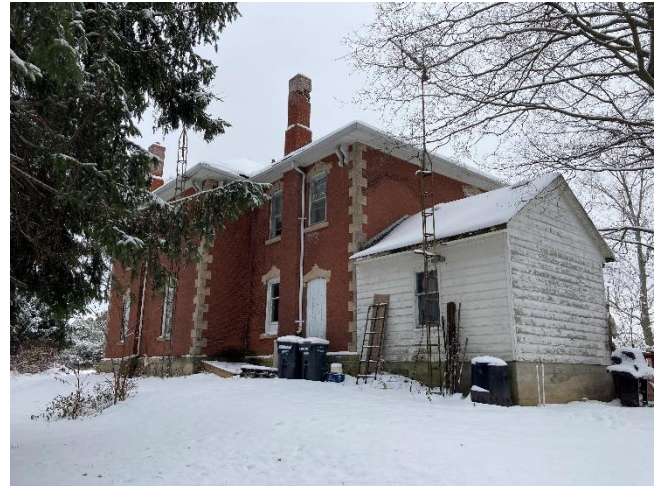
Plate 3: Oblique view of west and south elevations, including rear addition

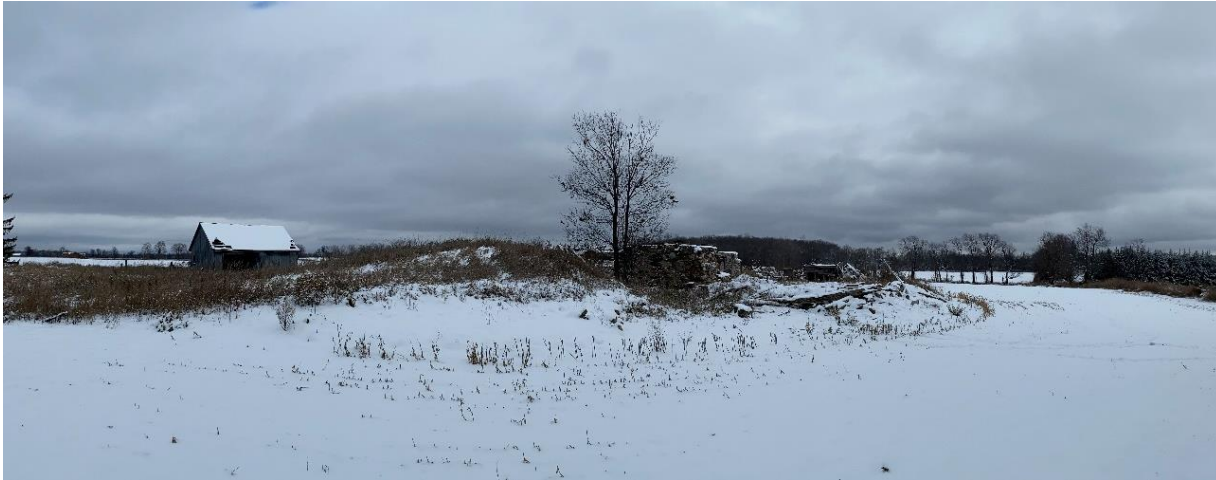
Plate 7: View across extant outbuilding and ruins at 1055 Charleston Sideroad, facing northeast

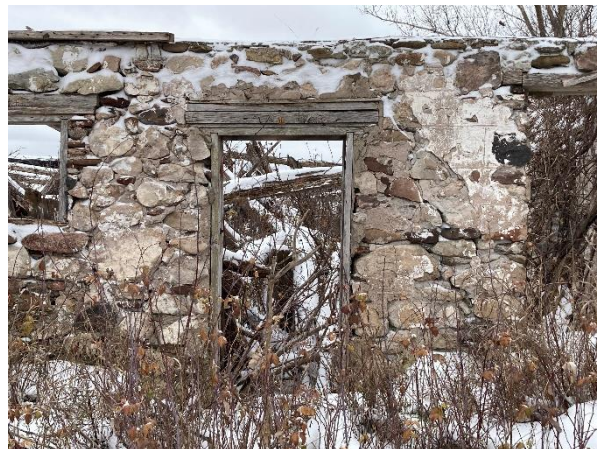
Plate 9: Detail showing wood doorframe and window frames and parged fieldstone foundations

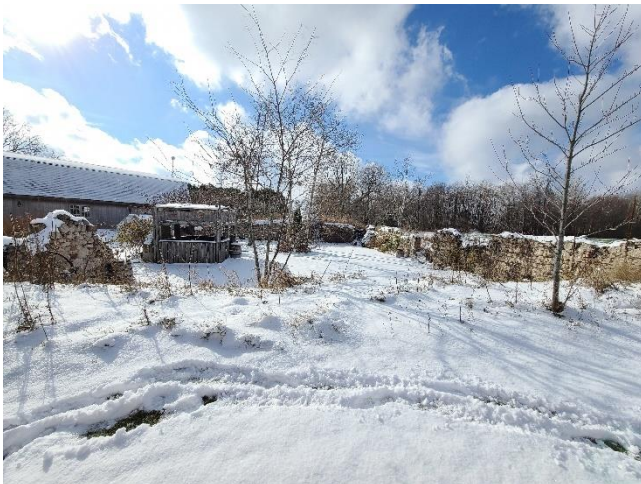
Plate 17: Barn foundation ruins, looking southwest

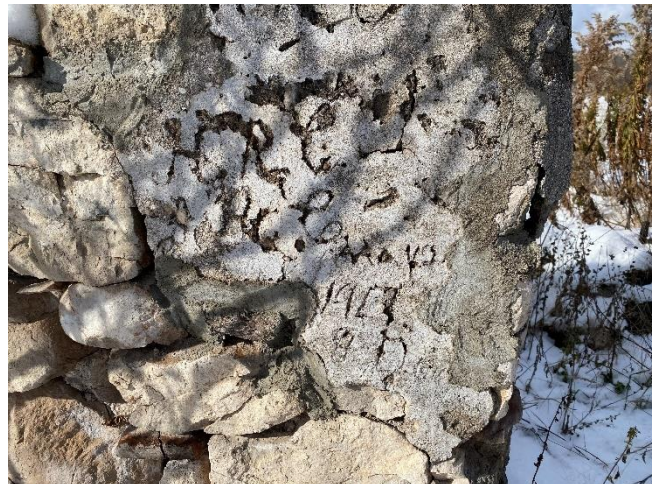
Plate 18: Closeup of inscription on barn ruins
